# Hunstanton Coastal Defences

## Section F & G Interim Works Non-Technical Summary

August 2026

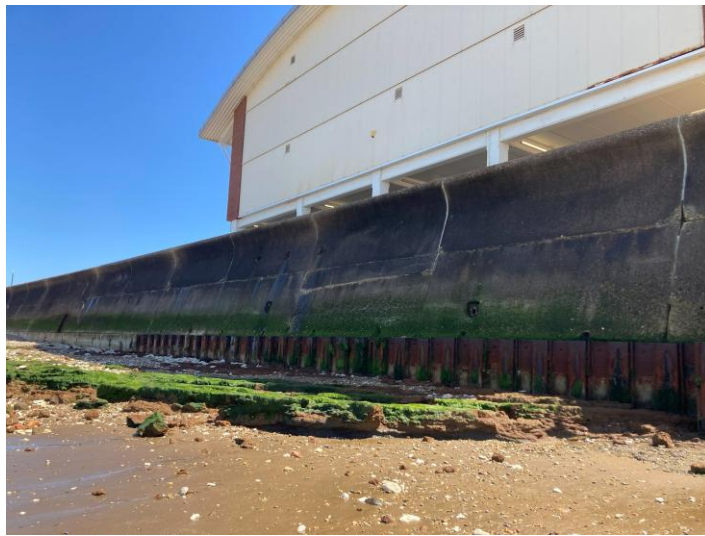
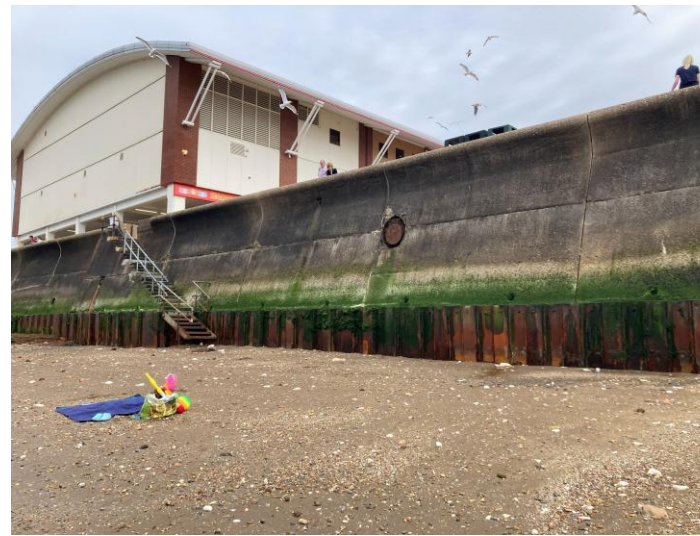
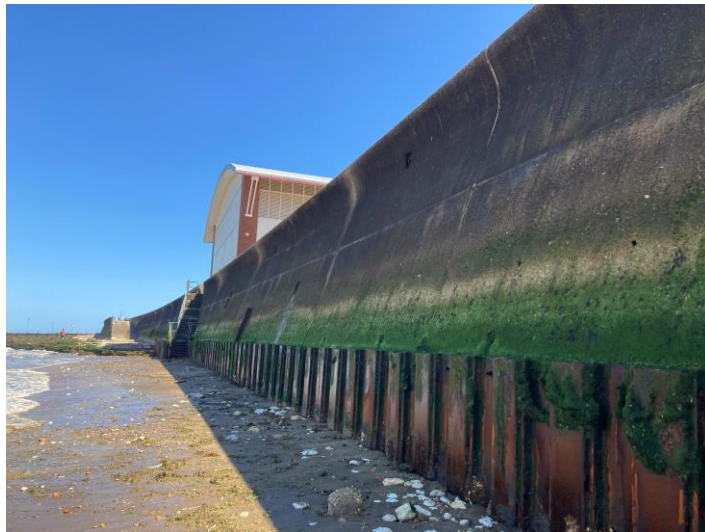
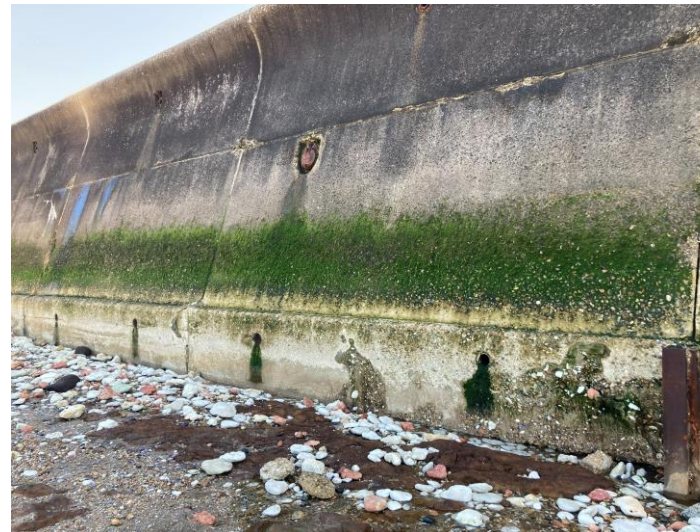
# Beach Levels Section G

Sheet pile exposure is now between 100cm to 149cm across length of Section G

Base of seawall toe exposed adjacent to northern end of sheet piles

Exposure of sheet piles over 1m sustained for over 2 months

Up to 39cm of beach material erosion occurred between the 25<sup>th</sup> June 2026 to 3<sup>rd</sup> July 2026

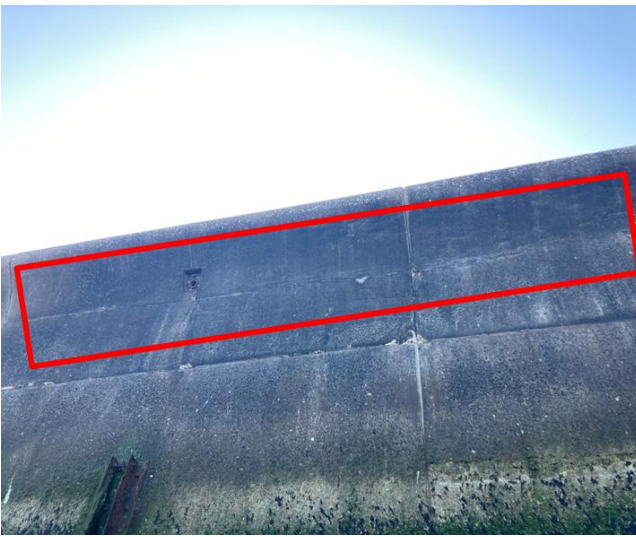
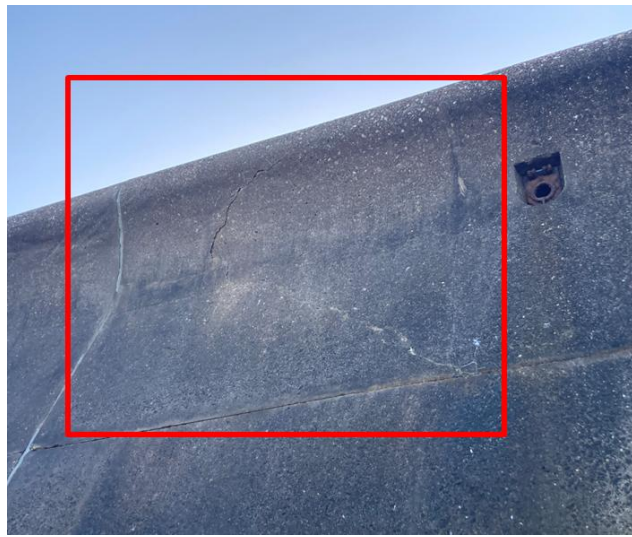
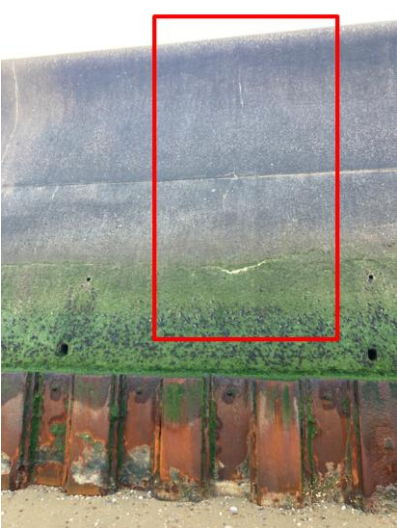
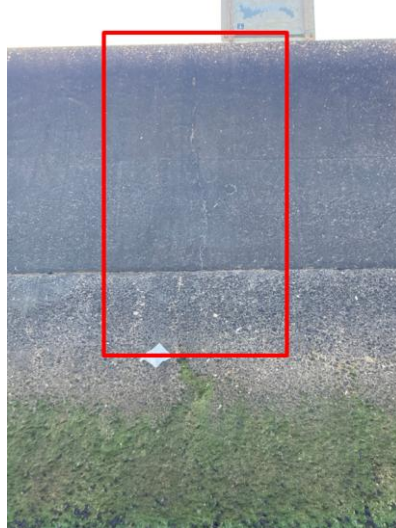
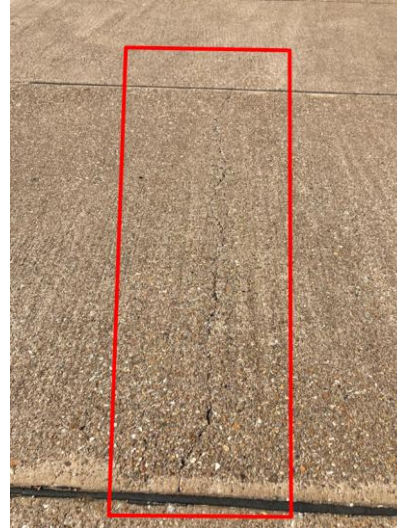
# New Structural Defects

New structural defects have been observed in June 2026 which were not present in May 2026.

Appearance of these defects corresponds with exceptionally low beach levels recorded

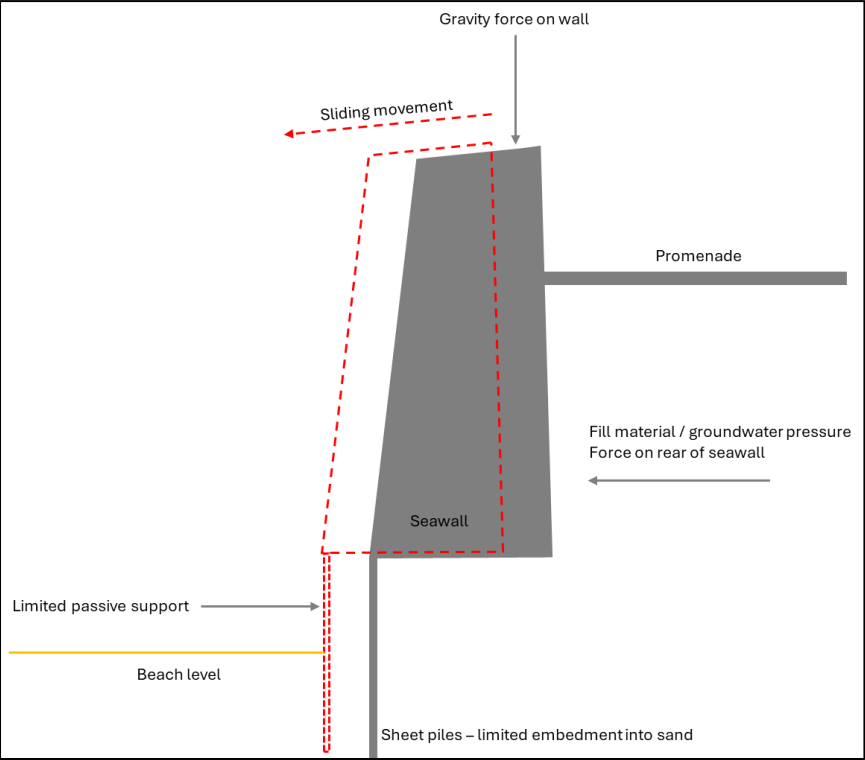
# Diagram of sliding failure

Based on the aforementioned reasons, the critical sliding failure mechanism identified is that assessment is directly driven by loss of passive resistance from the beach material in-front of the toe, continued erosion at the rate observed materially and progressively reduces the margin of safety against that mechanism.

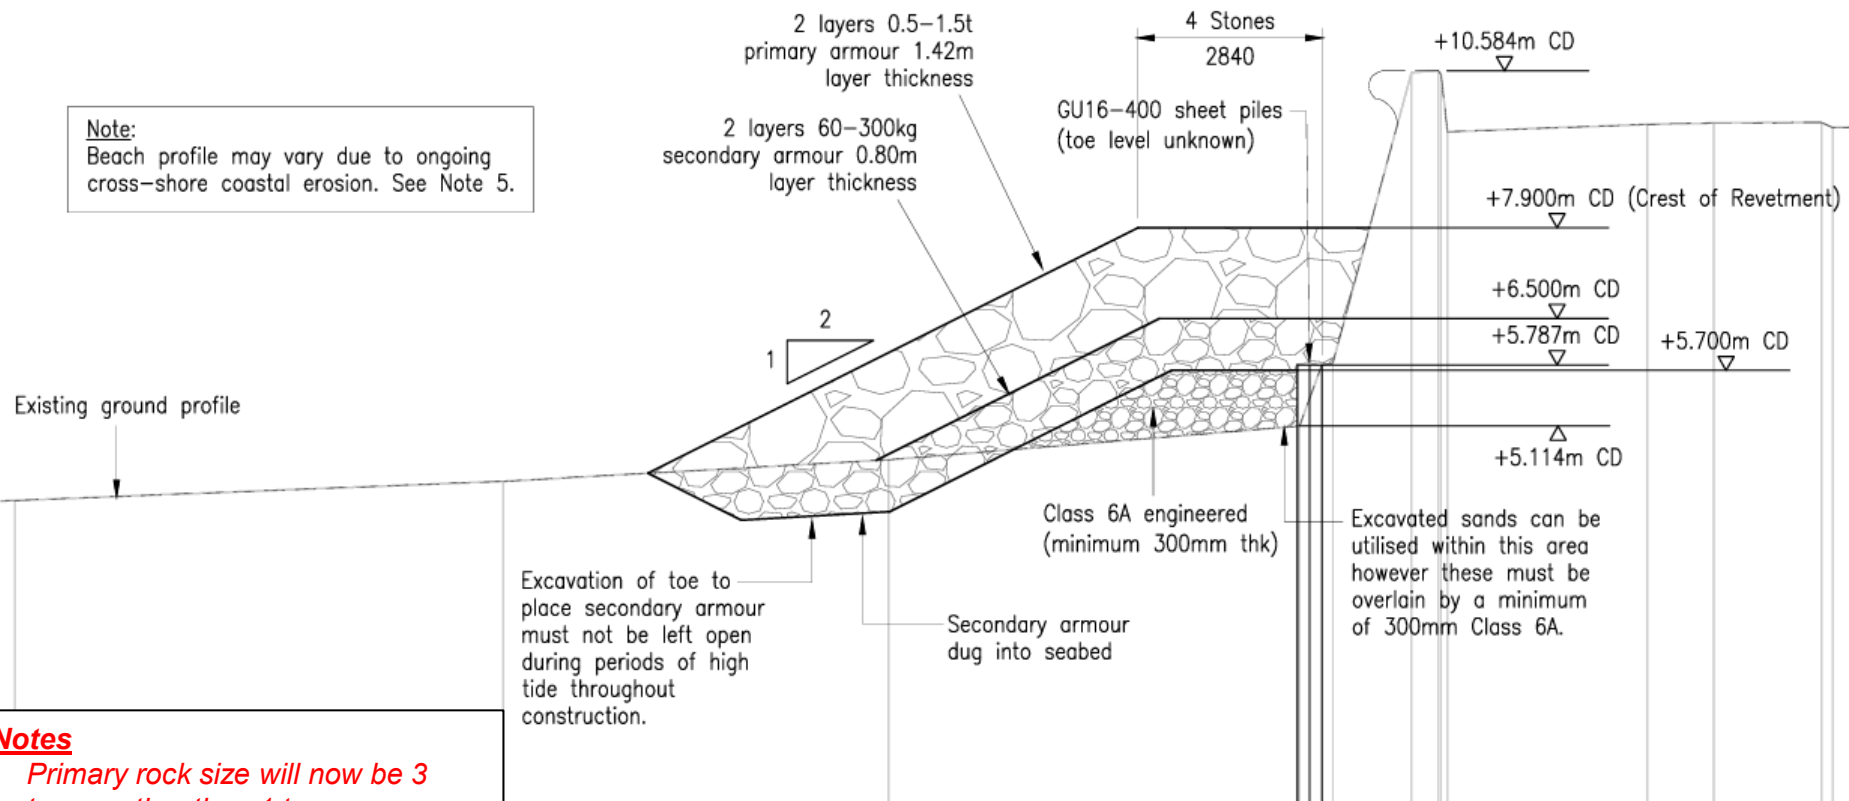
# Rock Armour Design

Beach profile may vary due to ongoing cross-shore coastal erosion. See Note 5.

- *Primary rock size will now be 3 tonne rather than 1 tonne*
- *Increased Class 6A engineering fill will be needed due to the lower beach levels on site*

Temporary installation of **granite rock armour at the base of the seawall toe** to provide sufficient mass to prevent further structural movement and failure until a permanent solution can be designed and constructed as part of the Hunstanton Coastal Defence capital works project.

Rock armour dimensions:                      200m (L) x 9m (W) x 2-3m (h)  
Primary rock layer will be 3 tonne rocks
