HUNSTANTON HERITAGE GARDENS

CONDITION SURVEY

HERITAGE LOTTERY FUND
PARKS FOR PEOPLE PROGRAMME

ROUND 2 APPLICATION FEBRUARY 2016

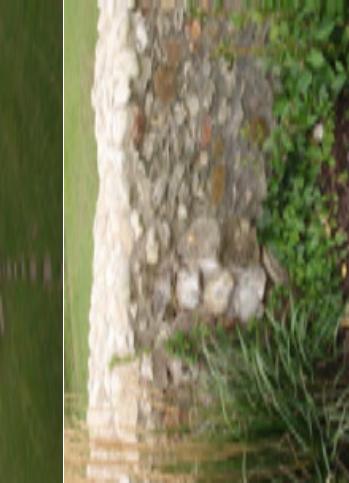
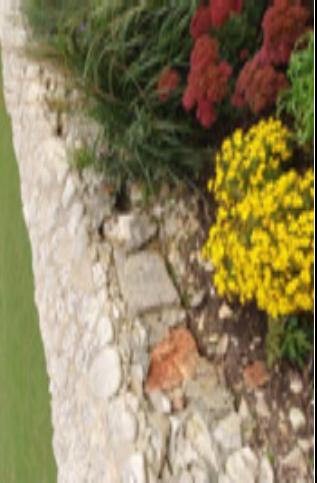
3.1.2	<p>South wall with arched opening at west buttressed to north, south & west 4m approx. overall height through western section.</p> <p>To east of south arch opening the walling reduces to approx. 600mm above ground level to south and continues roughly to a level to east & north.</p> <p>Rubble masonry, 'rough racking' to wall cappings at high and low level.</p> <p>Some dressed Barnack elements.</p> <p>See Appendix C for plans showing these locations:</p> <p>South wall;</p> <ul style="list-style-type: none"> • at A window reveal at high level, west jamb, 2 stones. • at B base of door jamb with door recess and outer blinds to attached column base. <p>North wall;</p> <ul style="list-style-type: none"> • at C chamfered base to door reveal and reveal stones re-used, possibly laid flat. 	<p>Sections of low level walling partially collapsed, particularly to interior, and some plant growth. Upper walling levels mortar and soft chalk eroded.</p> <p>Rebuild loose and disrupted areas, repoint pockets and eroded areas to watershedding profile. Implement flush pointed finish in soft lime based mortars to better protect and distinguish dressed masonry elements.</p> <p>Consider alternative treatment to wall top using soft capping techniques. Subject to advice and review of latest trials by Historic England.</p>	2

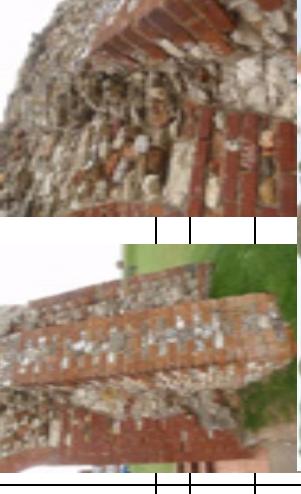
Item	Element and Description	Condition and Recommendation	Repair Category	Photograph
3.1.7	B4; Soft red brick quoins, flint facing to north slope mortar flaunch at head and base of west face.	Lowest 2 brick courses eroded at base. Mortar flaunch unsupported. North east internal corner eroded. Hard mortar used in excess. Remove unsightly hard mortar. Insert masonry to fill pockets and re-support. Repoint to weathering profile.	2

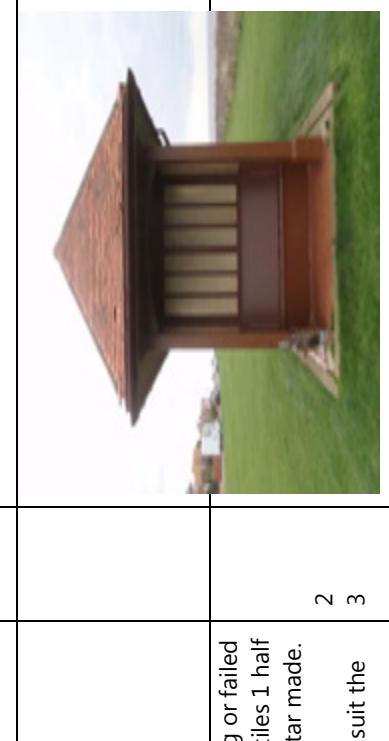
3.2	North Shelter

3.2.1	Generally, Timber framed structure, similar to the south shelter in construction (c.1898) but with shallower pitch to the roof and no gablets. 8 main timber posts with timber boarded panels and bench seating to dado level vertical panels of reinforced translucent sheeting above. Painted boarded soffit	Roof patched with mis-matched concrete tiles. 12 missing or failed west slope, 9 to south, 8 to east, 11 to north. 2 full ridge tiles 1 half and 1 ridge end to north, ridge capping is otherwise mortar made. Replace missing and broken tiles to match.	2

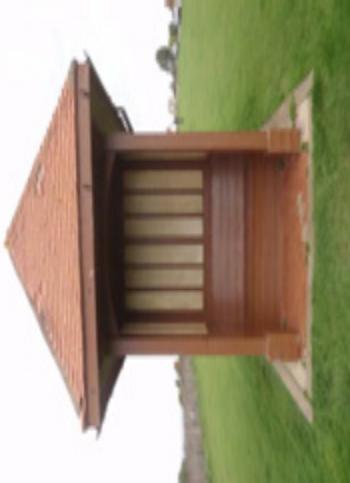
Item	Element and Description	Condition and Recommendation	Repair Category	Photograph
3.2.3	Rw goods; [brown] Plastic gutter & down pipes to north west & south west. Pipes discharge 300mm above paving, possibly formerly connected to CI drain.	50% broken & missing. Drain visible at NW outlet. Consider removal of the rw goods, altogether, or replacement in cast aluminium as a more robust material.	1

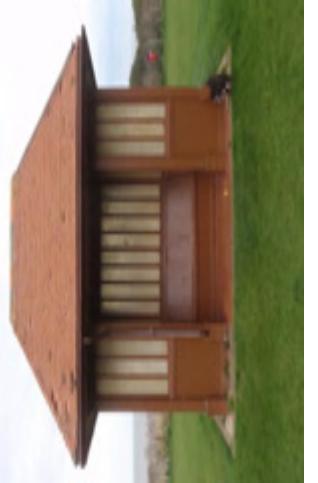
3.2.4	Timber Structure; 8no. posts on sandstone bases raised over paved platform. Boarded soffit & moulded profile/cap to posts. Boarding to dado level. Painted timber seat 1 plank width & boarded back at rake. Boarded stall riser.	Boarding added at low level as a plinth to conceal decayed base of posts. Assume originally posts and structured exposed [as the south shelter]. Post to north re-faced post at west centre north entire to plinth level. West centre south & south faced in ply. South east ply faced. East ply faced. North east base exposed by lost section of boarded plinth. Ship lap boarded panels to north & south of centre west elevation. East elevation vertical boarding. Different board widths and setting out to panels, seats, stall risers etc. Remove added and mismatched elements and repair/restore original structure and boarding.	2

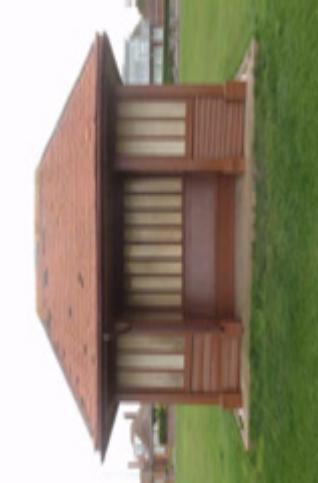
3.2.5	Reinforced polycarbonate/glassfibre, translucent glazing in narrow vertical panels above dado level.	Yellowed with age [EDP image shows installation 1982] shabby and unsightly. Durable replacement panels in appropriate material desirable.	2

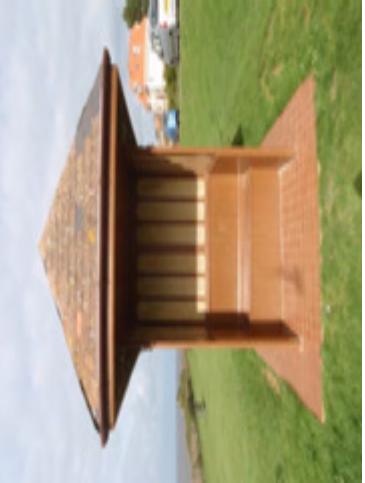
Item	Element and Description	Condition and Recommendation	Repair Category	Photograph
3.3	Middle Shelter Generally; Timber panelled structure, braced by 4No. posts at low level. Roof structure a lattice of timber beams with cast iron bracket supports. Reportedly dismantled and re-erected 6m inland [after 2009?]. This shelter is very similar in plan and elevation to 1898 Boulton and Paul catalogue Arboretum Shelter titled 'Jubilee Memorial' (likely celebrating coronation of King Edward VII and Queen Alexandra in 1902). Its current location near Clarence Road ties in with use by the Convalescents of the 'Home of Recovery' seen on the 1905 OS plan.	Construction not fully understood due to applied elements and no opening up. Roof structure suspect. Heavy accumulation of paint coatings obscures detail to CI brackets.

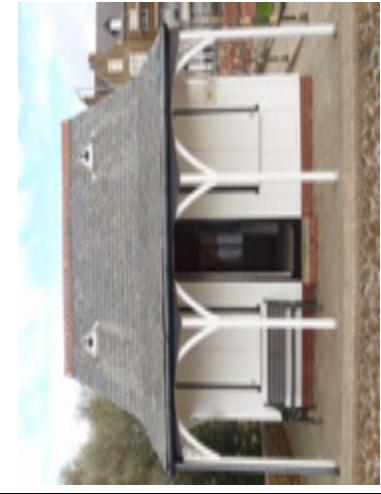
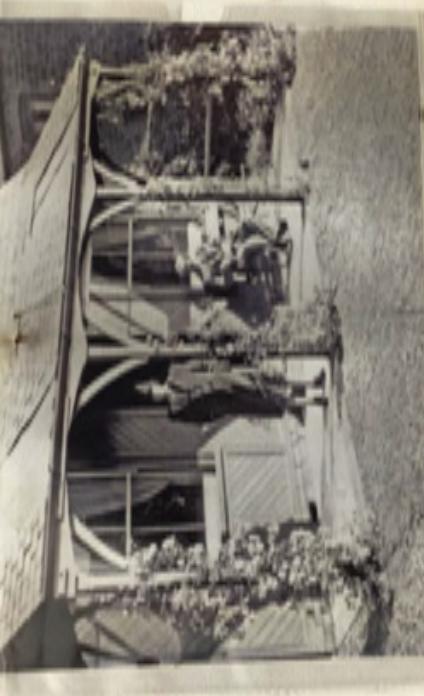
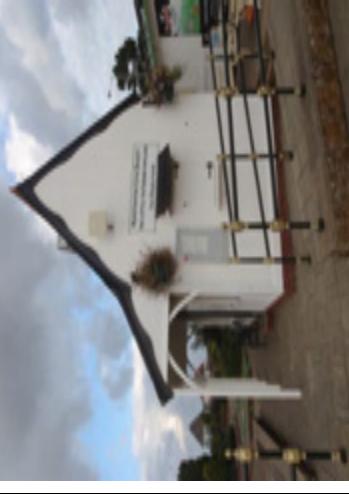
Item	Element and Description	Condition and Recommendation	Repair Category	Photograph
3.5	ESPLANADE STRUCTURES			
3.5	<p>Edwardian Pavilion</p> <p>Timber framed and boarded pavilion raised over a machine made brick plinth 3 courses above GL. Timber floor over ventilated void. Timber dhss windows to west elevation, external shutters added, hatch formed and, shutters and pent roof added to south elevation. All painted externally, main area internally clear finished pine boarding of very good quality.</p> <p>The building formerly stood in the garden of No.2 Westgate and was donated by Lt. Col. & Mrs G.B. Wellard.</p>

3.5.1	<p>Roof; Steep pitched slate to main duo pitch and shallow slip roof to west verandah [formerly with patent glazed sections above the windows], 2No lead covered gablet vents trefoil pierced and painted to west slope 4 courses below the ridge.</p> <p>Pierced terracotta ridge tiles.</p>	<p>Eaves boards replaced to shallower western pitch, to not quite matching profile. Replace to match to maintain integrity.</p> <p>1 slate missing north west to verandah pitch and 1 slipped to north eaves. Replace to match.</p>	<p>2 1</p>

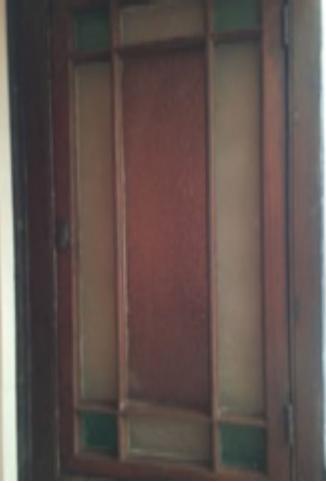
3.5.5	<p>2no d/h vertical sliding sashes. 2 over 2. N window glazed with GWPP to lower sash. Plain above.</p> <p>South window film applied to lower sash. Knurled and painted sash keeps – brass.</p> <p>Coloured patterned glass fan light over 6 panel door.</p> <p>Diagonal boarding to bottom panels, painted glass above.</p> <p>2 chubb locks + rim mortice lock & latch, rebated lock & latch with brass oval handle + Yale rim lock.</p>	<p>Keep plate to north window missing. Replace to match existing.</p> <p>Fanlight boarded over externally, assumed for security. Desirable to use security glass externally to maintain original intent and provide lay light to interior.</p> <p>Bottom rail/hinge stile suspect. Repair original fabric in selected durable timber to original profile.</p>	3 3

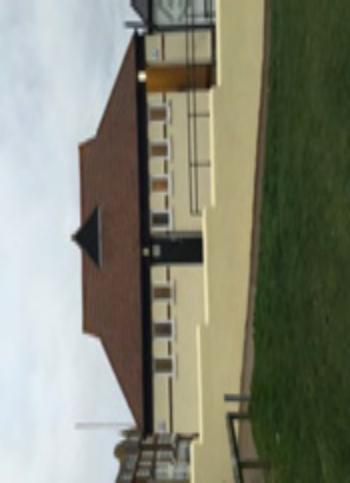
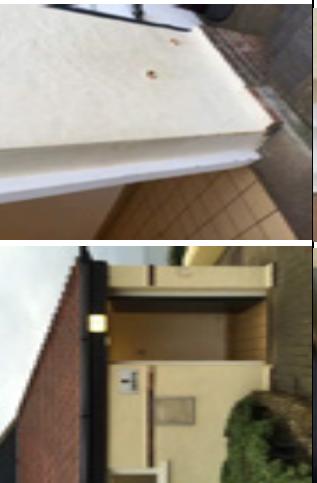
3.6.2	Rw goods; Profilled plastic gutter and square section down pipes	In good order.		
3.6.3	Walling; Opening to entrances to Gents and Ladies wcs assumed to have been reduced in width and door and frame fitted, from evidence of threshold stones.	Patches of missing and damaged paintwork and disruption to render finish. Monitor. Redecorate in cycle. Rust to metal corner bead at west jamb of entrance to Ladies wc. Remove paint de-rust and treat or replace with stainless steel. Rust to fixings for former handrail to adjacent steps. Remove entirely and make good or thoroughly de-rust and paint protect.	3 3 3

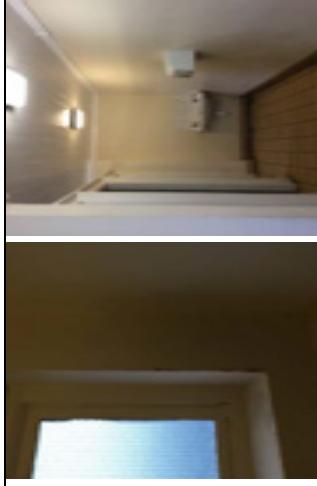
3.6.8	Floor to ceiling masonry walls, plastered and painted to cubicles, tiled skirting matching flooring, except to rear of wcs, timber boarded enclosure to wc cisterns.	In fair order, tired looking, particularly around hand drier and fittings. Some rust to corner beads to plastered reveals. Refurbish. Boarded enclosure vulnerable to damp at base and not easily cleaned in this location. Consider alternative material.	3 3

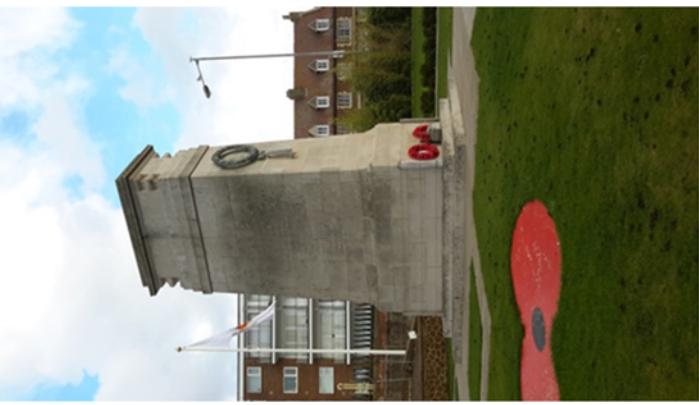
Item	Element and Description	Condition and Recommendation	Repair Category	Photograph
3.7	Cenotaph and 1953 Flood Memorial Generally Rectangular Portland stone memorial situated in the Esplanade gardens to commemorate those who gave their lives in the Great War 1914 - 1918 and WWII 1938 - 1945. Rectangular base, four stone courses and tapered section with decorative capping stones. 2 Portland stone steps to base, copper wreath mounted to west elevation and carved inscriptions to all 4 sides. Timber post and wire for securing wreaths at low level of base at top of steps. 600 mm square concrete paving slabs about base of stone steps with grass areas around paving, 2 no. painted ground level concrete? Poppies set within grass area. Carstone walled raised planting bed with coping maintained by British legion. Note: Previous condition surveys have been carried out by John V A Froggett in 2000 and by Januaries (date currently unknown but understood to be in the late 1990's). The 2000 condition survey notes "ground around base has an apron of paving slabs. The memorial is situated in a well maintained area of grass lawn surround by a small hedge." The hedging can be seen in the 1982 Lynn News aerial photo (without the rose beds and concrete poppies). The cenotaph can be seen on the Francis Frith 1921 photograph showing the original low hedge setting.	Evidence of previous repointing to side elevation facing away from butterfly shelters. A few open joints at base of monument to steps which would benefit from being repointed. Inscriptions go over some mortar joints which have become slightly eroded but without large detriment to legibility of inscriptions. Monitor and consider re-pointing and re-forming of letters, if inscriptions become illegible. Open joint at top of capping stones is allowing water to stain inscription of "1939-1945" and would benefit from appropriate mortar repointing. Minor lichen growth to stone base, particularly to more sheltered east elevation splayed stone forming transition between main shaft and base of monument. Painted concrete poppies have failing paint finish. Would benefit from scraping back old coatings and application of new finish.	5 2 2 2 5

Lichen growth to base

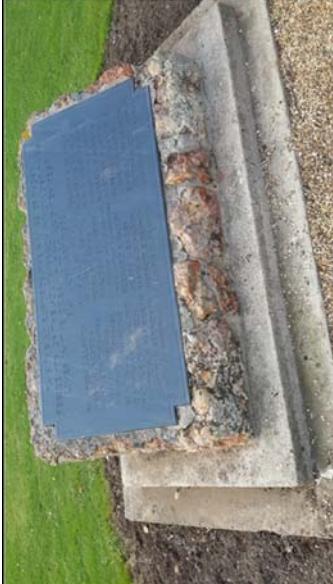
Item	Element and Description	Condition and Recommendation	Repair Category	Photograph
	1953 memorial to flood Plaque mounted on mortar pointed carrstone base set on 2 stone plinths. The floods of 31 st January 1953 caused significant damage; 35 bungalows had been wrecked, 70 more had been damaged, 180 beach huts had been lost, 6000 acres between Hunstanton and Wolferton Station had significant damage. 31 people – 15 British and 16 Americans – had died in Hunstanton.	In good condition. Localised pointing failing. Carry out minor repointing works	5

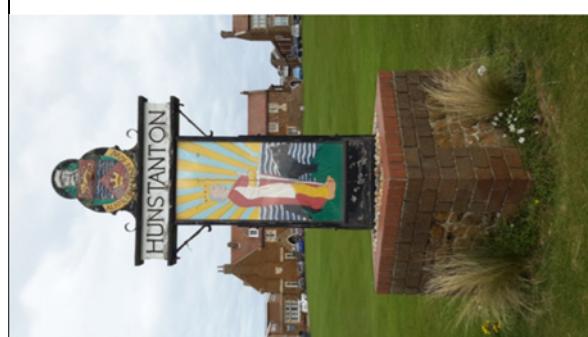
3.8	UPPER GREEN Hunstanton Town Sign	<p>Top section of sign has 2 splits in the timber with open joints and has a lean. Minor lichen growing on the top sign and minor areas of paint failing to less exposed elevation. Elevation facing the sea has more significant paint loss to all timber areas.</p> <p>Carry out redecoration to match existing paint scheme and provide access for inspection for timber repairs.</p> <p>Centre split to carved main section of sign which is seen from both sides. Condensation build up seen on inside of glass to less exposed elevation with minor mould growth internally. Unable to determine if timber has been affected as unable to gain access for closer inspection. Remove glass panels to enable closer inspection to determine what repairs are necessary.</p> <p>Rust staining and paint failing to metal side support plates and plate to side nearest sea has a bowed section. Base has vertical crack to south elevation which extends from coping down to carrstone decorative panel. Open joints around carrstone to same elevation and lichen growth to pointing. Elevation of base facing sea has minor crack from coping down to carrstone decorative panel and small areas of open perpend joints to brickwork. Corner cut brick forming</p>	1

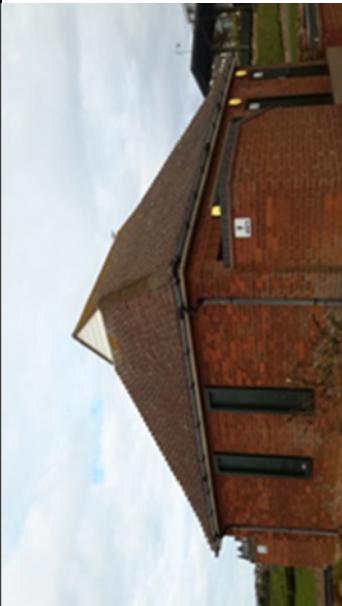
3.11.1	Roof: Plain tile roof with tiled hips and ridge with 2 areas of white boarding. Soil vent pipe to end elevation. Lead flashing between plain tile and boarding areas to East and West elevations. Sun faded black plastic gutter with 2 sunfaded black square profile downpipes. External lighting sensor mounted to boards to north elevation at high level. Upvc white fascia board and soffit with no evidence of ventilation. No access to the roof void.	1 down pipe unconnected between swan neck and outlet point to west elevating facing sea. The gutter and rainwater pipes are very sun faded and previous repairs can be seen. Joint locations look poor, with unsupported section to the north elevation and section which bows to east elevation. New replacement guttering and rainwater pipes to be installed.	1	2 The roof has area of moss and lichen growth, particularly to the 3 courses to the south elevation directly below the ridge. Treat with biocide and repoint open joints.

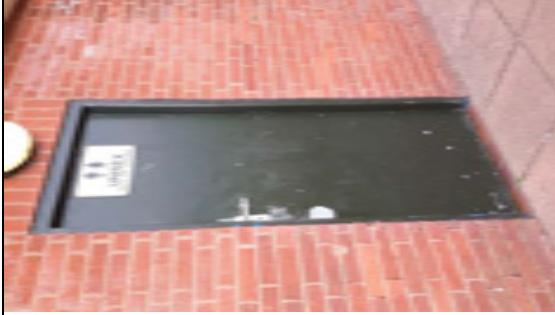
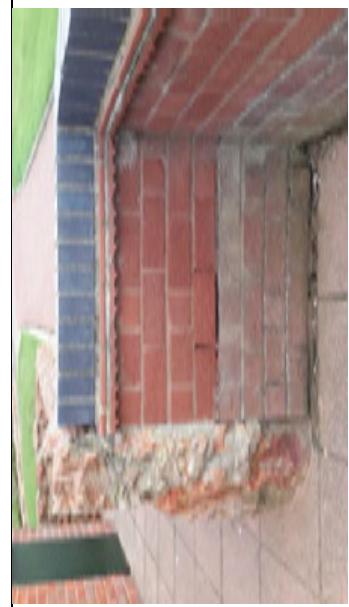
Item	Element and Description	Condition and Recommendation	Repair Category	Photograph
3.11.3	Doors: Entrance doors to gents, ladies 2 no. Unisex out of hours WCs and disabled WC. Doors are dark green painted timber with galvanised metal plates and painted timber frames. Plate to Disabled WC entrance door appears to be later addition to timber door. Disabled WC has radar scheme lock and blue painted metal horizontal grab rail. 'Unisex Out of hours' signage to out of hours WC with aluminium pull handle with backplate with keyhole and lock indicator. No access gained to gents WC, disabled WC and Unisex out of hours WCs.	Paint is flaking from doors (paint finishes generally do not like being applied to a galvanised steel finish without suitable acid etch priming and the atmosphere is particularly harsh due to the coastal environment). It is unknown whether the plates have been fixed to cover up areas of failing timber doors or provide enhanced security. Remove plate to disabled door to assess integrity. Allow for new replacement metal door with new ironmongery. Allow to thoroughly prepare and paint doors and frames. Allow for localised resin repair of timber frames to base.	1 1

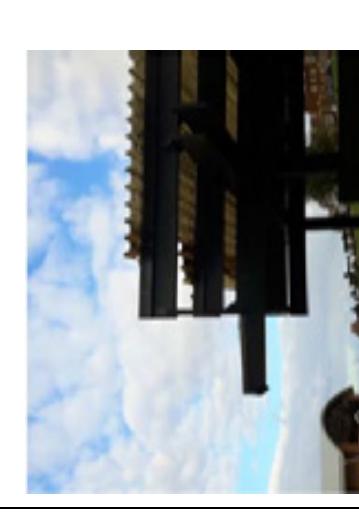
<p>Originally translucent sheeting has moss growth and rusting fixings throughout. Section of roof broken and missing to west elevation. Unable to see inside central timber gutter but likely to have moss and general build-up of detritus based on condition of roof sheeting.</p> <p>Given the issues with the roof, replacement of the roof covering and support is recommended using a new zinc lining for the gutter and new GRP sheeting.</p> <p style="text-align: center;">1</p>

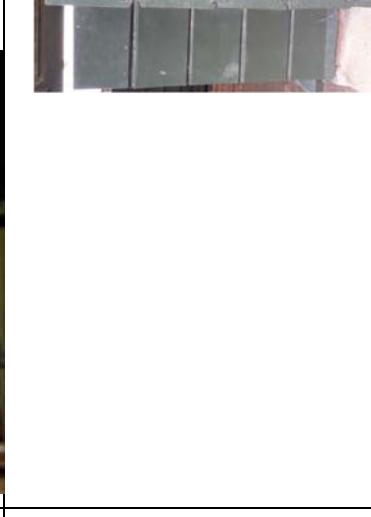
<p>Single joist to east elevation has become detached from roof joist and split. Evidence of previous metal angle repair evident. 2 other joists have splits to the east end elevation. Joist to west elevation has a significant split and likely to be rotten as exposed to elements due to missing section of roof.</p> <p>Areas of boarding have moved causing tongues to be exposed and general movement can be seen. This is exacerbated by the movement in the brickwork below and can only be monitored. Carry out preparation, suitably prime and redecorate.</p> <p style="text-align: center;">1</p>

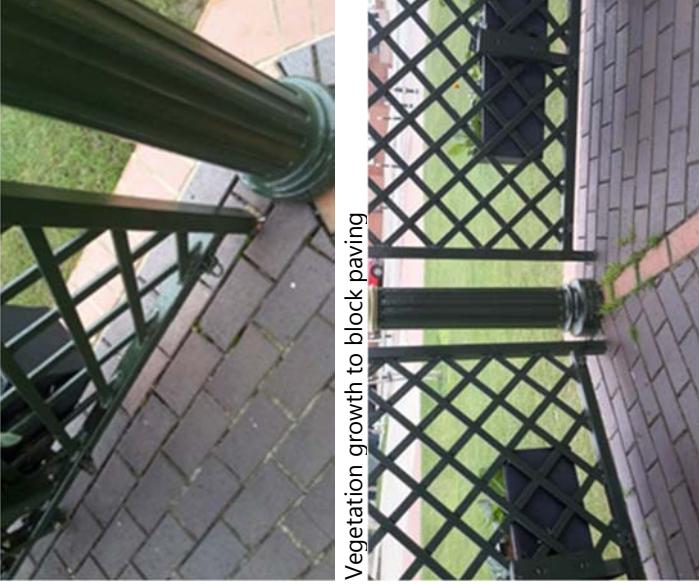
<p>Vegetation growth to block paving</p>

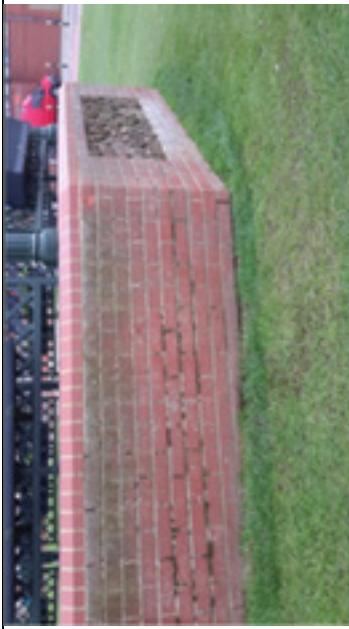
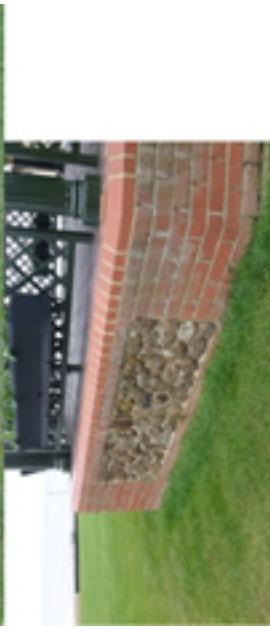
3.13.4	<p>Steps and block paving Softer red brick steps up to bandstand platform, with brick on edge detailing and 2 dwarf walls.</p> <p>Block paving laid in square pattern with open joints.</p>	<p>Bricks are eroded on their exposed external corners from wear and tear. Moss growth to joints. Treat with biocide and clean off. In the long term, the steps should be replaced.</p> <p>Block paving has grass growing through joints. Treat with biocide and clean off.</p>	<p>2</p> <p>2</p>

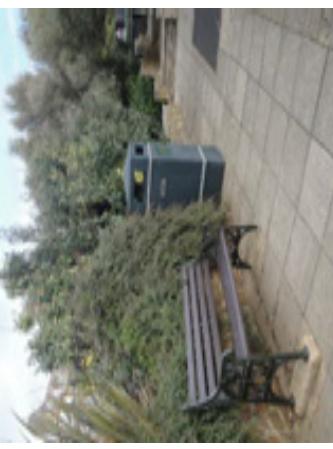
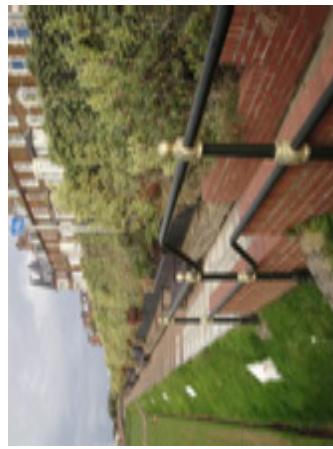
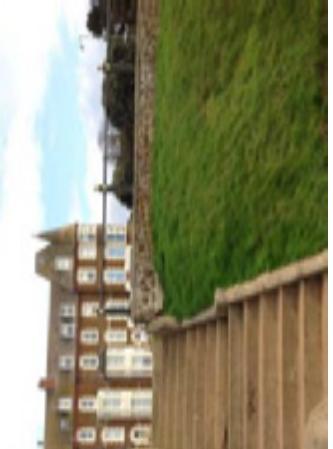
4.2.3	Railings & Fences	<p>The same style of the green and gold railings are continued in this area of the site, however in this area of the site some are instead painted black and gold. They line the steps and ramps; adjacent to the playground, adjacent to the Salad Bowl Café, between the crazy golf and the bowling greens, from the bowling greens up to the street.</p> <p>Along the western edge of the bowling greens is a lower simpler railing which is also painted green and gold.</p> <p>Around the viewpoint area, and from this down the ramps to the seafront is a metal bar railing with circular section frame and handrail. This is painted green.</p> <p>There is also a timber close board fence which runs the length of the most western path. This too is painted green.</p>	<p>The green and gold (and black and gold) railings are mostly in a fair condition and only require repainting.</p> <p>The lower simpler railings at the edge of the bowling green also look to be in a fair condition and not in need of being replaced.</p> <p>The metal bar railings are in various states – some are newer than others. The railings around the viewpoint in particular are showing signs of rust and require replacement.</p> <p>The timber boundary fence is in poor condition. Large sections of it are damaged and there are some sections which have been replaced or repainted at different times, making the fence look patchy. The fence is also an obtrusive barrier with no permeability between the footpath and the sea.</p> <p>It is recommended that the timber fence is replaced with new railing of appropriate design, and for consistency the railings around the lookout should be of the same design.</p>

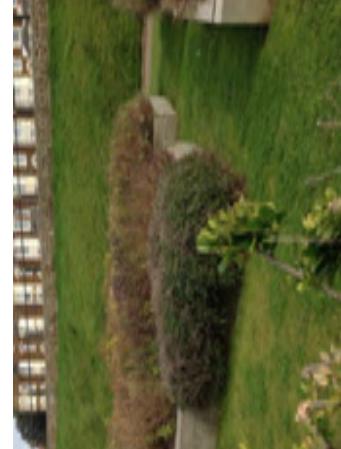
4.27	Planting beds

<p>There are rose gardens leading on from the esplanade gardens, and further north there are raised planting beds.</p> <p>There is also a hedge which runs along the edge of the most westerly path, to the east of the raised planting beds.</p> <p>Planting is in a good condition.</p>
