Hunstanton Cliffs Preliminary Assessment

Hunstanton Coastal Management Plan

60552153

October 2017

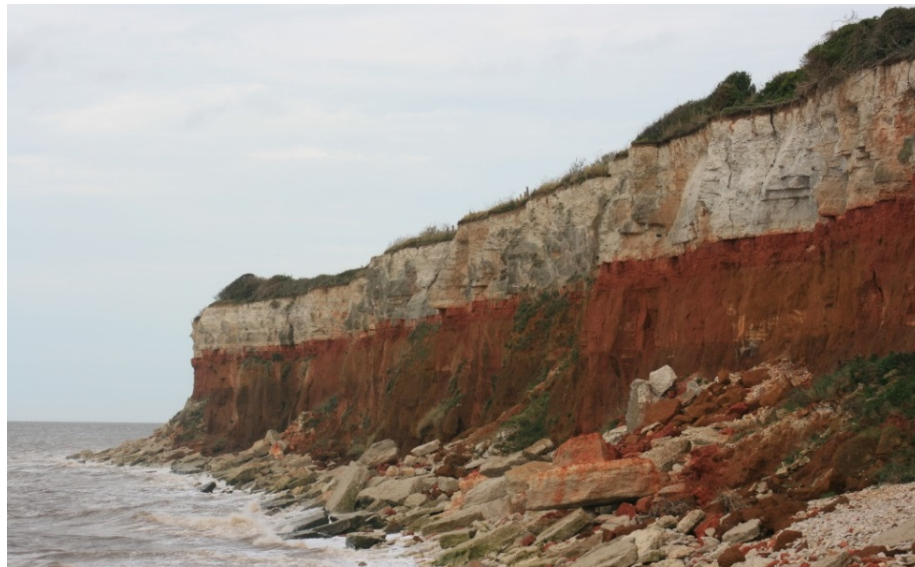
The photo below was taken at high tide at 10:39hrs on Wednesday 11th October 2017. This tide had a predicted level of 6.7m, compared to a higher predicted level of 7.4m in subsequent months. Note that the sea was fairly calm at this time, with little evidence of waves breaking onto the cliffs. A higher tide with rough conditions would look very different.

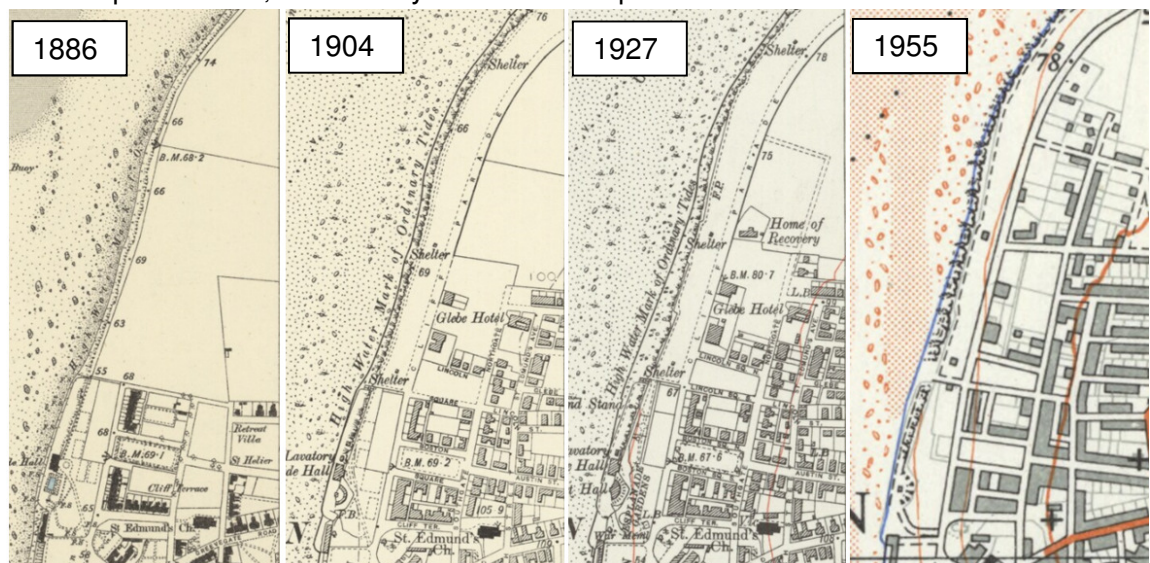
- Historic maps viewed on the National Library of Scotland website, dated 1886, 1904, 1927 and 1955, appear to show the progression of the cliff top to the east, with deviation of the top of the cliff, a boundary line and a footpath.

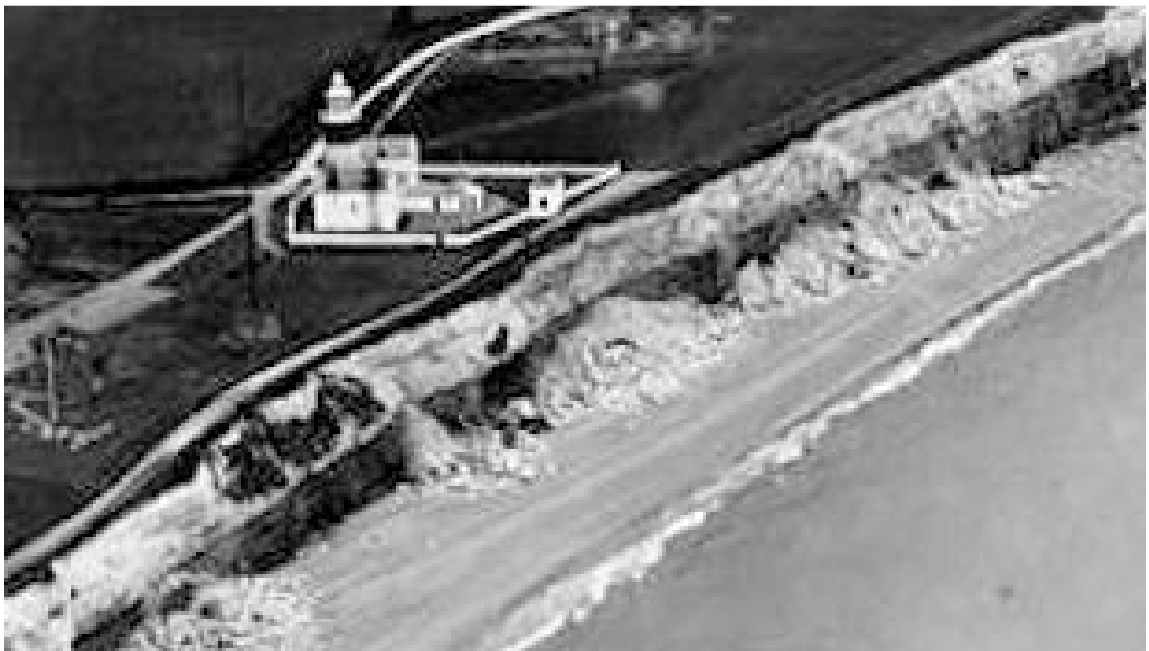
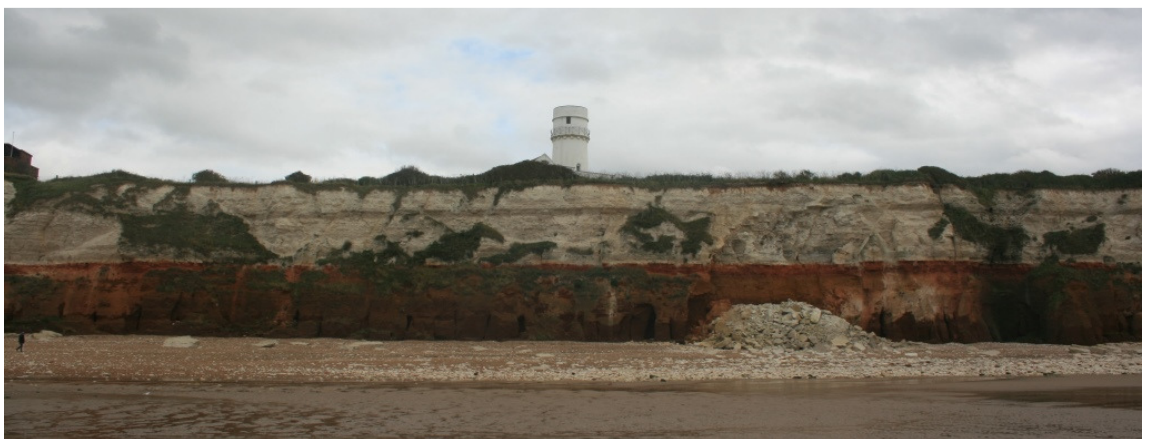
- Several photographs show a public footpath directly along the crest, which has since fallen away, including the extract below taken from an image obtained from 'Kings Lynn Forum'. Although a photograph date and direct comparison of the base of the cliff is not available from this aerial position, the photograph below was taken on 11th October 2017 from the foreshore. The striking feature from the aerial shot is the amount grey / white material mounded at the base of the cliff. This material is chalk, which has collapsed from the upper cliff.

In direct comparison, it is important to note the lack of failed material on the beach in the recent photograph, which highlights the power of the sea to wash failed material away. As such, it can be concluded that relying on the failed material alone to protect the toe of the cliff is not a long term solution.

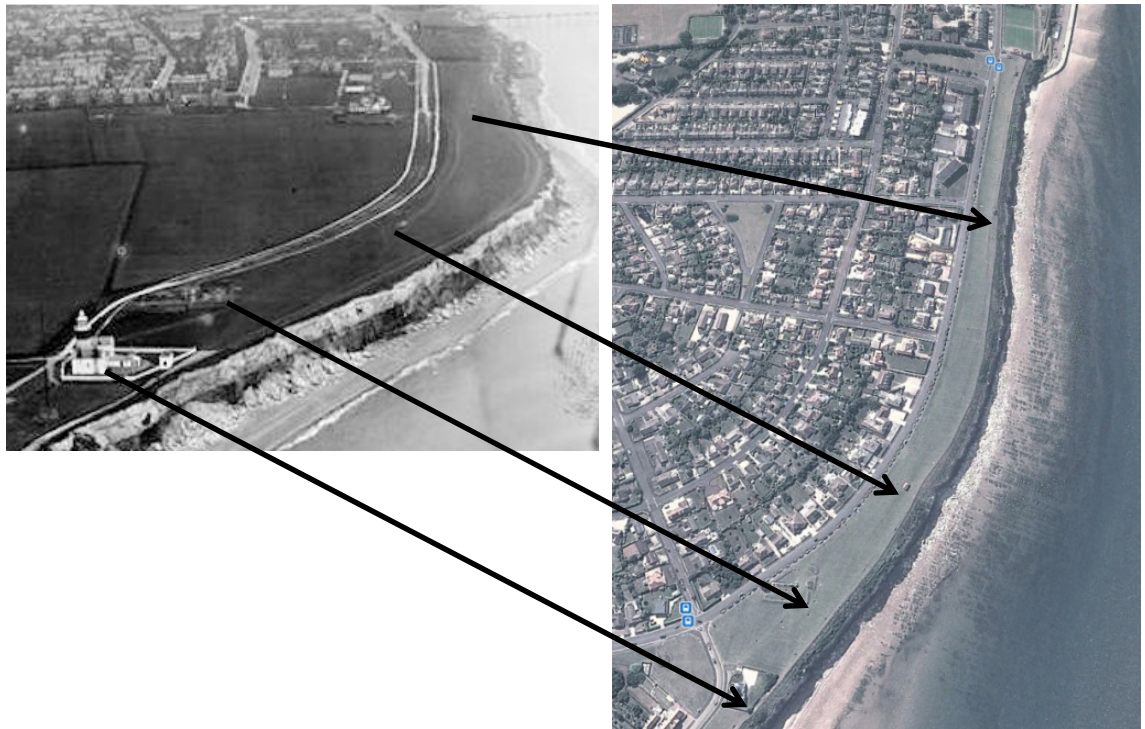
- Several photographs show a significant reduction in the area of land previously associated with the lighthouse, which previously included a larger plan area and further buildings on the seaward side of the existing building. A wider view of the image obtained from the 'Kings Lynn Forum' shown above can be directly compared with the image for the area available on Google Earth Pro. Noting the position of the shelters in

the distance, the remains of St. Edmunds Chapel and the extent of the grounds and outbuildings associated with the lighthouse, this comparison clearly demonstrates the amount of regression of the cliff top towards these features.

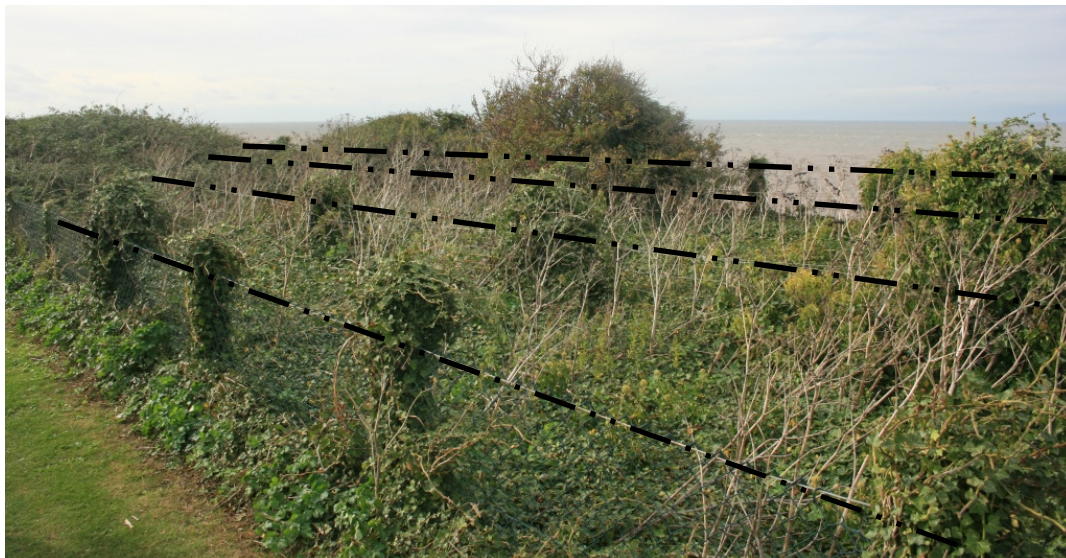
Currently, there are four visible fence lines or lines of fence posts along the cliff top, which are considered to have been erected as the cliff top progressively failed in order to keep the public a safe distance from the crumbling crest. Some concrete fence posts and wire are also present along the beach, which is also evidence of the progressive failure.

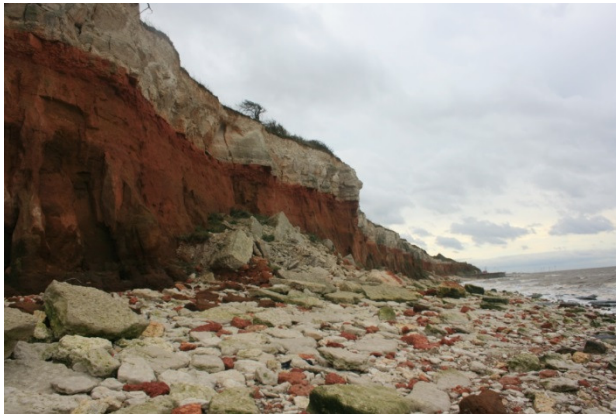
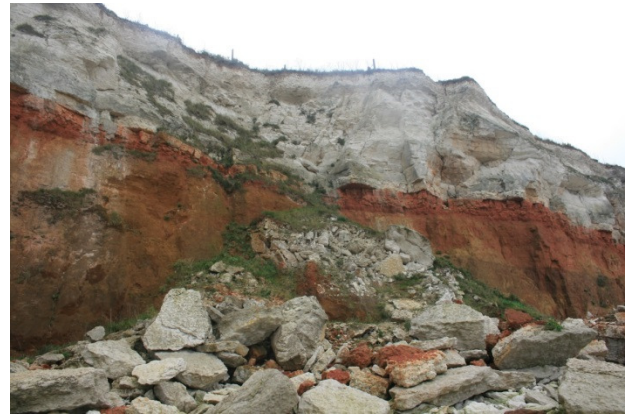
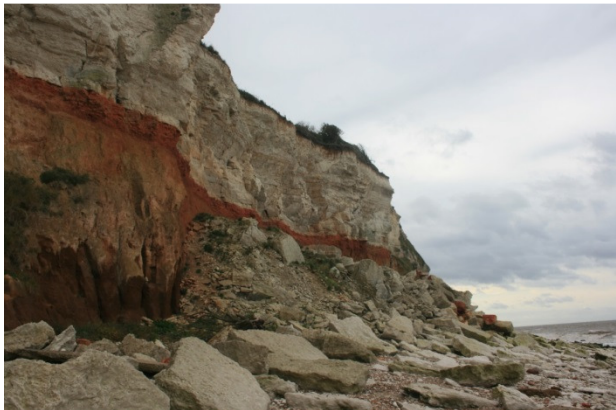
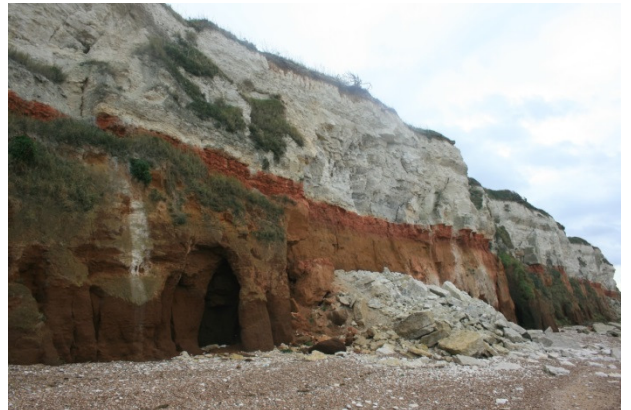
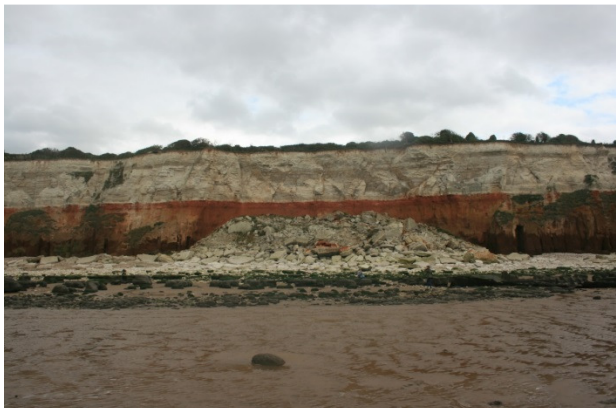
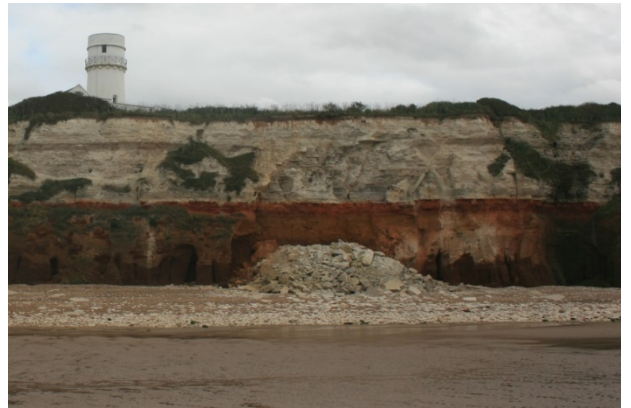
The risk posed to the public by the instability of Hunstanton Cliff was immediately noticeable. Numerous significant blockfalls were present along the whole length (approximately 16 No.), as well as scattered and groups of large blocks of chalk along the majority of the beach. This shows that, without any intervention, rockfalls should be expected to continue to occur in the future at any point along the length of the cliff.

It should be noted that there are numerous significant detached blocks high on the cliff face which may fall to the beach during the next significant rainfall / weather event.

Photos of some of the larger blockfalls are provided below.

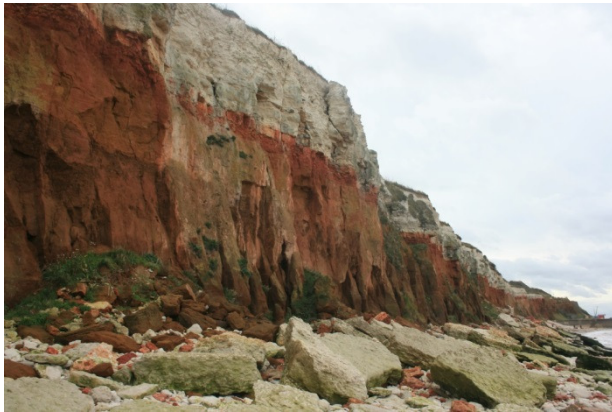
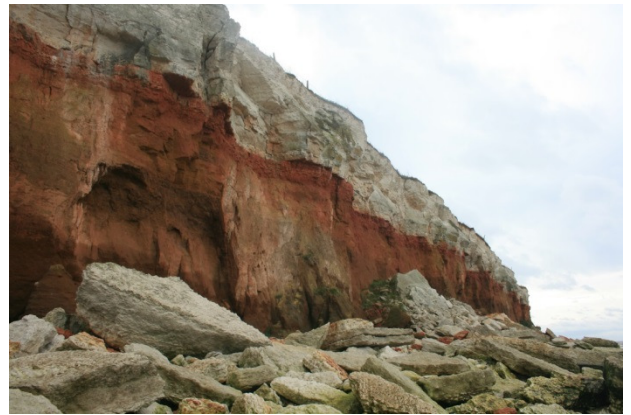
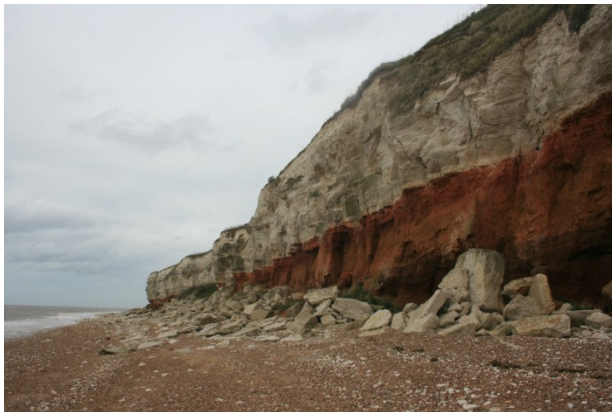
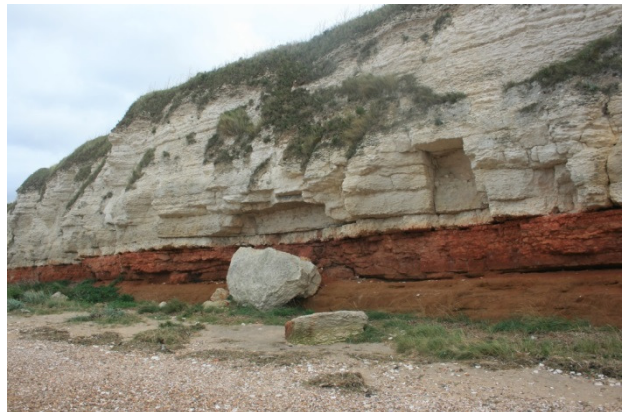
Photos of some of the scattered and groups of large blocks are provided below.

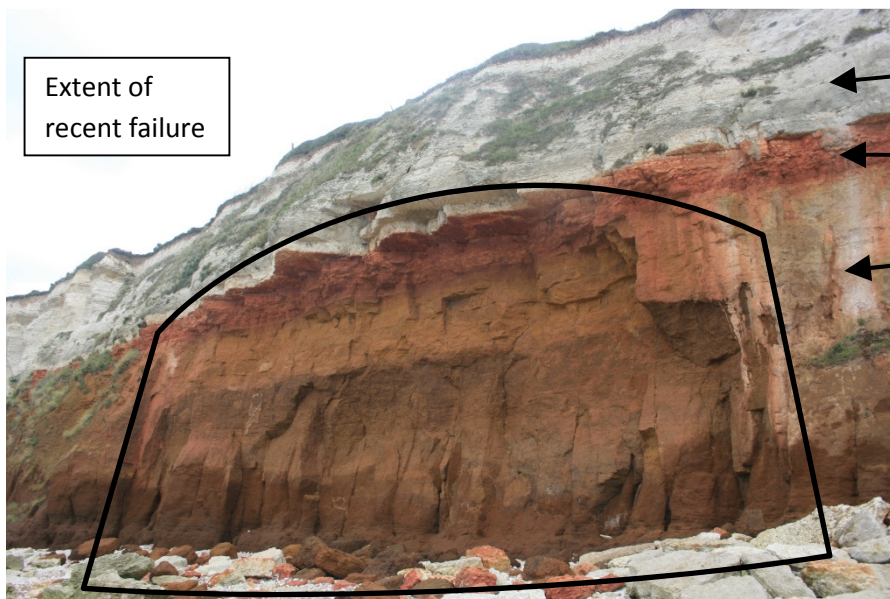
While the above primarily show chalk as the failed material, significant blockfalls have occurred from the Carstone, which have resulted in a number of overhangs, both in the chalk (red and white) and the Carstone. In contrast to the accumulations of chalk debris, the failed Carstone material is often no longer present because it is a much softer, weaker material than the chalk and has been totally eroded away by wave action. The main recent collapse feature in the Carstone is shown below; note the lack of failed material from what will have been a significant failure.

Extent of
recent failure

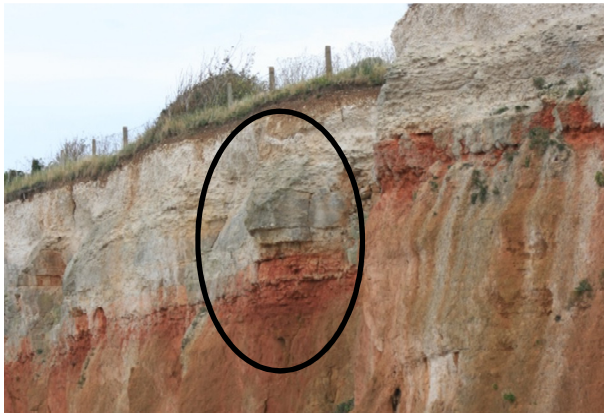
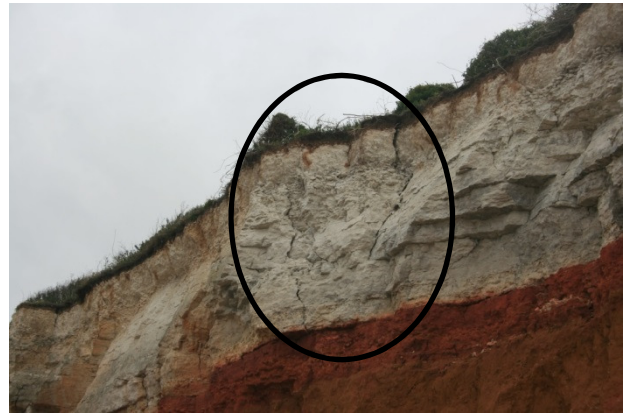
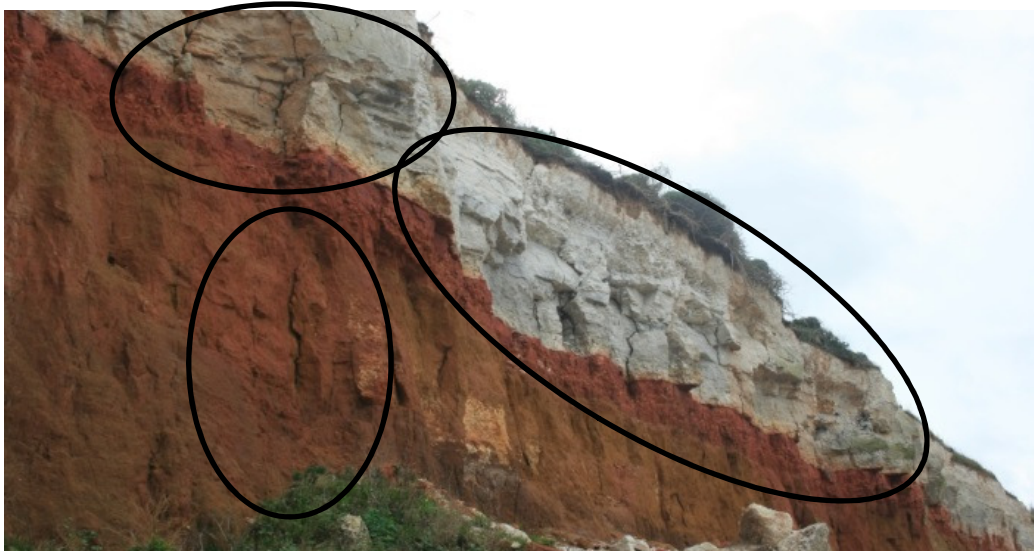
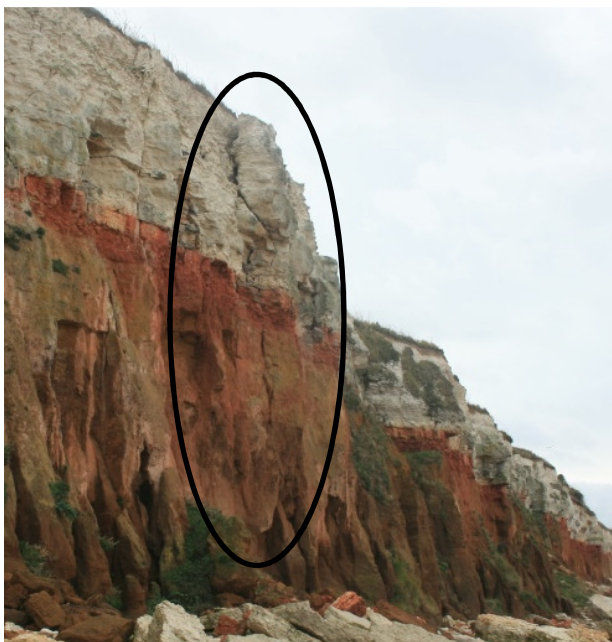
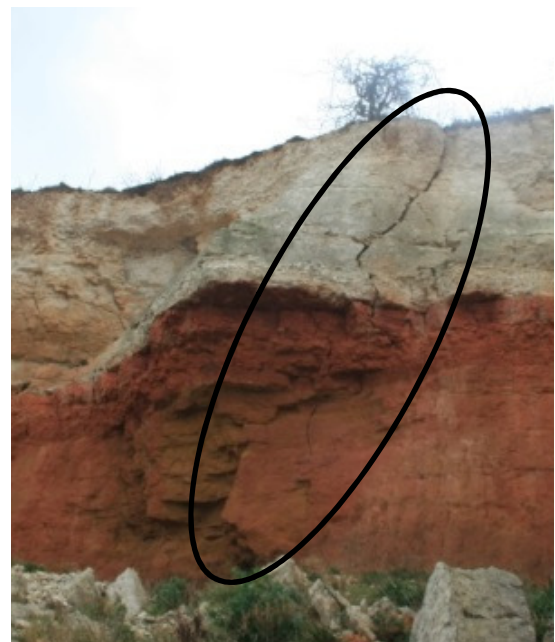
Evidence of the progressive nature of failures was identified by the dilation (gradual widening) of joints (cracks / fissures) within the rockmass. This was particularly evident in the upper areas of the cliff where wave action and undercutting had resulted in removal of the support provided by the rockmass below.

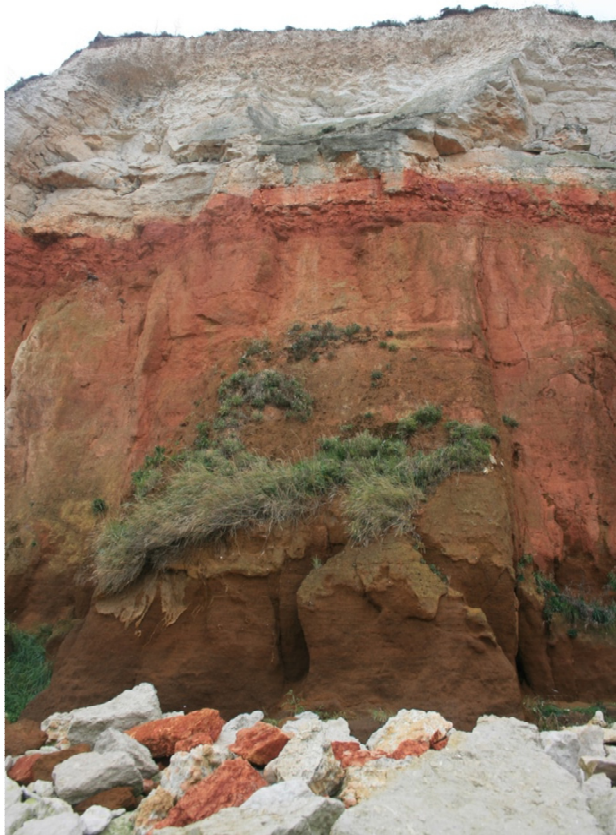
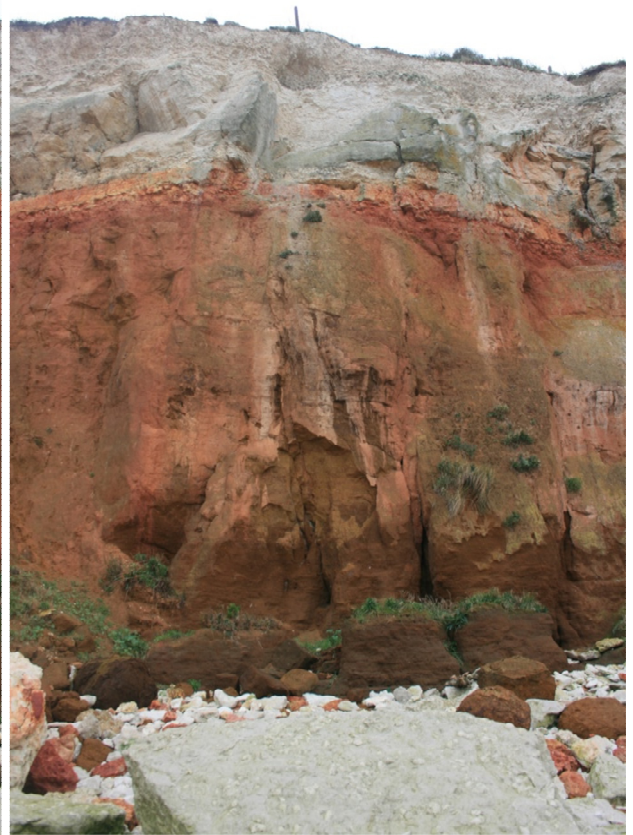
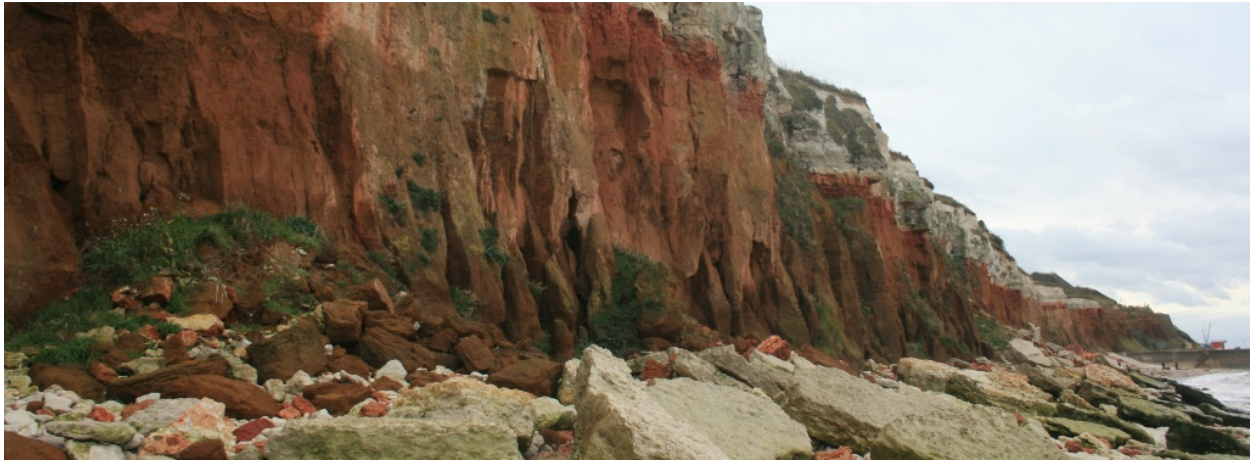
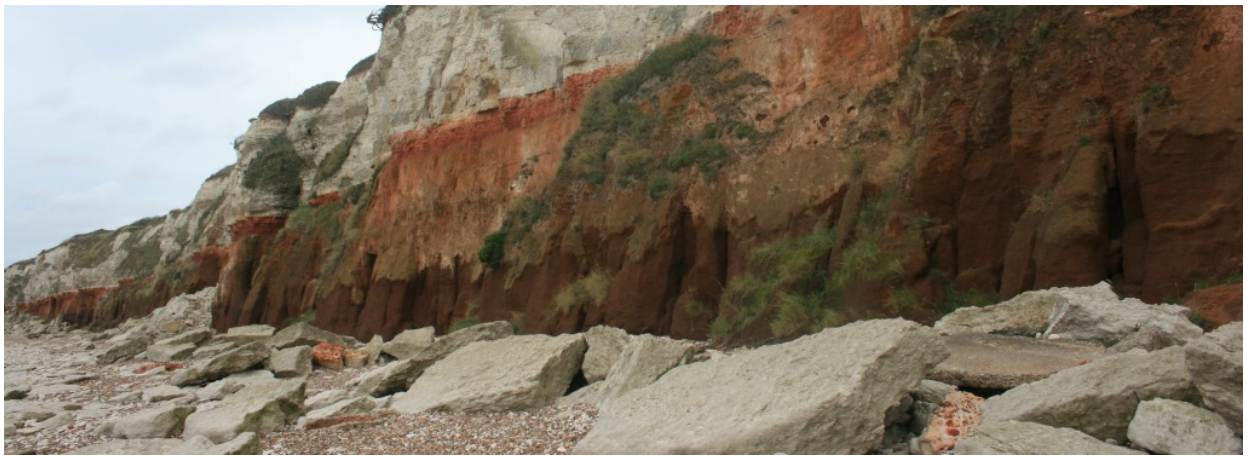
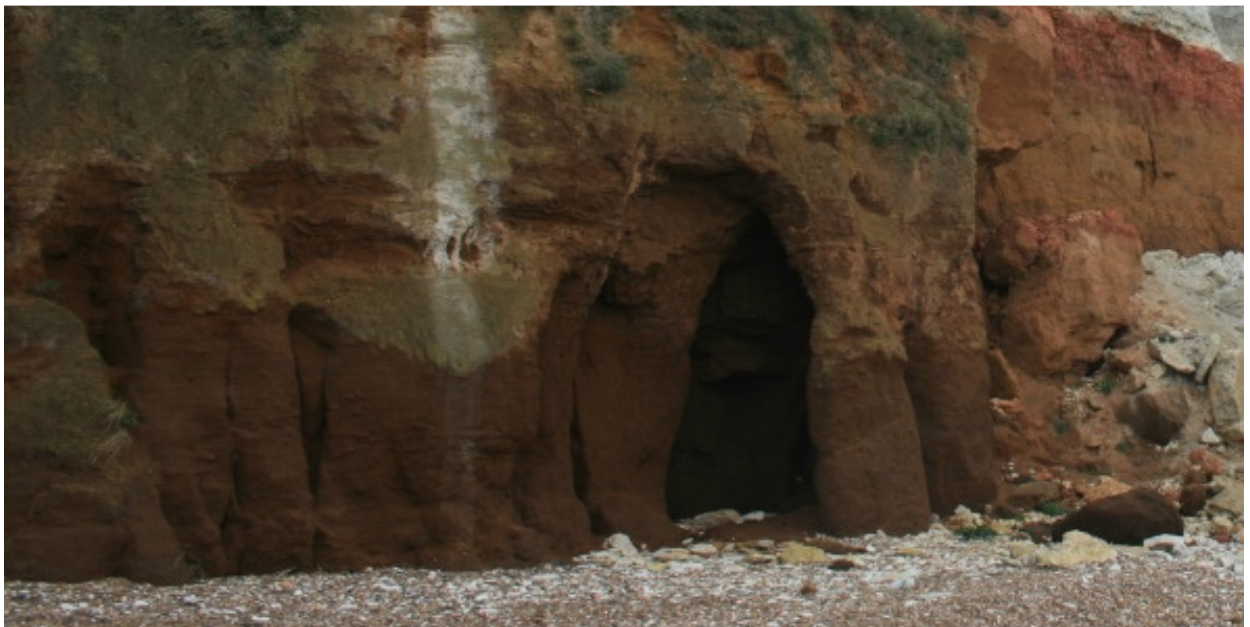
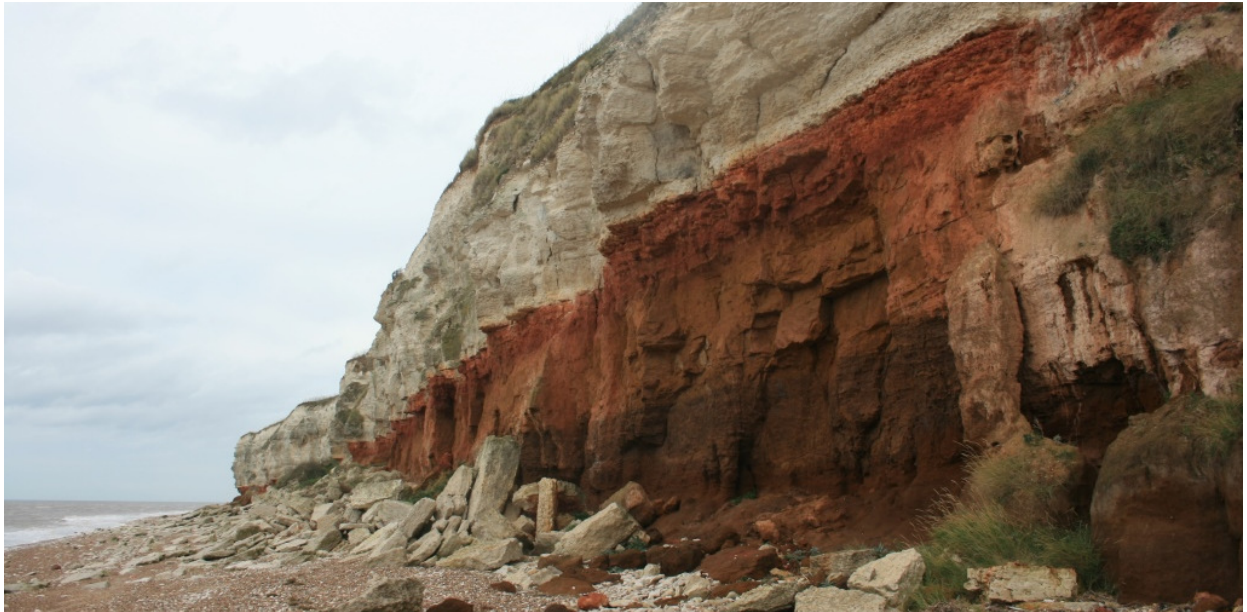
Erosion due to wave action along the base of the Carstone is evident along the base of the length of the cliff where it is not masked by debris from blockfalls. This erosion results in a smooth surface on the Carstone, as opposed to the broken appearance further up the cliff. Wave action also targets the joints, working away through scour, abrasion and hydraulic action to result in open joints, which are then prone to progressively worsening as the waves hit, resulting in significant loss of support to the material above.

Of these mechanisms, the majority of the cliff erosion of Hunstanton Cliff is due to wave action / erosion at the base of the cliff. As shown on the photographs above, wave action forms a smooth surface on the base of the Carstone as it erodes, which also targets the joints, working away through scour and abrasion to result in open joints, which are then prone to progressively worsen as the waves continue to hit. This continued erosion results in loss of support to the Carstone above which ultimately results in blockfall as the upper unsupported material fails along the naturally occurring joints. How far this failure continues through the Carstone and the chalk depends on the competence of the rock and the condition of the joints. In addition, where the face above does not fail immediately, creep may start to occur due to loss of support, resulting in the opening up of the joints and later failure.

As set out above, the mechanism considered likely to be the cause of the majority of the instability of Hunstanton Cliff is wave action / erosion at the base of the cliff, which results in lack of support at the cliff base and subsequent collapse of the Carstone, leaving overhangs in the chalk to collapse at a later date. As such, it is this feature which needs attending to if any.

The creation of a **Rock Sill** fits this requirement, but construction works undertaken at the base of the cliff would have to consider the risk of injury to construction personnel at the base of the cliff resulting from vibration of construction plant. Such vibrations may result in the existing chalk overhangs failing while construction teams are on the beach. As such, it may be prudent to consider a scaling exercise to remove loose blocks or masses of chalk ahead of the placement of the rock.

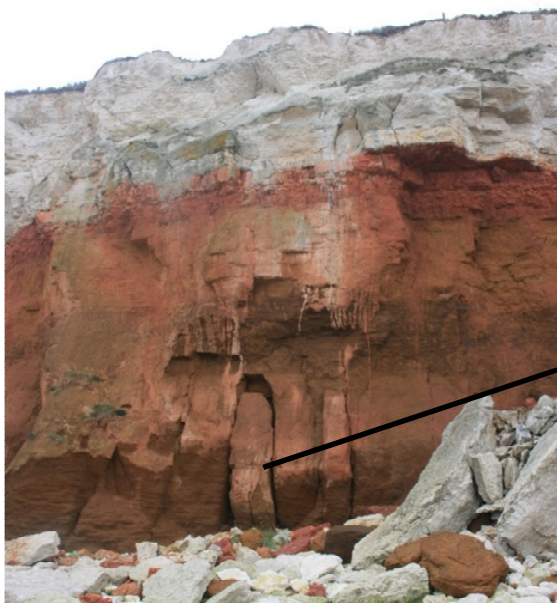
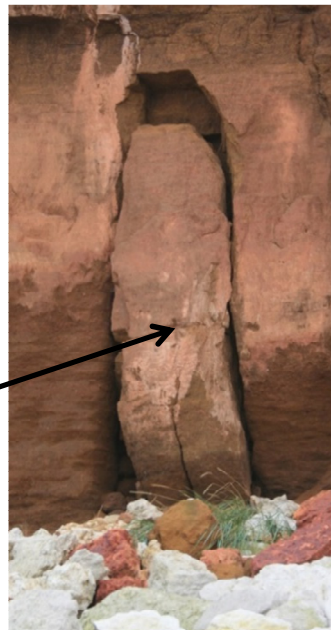
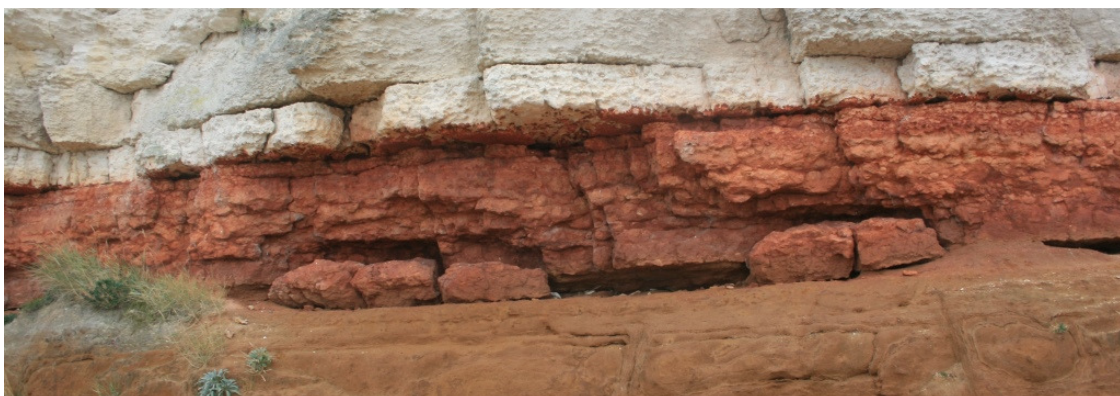
This continued scour results in loss of support to the Carstone. Although the majority of failed material from the Carstone has been totally eroded away by wave action, some examples of the mechanism are still visible, as below.

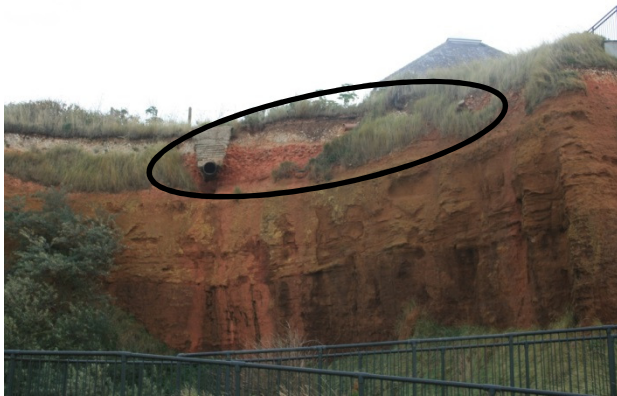
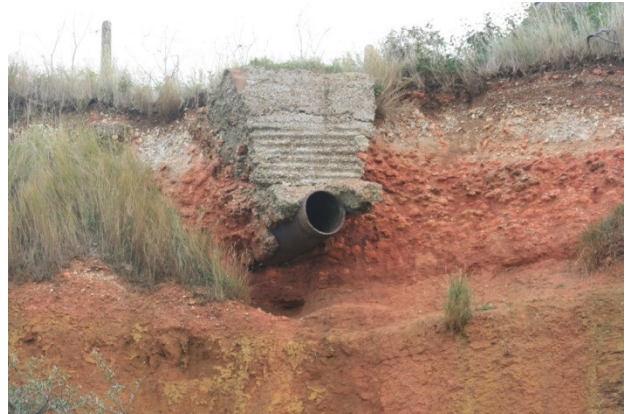
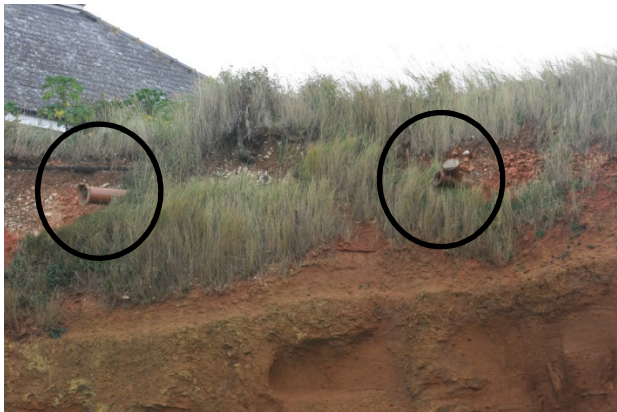
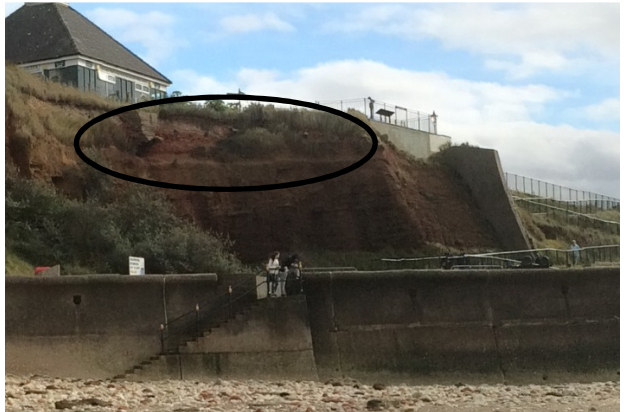
Other features present on the face which may be having an adverse effect on stability of the cliff are associated with drainage. There are numerous pipes daylighting at the crest of the cliff. The age of these pipes is not known, but it is considered likely that they are historic and that sections have broken off as the cliffs have failed around them, possibly as a result of poor joints / leakage.

None of the pipes were flowing at the time of this visit, so it is not known if they are still connected to a drainage system, or taking groundwater, but the scour and discolouration of the rock below them highlight the effect they can have on stability. 3 No. pipes are visible at the southern extent of Hunstanton Cliff, above the northern end of the sailing club carpark, the largest one of which is supporting a large concrete block.

Below the shelter opposite the end of Clarence Road, there is a gulley within discoloured rock, which may be indicative of a pipe being present, although nothing was visible from beach level. The bottom two photos below show a small pipe daylighting above a significant blockfall, although it is not known if the presence is coincidental.

Also discussed in the Wash East Coast Management Strategy (EA, 2013), but neither discarded nor included in the recommendations, is the improvement of cliff drainage. While this option would not reduce erosion due to the action of waves, both improving the current drainage network and intersecting groundwater or run-off before it percolates down through the joints in the chalk or flows over the cliff edge would reduce the possibility of failures associated with saturation of the rock and the joints in the upper parts of the cliff, as is evident at several locations along Hunstanton Cliff and referred to above.

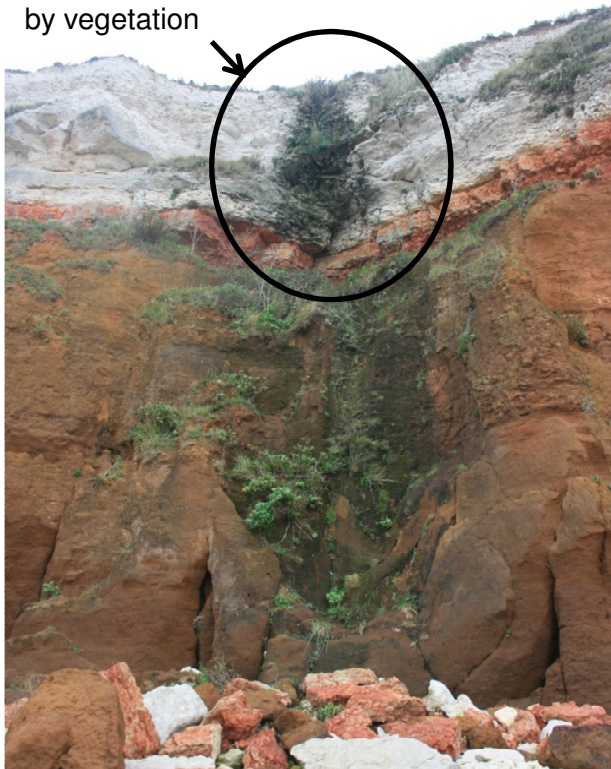
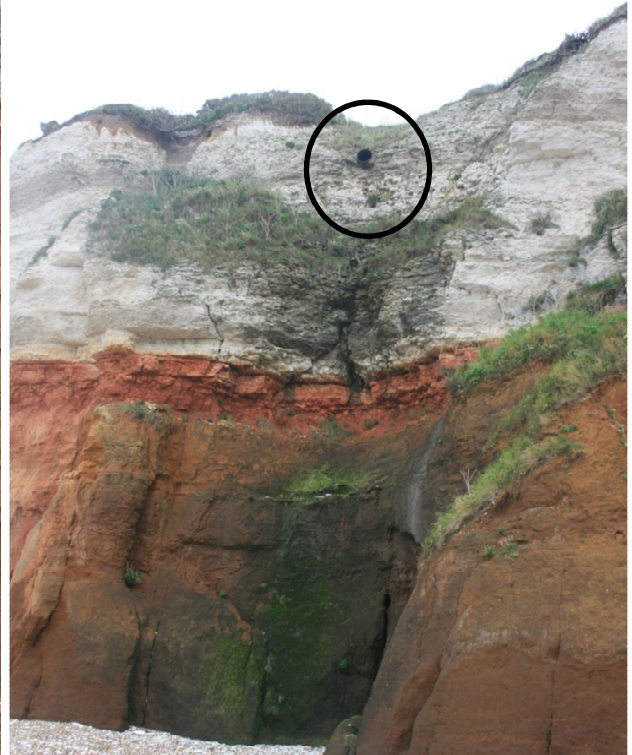
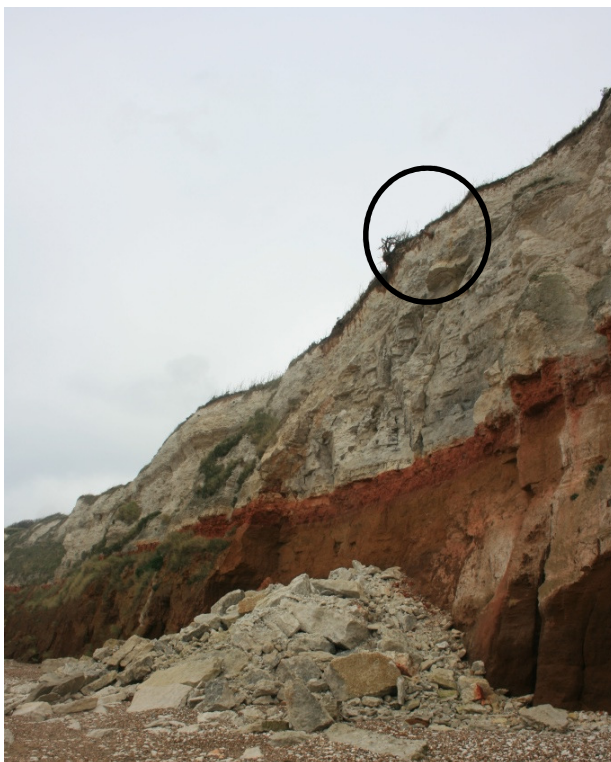
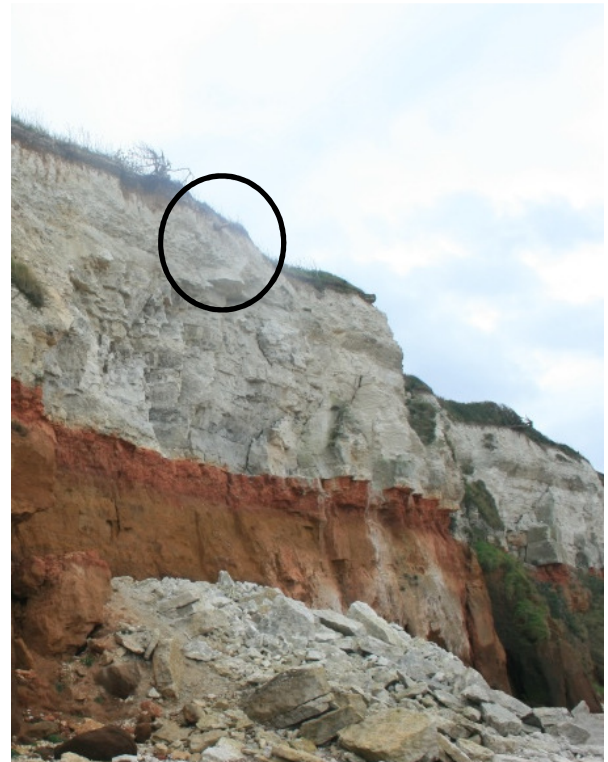
Possible pipe masked
by vegetation

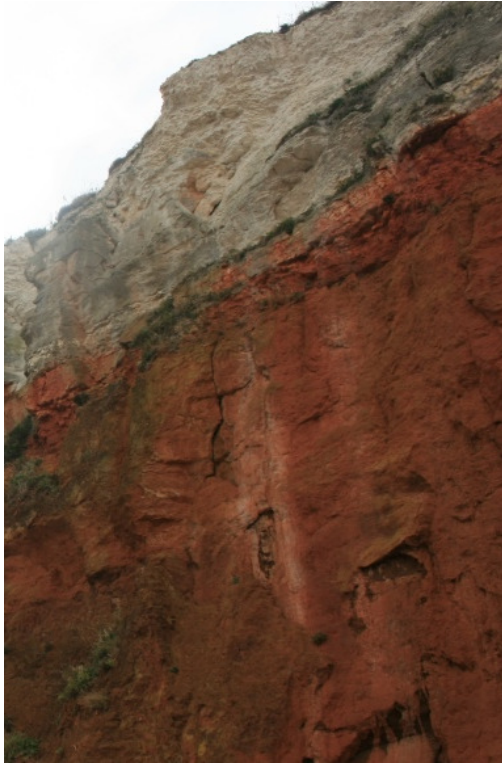
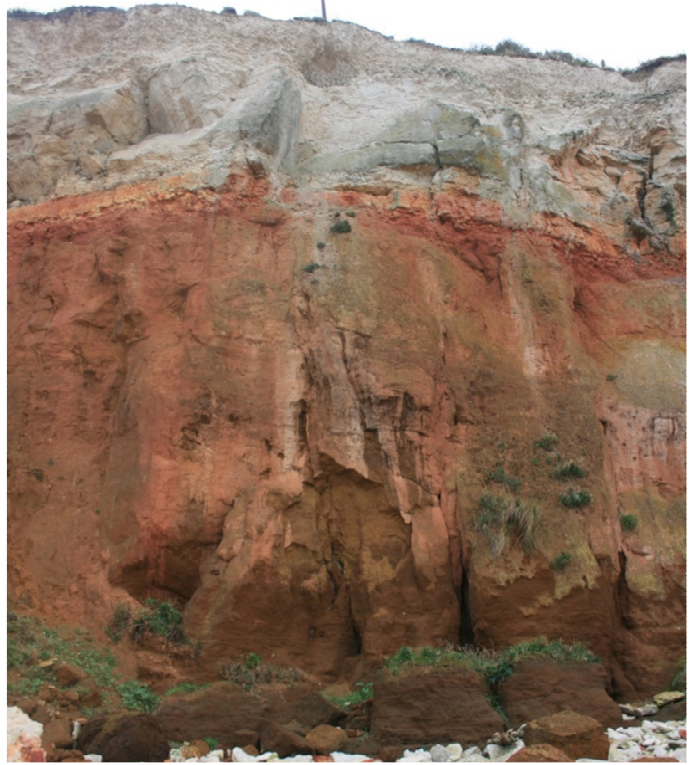
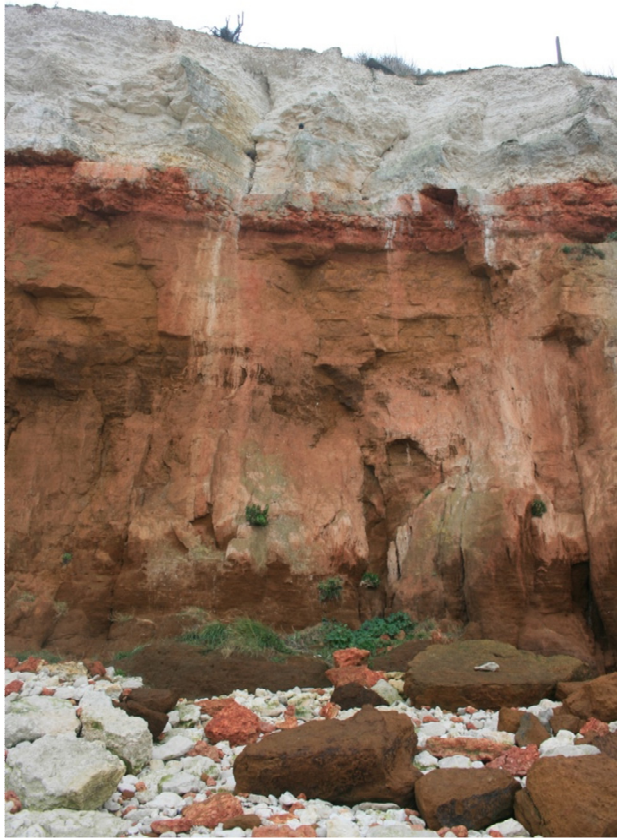
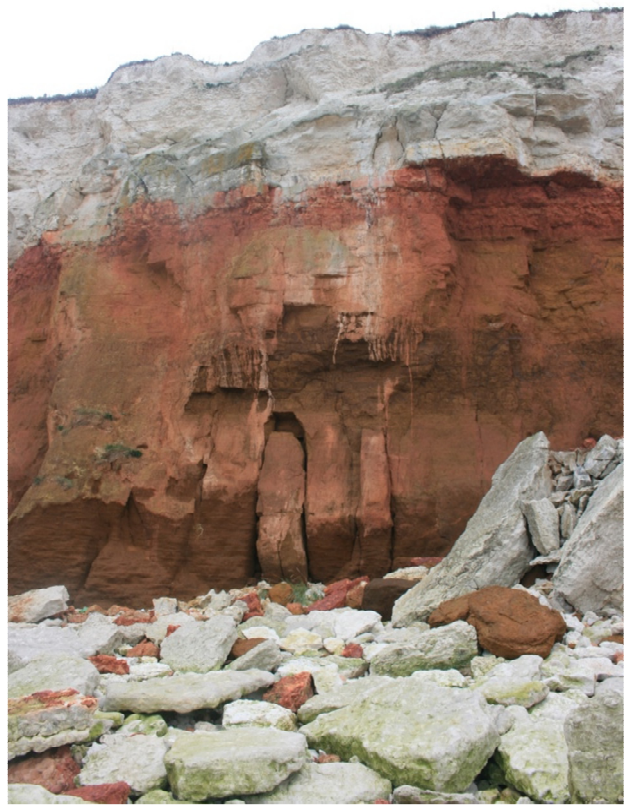
Surface staining is present along several sections of the face of the Carstone, which suggests that water does percolate out of the rock face, although being dry at the time, it is not known if this water originates as surface water flowing directly across the ground surface above and down the face, through joints in the chalk or along the interface between the chalk and the Carstone.
