# Condition Assessment Summary Report

Hunstanton Coastal Management Plan

60552153

December 2017

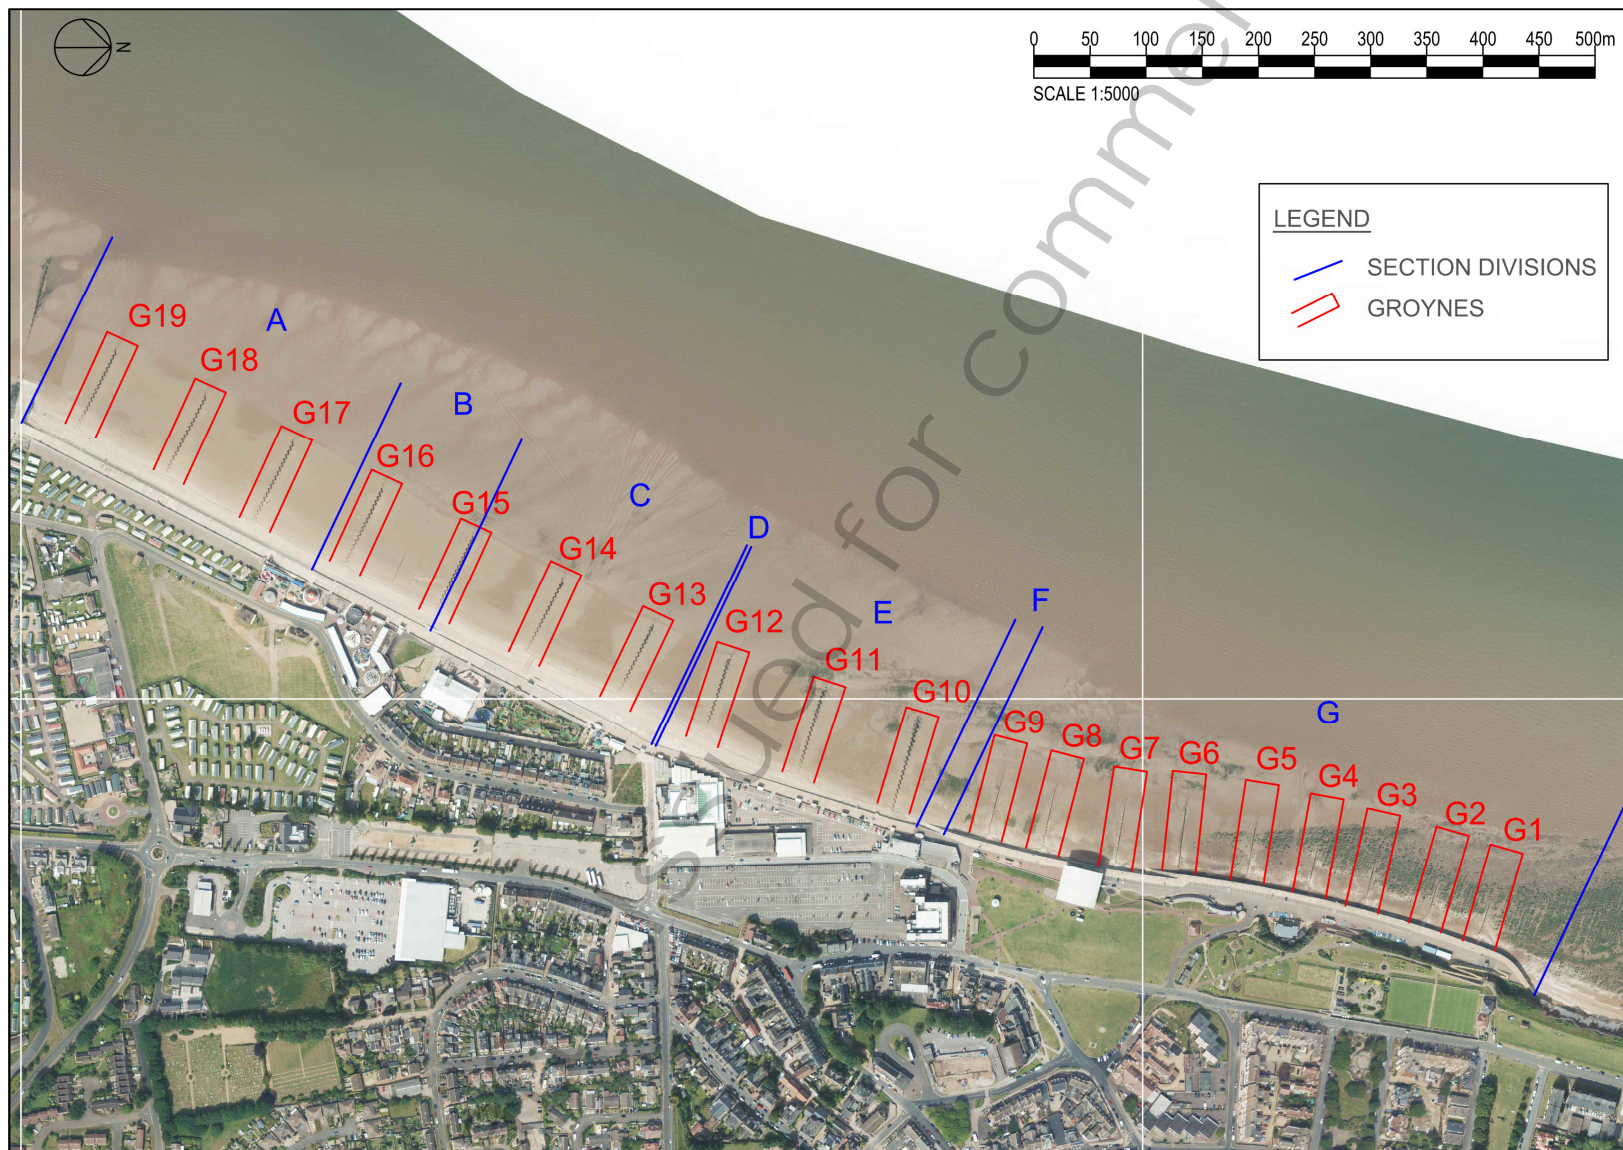
The previous inspections have used the reference system established by the 1996 Mott MacDonald inspection and also used in the subsequent inspections. The frontage is divided into seven sections (A to G) based on the different types of seawall, as shown in Figure 2 and then within these sections given sub-sections by panels (i.e. construction joint to construction joint).

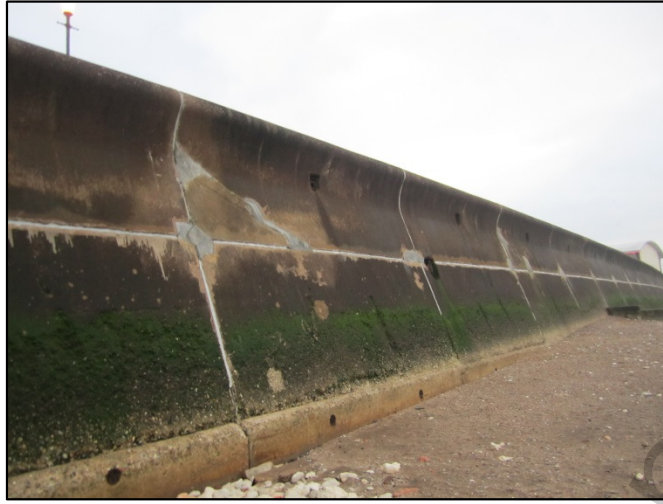
During a site visit on 5<sup>th</sup> December 2017 it was observed that patch repairs were being completed along the face of the seawall in Section G as shown in Figure 3. It was suggested by the contractors carrying out the work that approximately 50 patch repairs were being made. From inspection the majority of these were on the face of the seawall in Section G where the bottom corners of the upper panel meet the top corners of the lower panel. The visual inspection of this section had already taken place at the time these repairs were observed and therefore the repairs and any potential influence they might have on condition grade or residual life of the structures have not been included in this report.

Figure 3: Photograph of recent patch repairs on seawall in Section G
