Hunstanton Sea Cliff – Ground Engineering feedback following site visit on 11th October 2017

Prepared : David Townend 17/10/17

An AECOM team visited the area on 11th October 2017 to assess the current condition of Hunstanton Cliff from a Geotechnical and Coastal Engineering perspective, walking south to north along the beach and north to south along the cliff top.

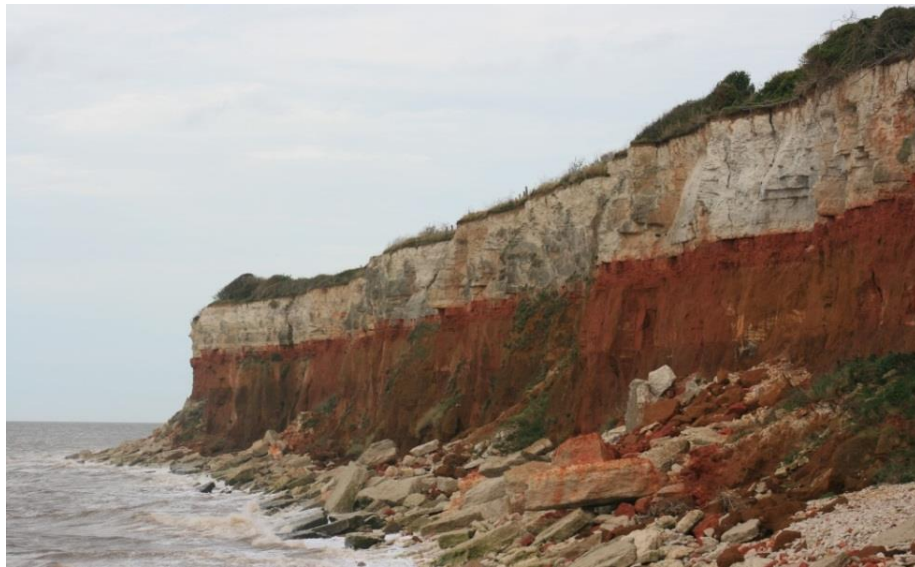
The photo below was taken at high tide at 10:39hrs on Wednesday 11th October 2017. This tide had a predicted level of 6.7m, compared to a higher predicted level of 7.4m in subsequent months. Note that the sea was fairly calm at this time, with little evidence of waves breaking onto the cliffs. A higher tide with rough conditions would look very different.

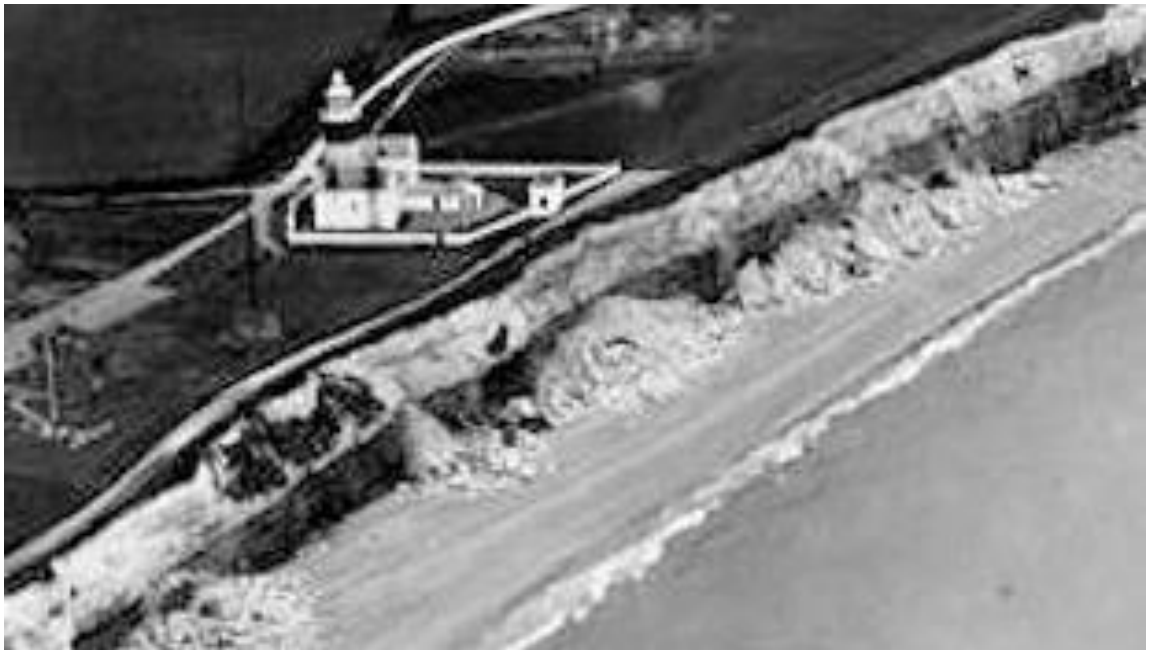
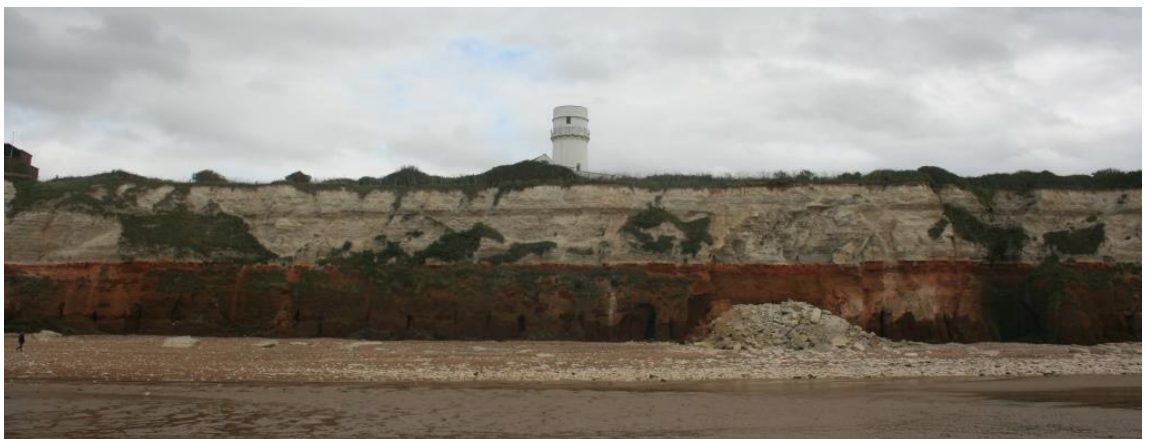
- Several photographs show a public footpath directly along the crest, which has since fallen away, including the extract below taken from an image obtained from 'Kings Lynn Forum'. Although a photograph date and direct comparison of the base of the cliff is not available from this aerial position, the photograph below was taken on 11th October 2017 from the foreshore. The striking feature from the aerial shot is the amount grey / white material mounded at the base of the cliff. This material is chalk, which has collapsed from the upper cliff.

In direct comparison, it is important to note the lack of failed material on the beach in the recent photograph, which highlights the power of the sea to wash failed material away. As such, it can be concluded that relying on the failed material alone to protect the toe of the cliff is not a long term solution.

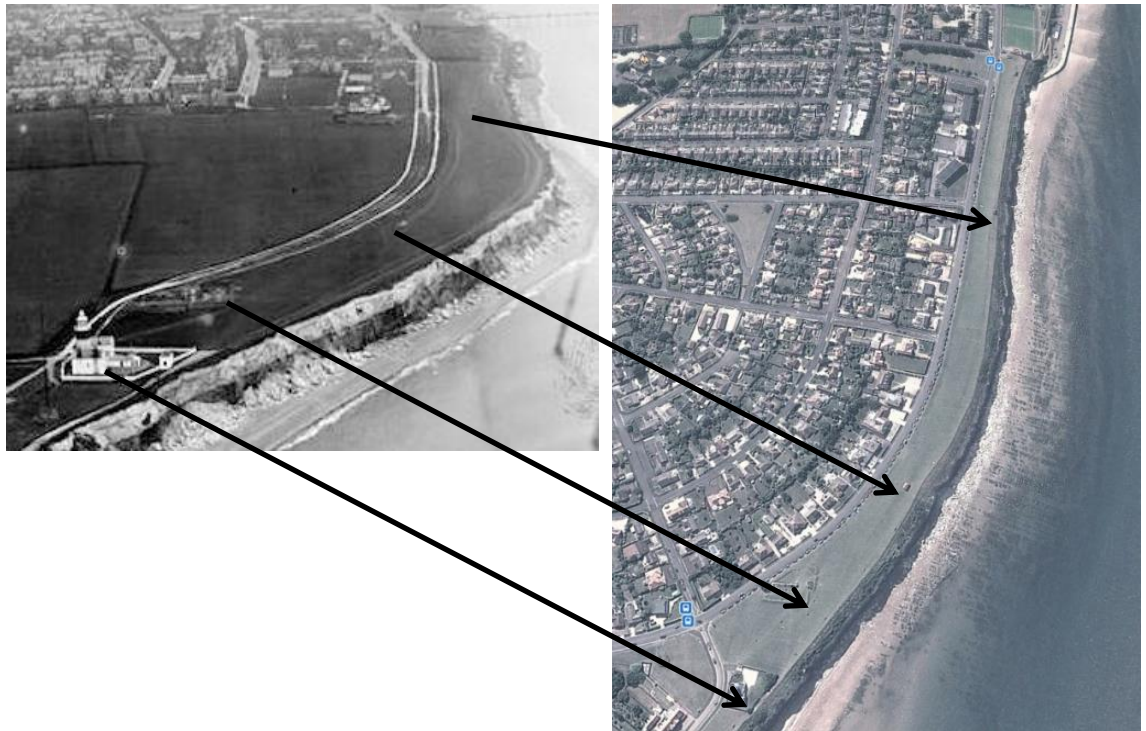
- Several photographs show a significant reduction in the area of land previously associated with the lighthouse, which previously included a larger plan area and further buildings on the seaward side of the existing building. A wider view of the image obtained from the 'Kings Lynn Forum' shown above can be directly compared with the image for the area available on Google Earth Pro. Noting the position of the shelters in

the distance, the remains of St. Edmunds Chapel and the extent of the grounds and outbuildings associated with the lighthouse, this comparison clearly demonstrates the amount of regression of the cliff top towards these features.

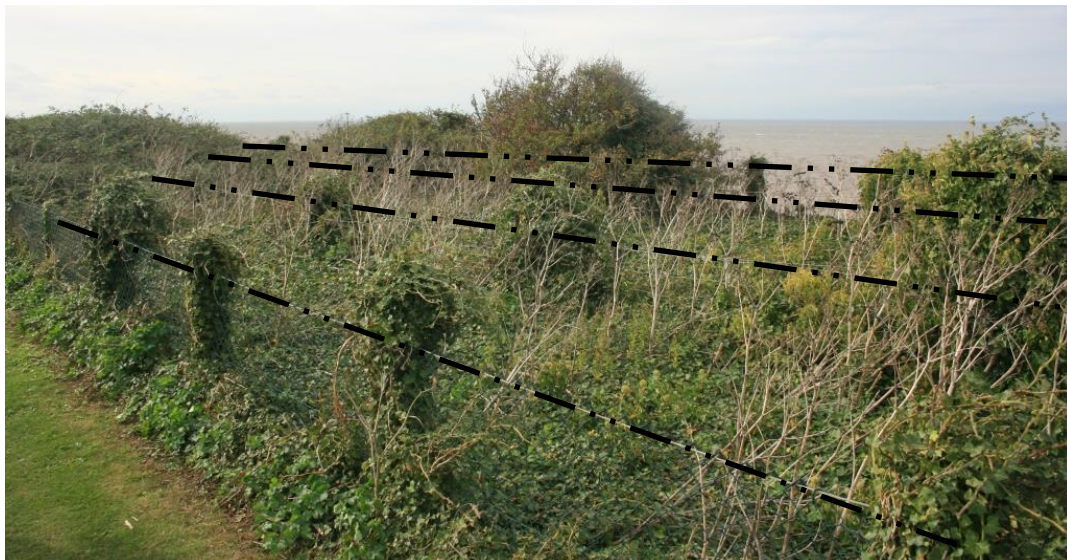
Currently, there are four visible fence lines or lines of fence posts along the cliff top, which are considered to have been erected as the cliff top progressively failed in order to keep the public a safe distance from the crumbling crest. Some concrete fence posts and wire are also present along the beach, which is also evidence of the progressive failure.

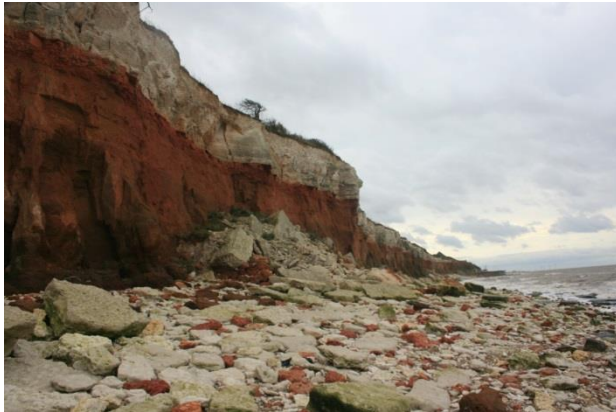
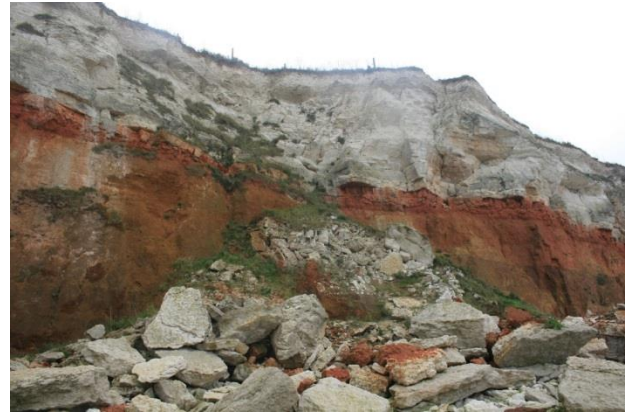
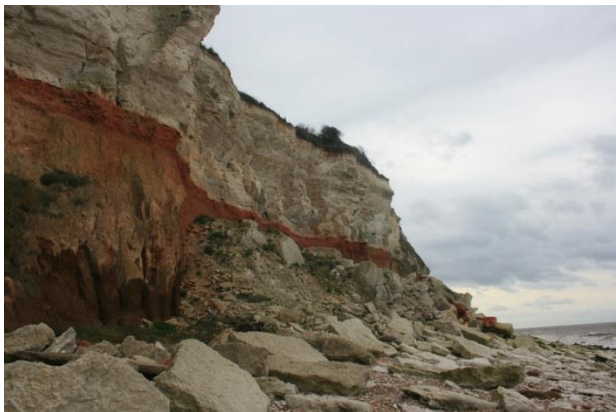
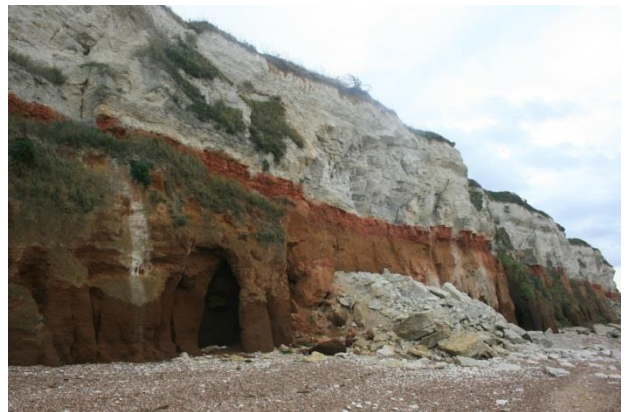
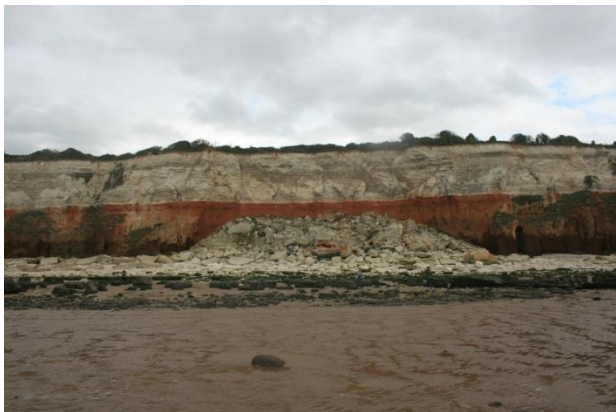
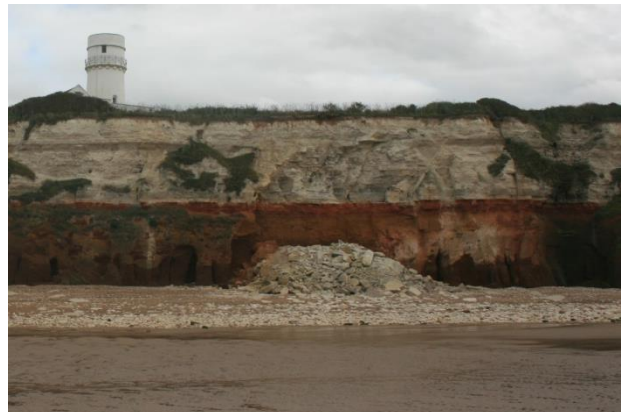
The risk posed to the public by the instability of Hunstanton Cliff was immediately noticeable. Numerous significant blockfalls were present along the whole length (approximately 16 No.), as well as scattered and groups of large blocks of chalk along the majority of the beach. This shows that, without any intervention, rockfalls should be expected to continue to occur in the future at any point along the length of the cliff.

It should be noted that there are numerous significant detached blocks high on the cliff face which may fall to the beach during the next significant rainfall / weather event.

Photos of some of the larger blockfalls are provided below.

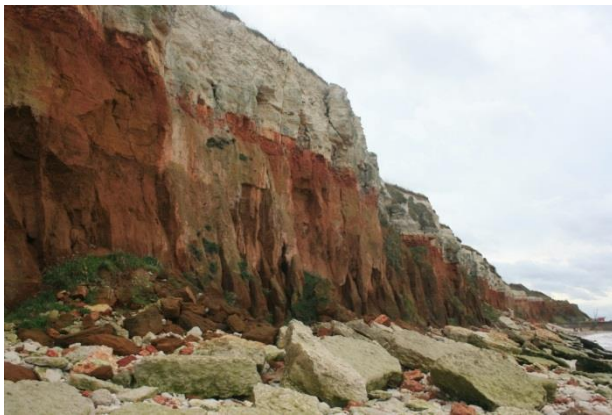
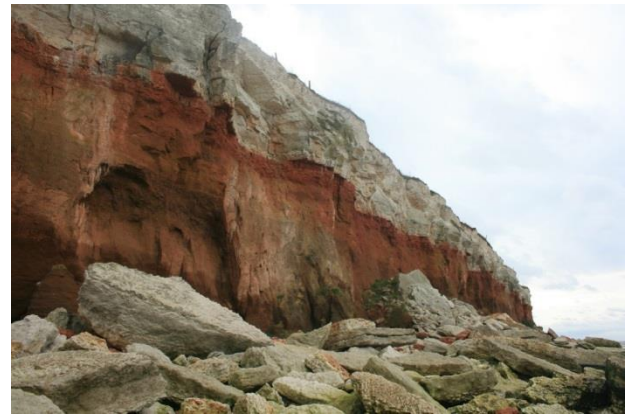
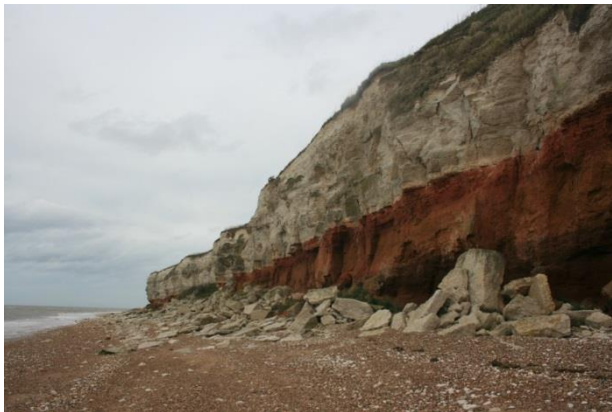
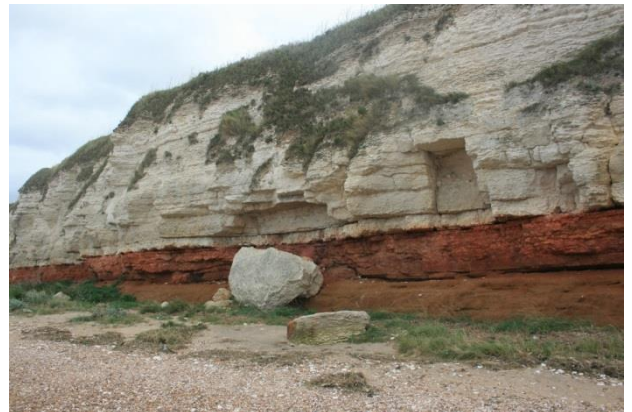
Photos of some of the scattered and groups of large blocks are provided below.

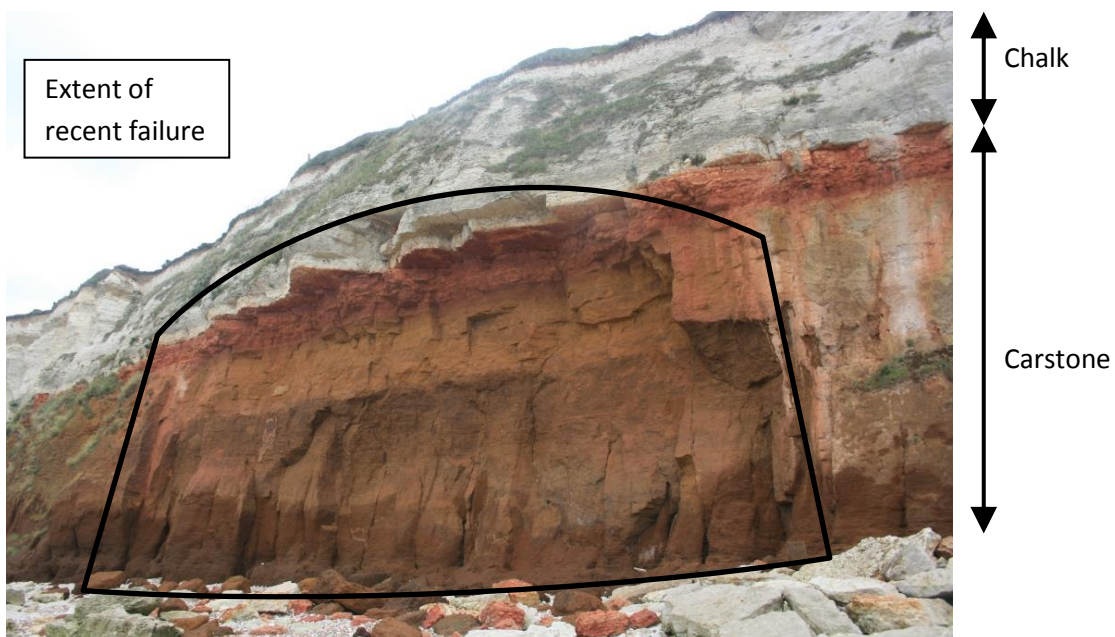
While the above primarily show chalk as the failed material, significant blockfalls have occurred from the Carstone, which have resulted in a number of overhangs, both in the chalk and the Carstone. In contrast to the accumulations of chalk debris, the failed carstone material is often no longer present because it is a much softer, weaker material than the chalk and has been totally eroded away by wave action. The main recent collapse feature in the Carstone is shown below; note the lack of failed material from what will have been a significant failure.

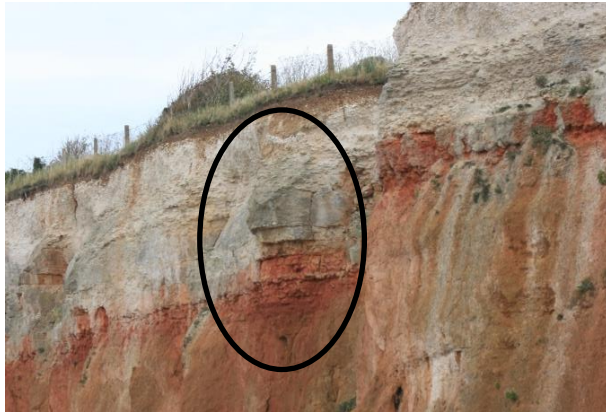
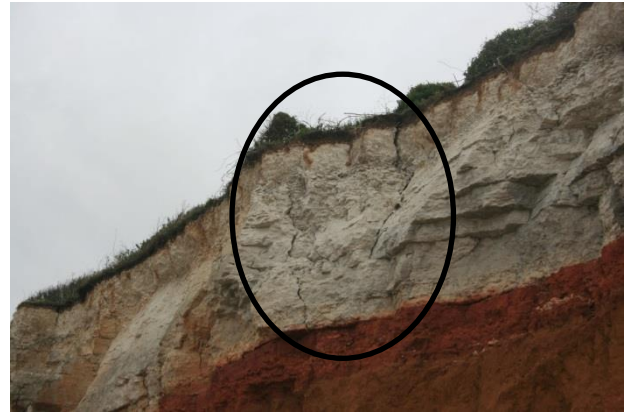
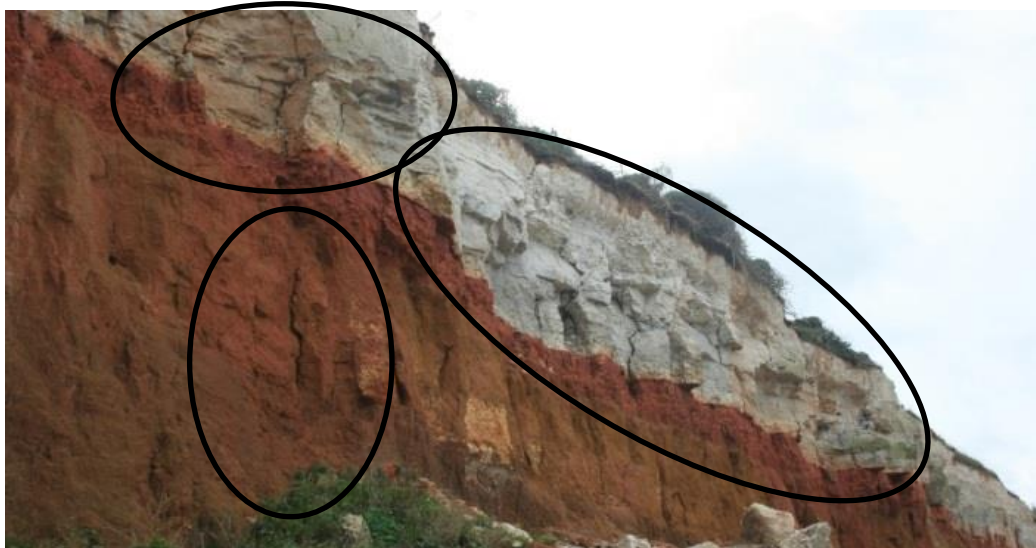
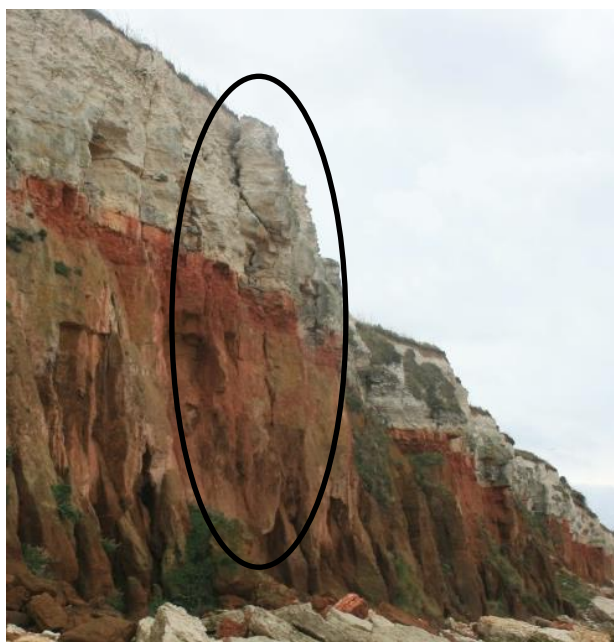
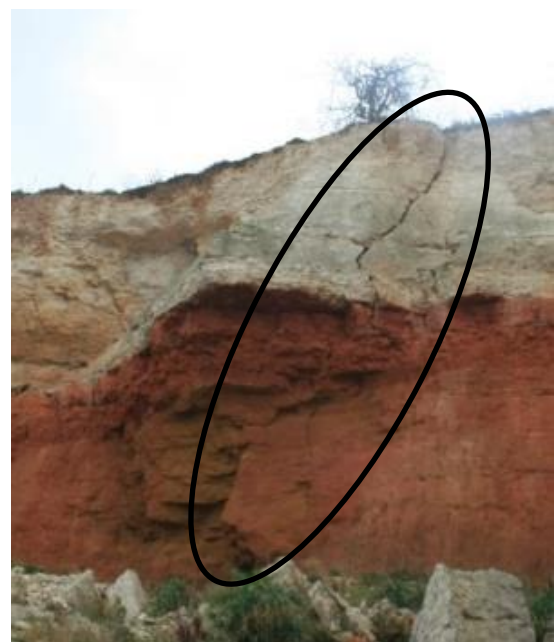
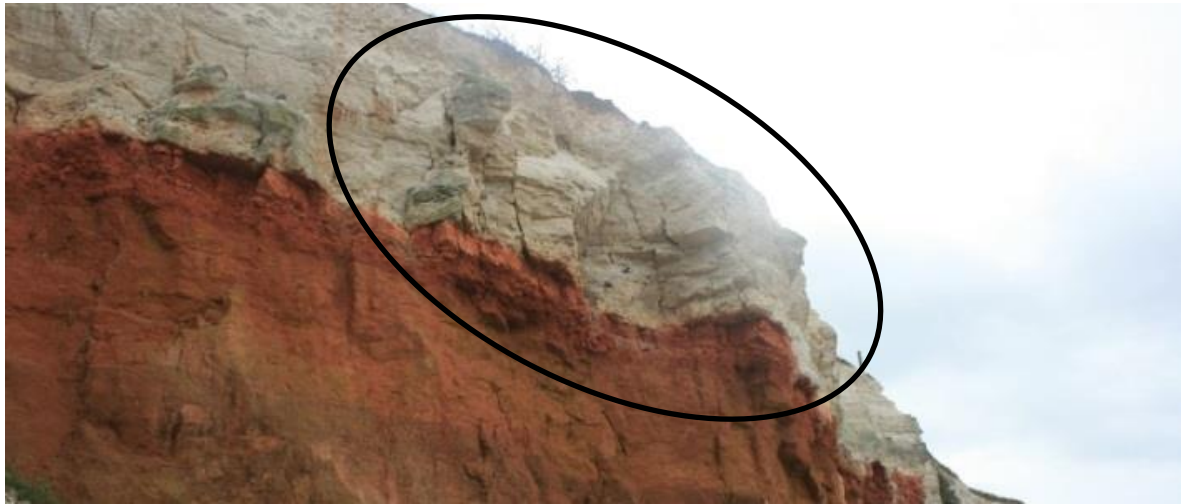
Evidence of the progressive nature of failures was identified by the dilation (gradual widening) of joints (cracks / fissures) within the rockmass. This was particularly evident in the upper areas of the cliff where wave action and undercutting had resulted in removal of the support provided by the rockmass below.

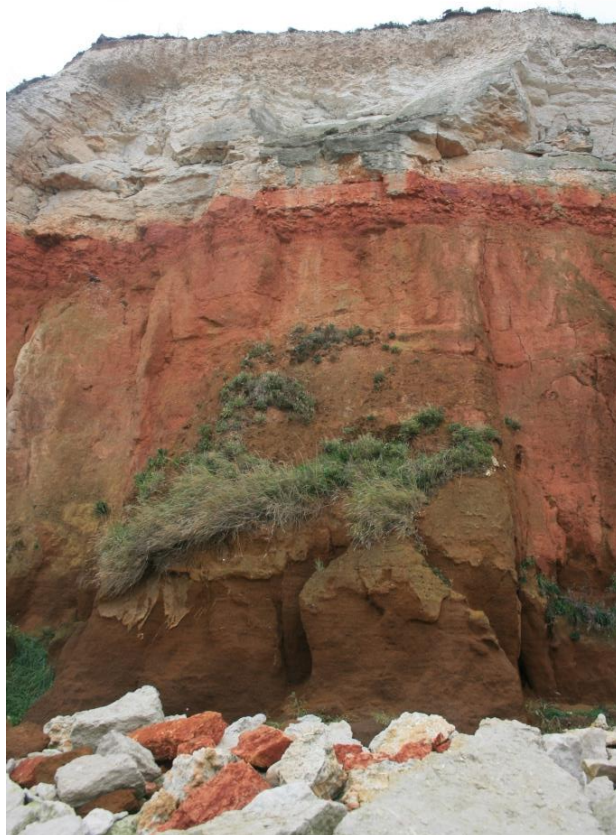
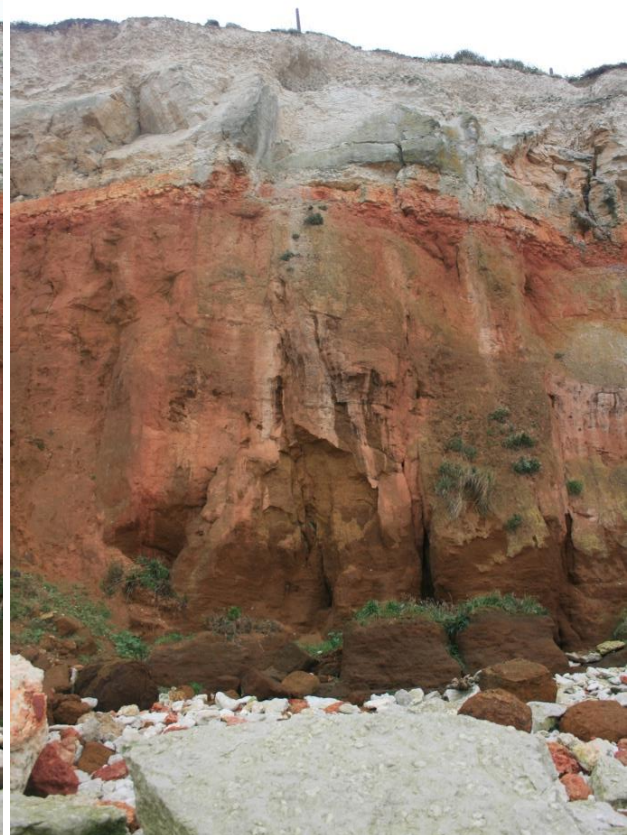
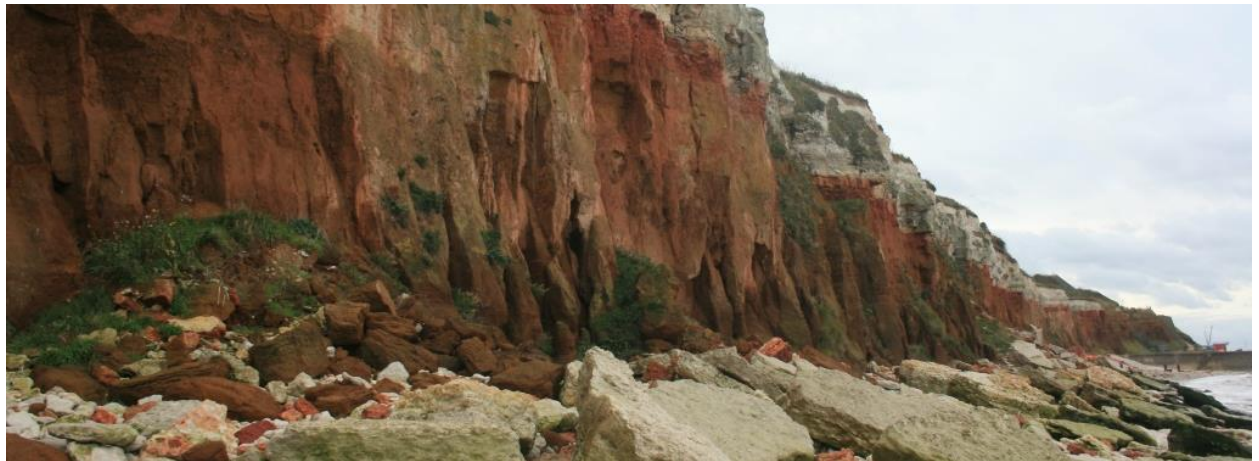
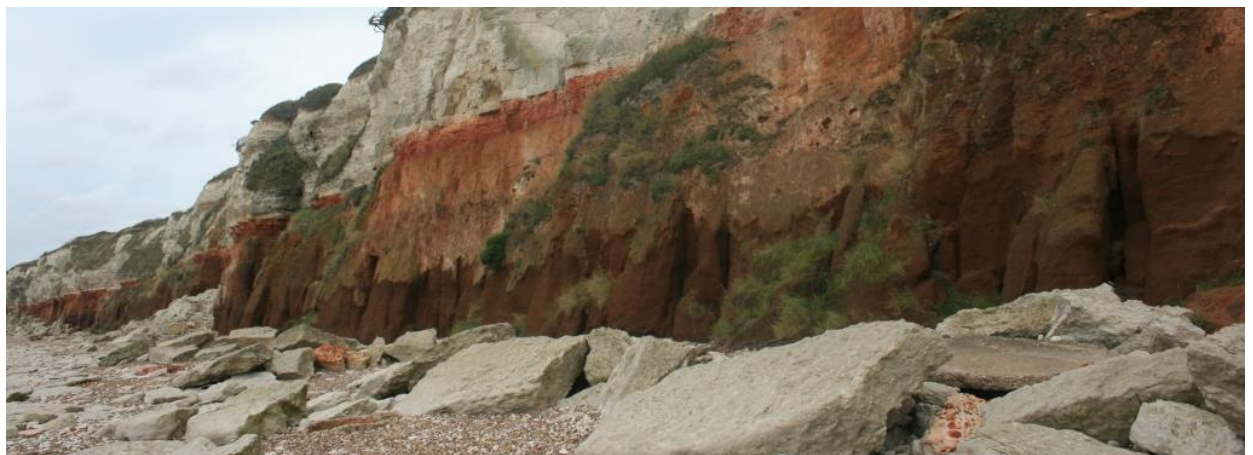
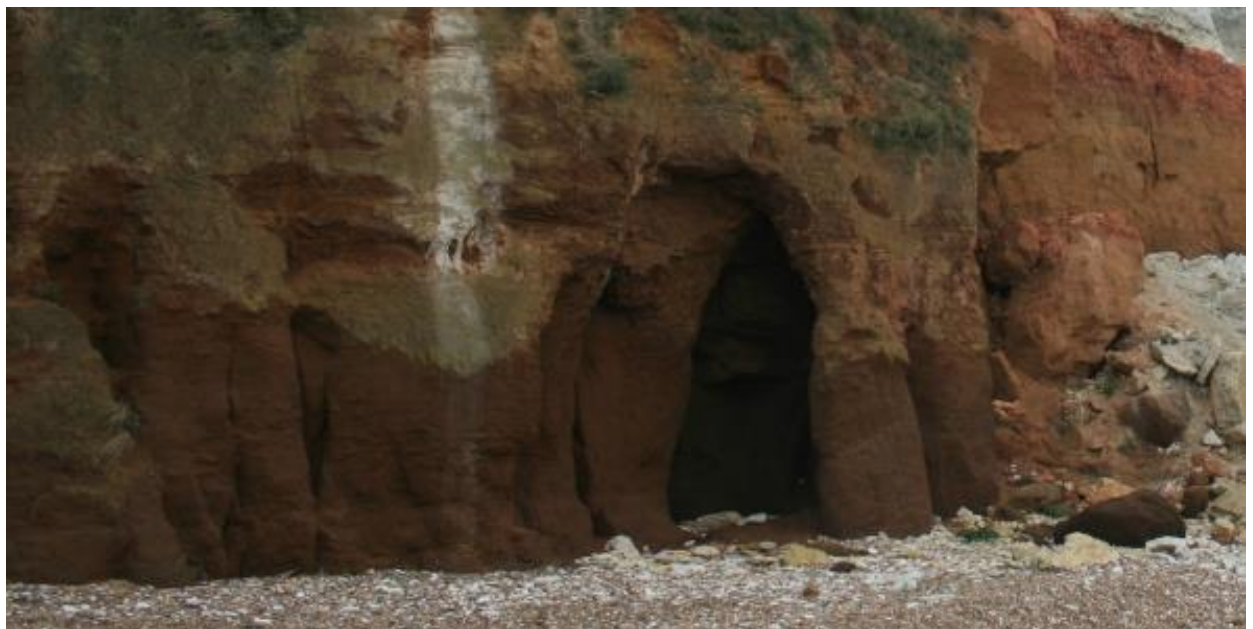
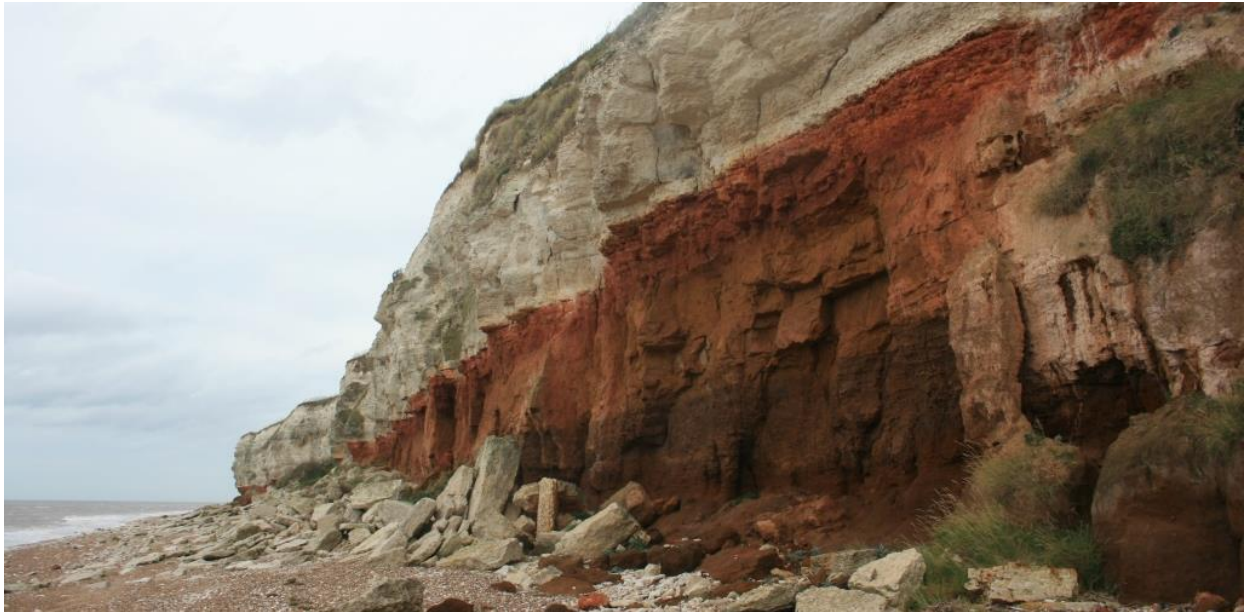
Erosion due to wave action along the base of the Carstone is evident along the base of the length of the cliff where it is not masked by debris from blockfalls. This erosion results in a smooth surface on the Carstone, as opposed to the broken appearance further up the cliff. Wave action also targets the joints, working away through scour, abrasion and hydraulic action to result in open joints, which are then prone to progressively worsening as the waves hit, resulting in significant loss of support to the material above.

Of these mechanisms, the majority of the cliff erosion of Hunstanton Cliff is due to wave action / erosion at the base of the cliff. As shown on the photographs above, wave action forms a smooth surface on the base of the Carstone as it erodes, which also targets the joints, working away through scour and abrasion to result in open joints, which are then prone to progressively worsen as the waves continue to hit. This continued erosion results in loss of support to the Carstone above which ultimately results in blockfall as the upper unsupported material fails along the naturally occurring joints. How far this failure continues through the Carstone and the chalk depends on the competence of the rock and the condition of the joints. In addition, where the face above does not fail immediately, creep may start to occur due to loss of support, resulting in the opening up of the joints and later failure.

As set out above, the mechanism considered likely to be the cause of the majority of the instability of Hunstanton Cliff is wave action / erosion at the base of the cliff, which results in lack of support at the cliff base and subsequent collapse of the Carstone, leaving overhangs in the chalk to collapse at a later date. As such, it is this feature which needs attending to if any.

The creation of a **Rock Sill** fits this requirement, but construction works undertaken at the base of the cliff would have to consider the risk of injury to construction personnel at the base of the cliff resulting from vibration of construction plant. Such vibrations may result in the existing chalk overhangs failing while construction teams are on the beach. As such, it may be prudent to consider a scaling exercise to remove loose blocks or masses of chalk ahead of the placement of the rock.

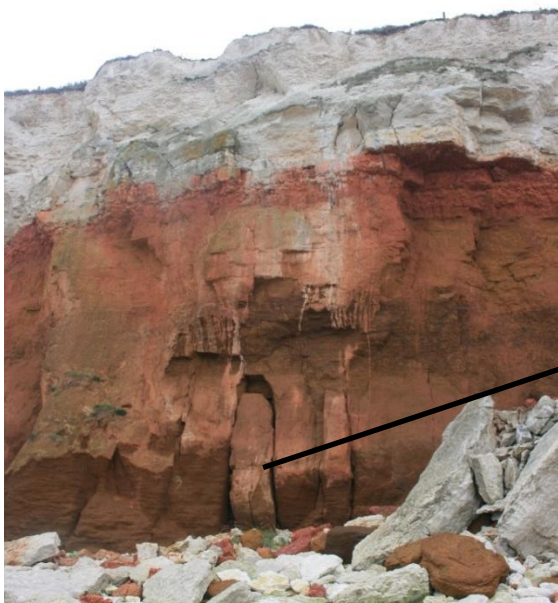
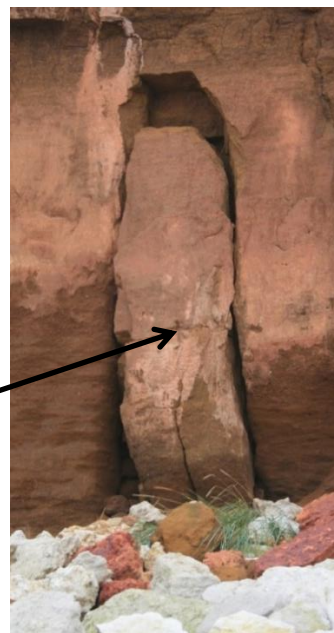
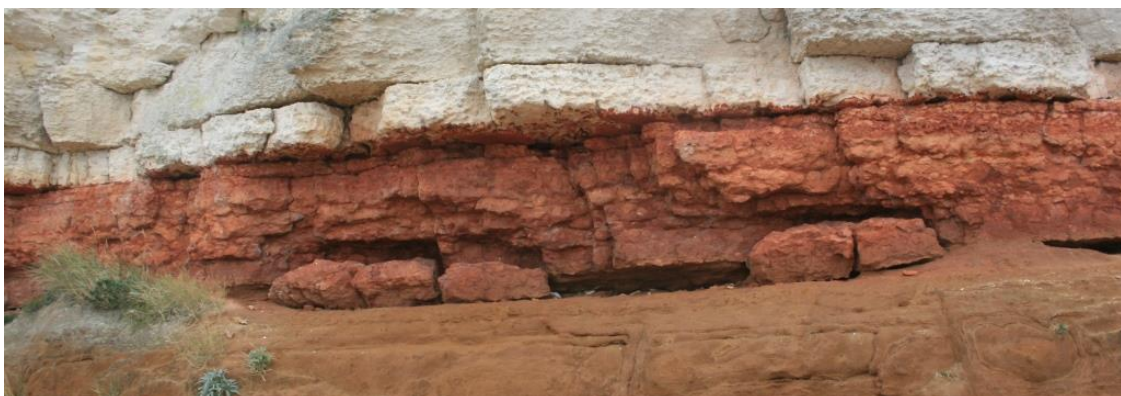
This continued scour results in loss of support to the Carstone. Although the majority of failed material from the Carstone has been totally eroded away by wave action, some examples of the mechanism are still visible, as below.

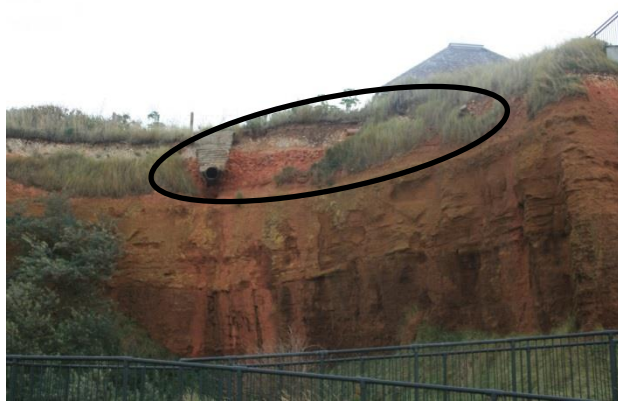
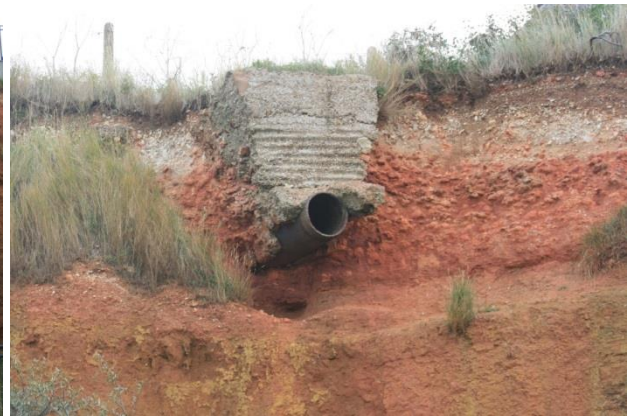
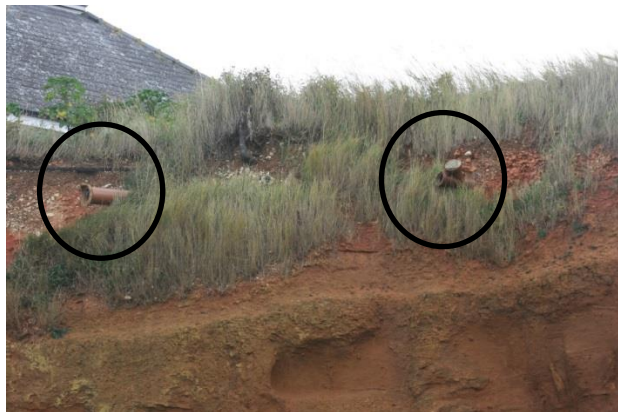
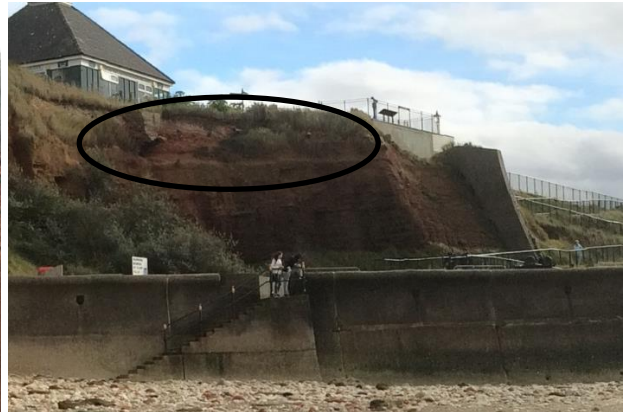
Other features present on the face which may be having an adverse effect on stability of the cliff are associated with drainage. There are numerous pipes daylighting at the crest of the cliff. The age of these pipes is not known, but it is considered likely that they are historic and that sections have broken off as the cliffs have failed around them, possibly as a result of poor joints / leakage.

None of the pipes were flowing at the time of this visit, so it is not known if they are still connected to a drainage system, or taking groundwater, but the scour and discolouration of the rock below them highlight the effect they can have on stability. 3 No. pipes are visible at the southern extent of Hunstanton Cliff, above the northern end of the sailing club carpark, the largest one of which is supporting a large concrete block.

Below the shelter opposite the end of Clarence Road, there is a gulley within discoloured rock, which may be indicative of a pipe being present, although nothing was visible from beach level. The bottom two photos below show a small pipe daylighting above a significant blockfall, although it is not known if the presence is coincidental.

Also discussed in the Pilot Study, but neither discarded nor included in the recommendations, is the improvement of cliff drainage. While this option would not reduce erosion due to the action of waves, both improving the current drainage network and intersecting groundwater or run-off before it percolates down through the joints in the chalk or flows over the cliff edge would reduce the possibility of failures associated with saturation of the rock and the joints in the upper parts of the cliff, as is evident at several locations along Hunstanton Cliff and referred to above.

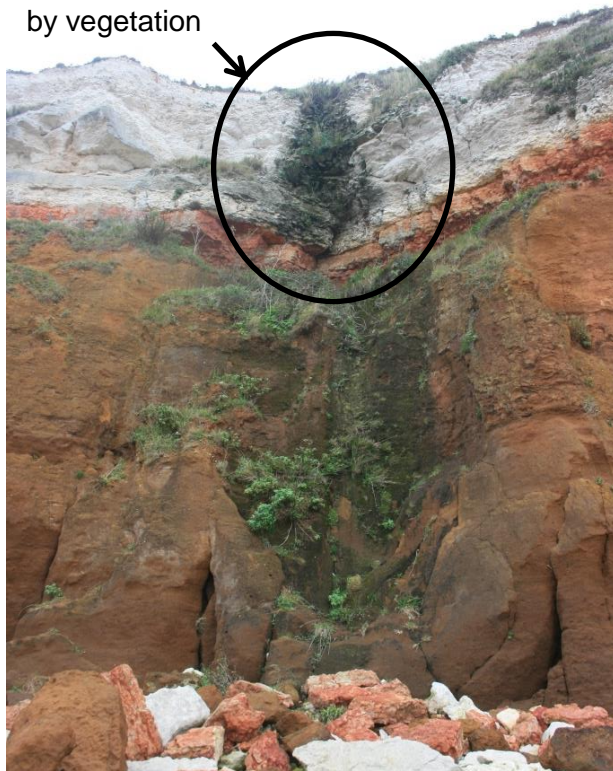
Possible pipe masked
by vegetation

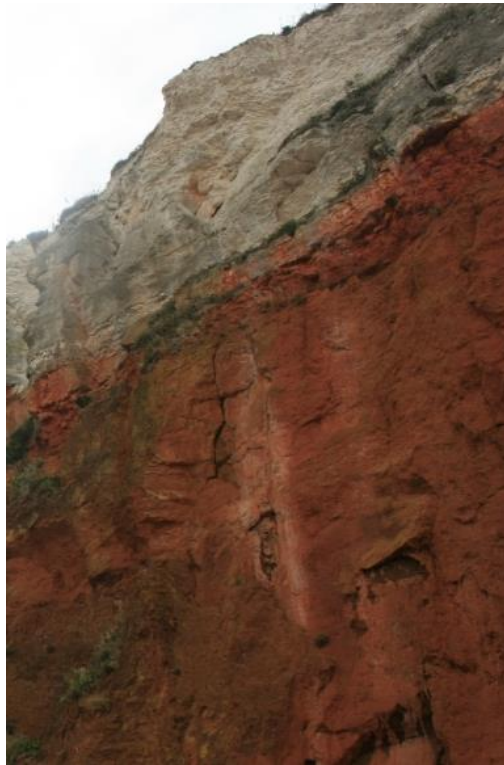
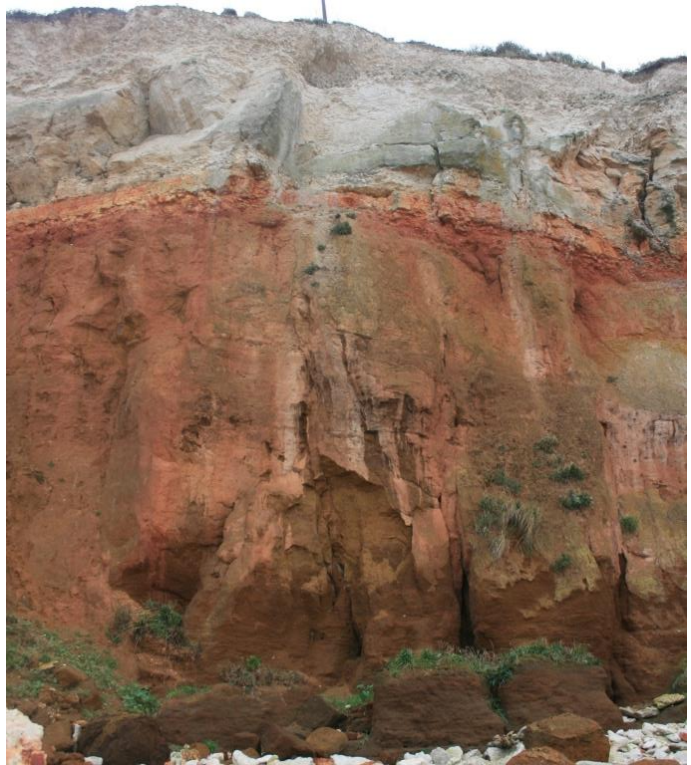
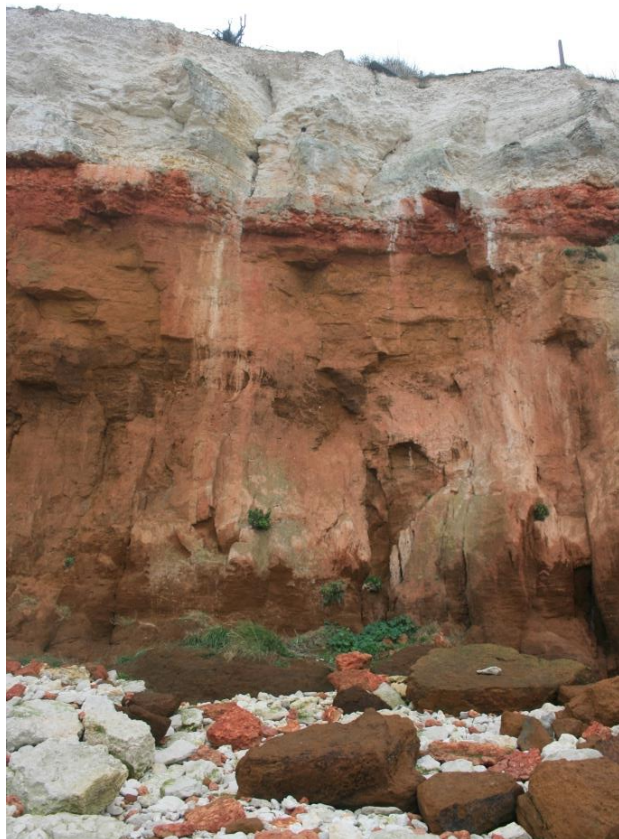
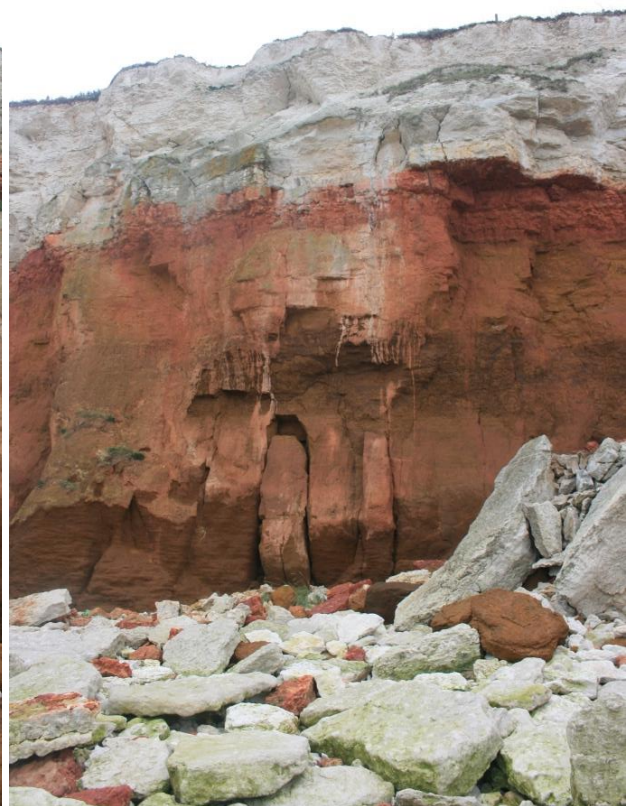
Surface staining is present along several sections of the face of the Carstone, which suggests that water does percolate out of the rock face, although being dry at the time, it is not known if this water originates as surface water flowing directly across the ground surface above and down the face, through joints in the chalk or along the interface between the chalk and the Carstone.

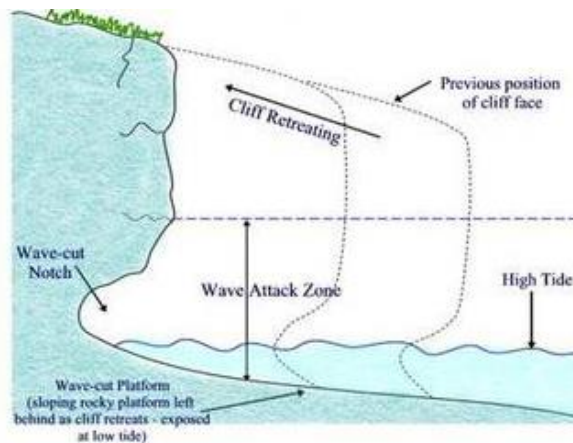
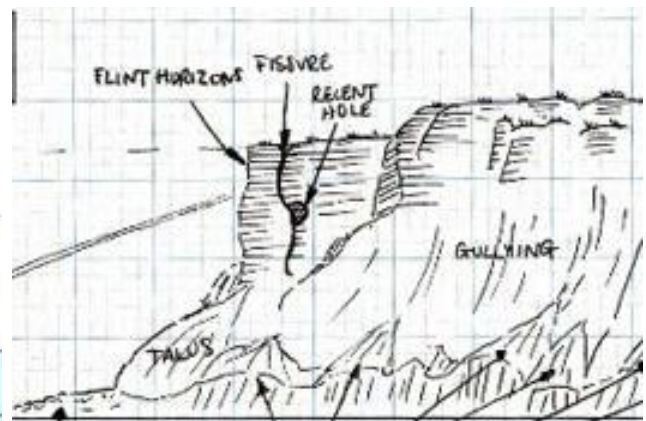
The images below depict the action of coastal erosion which results in retreating cliffs, as is present at Hunstanton, where there is a 'wave attack zone' extending well above the level of high tide, a 'wave-cut notch' undercut into the base of the cliff as the wave action erodes the Carstone, 'fissures' in both the chalk and the Carstone, which start to open up as the support below reduces, and 'gullying' as a result of the various actions of water running down the cliff face. Talus is a term given to failed material which gathers at the base of a cliff or face as a result of failure.
