# Condition Assessment Summary Report

Hunstanton Coastal Management Plan

60552153

December 2018

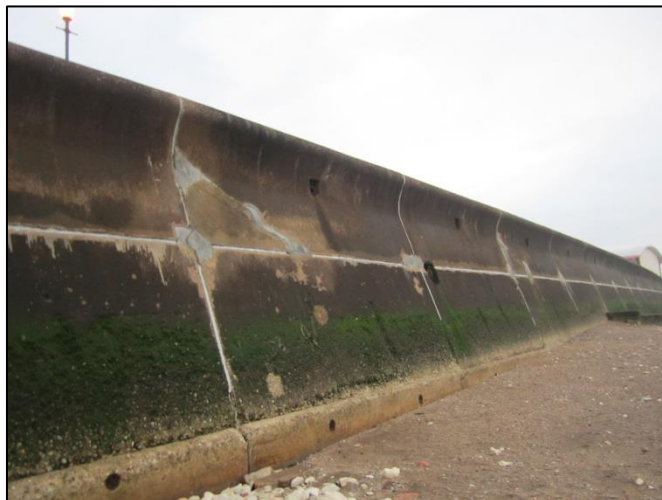
During a site visit on 5<sup>th</sup> December 2017 it was observed that patch repairs were being completed along the face of the seawall in Section G as shown in Figure 3. It was suggested by the Contractor carrying out the work that approximately 50 patch repairs were being made. From inspection the majority of these were on the face of the seawall in Section G where the bottom corners of the upper panel meet the top corners of the lower panel. The visual inspection of this section had already taken place at the time these repairs were observed and therefore the repairs and any potential influence they might have on condition grade or residual life of the structures have not been included in this report.

Figure 3: Photograph of recent patch repairs on seawall in Section G
