# **Hunstanton Groyne Fields: appraisal of groyne effectiveness**

## **Appendix B. Review of existing groyne structures**

December 2021

**Environment Agency**

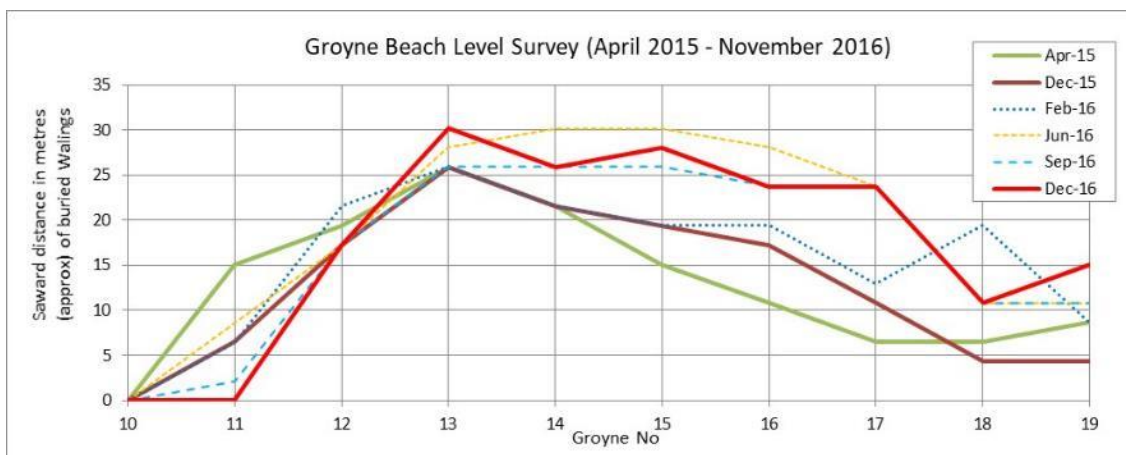
A similar situation was noted by the 2015–2016 beach surveys, which measured the number of walings covered by beach material over a 20-month period (noting the toe of this upper beach would be a little further seaward than the covered walings). The maximum was approximately 30% of the groyne length, and on average the buried length was between 15% and 20%. The variations in width of beach above the groynes have been estimated based upon those records, as shown in Figure B-1. These all showed no beach retention at Groyne 10, and a diminishing width of beach at Groyne 11. A slightly wider beach was observed from groyne 12 southward, although it is notable that the beach width narrowed again towards the Power Boat Ramp – Groynes 17 to 19. Over the period some increase in beach width was observed between Groynes 13 and 19.

Figure B-1 Survey of groyne coverage (buried walings) between April 2015 and November 2016 (adapted from source: BCKLWN).

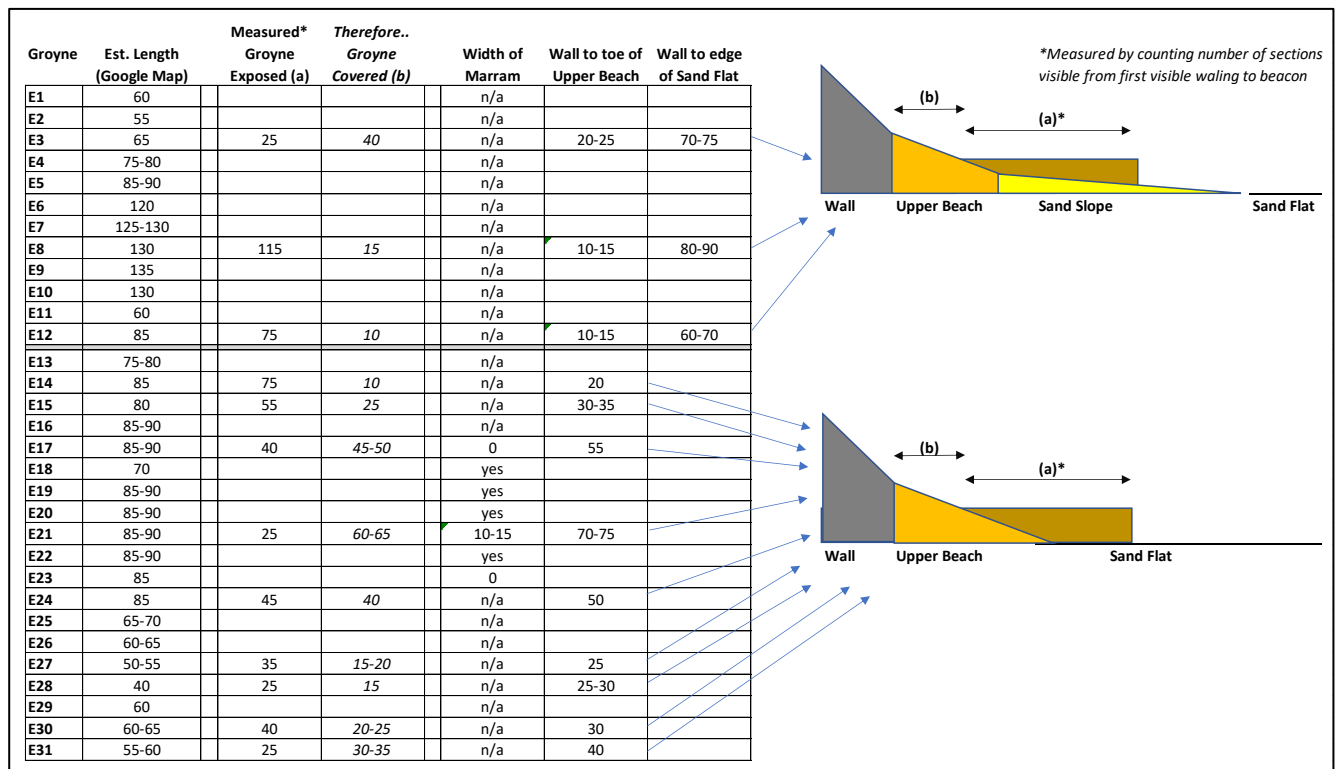
Figure B-2 Measurements made during the November site visit of groyne exposure and estimated beach widths.

Throughout all of the 31 Environment Agency groynes (a distance of 2.6km) there is no sand/shingle differential either side of them anywhere along their profiles. There were also no visible signs of any transport beyond the ends of the groynes. The sandflat features small sand ripples but there is no indication of groynes having any influence on those. The groynes do not even really seem to be trapping pebbles.

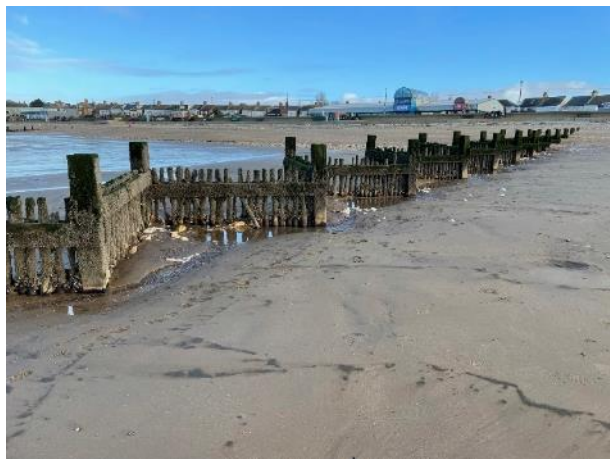
Around Groynes 10 and 11

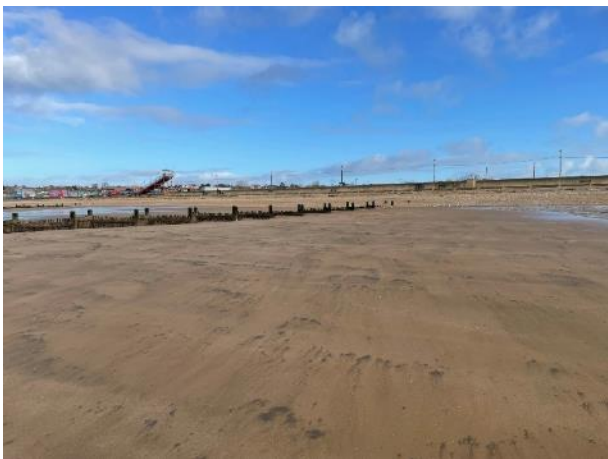
Just north of the Power Boat Ramp

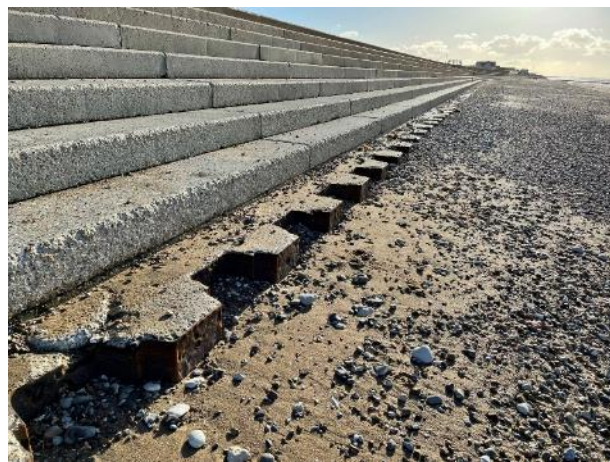
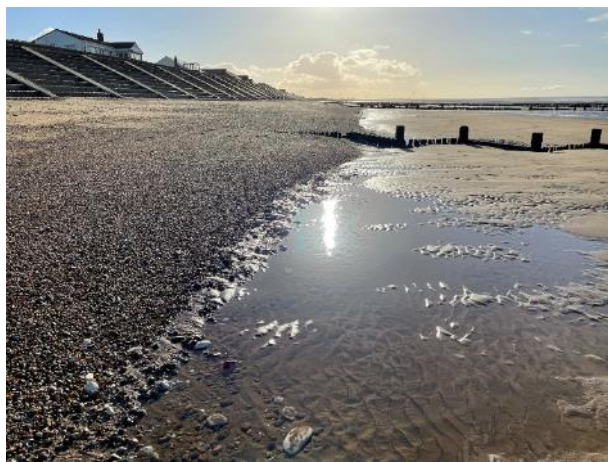
Northern stretch to Groyne EA6

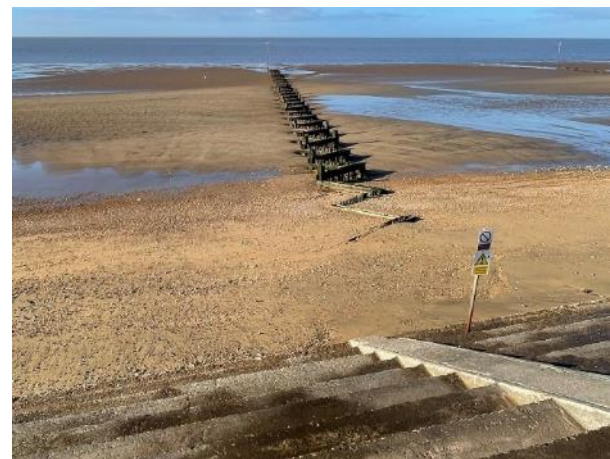
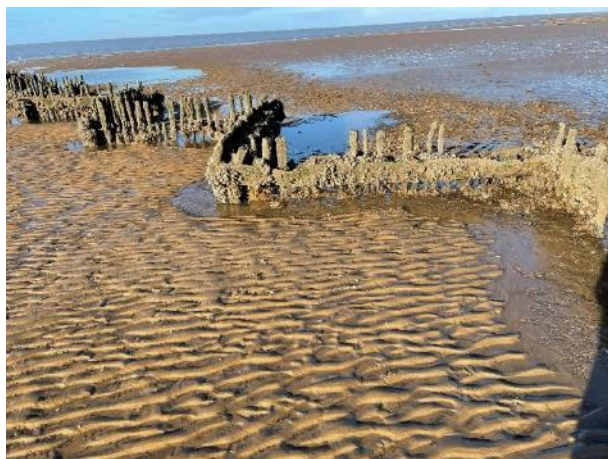
Groynes EA7 to EA10 (long groynes)

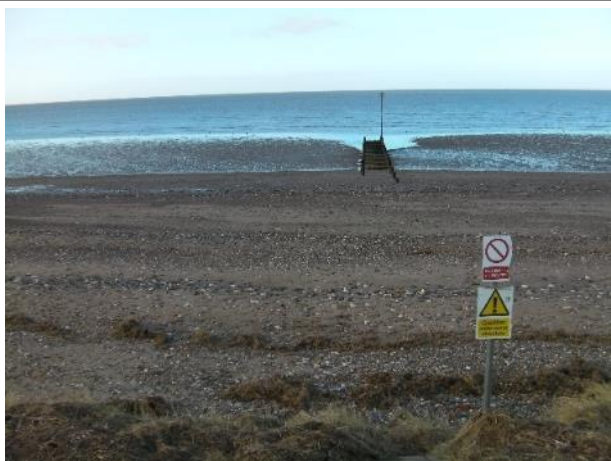
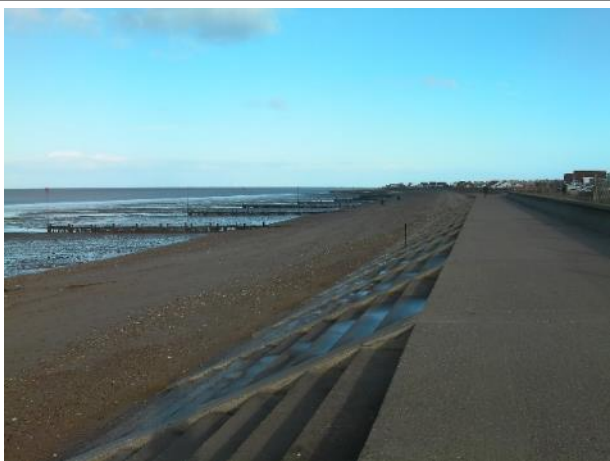
Embayment area (Left: Groyne EA17, Right: looking north from Groyne EA27)

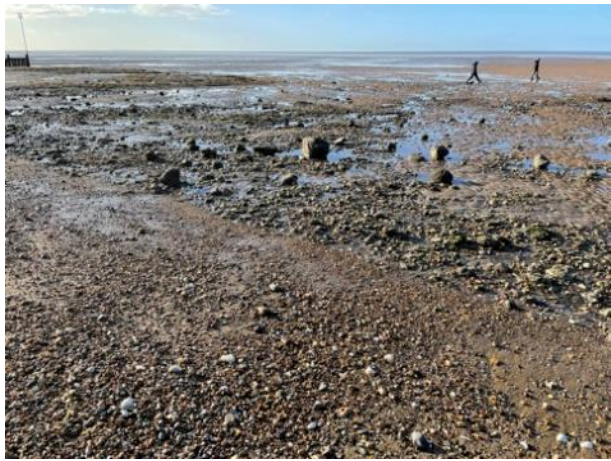
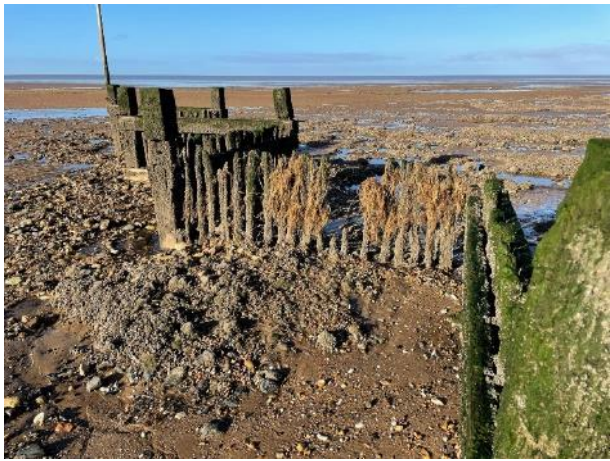
Around Groyne EA28

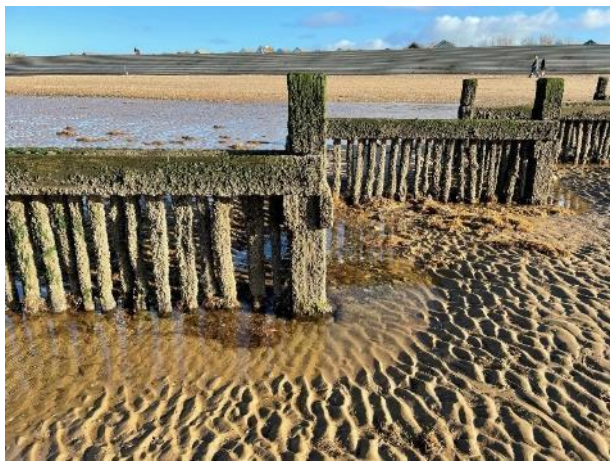
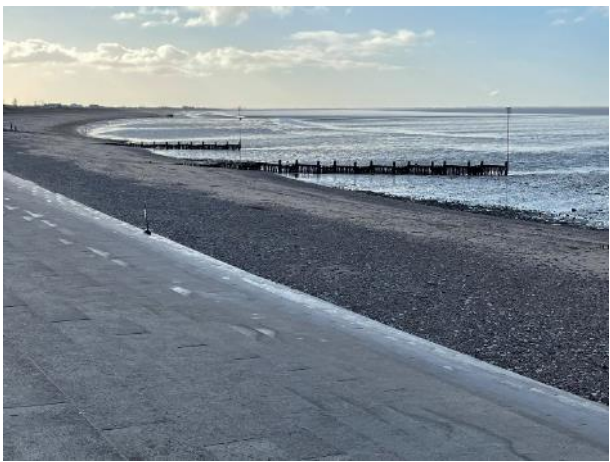
Southern stretch: Groynes EA29 to EA31
