# **Hunstanton Groyne Fields: appraisal of groyne effectiveness**

**Appraisal report**

**December 2021**

**Environment Agency**

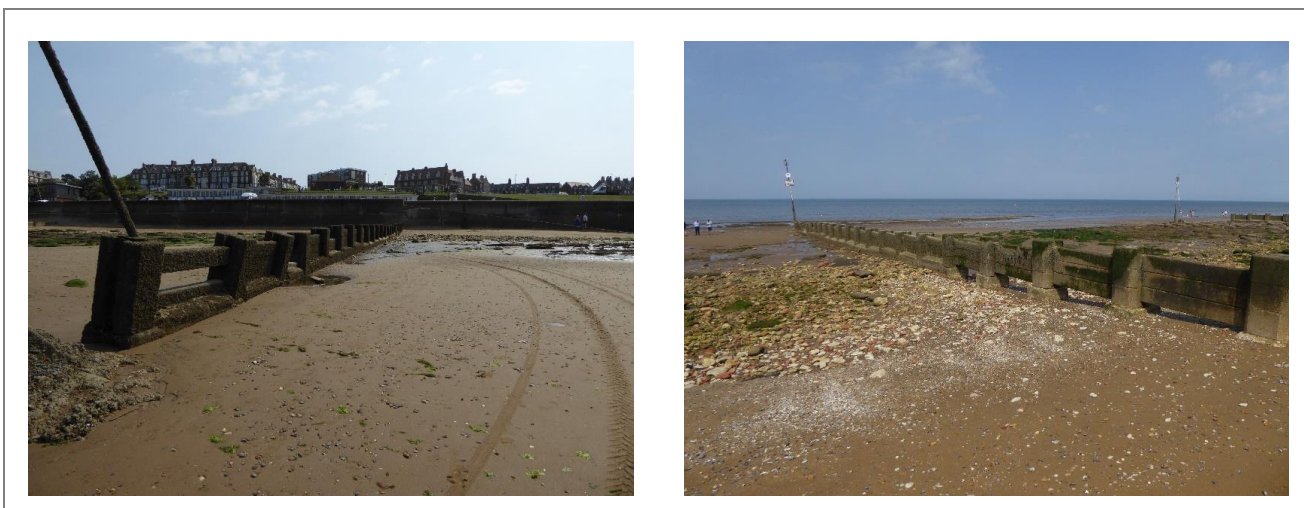
The site inspection undertaken in 2017 for the Hunstanton Coastal Management Plan (AECOM, 2019) concluded that the groynes were in 'Fair' condition, but with notable damage. This was however focussed on the condition of the structural elements, not to be confused with an assessment of their overall functioning or effectiveness. From the recent site walkovers (2021), it was observed that the major structural issue throughout this groyne field appears to be one of overall stability rather than material degradation; in particular lowering of the beach and these would be more accurately described to be 'Poor' or even 'Very Poor'. Several groynes currently have one or more sections where there are gaps beneath the lowest planks. Previous gaps were filled as part of the remedial works in 2012, but other gaps have since appeared. In one instance (Groyne 7) the scour hole reaches a depth of

up to 50 cm below the groyne underside. Several groynes are also damaged or leaning at their seaward ends due to the same foreshore lowering, for example, Groyne 6 where 3 three to 4 four bays are collapsing. The end of Groyne 5 has already been removed.

During both site walkovers, it was observed that only a little sand had accumulated in a triangle on the north sides of most groynes against the seawall, but otherwise there was little difference in beach levels either side, indicating little effectiveness in controlling alongshore sediment movement between the groynes. It is conceivable that the sand predominately deposited here is simply material that is in suspension, dropping out at the top of the tide, rather than being driven by longshore processes. The groynes have not helped to prevent further foreshore lowering either, with the Carstone exposures here similar to those seen along the cliff frontage immediately to the north.

Figure 3-1 Condition of BCKLWN concrete groynes

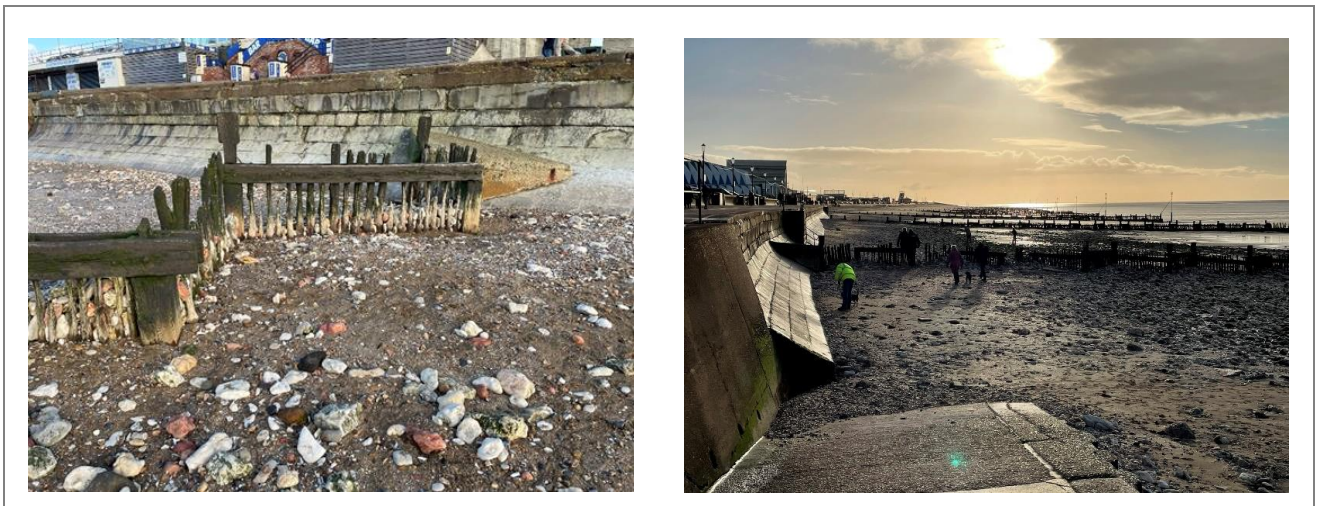
The site inspection undertaken in 2017 for the Hunstanton Coastal Management Plan (AECOM, 2019) concluded that the groynes were in 'Poor' to 'Fair' condition, but with notable damage. Once again, this refers to the timber elements and not to their effectiveness. From the recent site walkovers (2021), it was observed that due to abrasion, much larger gaps now exist between the posts than when constructed. Given the significant

deterioration of these fundamental components of the groynes, the overall condition has to be concluded to be 'Poor' or even 'Very Poor'. In several places the walings have also been damaged, split, or lost completely. Along the seaward ends of several of the timber groynes, rock has been placed around their base to resist further erosion and prevent overturning and collapse of the supporting piles and thus overall structure.

Figure 3-2 Condition of BCKLWN timber groynes.

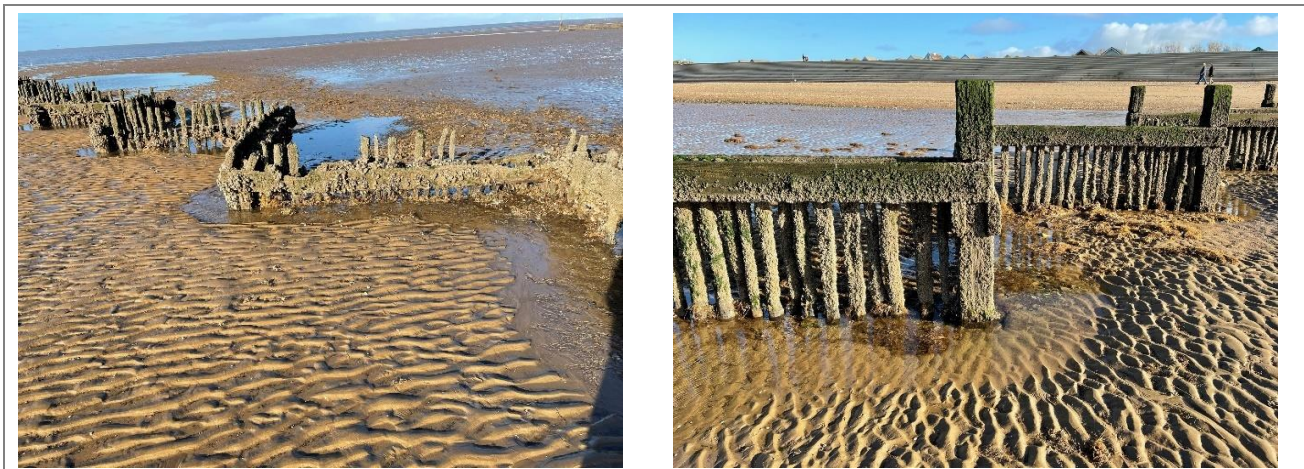
Observations from the recent site walkovers (2021) were that the general condition of the groynes was similar to those at Hunstanton in places, but better in others, specifically through the embayment area (Groynes EA16 to EA23), but worse on some of the more exposed areas of seawall (e.g. around Groyne EA8). In a number of places the ends of the groynes have previously failed and have been removed. Much larger gaps now exist between these posts than when constructed, and in this regard any potential trapping efficiency will be considerably reduced compared to when constructed. Given the significant deterioration of these fundamental components of the groynes, the overall condition has to now be concluded to be 'Poor' or even 'Very Poor'.

It is also notable that none of the groynes appear to be higher than the toe of the seawall, so will have little effectiveness in terms of holding a beach to a height that would help protect that structure. During the site visits, there was no differential in sand levels evident across the lower beach either side of the groynes. The evidence therefore suggests that the groynes are not having an influence on longshore transport along the upper beach.

Figure 3-4 Condition of Environment Agency timber groynes.

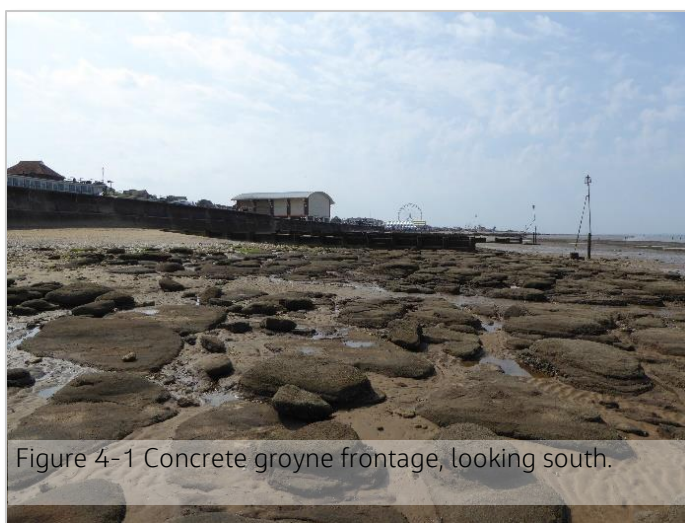
Beaches along this frontage (Figure 4-1) are characterised by a steep but very narrow mixed sand and gravel beach at the base of the seawall, which typically lies between +1 mOD and +3 mOD (referred to as 'upper beach'). This is fronted by an outcrop of Carstone and lower sand beach ('lower beach'), beyond which is a sandflat below mean sea level (referred to as 'sandflat'). Offshore of this frontage lies the nearshore sand bank of Sunk Sand.

Figure 4-1 Concrete groyne frontage, looking south.

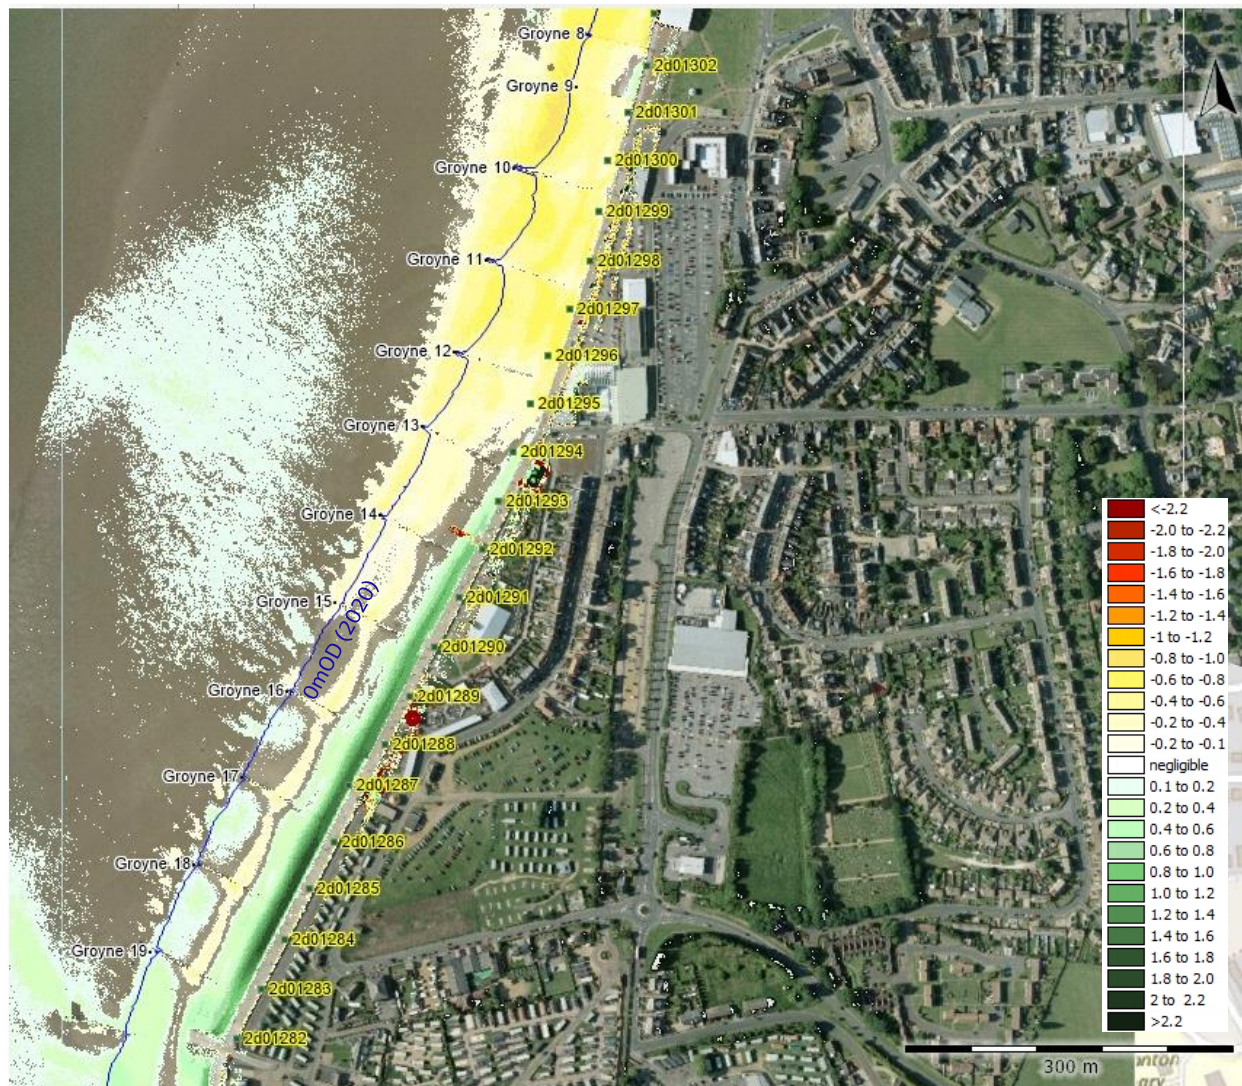
The beach profile data and LiDAR indicate differing patterns of change along the frontage, as illustrated in Figure 4-6. Along the northern half of this frontage, there has been a trend of beach lowering and therefore beach sediment loss over the past 10 years. In contrast, the southern half has generally seen net gain across the upper beach.

This corresponds with the distinct change in shoreline orientation along this frontage around Groyne 12. Notably, losses across the northern half have typically been across the beach profile and contour data derived from the LiDAR show that there has been a landward translation of the beach profile (see Appendix A). To the south, the gains have predominately been across the upper beach, i.e. along the base of the seawall, although some increase in the level of the lower sand beach is also evident from the data.

Figure 4-6 Difference plot for the BCKLWN timber groyne frontage, generated from LiDAR data from 2020 and 2011, with change in beach level in metres. (data courtesy of ACM). Negative values (green) mean that there has been a drop in level in 2020, and positive values (red and yellow) indicate an increase in level.

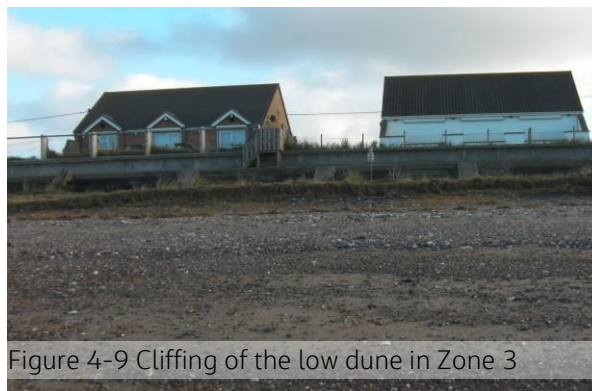
Further south, along the Heacham Manor Golf Club frontage there is a deeper embayment (Zone 3; Groyne EA14 to Groyne EA23); the low dunes that have developed here are evidence of the potential for sediment retention at the back of the beach/ base of the seawall. Much of the groyne lengths are buried here, and due to the embayed nature of the shoreline, the effective length of the groynes is also reduced. It is notable that the beach line does not follow the embayed backshore alignment. At the northern end of this embayment, there has, however, been more recent erosion (as acknowledged above) and during the November site visit cliffing of the backshore dunes was also observed (Figure 4-9). Historical aerals indicate that the dunes may be a fairly recent feature (since 1999) and have experienced previous periods of growth and erosion.

Figure 4-9 Cliffing of the low dune in Zone 3
