# Jacobs Groyne Effectiveness Report

Kevin Burgess - Jacobs

Borough Council of  
King's Lynn &  
West Norfolk

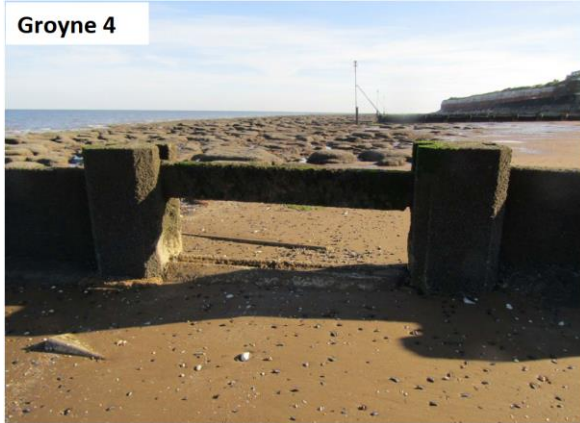
Groyne 4

- Concrete – unusual material choice
- Condition 'Poor' to 'Very Poor' throughout
- Missing planks etc but main structural issue is due to beach lowering below design levels, and abrasion

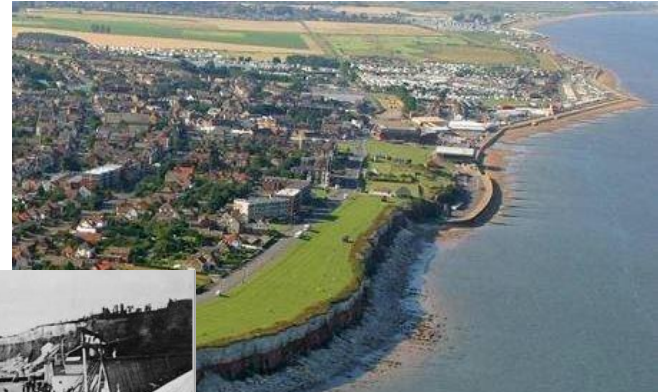
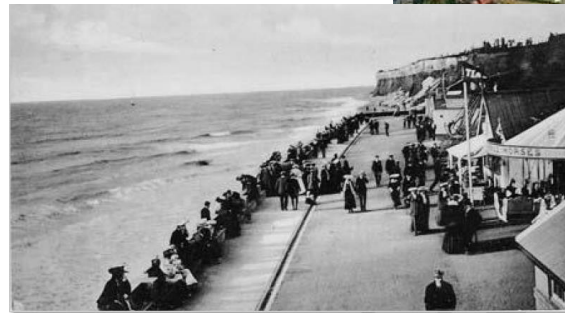
- Sand is almost non-existent – little evidence that substantial volumes of sediment have ever regularly moved onto this shoreline
- Promontory & high exposure to waves – unlikely for sediment to be retained for very long, even if a reasonable input of sediment
- Little differential in level of any beach material across the groynes
- Elevation of the groynes is too low to be effective in front of a reflective seawall

- Even if the groynes were made higher and longer it is still unlikely that these would have much effect
- At the very least need a different form of groyne design and recharging, but effectiveness would still be questionable

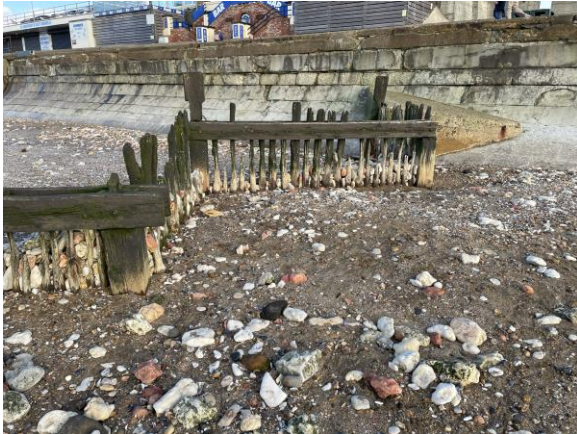
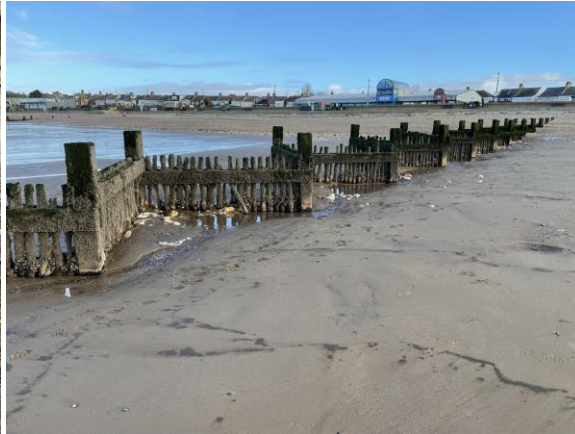
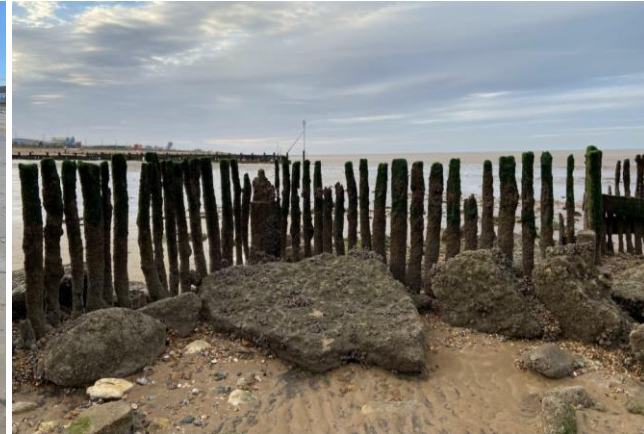
- Permeable timber structures
- Condition 'Poor' to 'Very Poor' throughout
- Main structural issue is due to beach lowering and abrasion
- Rock has been added in places

- With exception of southern end, reinstatement of these is unlikely to have significant effect – but they are not doing any harm either.
- Permeable groynes would still have the issue of insufficient sediment supply

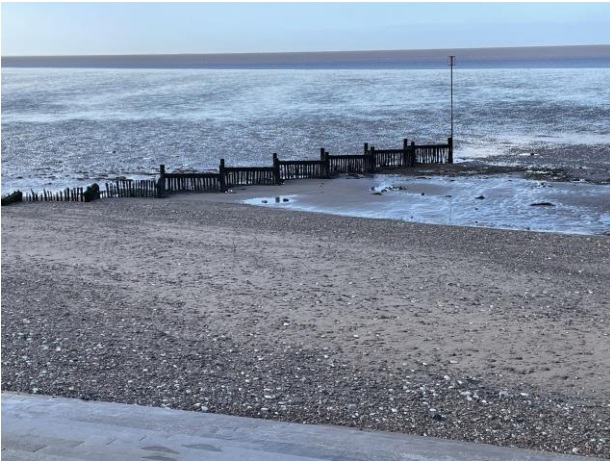
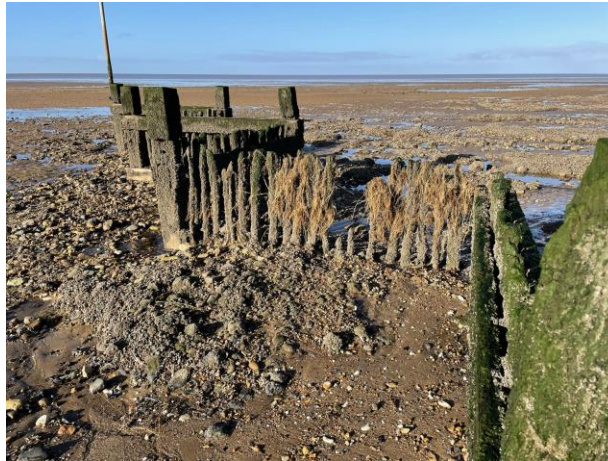
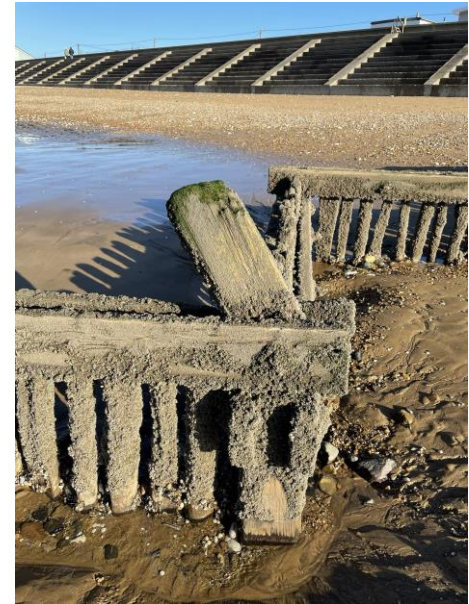
- Same design as those on Hunstanton town frontage
- Condition similarly 'Poor' to 'Very Poor' throughout
- More sand (in places) – but this frontage is also recharged annually

- With exception of Zone 1, reinstatement of these is unlikely to have significant effect – but they are not doing any harm either.
- Sand recycling provides sediment supply to upper beach – retention against seawall might be improved if the landward sections were replaced with higher impermeable structures
