Hunstanton Capital Sea Defence Works Briefing

Thursday 7th August 2025 Dave Robson & Jade Kite

Outcomes of Geotechnical Investigations

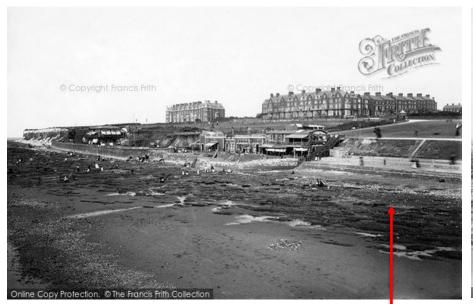
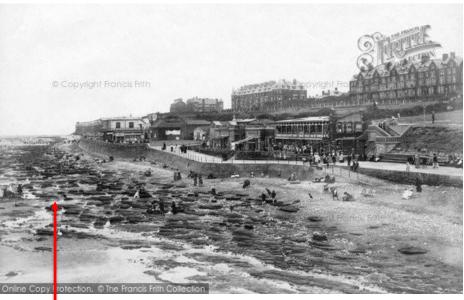
Hunstanton in 1893 & 1907 – Similar beach conditions to today

Widespread Carstone exposure and limited beach cover is evident

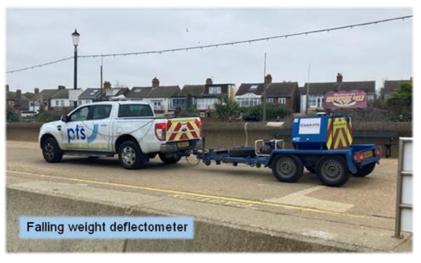
Section A (Boat Ramp / Caravan Park)

Wave-return wall – No current works required

Promenade deck – Poor concrete condition and voids

Stepped seawall – No refacing works required

- No toe protection works or sheet piling required

Window sampling required within next 12 months

Potential replacement of prom deck required (up to 68 panels)

Monitoring – Regular monitoring of beach levels

Structural stability monitoring every 5-years
