Hunstanton Coastal Defences Works Update June 2026

Borough Council of
King's Lynn &
West Norfolk

Hunstanton Coastal Defence Capital Works

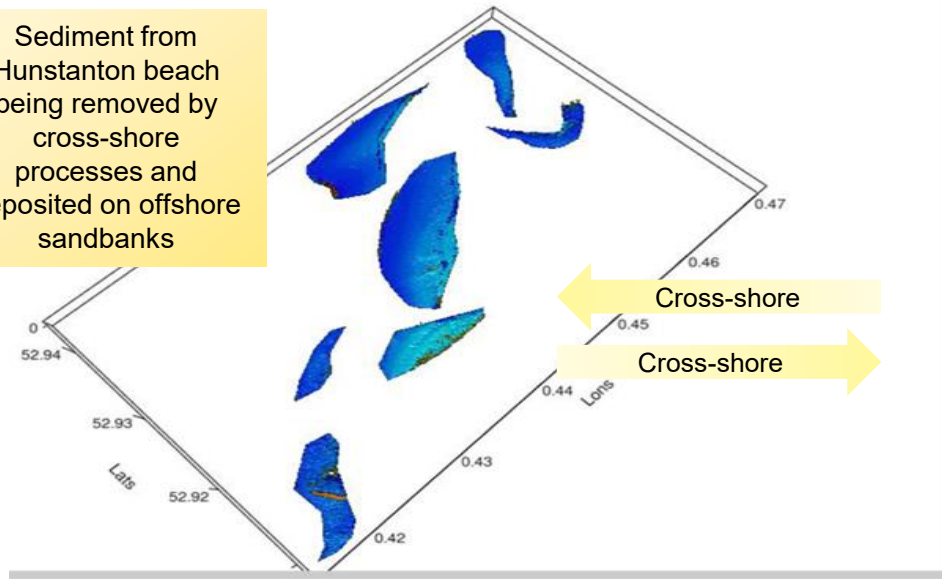
Sandbanks offshore from Hunstanton

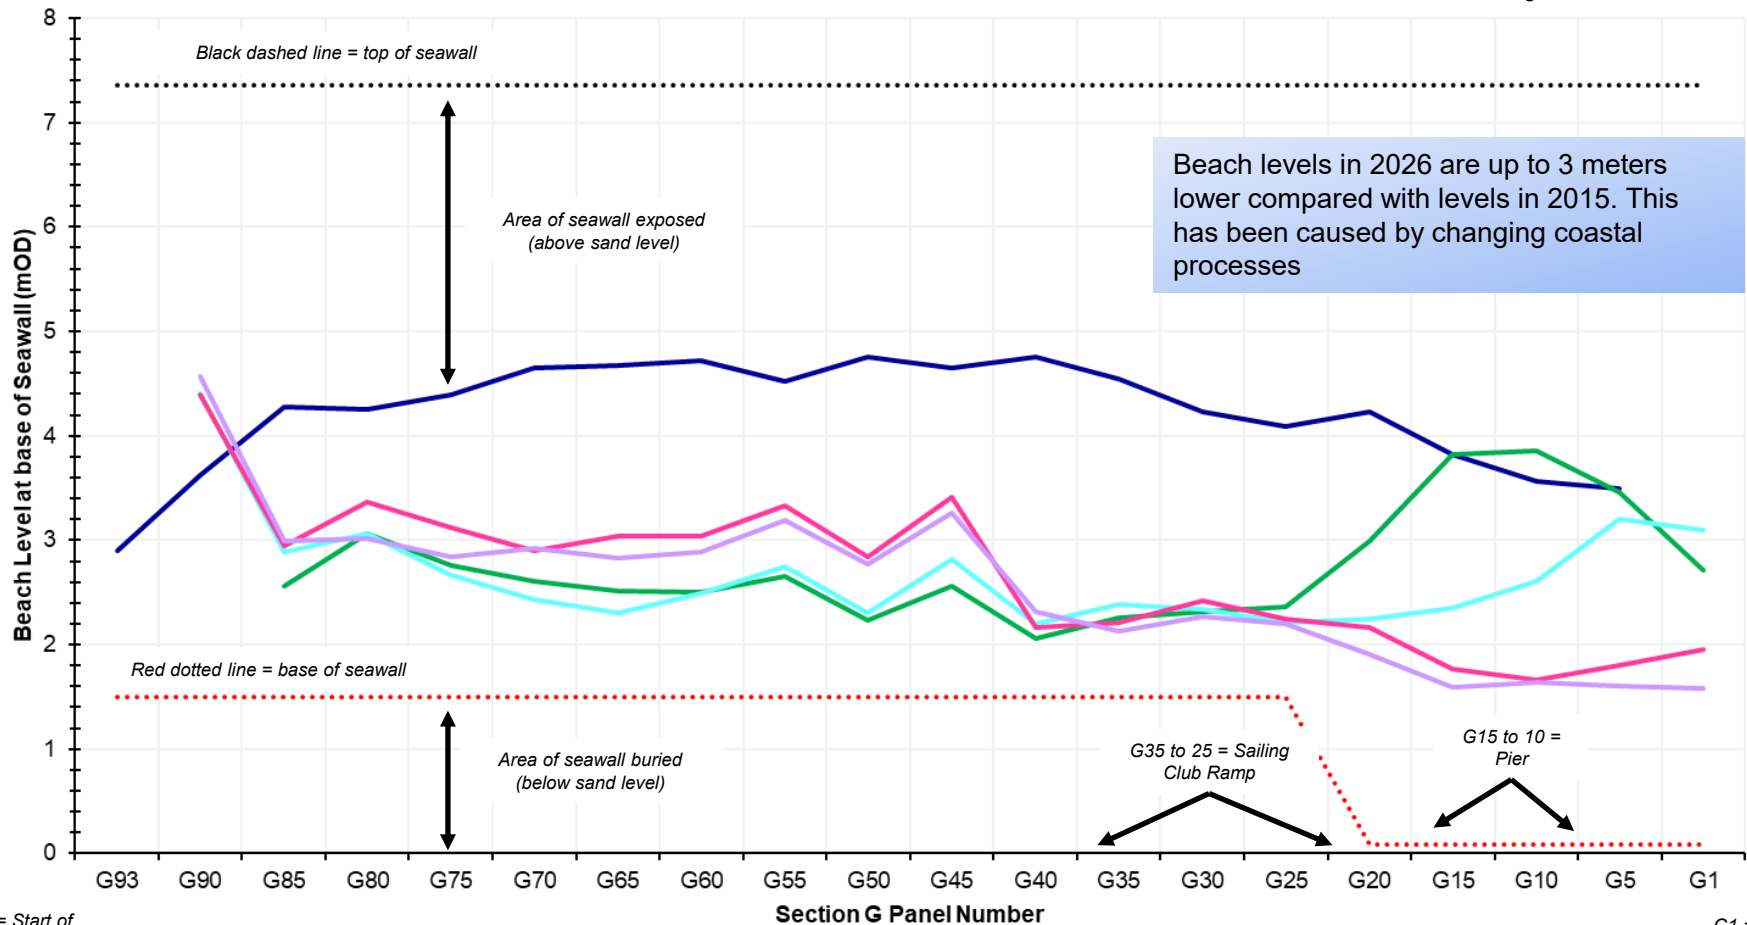
Section G Beach Level

Coloured lines = Height of beach material against the base of the seawall

G93 = Start of seawall at Cliffs

G1 = End of seawall ramp

..... Seawall Crest Base of Seawall — 2015 Average — 2020 Average — 2024 Average — 2025 Average — 2026 Average

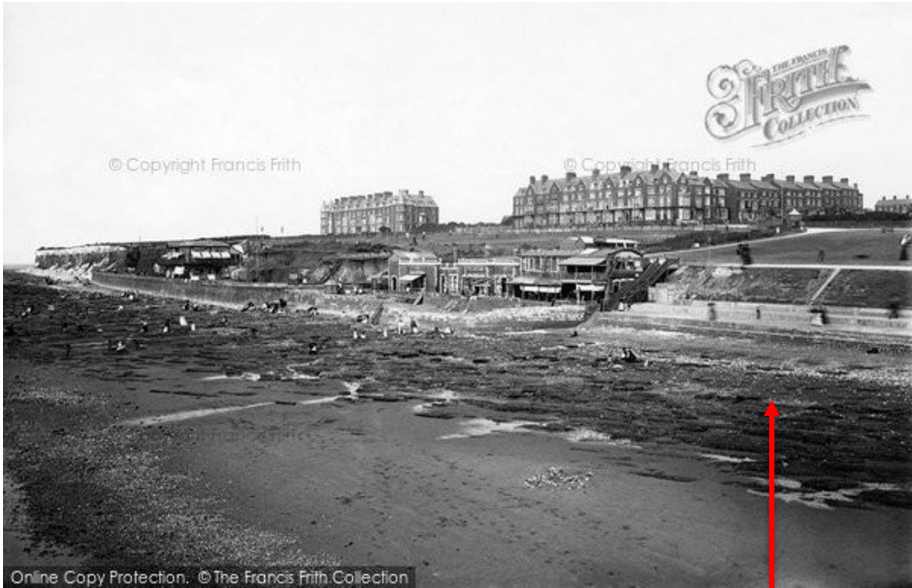
Hunstanton in 1893

Widespread Carstone exposure and limited beach cover is evident

Beach conditions between 1893-1907 look very similar to today

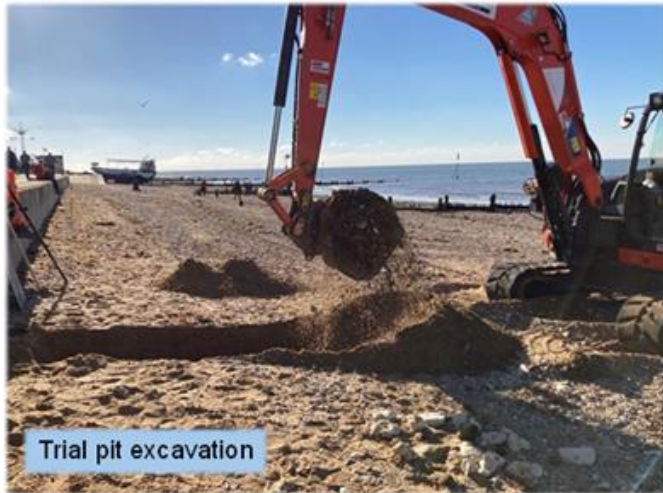
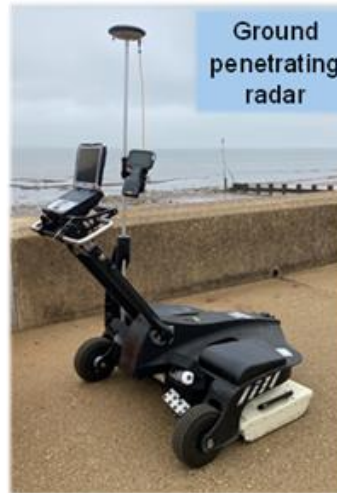
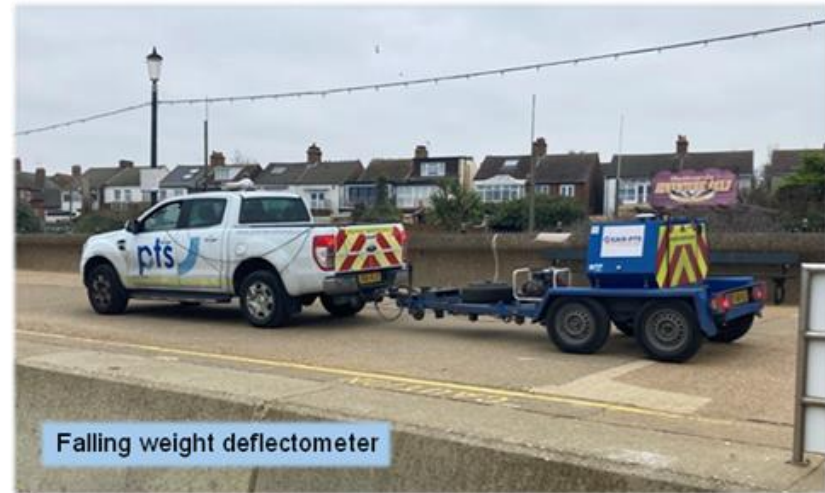
Geotechnical Investigation

- Excavation of 25 trial pits along the base of the seawall to expose the conditions seawall foundations which are normally buried beneath beach material.
- A ground penetrating radar survey to assess the internal condition of the promenade deck
- A falling weight deflectometer to test the material strength of the concrete promenade deck
- On site investigations were completed in Autumn 2024, and a final report of outcomes received in July 2025

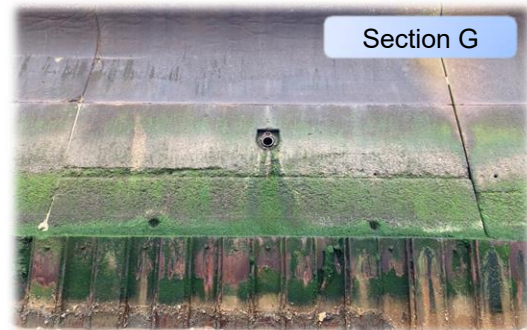
Geotechnical Investigations – Outcomes

- The concrete promenade deck has poor structural condition and voids beneath it and requires replacement
- Seawall Section E is at risk of undermining if beach levels lower further and requires toe protection (sheet pile) installation and a seawall reface to mitigate future risk of undermining failure.
- Seawall Sections F and G are at risk of structural failure if beach levels lower further and require toe protection (sheet pile) installation and a seawall reface to mitigate future risk of structural failure.
