Snettisham Caravan Park Access Road Pavement Investigation

FWD and GPR Report

For Norfolk County Council

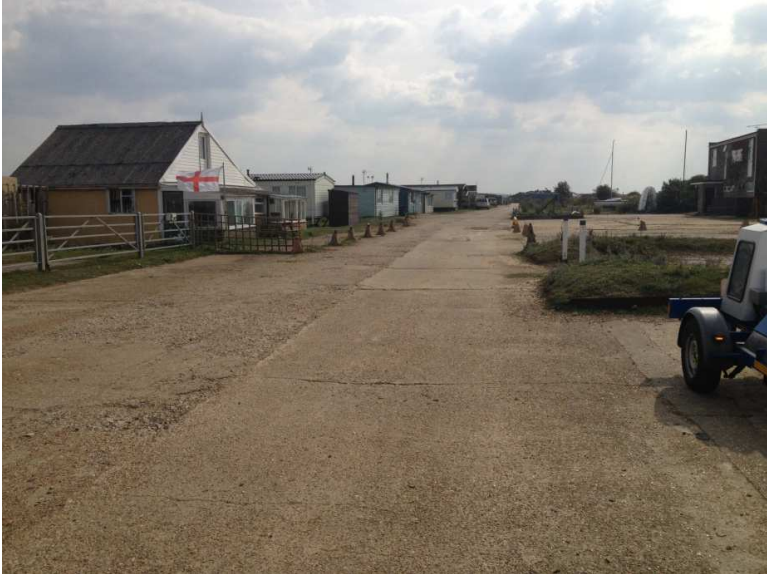
The road itself was found to comprise of a single trafficked lane constructed from cement bound material over a granular sub-base with no supporting kerblines or drainage system in place. Visually the surface of the carriageway was found to be in poor condition with heavy cracking in evidence throughout and several areas with no bound material at the surface. Numerous repairs had been carried out along its length, but these are inconsistent in construction and have also failed in many locations.

Figure 1.2 – View of carriageway in SB direction - Site Chainage 90

- Overall the majority of the cement bound material is performing poorly, although there are isolated areas where the stiffness values are good. This is particularly in evidence between chainage 207 – 260 adjacent to houses 65 to 72 and outside houses 95 to 97 where remedial work has taken place to replace the existing construction.

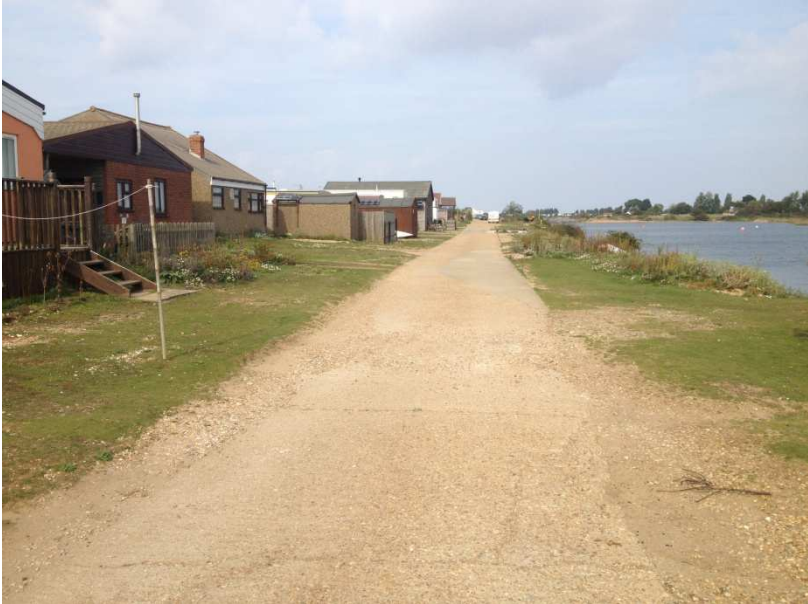
Figure 1.3 – View of carriageway in NB direction - Site Chainage 620

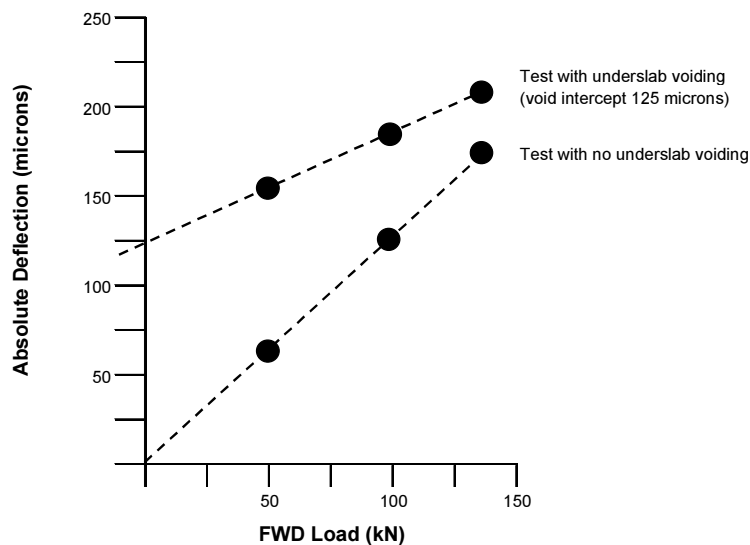
Figure 4.1 Void Intercept

In order to gain an understanding of any voiding issues affecting the pavement the FWD was setup to measure the deflection in the road at three different loads. Theoretically for a zero load the corresponding pavement deflection should also be zero. However, for voided foundations where deflections may not increase proportionally with load then a linear regression analysis may not intercept the origin of a load versus deflection plot. The point at which the linear regression line intercepts the y axis is known as the void intercept (see Figure 4.1).

To determine void intercept values at least three tests should be carried out at different load levels. Voids underneath the pavement will be closed as the pavement is loaded. Increasing the applied load will further increase the closure of the void resulting in deflections that will not increase proportionally with the load level. By extrapolating from the three tests the deflection corresponding to zero loading may be calculated by linear regression.

- Voiding has been found to be an issue within the pavement structure, however these values are inconsistent and in many places not high enough to cause concern. In pavements of this type high void intercepts can often be a result of a stiff concrete material above the supporting material but as most of the concrete here is in poor condition it is likely settlement has occurred and that the voiding is a result of compression between the granular sub-base and the bottom of the cement bound material.
