WISBECH CANAL ENVIRONMENTAL INVESTIGATION

DESKTOP STUDY SUMMARY

APRIL 2010

Wisbech Canal Study Summary

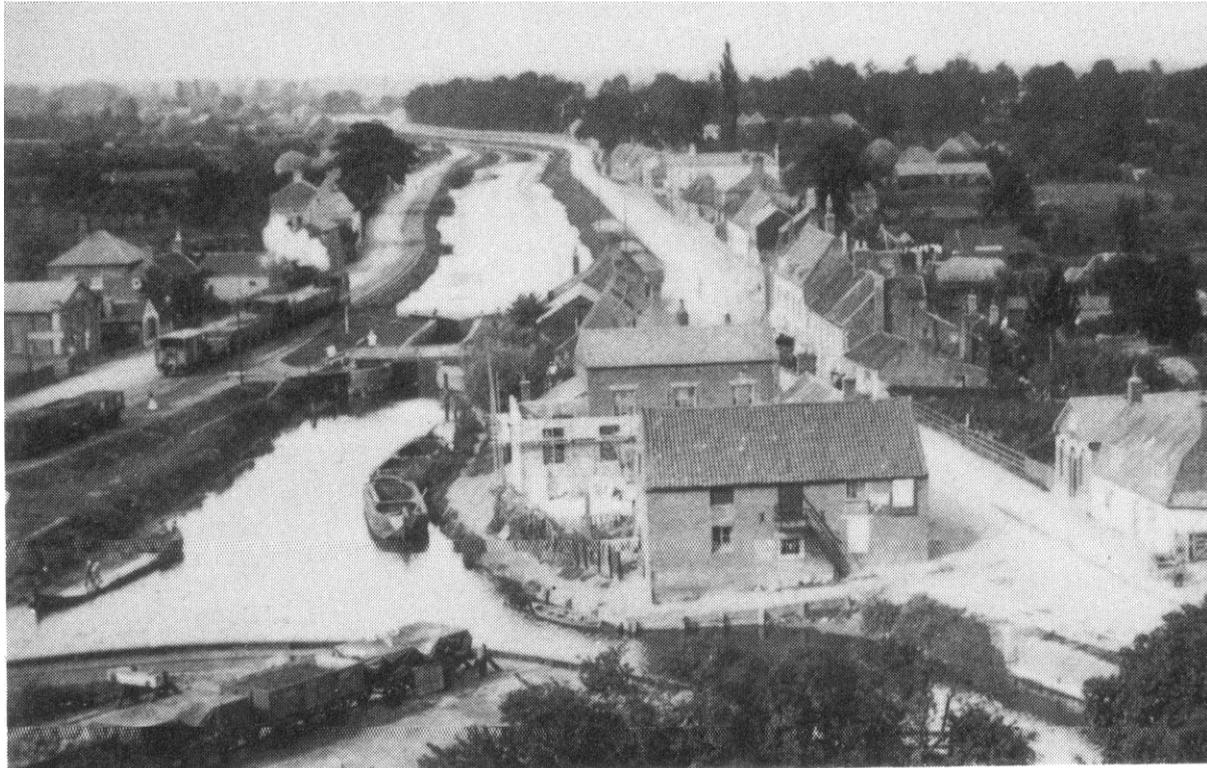
Figure 2: Outwell - Canal, Sluice, Well Creek and tramway in 1800s (Source William Smith)

The canal was authorised by an Act of Parliament in 1794 and opened in 1797. A tram line opened to Outwell on 20th August 1883. For a time the tramway helped the canal. The line followed the canal to Outwell Basin, where the first stopping point was. The canal widened at the basin so that barges could turn and moor. The canal carried coal for onward transport to the Fens on barges. The canal and tram also carried fruit back from the Fens.

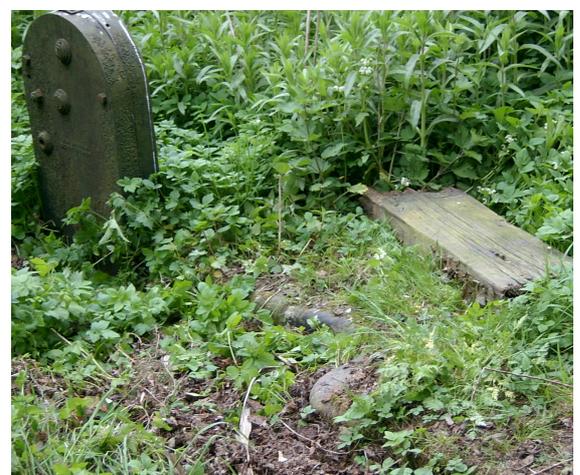
Figure 5: Photo of remains of Outwell Sluice

Remains of the old sluice are still visible at Outwell as this picture shows. A map extract is above showing the canal and tramway at Outwell in the 1800s.

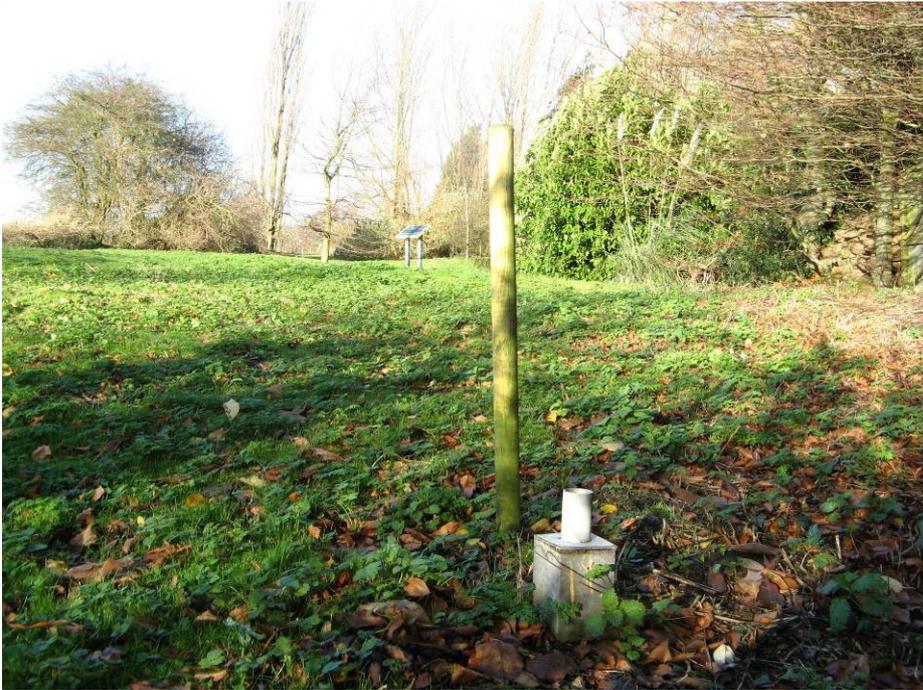
Figure 6: photo of gas monitoring well

Cambridge County Council and Norfolk County Council (NCC) took responsibility for the closed landfill as the Cambridgeshire and Norfolk border runs along the centre of the site. Norfolk County Council manages the land on behalf of both County Councils. As the waste can create ground gas such as methane and carbon dioxide (CO₂), NCC carries out monthly gas monitoring from 69 monitoring wells. The land falls in both West Norfolk and Fenland administrative areas.

Monthly gas monitoring by NCC to the south of the A47 has shown carbon dioxide in several monitoring wells within the waste. Recently methane has been detected in two locations.

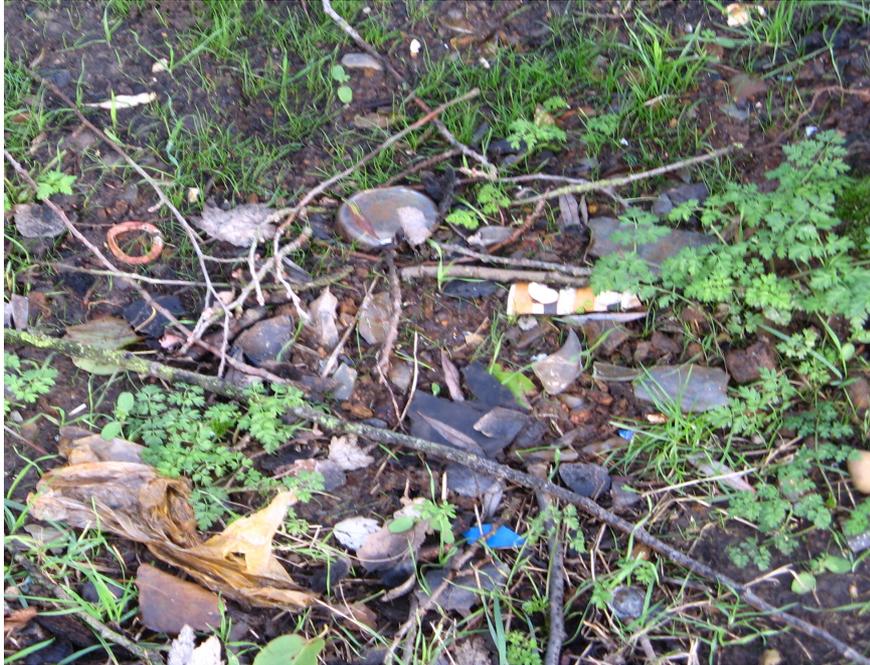
Figure 7: Photo of disturbed waste

As part of this investigation, soil samples were taken from four locations and submitted for laboratory analysis on 14th January 2010. This part of the investigation aimed to show what contaminants might be present in soil near the surface. Samples were collected at 0.2m and 0.5m below ground level. Where waste was present at the surface a sample was collected of the waste material.

Laboratory analysis suggested there were contaminants in the waste such as lead, oil or ash higher than would be expected in local soils.
