**Contaminated Land Inspection  
Desk Study and Preliminary Risk Assessment  
(Phase 1b)  
Manor Farm  
Chequers Lane  
North Runcton**

**September 2017**

**Reference no. 17/001**

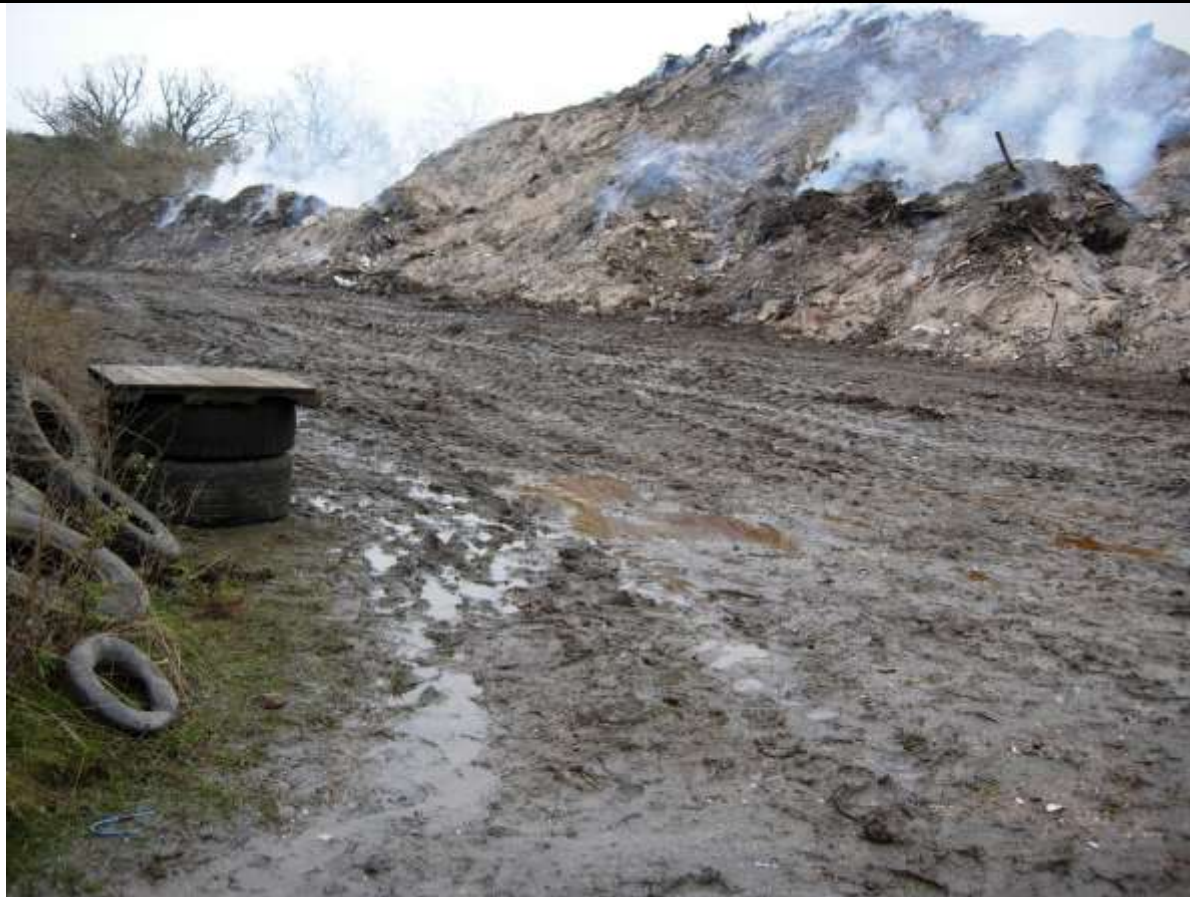
*Photograph 1. View of area of fire February 2017*

The size of the pile is now considerably reduced. Flames have not been noted on the regular site visits. However, at the time of writing, the pile is smouldering in the eastern part of the burnt waste wood area giving rise to odour off-site. The site occupier, Mr Mark Fuller and local residents have been kept informed of the outcome of site visits and proposed actions to investigate.

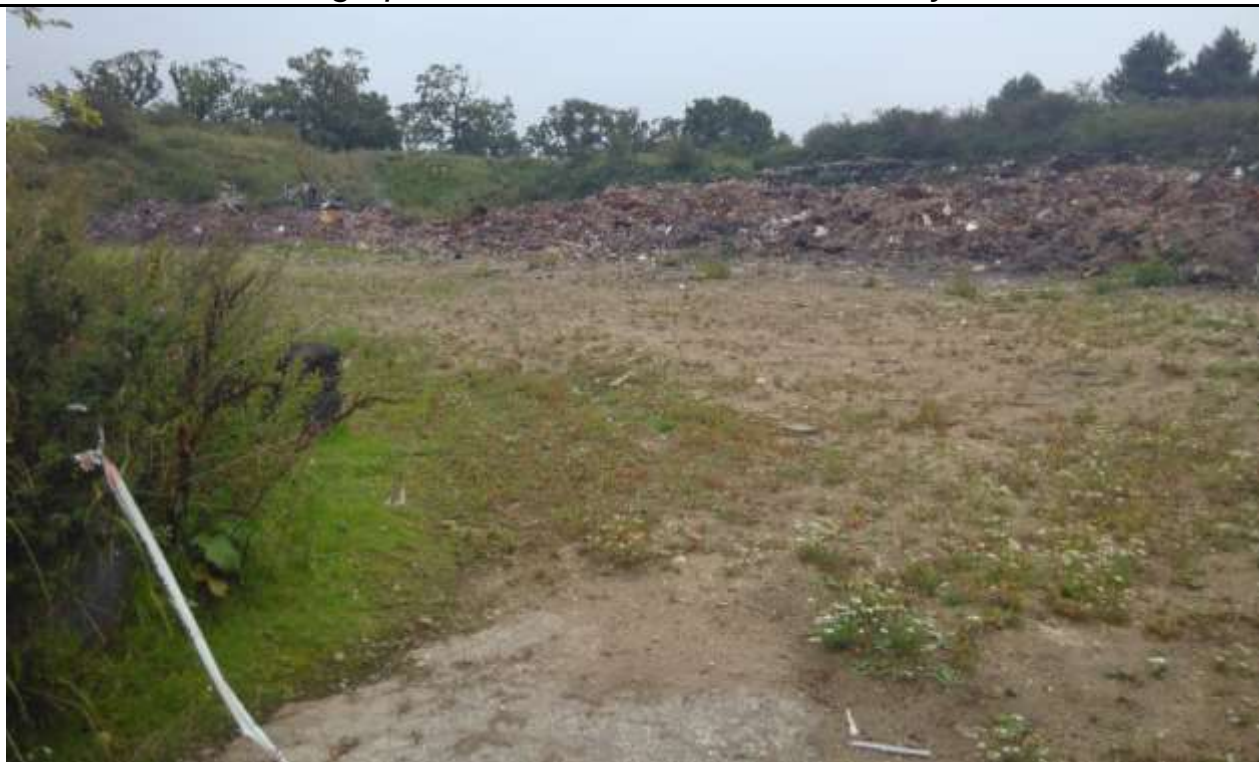
*Photograph 2. View of area of fire August 2017*

The original wood pile in Zone 1 was estimated to contain 27689m<sup>3</sup> of material and was a maximum height of 15m (estimated in LIDAR survey). The pile has been reduced to approximately 20% of the original volume and covers an area of approximately 70x40m and height of 1-3m (estimated from aerial photography and on site observations). Therefore it is estimated that approximately 5500m<sup>3</sup> of ash and metal remain in the heap. The precise weight and volume of ash and metal is not known and would be difficult to estimate without further formal surveying.
