**Contaminated Land Inspection
Phase 1
Preliminary Risk Assessment**
Manor Farm
Chequers Lane
North Runcton

February 2017

Reference no. 17/001

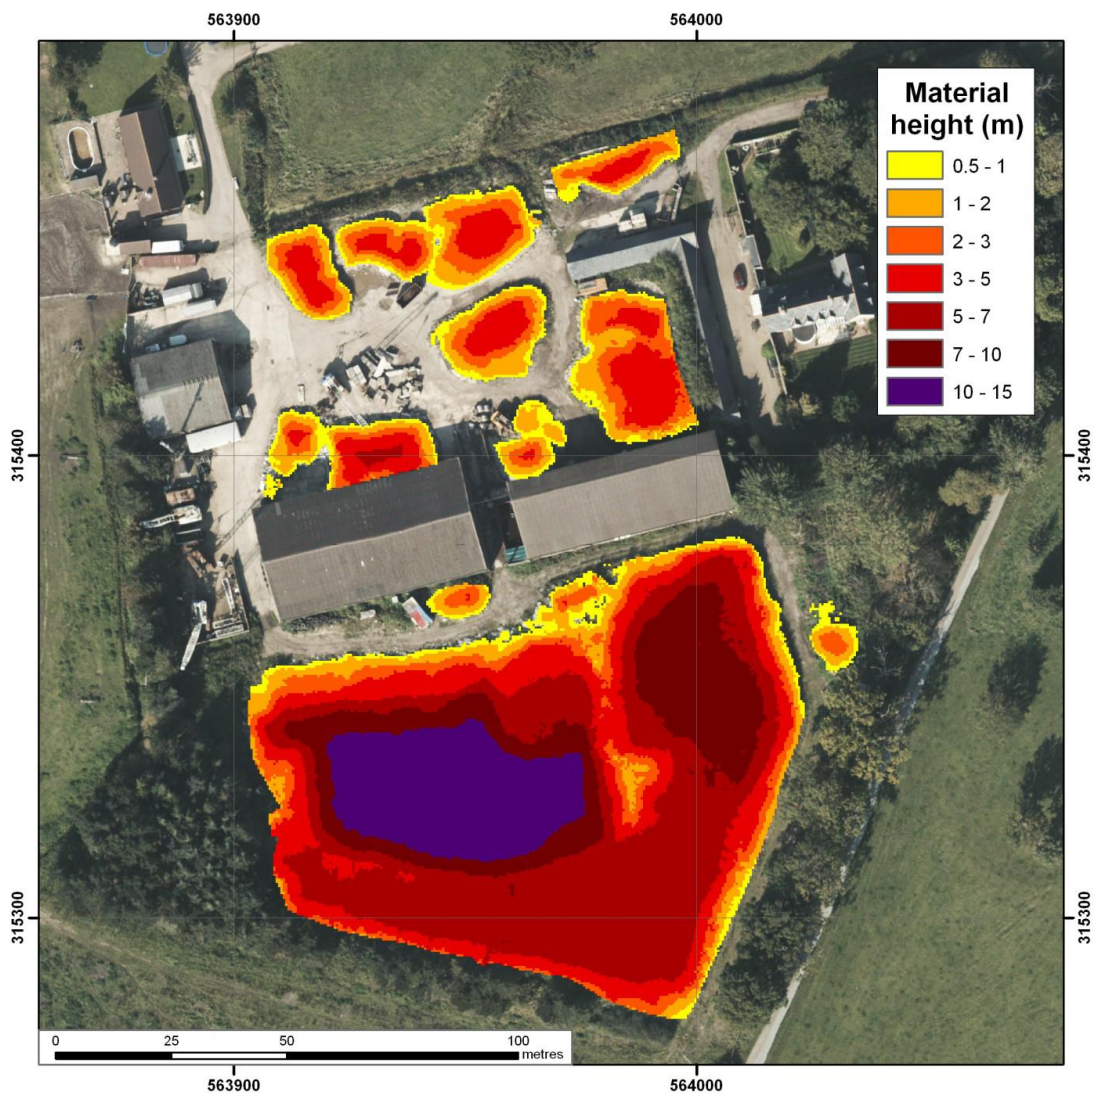
Figure 2: 2015 aerial photograph of the Manor Farm site with material heights overlaid (from Material Volume Calculations for Manor Farm report, Geomatics, October 2015)

There were stockpiles of waste wood and construction & demolition materials in both the northern and southern parts in similar locations to those indicated on the LIDAR survey as indicated in Figure 2 below.

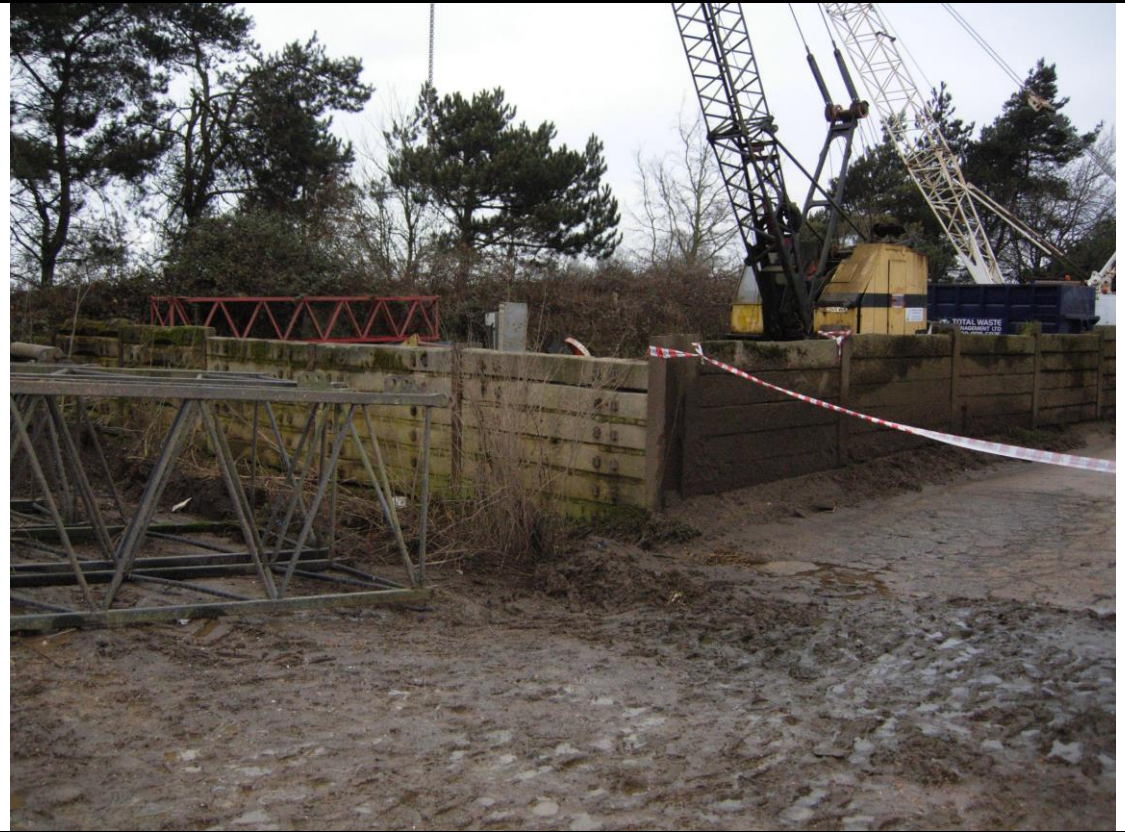
Site drainage was observed to reflect the conditions predicted by the EA within the ORP (Appendix E). A waterlogged area was noted on the western boundary corresponding to the main discharge route identified by the EA.

Photograph 1. Point of surface water run-off

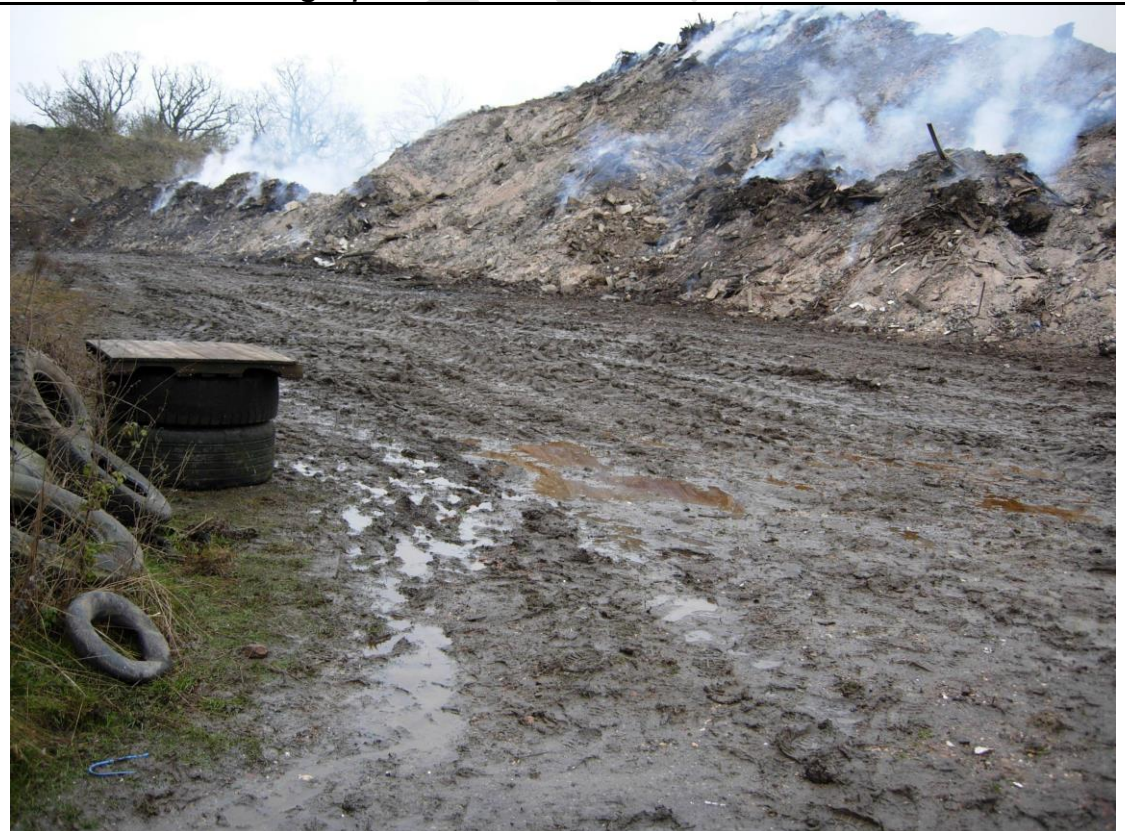
The southern part of the site consisted of the mound of waste wood which was on fire surrounded by an area of muddy disturbed ground. At the time of the visit the fire was proceeding in a controlled burn under supervision of Norfolk Fire and Rescue service. Mr Fuller was also assisting the fire service by moving material into one location to establish fire breaks. A crescent shaped bund approximately 10m high surrounded the fire to the east and west. The bund appeared to be formed of soil and demolition material and was well vegetated with grass, brambles and buddleia. The eastern, southern and western boundaries of the site were formed of rough grassland, hedge, shrubs and trees.

Photograph 2. Fire break showing fire and cleared muddy ground

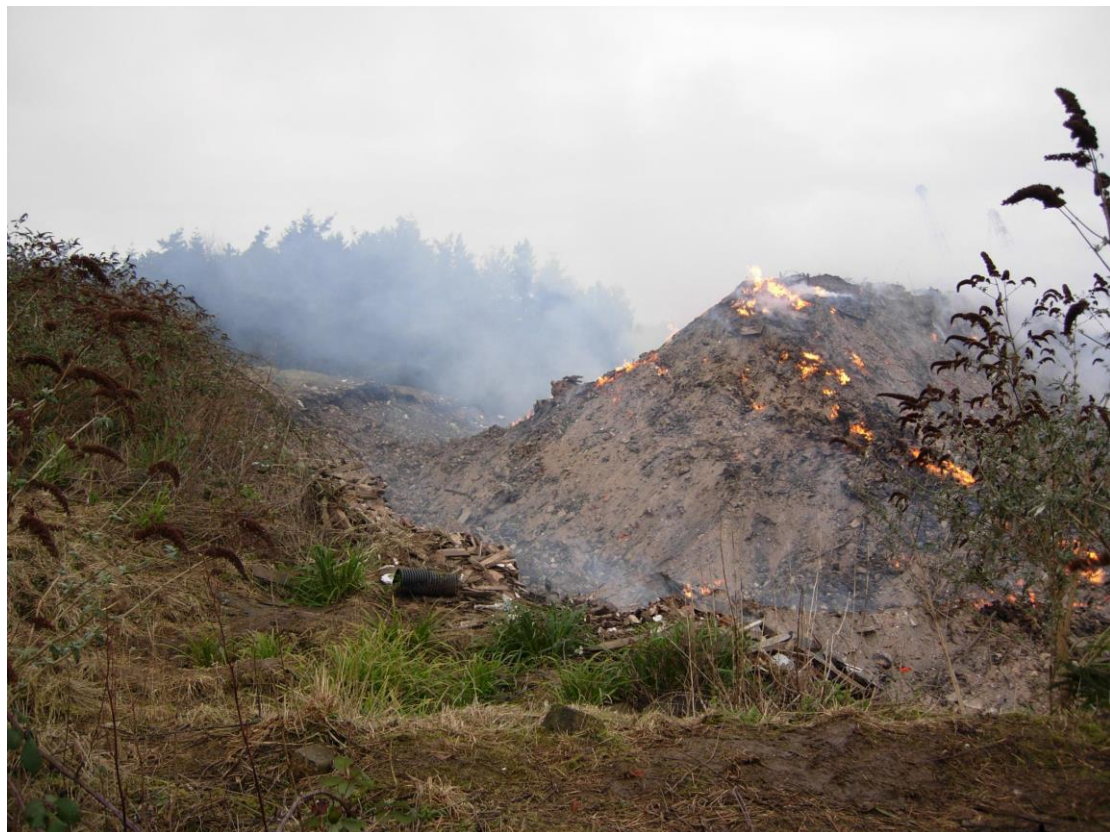
At the time of writing the fire is still ongoing and it is likely once the material is burned, quantities of ash will cover a large part of the southern half of the site. The site of the fire is mostly surrounded by a large bund and barn type buildings. The site is open to rainfall but sheltered to some degree from winds by the bund and buildings.

Photograph 3. The fire & crescent bund. Trees in SW of site

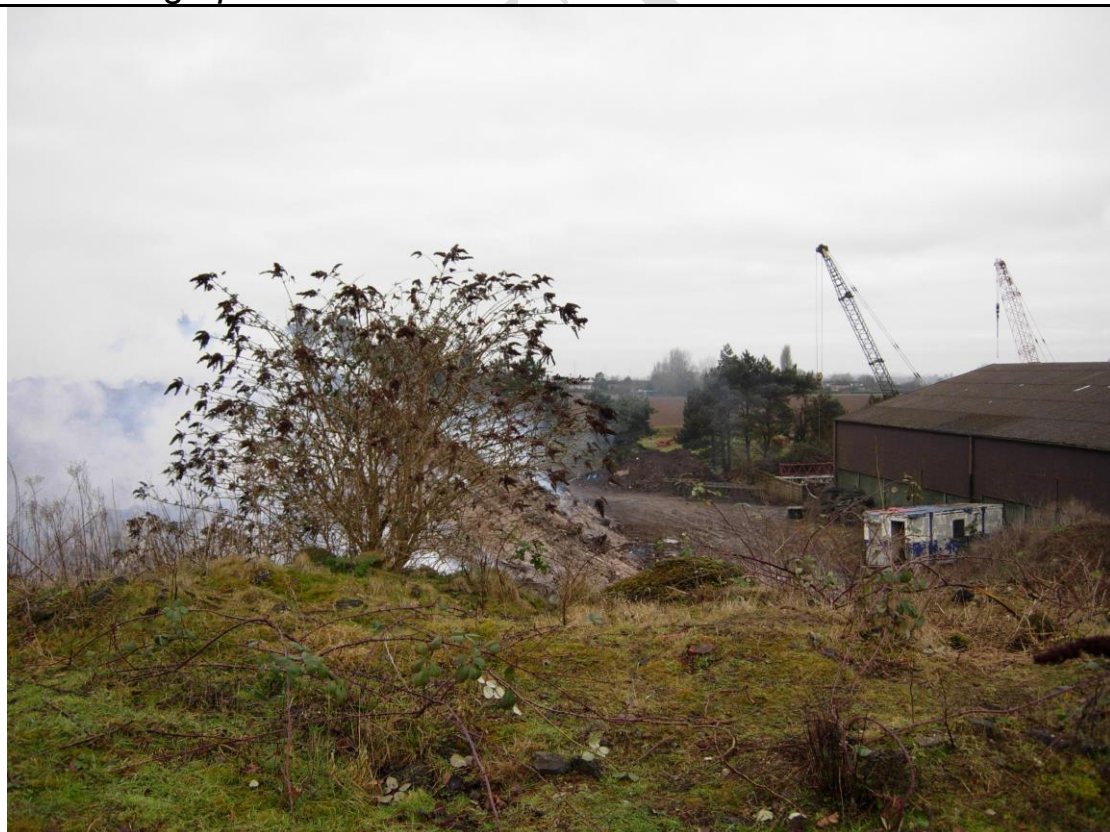
Photograph 4. Overview of southern part of site from bund

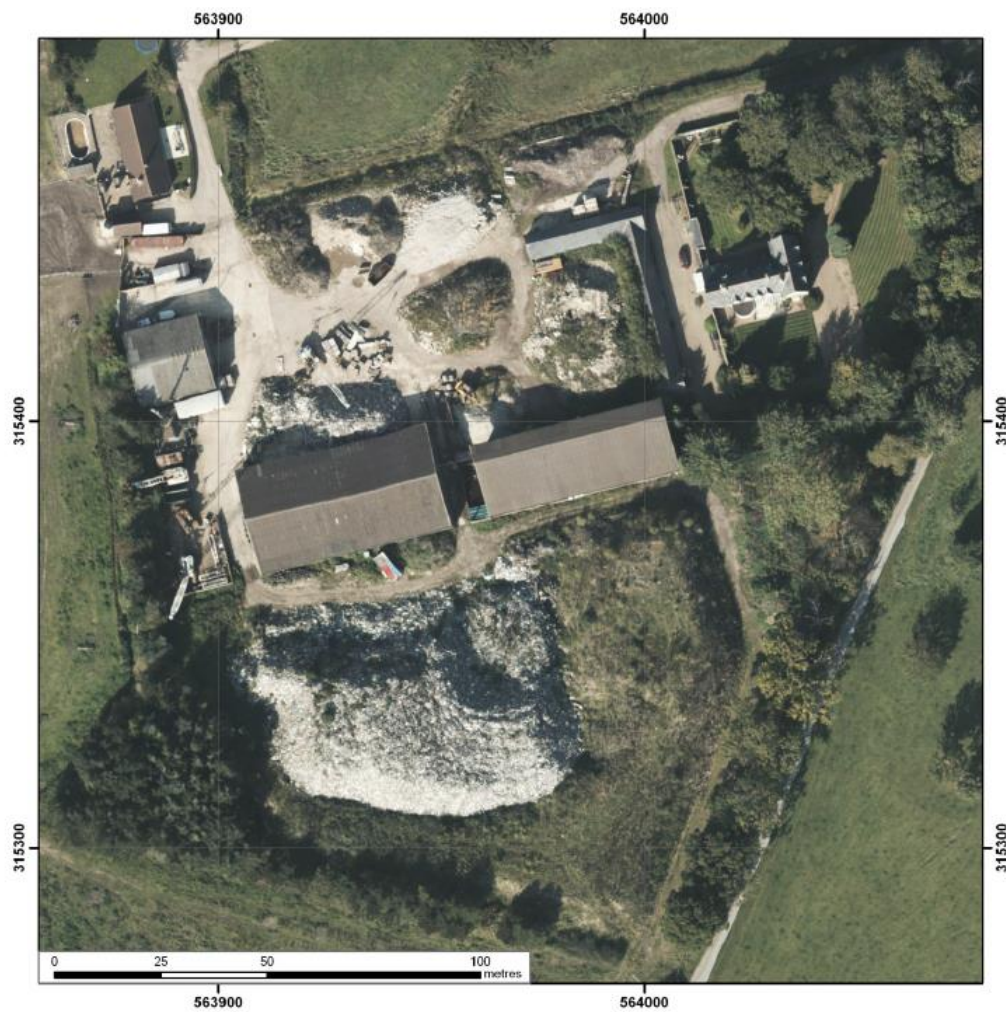
Plan 2: Aerial photography October 2015 (from Geomatics report)

The present site comprises farm buildings, yards and some rough grassland (plan 2). Most recently the land has been used for an illegal waste activity resulting in large stockpiles of waste materials (predominantly wood) accumulating on site. Mr Mark Fuller was convicted of three offences regarding operation of an illegal waste site. Details are provided in appendix C. Due to the potential fire risk an Operational Response Plan (ORP) was compiled by Norfolk Resilience Forum in 2016.
