Manor Farm, North Runcton
Contaminated Land Investigation
Non-Technical Summary

1. Site History

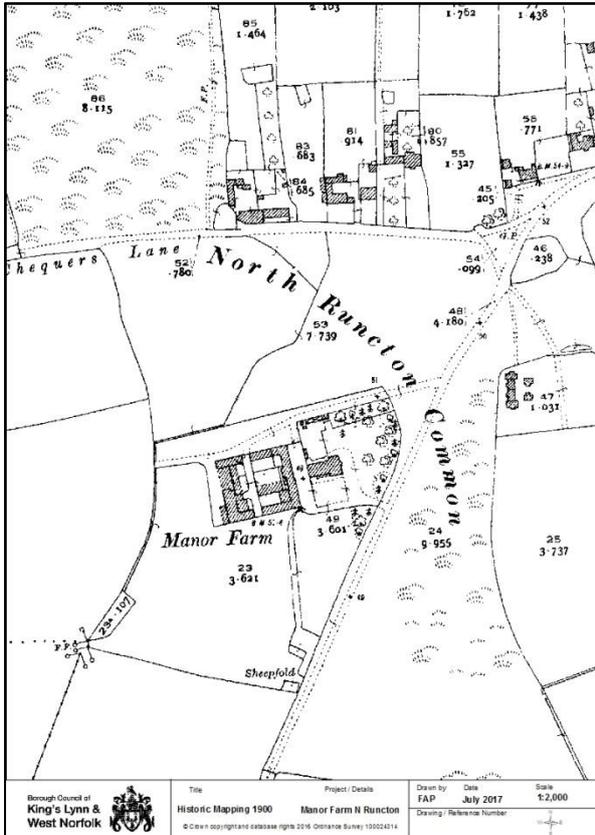
Figure 1: Manor Farm map 1900s

The site at Manor Farm, North Runcton includes farm buildings, yards and some rough grassland. A review of the old maps dated 1872 to 1999 was carried out as part of this research. These maps show previous land use and changes over time. Information on residential or commercial land use, natural water features and the many man-made water features can be seen on maps.

Originally a Victorian 'model farm', it is in a rural village and has been used as a transport yard in the last 10 years and more recently for an illegal waste processing activity.

Figure 1 shows the layout of Manor Farm on the historic Ordnance Survey mapping.

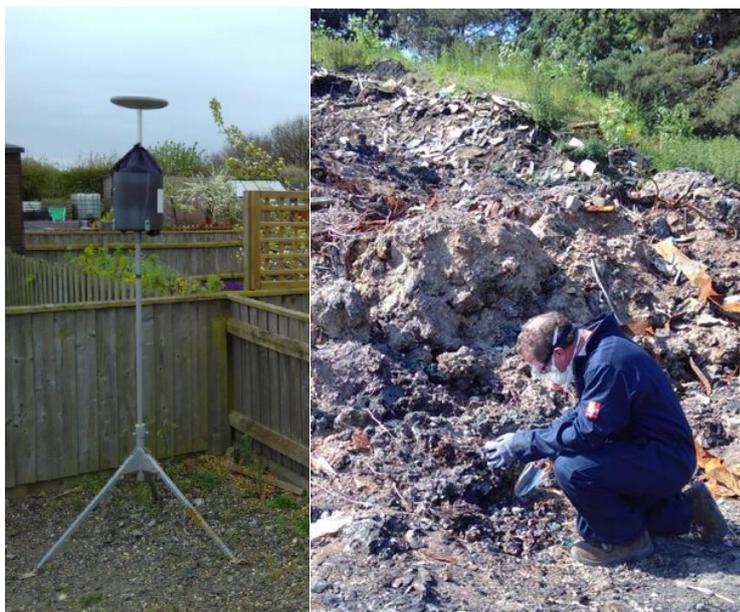
Figure 2: A dust gauge in a residential garden. Taking samples from the ash

Dust gauges were used to estimate how much ash was being deposited near houses and the types of materials that were in the dust. Samples were taken of ash from the site of the fire and sent to a laboratory. The samples were analysed for contaminants that can be found in waste wood fires. Figure 3 shows where samples were taken.

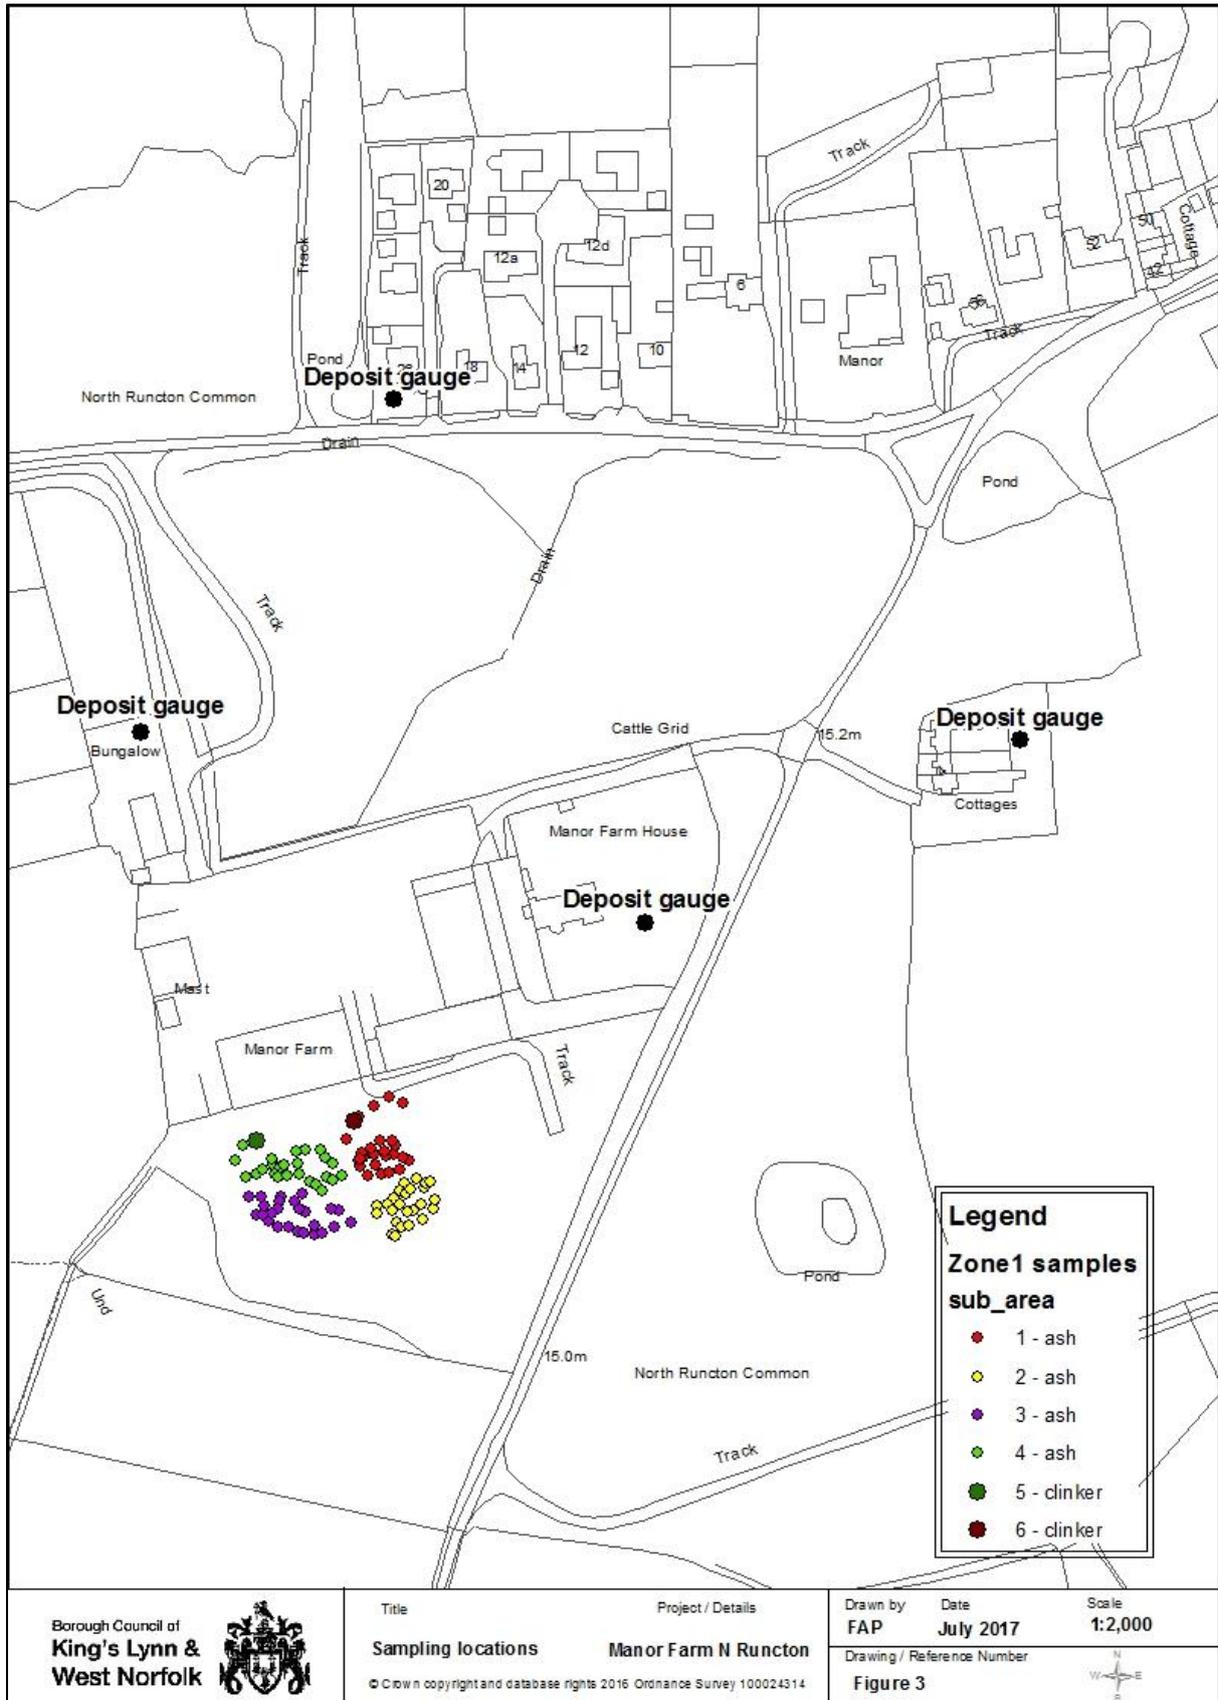
Figure 3: Location of ash and deposit gauge samples

Samples were analysed for heavy metals, petroleum hydrocarbons, dioxins & furans, semi volatile organic compounds, polyaromatic hydrocarbons and asbestos. These were substances that could have been present in the waste material or can be produced during a fire. Where contaminants were detected in the ash samples by the laboratory, the results were compared to acceptable levels for residential and commercial land for receptors located on the site. The laboratory analysis showed that the levels of contaminants in the ash were not likely to be harmful to human health or to water. Asbestos was not detected in any of the samples. The screening showed that even if the receptors were located on Manor Farm itself, the contamination isn't likely to cause significant harm to health or the wider environment. There are full details of the laboratory analysis and risk assessment in the Phase 1b report.
