Interim Baseline Report

Hunstanton Coastal Management Plan

January 2018

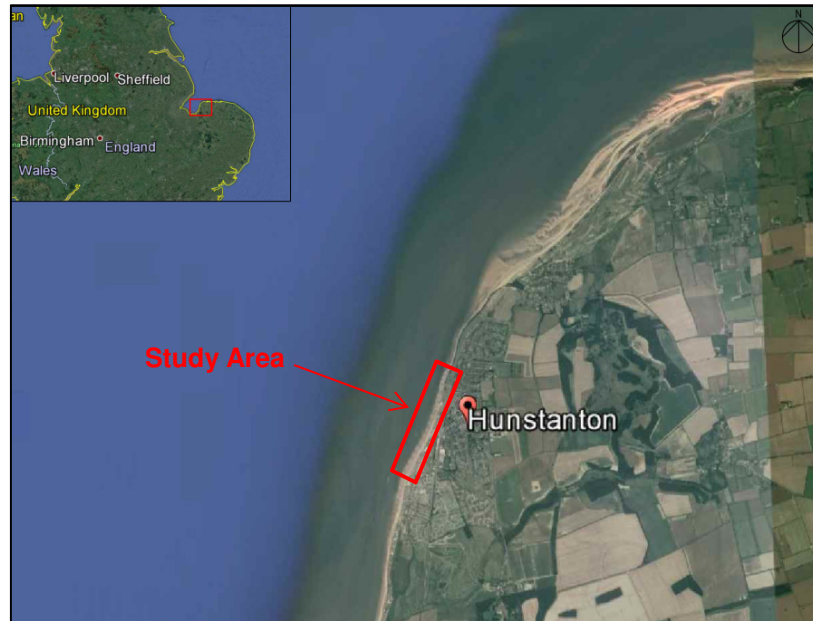
Figure 1-1: Location of Hunstanton and study area (imagery ©2017 Google)

Hunstanton is a seaside town along the west facing coast of the Wash in Norfolk, approximately 21km north east of the town of King's Lynn (Figure 1-1). The study area comprises approximately 1.3km of undefended cliffs (Unit A) and approximately 1.5km of defended coastline (Unit B) that consists of seawalls, promenade, rear wave wall and beach management groynes. The entire coastline is fronted by a sandy/shingle beach of varying levels.

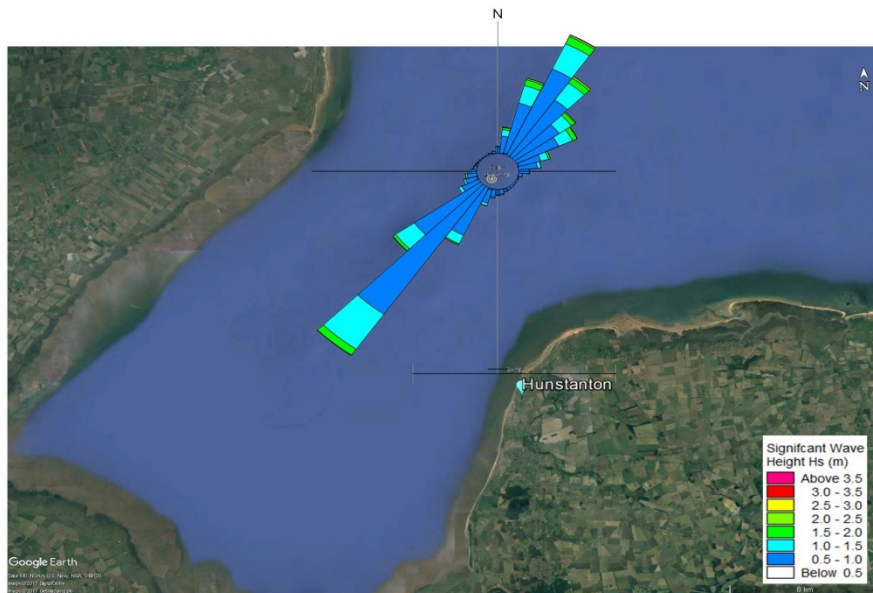
From this wave data the wave rose diagram, Figure 2-2, has been created. Based on this, it can be concluded that at the mouth of The Wash, the waves generated in or propagating from the North Sea approach from a narrow range of directions with the larger waves coming predominantly from the north-east sector. They travel along the length of the main channels before being dissipated by the shallow bed profiles and surface roughness of the inter-tidal sand and mud flats. Waves are also generated inside The Wash via strong winds combined with high water spring tides. These waves will generally have shorter periods than the ones coming from the North Sea.

Figure 2-2 Wave rose diagram (imagery ©2017 Google)

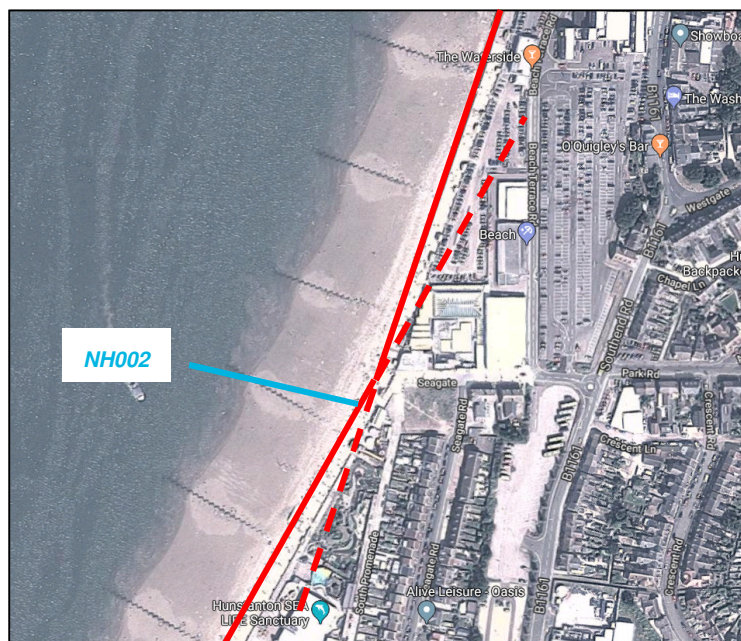
Figure 2-26: Change in seawall alignment at NH002

The largest change in beach levels surveyed has been approximately 1.5m over the last 7 years. It has generally been observed that the level of the upper 100m of beach is more variable, with the lower beach being typically more stable. The only profile analysed that shows a trend of accretion over the 7 years was NH002. It is postulated that material could be accreting in this location because of changes to the coastline alignment here, as shown in Figure 2-26. The net transport is from north to south and as the alignment changes just north of NH002 the wave angle to the coast reduces the amount of down-drift material.

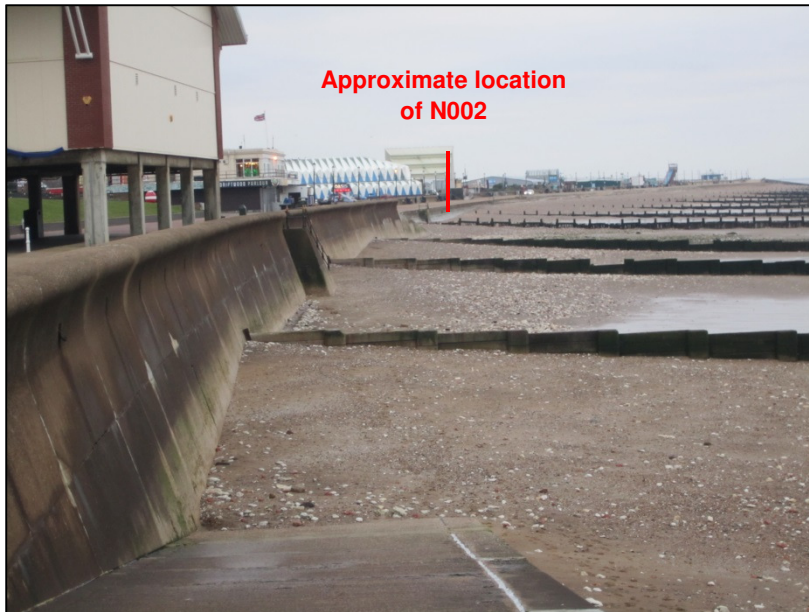
Figure 2-28 illustrates how the beach level at the toe of the wall gradually increases moving from north to south towards NH002. The drift of material from north to south in the study area can also be observed by the difference in beach levels on either side of the groyne as shown in the image.

Figure 2-28: Looking south towards NH002, increasing beach levels observed

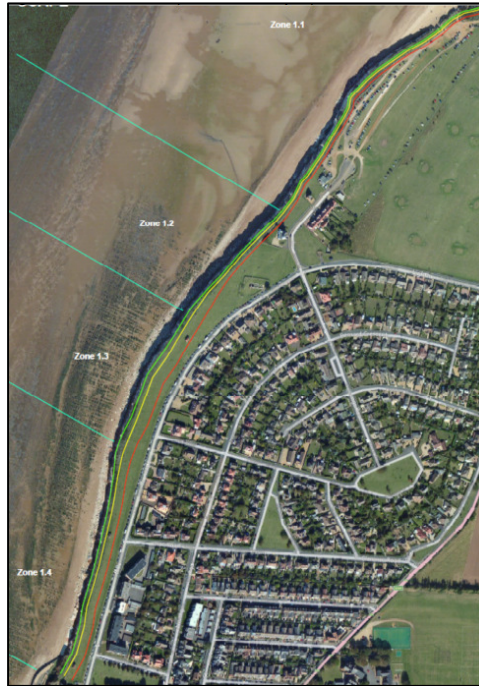
**Figure 7-1: Output from SCAPE model for Unit A extracted from Strategy Appendix K2
(Cliff lines - green line 2030, yellow line 2060, red line 2110)**

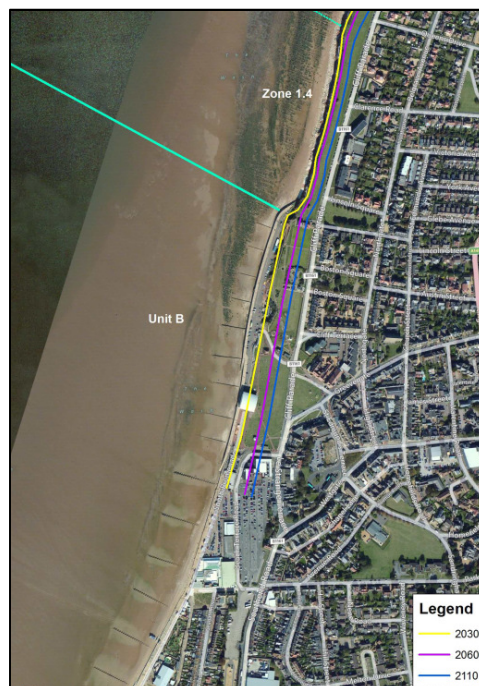
Unit B is a different situation because there are already existing defences. The SCAPE model considers that once the structures have failed, the cliffs would eventually ‘step-back’ to be in line with Unit A, whereas the coastline in Unit B is currently held further seaward by the defence structures. The model also assumes that the cliffs would have reached their equilibrium alignment at the end of epoch 2 (2060). This means an accelerated rate of erosion has been assumed from the time when the structures fail and 2060 as the cliff returns to the natural alignment, as shown in Figure 7-2.

Figure 7-2: Output from SCAPE model for Unit B extracted from Strategy Appendix K2

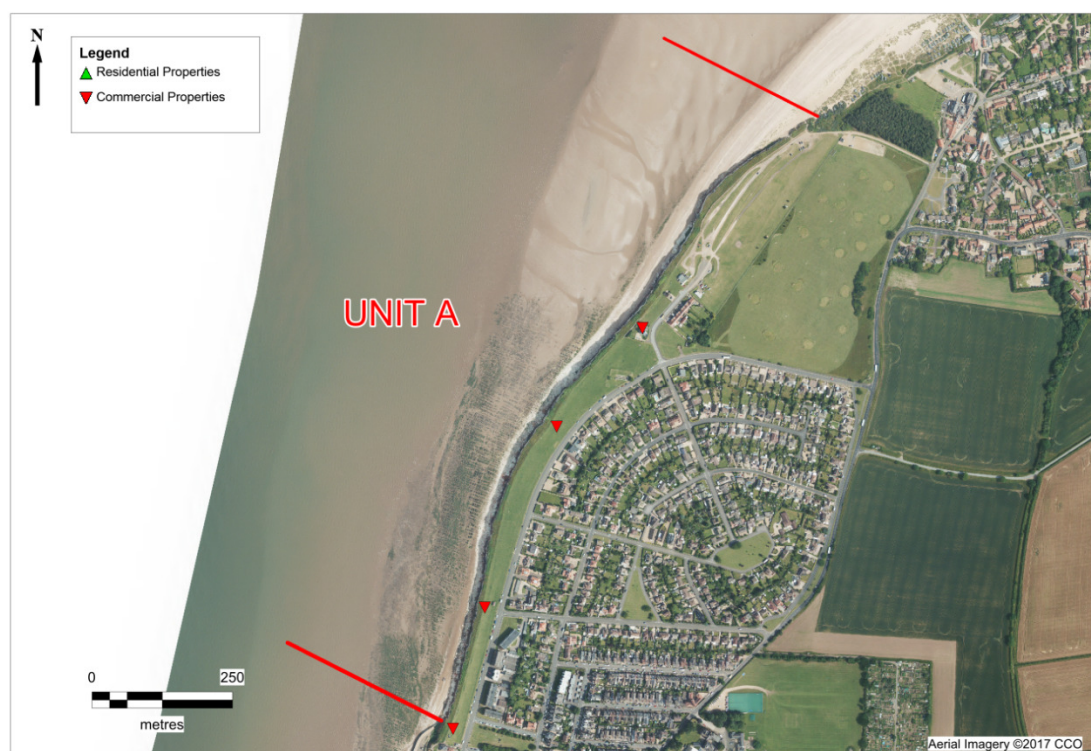
Figure 7-5: Map showing properties in Unit A at risk of erosion in the next 100 years

This initial analysis indicates that the only properties expected to erode in Unit A throughout the appraisal period including the Lighthouse holiday accommodation building in year 95 and 3 shelters in years 15, 41 and 47 respectively. Figure 7-5 shows the locations of these properties in Unit A. It is also worth noting that several other properties (the coastguard cottages, the former coastguard lookout tower/Marconi Wireless station and the remains of St. Edmund's Chapel) although not predicted to be lost to erosion are expected to be placed at significantly greater risk.

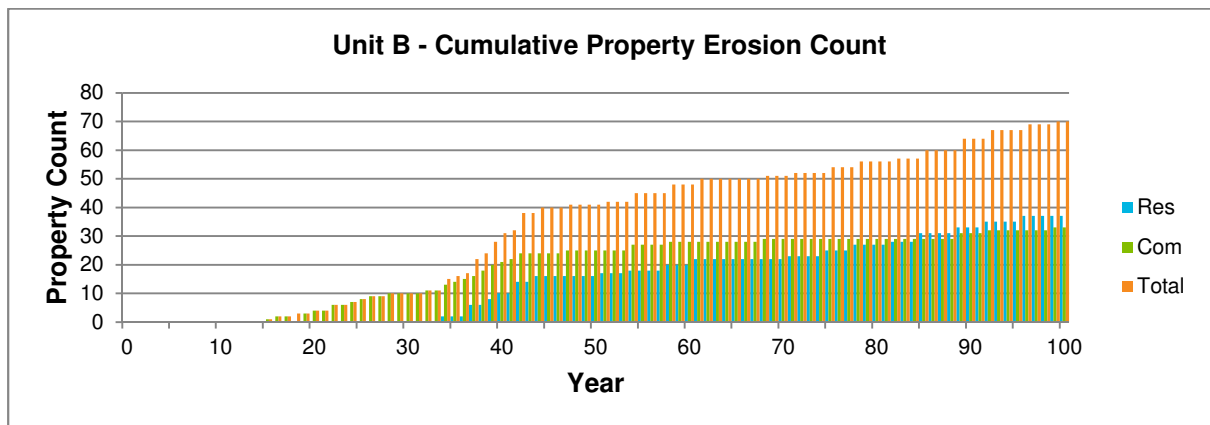
Figure 7-7: Cumulative count of properties in Unit B at erosion risk in the next 100 years

In Unit B, 37 residential properties are at risk from erosion and 33 commercial properties. Figure 7-6 shows the locations of these properties and Figure 7-7 illustrates when the properties in Unit B are predicted to erode.

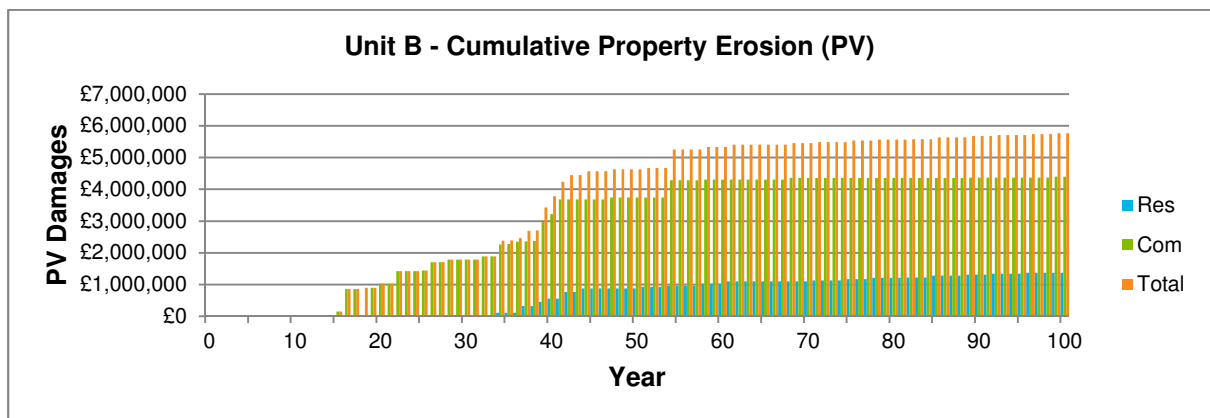
Figure 7-8 shows how the PV damages in Unit B are accrued over time.

Figure 7-8: Cumulative PV damages of properties in Unit B at erosion risk in the next 100 years
