# GROUND INVESTIGATION REPORT

Location: Marsh Lane, King's Lynn, Norfolk

Client: Borough Council of King's Lynn and West Norfolk  
and Lovell Partnerships Limited

Project no: 45751

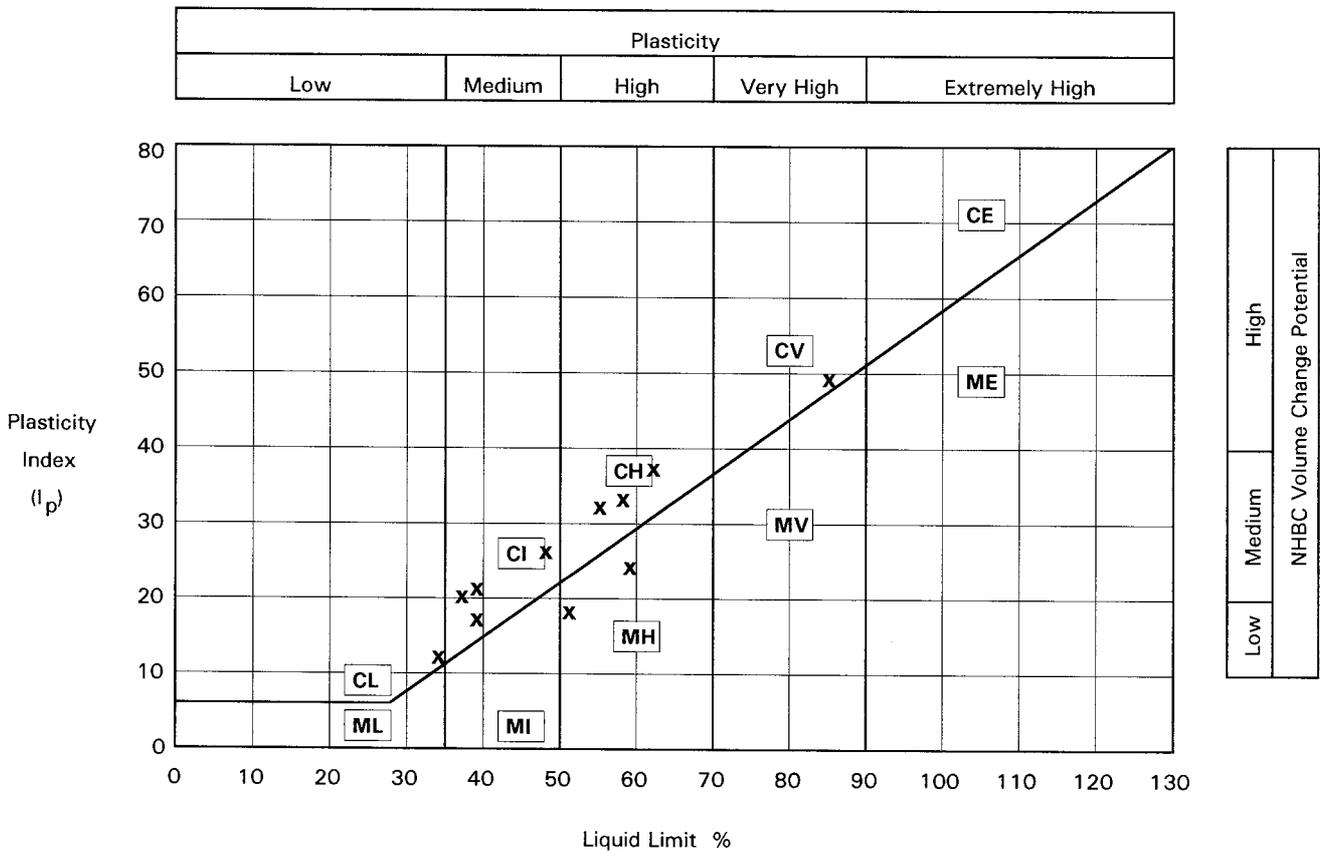
## PLOT OF PLASTICITY INDEX AGAINST LIQUID LIMIT USING CASAGRANDE CLASSIFICATION CHART

METHOD OF PREPARATION: BS 1377:PART 1:1990:7.4 & PART 2:1990:4.2

METHOD OF TEST : BS 1377:PART 2:1990:3.2, 4.4, 5.3, 5.4

Borehole	Depth, bgl (m)	Moisture Content (%)	Liquid Limit (%)	Plastic Limit (%)	Plasticity Index (%)	Modified Plasticity Index* (%)
BH3	2.0	53	85	36	49	49
WS1	1.35-1.45	17	34	22	12	12
WS6	0.90-1.00	27	53	23	32	32
WS7	1.00-1.45	33	58	25	33	33

Borehole	Depth, bgl (m)	Moisture Content (%)	Liquid Limit (%)	Plastic Limit (%)	Plasticity Index (%)	Modified Plasticity Index* (%)
BH2	5.5	18	37	17	20	18
WS9	3.5	22	39	18	21	20
WS12	3.65	25	48	22	26	24

Borehole	Depth, bgl (m)	Moisture content (%)	Liquid Limit (%)	Plastic Limit (%)	Plasticity Index (%)	Modified Plasticity Index* (%)
BH1	11.0	32	59	35	24	14
BH2	11.5	24	62	25	37	37
BH3	8.1	37	51	33	18	12

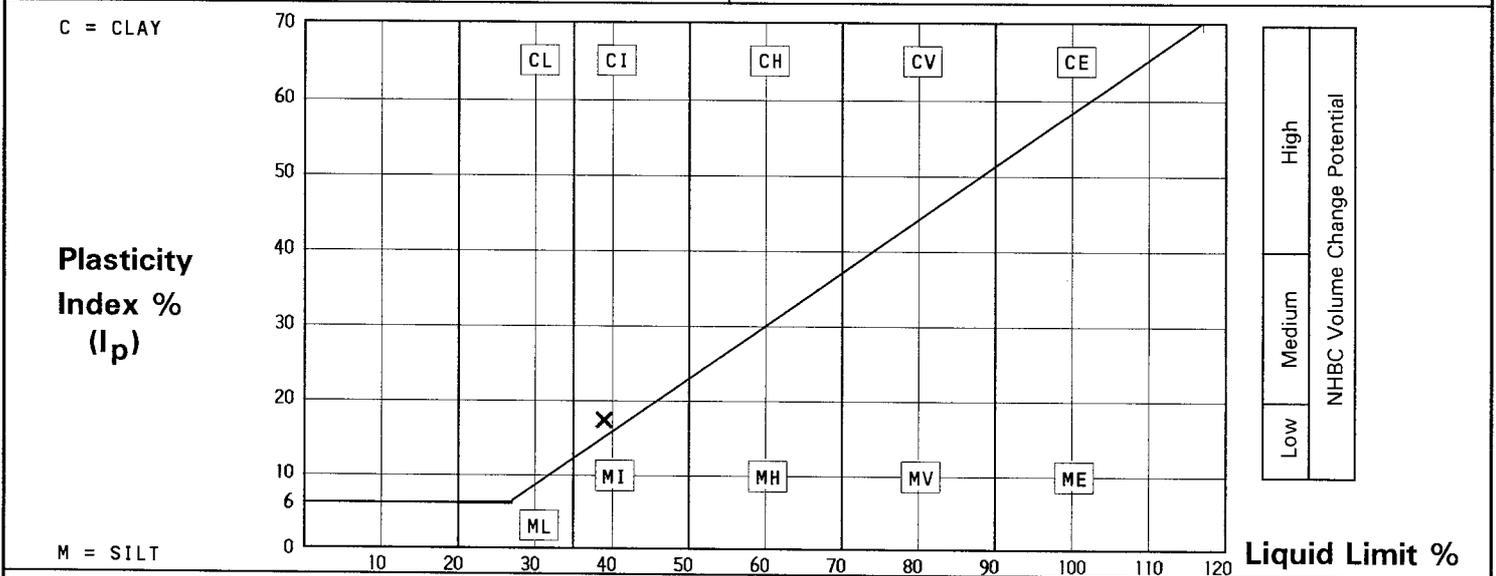
Borehole/ Pit No.	Depth m.	Sample	Moisture Content %	Description	Remarks
BH1	0.90	D3	26	Firm brown slightly sandy silty CLAY with occasional light orangey brown mottling, concrete and brick fragments and rare decayed roots

PREPARATION		Liquid Limit	39 %
Method of Preparation	Specimen from Natural Soil	Plastic Limit	22 %
Sample retained 0.425 sieve	(Assumed) 3 %	Plasticity Index	17 %
Corrected moisture content for material passing 0.425mm	27 %	Liquidity Index	0.29
Curing Time	24 Hours	Clay Content	Not analysed. %
		Derived Activity (PI/CC)	Not analysed.

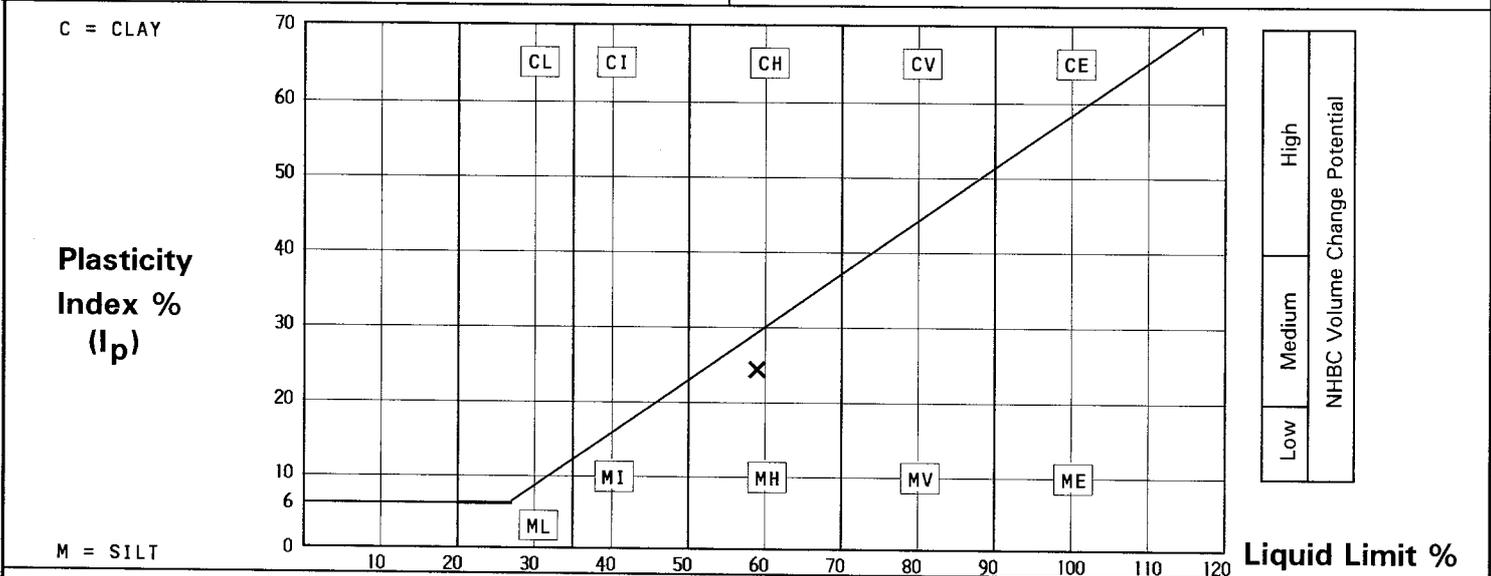
Borehole/ Pit No.	Depth m.	Sample	Moisture Content %	Description	Remarks
BH1	11.00	U6	32	Very stiff (Very high strength) fissured friable dark grey CLAY with fine and medium angular and subangular mudstone fragments and shell debris	Material noted as plotting below the A-Line

PREPARATION		Liquid Limit	59 %
Method of Preparation	Sieved Specimen	Plastic Limit	35 %
Sample retained 0.425 sieve (Measured)	43 %	Plasticity Index	24 %
Corrected moisture content for material passing 0.425mm	%	Liquidity Index	
Curing Time	24 Hours	Clay Content	Not analysed. %
		Derived Activity (PI/CC)	Not analysed.

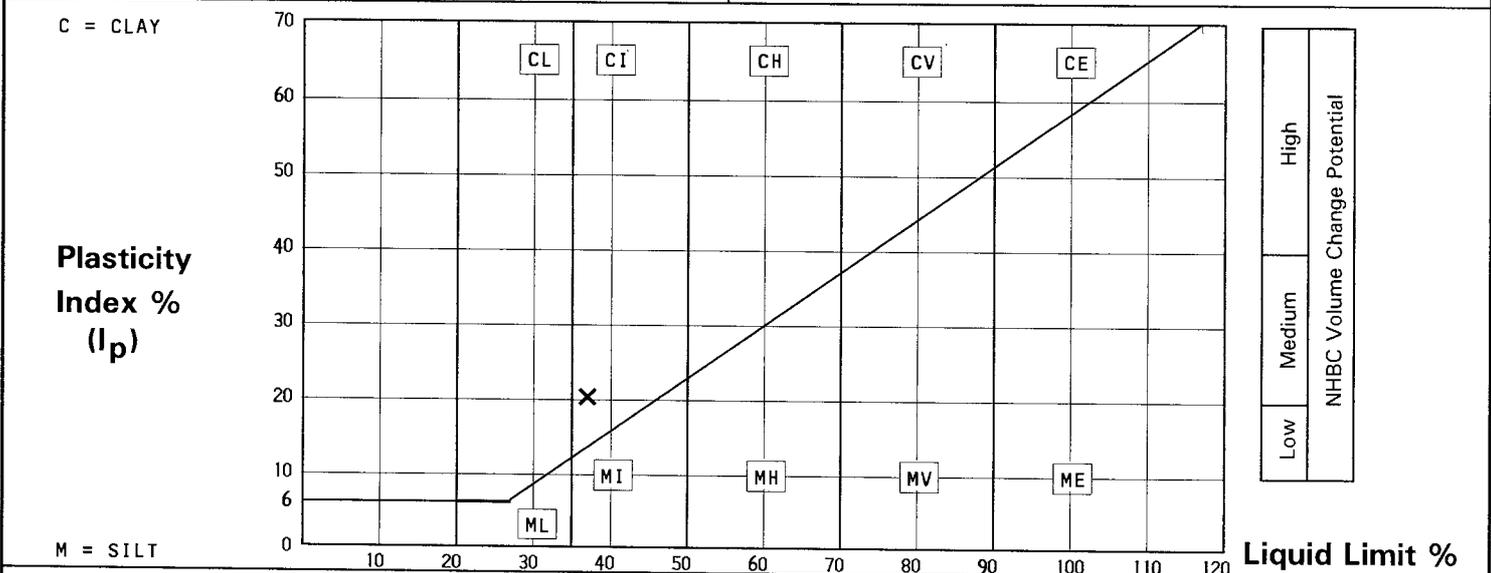
Borehole/ Pit No.	Depth m.	Sample	Moisture Content %	Description	Remarks
BH2	5.50	D8	18	Stiff fissured dark grey slightly gravelly slightly sandy silty CLAY. Gravel is fine and medium chalk

PREPARATION		Liquid Limit	37 %
Method of Preparation	Sieved Specimen	Plastic Limit	17 %
Sample retained 0.425 sieve (Measured)	9 %	Plasticity Index	20 %
Corrected moisture content for material passing 0.425mm	20 %	Liquidity Index	0.15
Curing Time	25 Hours	Clay Content	Not analysed. %
		Derived Activity (PI/CC)	Not analysed.

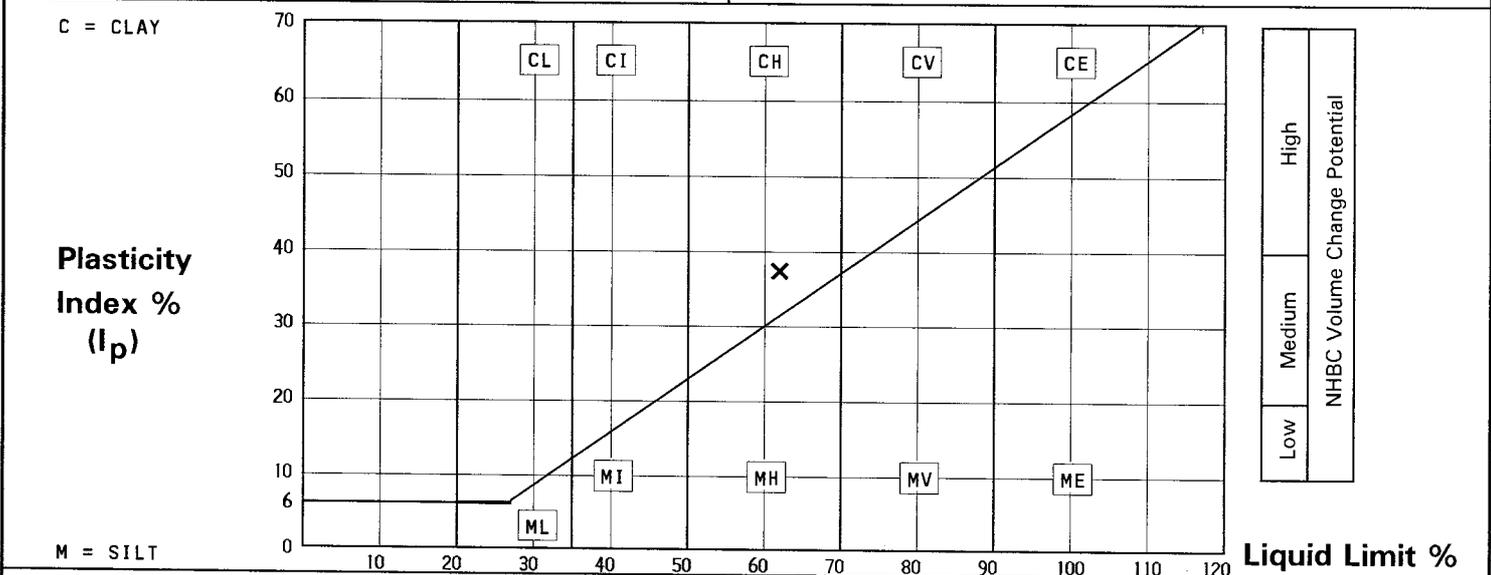
Borehole/ Pit No.	Depth m.	Sample	Moisture Content %	Description	Remarks
BH2	11.50	D16	24	Stiff fissured dark greyish brown CLAY with occasional dark olive grey

PREPARATION		Liquid Limit	62 %
Method of Preparation	Specimen from Natural Soil	Plastic Limit	25 %
Sample retained 0.425 sieve	(Assumed) %	Plasticity Index	37 %
Corrected moisture content for material passing 0.425mm	%	Liquidity Index	-0.03
Curing Time	100 Hours	Clay Content	Not analysed. %
		Derived Activity (PI/CC)	Not analysed.

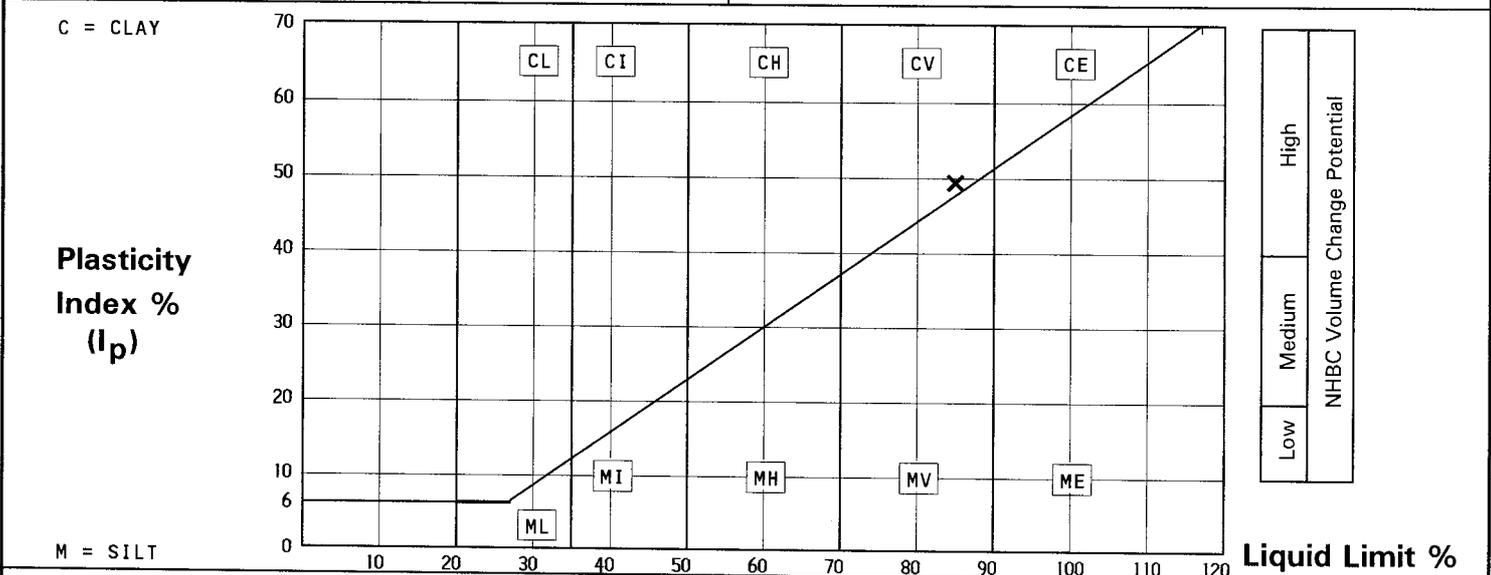
Borehole/ Pit No.	Depth m.	Sample	Moisture Content %	Description	Remarks
BH3	2.00	D4	53	Soft brown CLAY	Peat noted - probably fallen from above during sampling excluded from tests

PREPARATION		Liquid Limit	85 %
Method of Preparation	Specimen from Natural Soil	Plastic Limit	36 %
Sample retained 0.425 sieve (Assumed)	0 %	Plasticity Index	49 %
Corrected moisture content for material passing 0.425mm	%	Liquidity Index	0.35
Curing Time	24 Hours	Clay Content	Not analysed. %
		Derived Activity (PI/CC)	Not analysed.

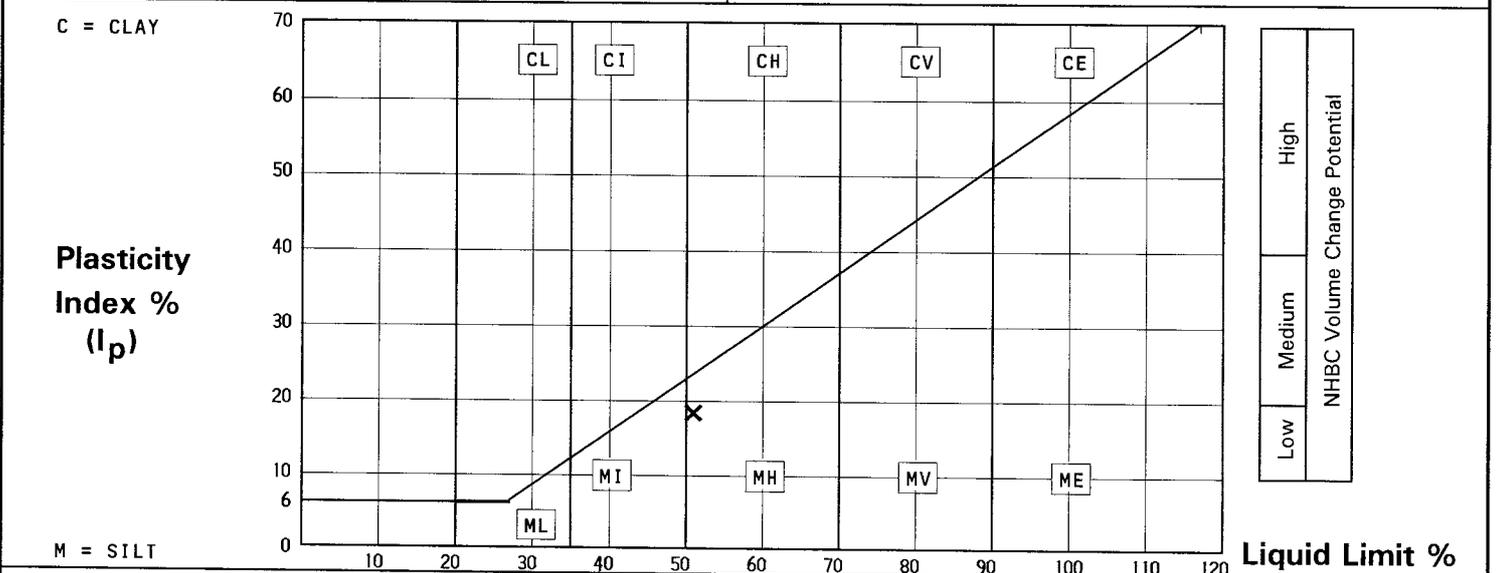
Borehole/ Pit No.	Depth m.	Sample	Moisture Content %	Description	Remarks
BH3	8.10	D13	37	Soft dark grey CLAY with claystone/mudstone fragments from fine to coarse gravel size and shell debris	Material noted as plotting below the A-Line

PREPARATION		Liquid Limit	51 %
Method of Preparation	Sieved Specimen	Plastic Limit	33 %
Sample retained 0.425 sieve (Measured)	34 %	Plasticity Index	18 %
Corrected moisture content for material passing 0.425mm	%	Liquidity Index	
Curing Time	24 Hours	Clay Content	Not analysed. %
		Derived Activity (PI/CC)	Not analysed.

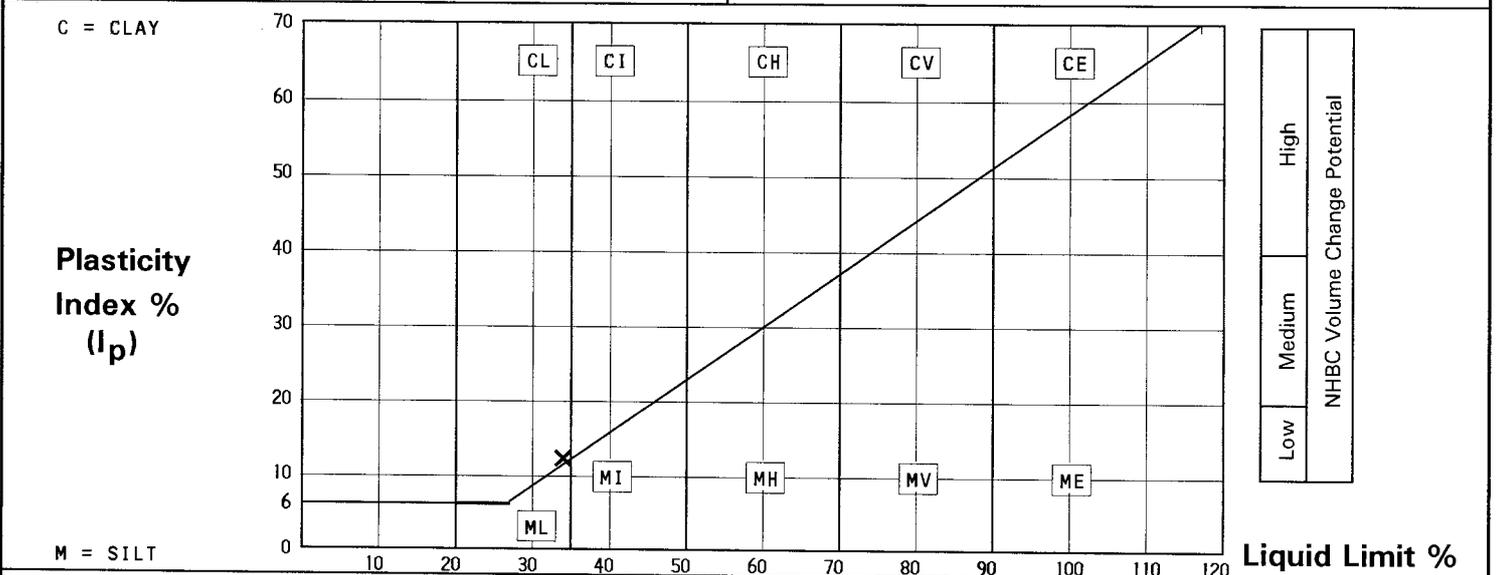
Borehole/ Pit No.	Depth m.	Sample	Moisture Content %	Description	Remarks
WS1	1.35 -1.45	D2	17	Very stiff friable yellowish brown silty CLAY with occasional recently active roots

PREPARATION		Liquid Limit	34 %
Method of Preparation	Specimen from Natural Soil	Plastic Limit	22 %
Sample retained 0.425 sieve	(Assumed) 0 %	Plasticity Index	12 %
Corrected moisture content for material passing 0.425mm	%	Liquidity Index	-0.42
Curing Time	24 Hours	Clay Content	Not analysed. %
		Derived Activity (PI/CC)	Not analysed.

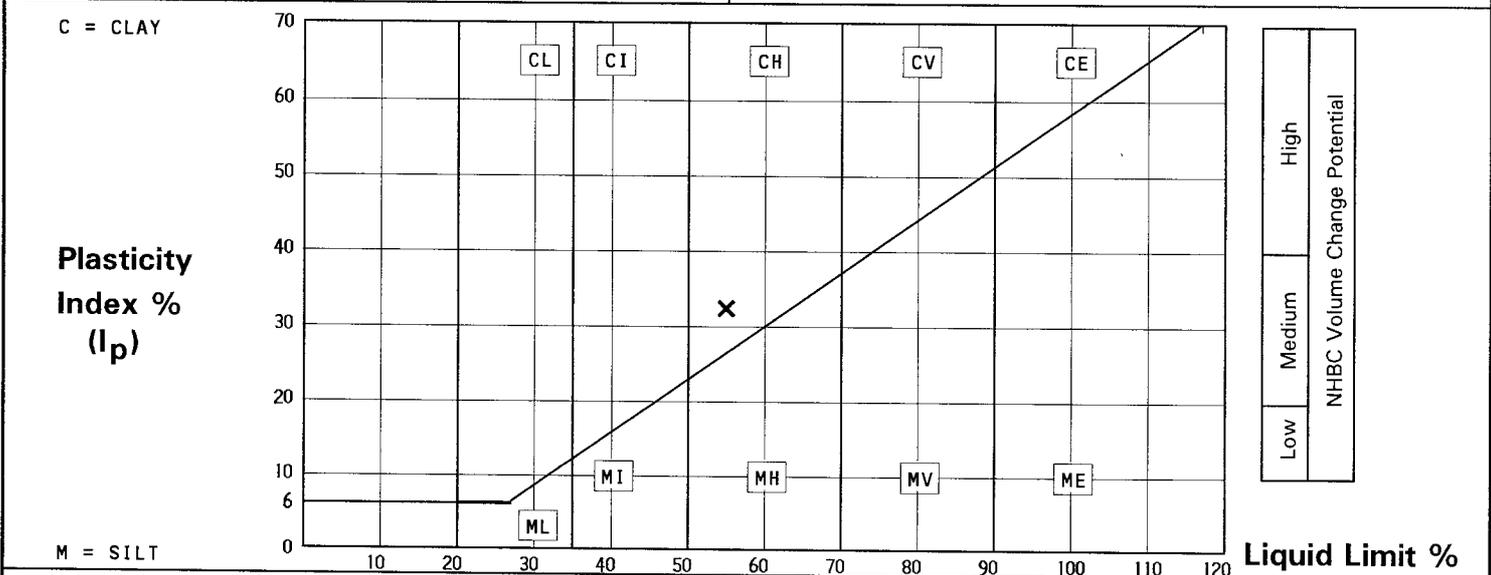
Borehole/ Pit No.	Depth m.	Sample	Moisture Content %	Description	Remarks
WS6	0.90 -1.00	D2	27	Stiff dark yellowish brown CLAY with occasional bluish grey veins and decayed roots

PREPARATION		Liquid Limit	55 %
Method of Preparation	Specimen from Natural Soil	Plastic Limit	23 %
Sample retained 0.425 sieve	(Assumed) 0 %	Plasticity Index	32 %
Corrected moisture content for material passing 0.425mm	%	Liquidity Index	0.13
Curing Time	24 Hours	Clay Content	Not analysed. %
		Derived Activity (PI/CC)	Not analysed.

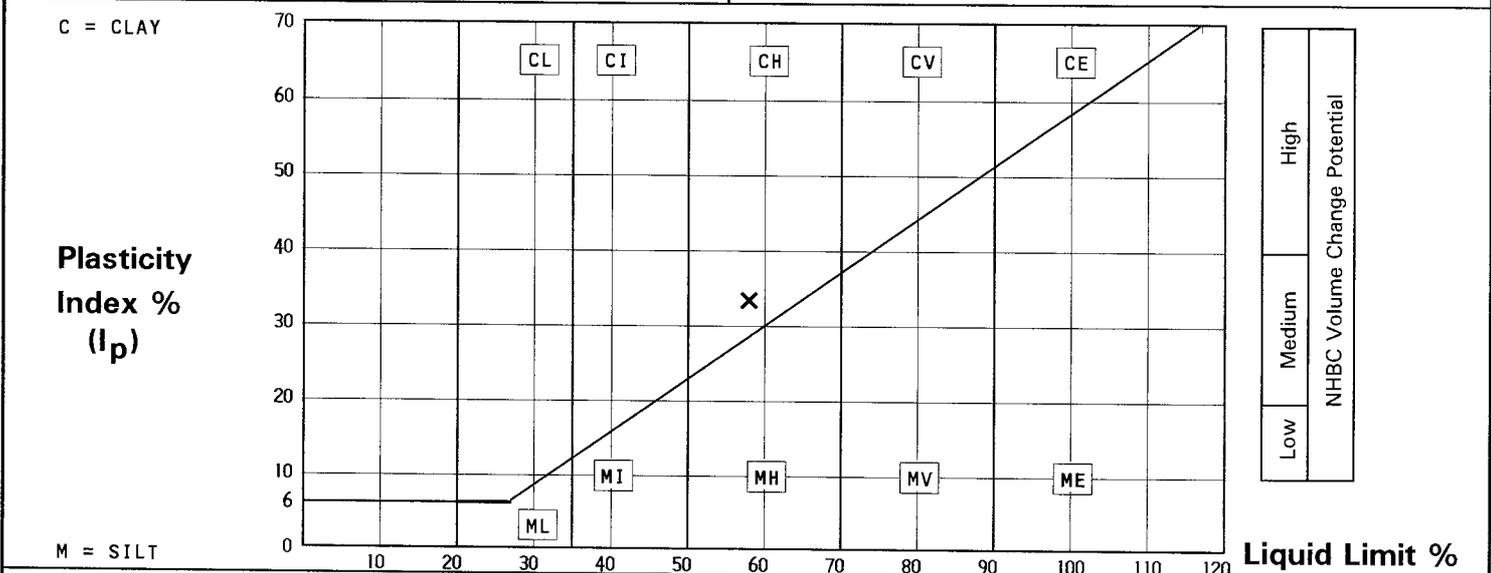
Borehole/ Pit No.	Depth m.	Sample	Moisture Content %	Description	Remarks
WS7	1.00 -1.45	D2	33	Stiff dark yellowish brown CLAY with occasional recently active roots

PREPARATION		Liquid Limit	58 %
Method of Preparation	Specimen from Natural Soil	Plastic Limit	25 %
Sample retained 0.425 sieve	(Assumed) 0 %	Plasticity Index	33 %
Corrected moisture content for material passing 0.425mm	%	Liquidity Index	0.24
Curing Time	24 Hours	Clay Content	Not analysed. %
		Derived Activity (PI/CC)	Not analysed.

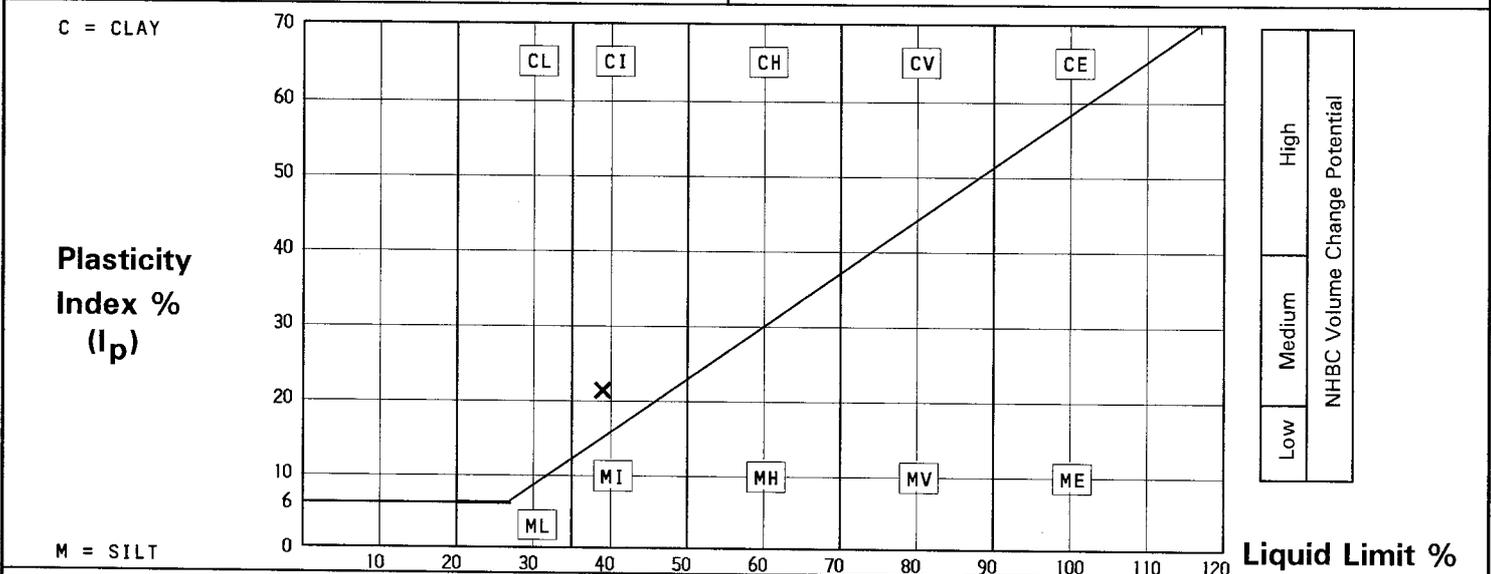
Borehole/ Pit No.	Depth m.	Sample	Moisture Content %	Description	Remarks
WS9	3.50	B4	22	Firm grey and light olive brown slightly gravelly slightly sandy silty CLAY with occasional dark grey and yellowish brown mottling and rare decayed roots. Gravel is fine and medium rounded to subangular chalk

PREPARATION			
		Liquid Limit	39 %
Method of Preparation	Sieved Specimen	Plastic Limit	18 %
Sample retained 0.425 sieve	(Measured)	Plasticity Index	21 %
Corrected moisture content for material passing 0.425mm	24 %	Liquidity Index	0.29
Curing Time	24 Hours	Clay Content	Not analysed. %
		Derived Activity (PI/CC)	Not analysed.

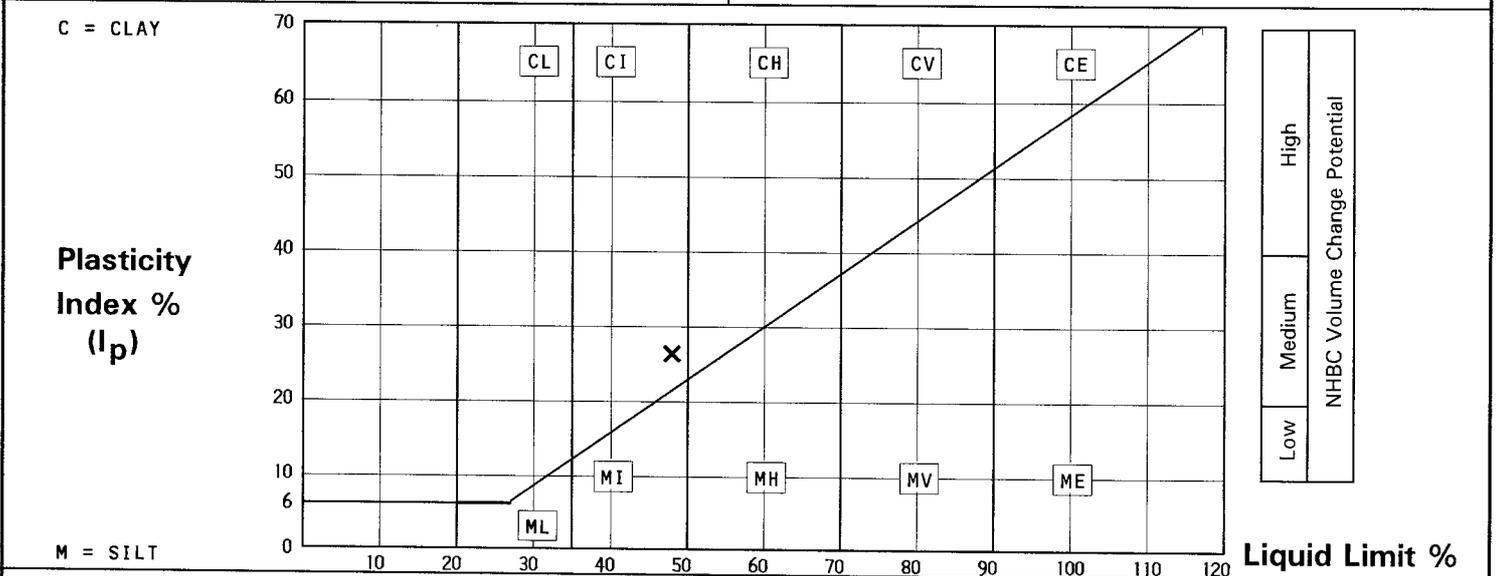
Borehole/ Pit No.	Depth m.	Sample	Moisture Content %	Description	Remarks
WS12	3.65	B3	25	Firm dark grey and olive grey slightly gravelly slightly sandy silty CLAY with occasional olive mottling and rare decayed roots. Gravel is fine and medium subrounded and subangular chalk

PREPARATION		Liquid Limit	48 %
Method of Preparation	Sieved Specimen	Plastic Limit	22 %
Sample retained 0.425 sieve	(Measured) 8 %	Plasticity Index	26 %
Corrected moisture content for material passing 0.425mm	27 %	Liquidity Index	0.19
Curing Time	25 Hours	Clay Content	Not analysed. %
		Derived Activity (PI/CC)	Not analysed.

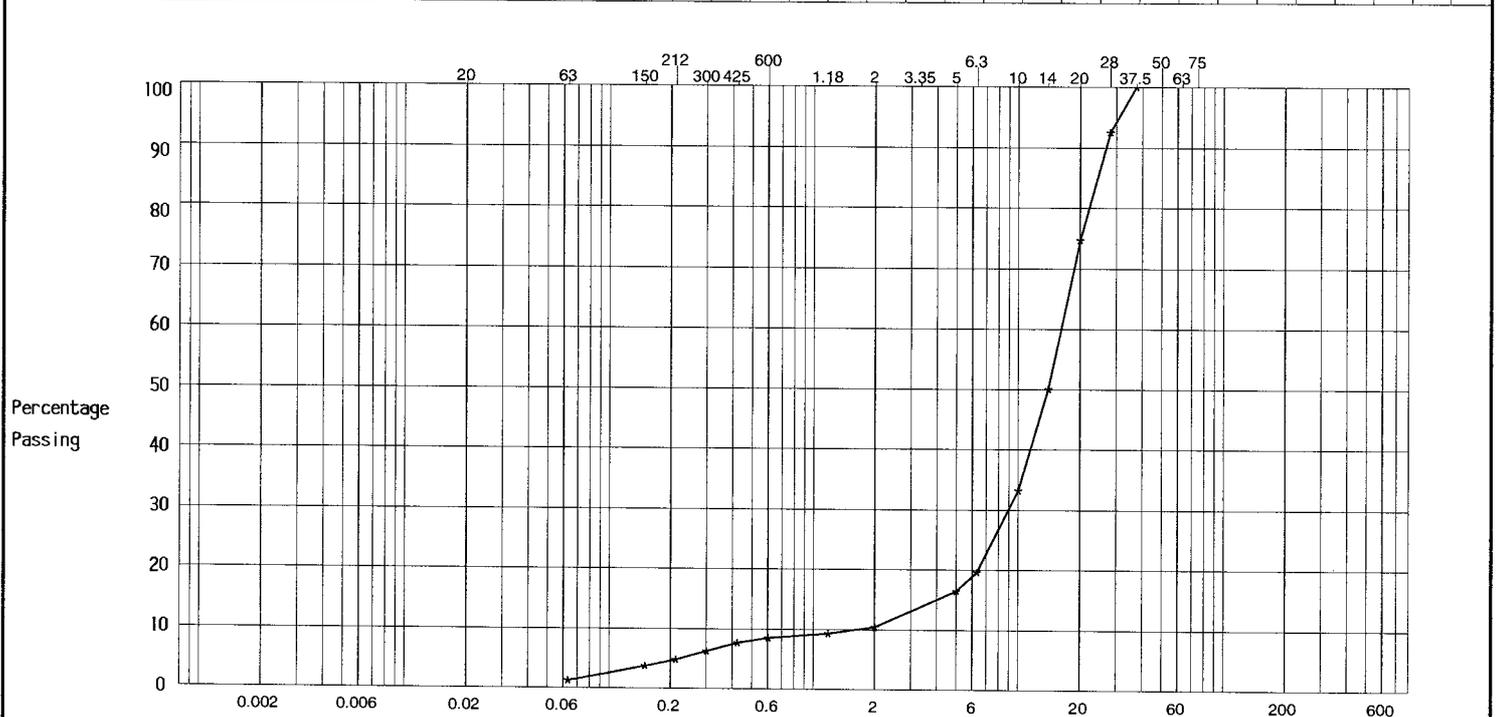
Method of Test: Wet Sieve      Method of pre-treatment:

Sieve Size	Size (microns)										Size (mm)									
	63	150	212	300	425	600	1.18	2	5	6.3	10	14	20	28	37.5	50	75			
Percentage by Mass passing Sieve	1	4	5	6	8	8	9	10	16	20	33	50	75	92	100	-	-

CLAY	Fine	Medium	Coarse	Fine	Medium	Coarse	Fine	Medium	Coarse	COBBLES	BOULDERS
	SILT			SAND			GRAVEL

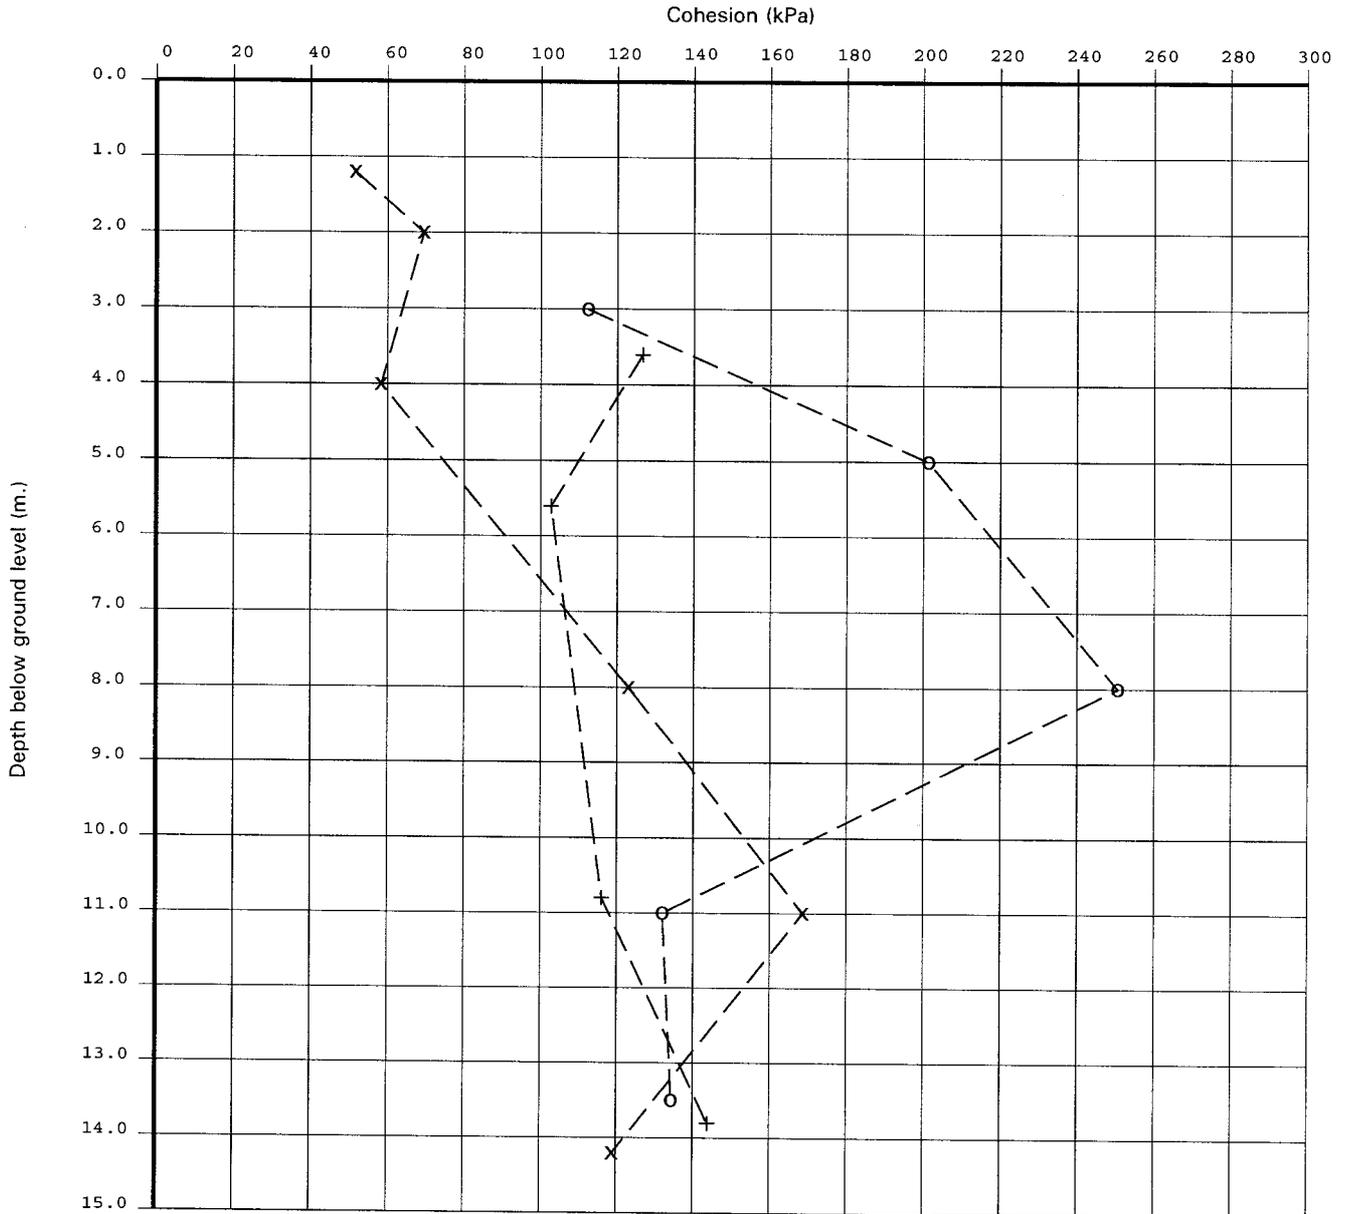
## Cohesion (kPa) vs Depth below ground level (m.).

Key to  
Data Points

x : BH1

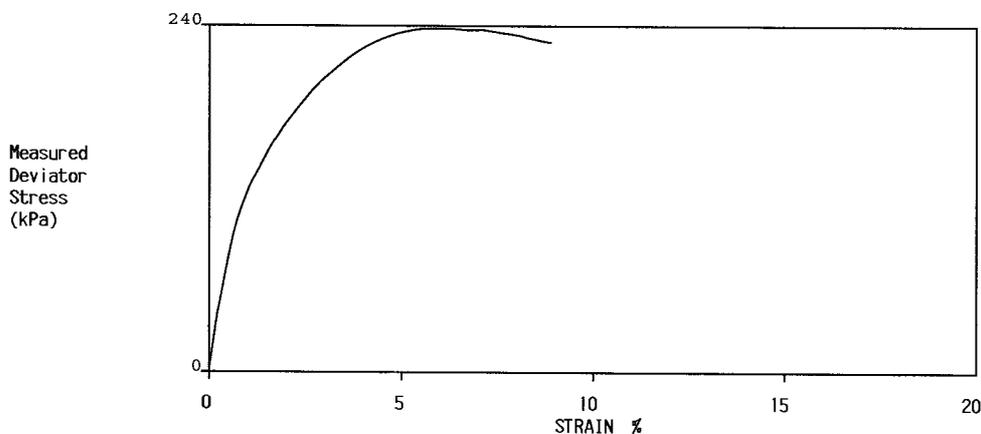
Borehole/ Pit No.	Depth m.	Sample	Description				Remarks	
BH1	14.20	U7	Stiff (High strength) very dark grey CLAY with rare shell debris					
Initial Specimen		Height mm	Diameter mm	Weight g	Moisture Content %	Wet Density Mg/m <sup>3</sup>	Dry Density Mg/m <sup>3</sup>	
 Depth of Top of Specimen (m)								
14.24		199.6	102.8	3231	27	1.95	1.54

TEST INFORMATION                      Rate of Strain    2.0    % per Min                      Rubber Membrane Thickness                      0.3    mm

Specimen at Failure	Measured Cell Pressure $\sigma_3$ (kPa)	Strain at Failure (%)	Stress Corrections (kPa)		Corrected Max. Deviator Stress $\sigma_1 - \sigma_3$ (kPa)	Shear Stress $\frac{1}{2}(\sigma_1 - \sigma_3)_f$ (kPa)	Mohr's Circle Analysis	
			Rubber Membrane	Piston Friction			Cu (kPa)	PHI °
	285	6.3	0.4	/	238	119
