King's Lynn Parkway - Water Vole Report

20 January 2020

Borough Council of King's
Lynn & West Norfolk
Kings Court
Chapel Street
King's Lynn
Norfolk
PE30 1EX

Document reference: 407004 | 1 | A

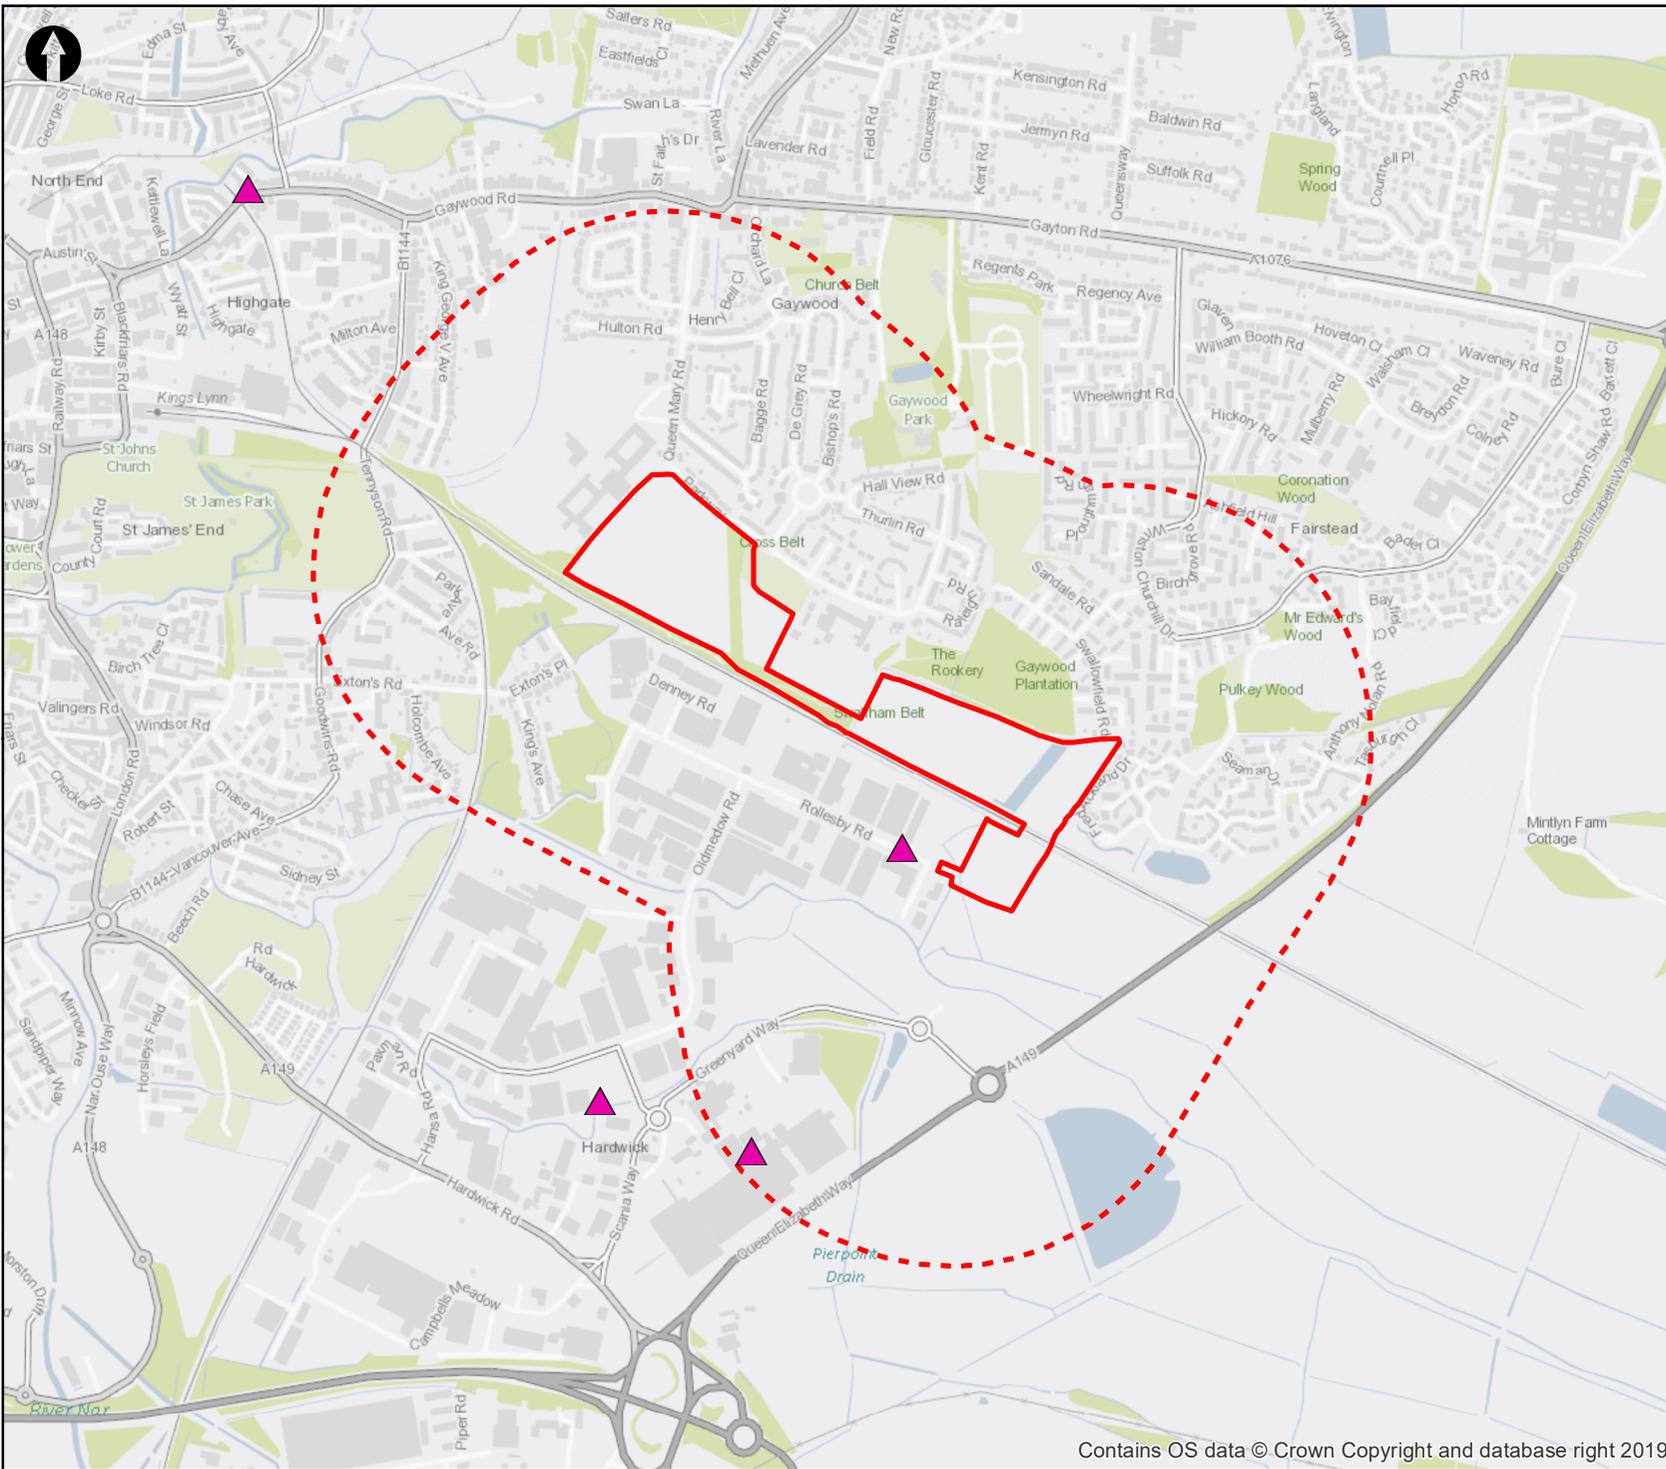
Drawing Title
Water vole biological records

Five records of the European water vole were recorded within 500m of the Proposed Scheme in the last 10 years. These are detailed below in Table 3.1 below and shown on the map in Appendix B.

The water vole record obtained in May 2013 does not have sufficient geographic data to reliably identify its location and proximity to the scheme.

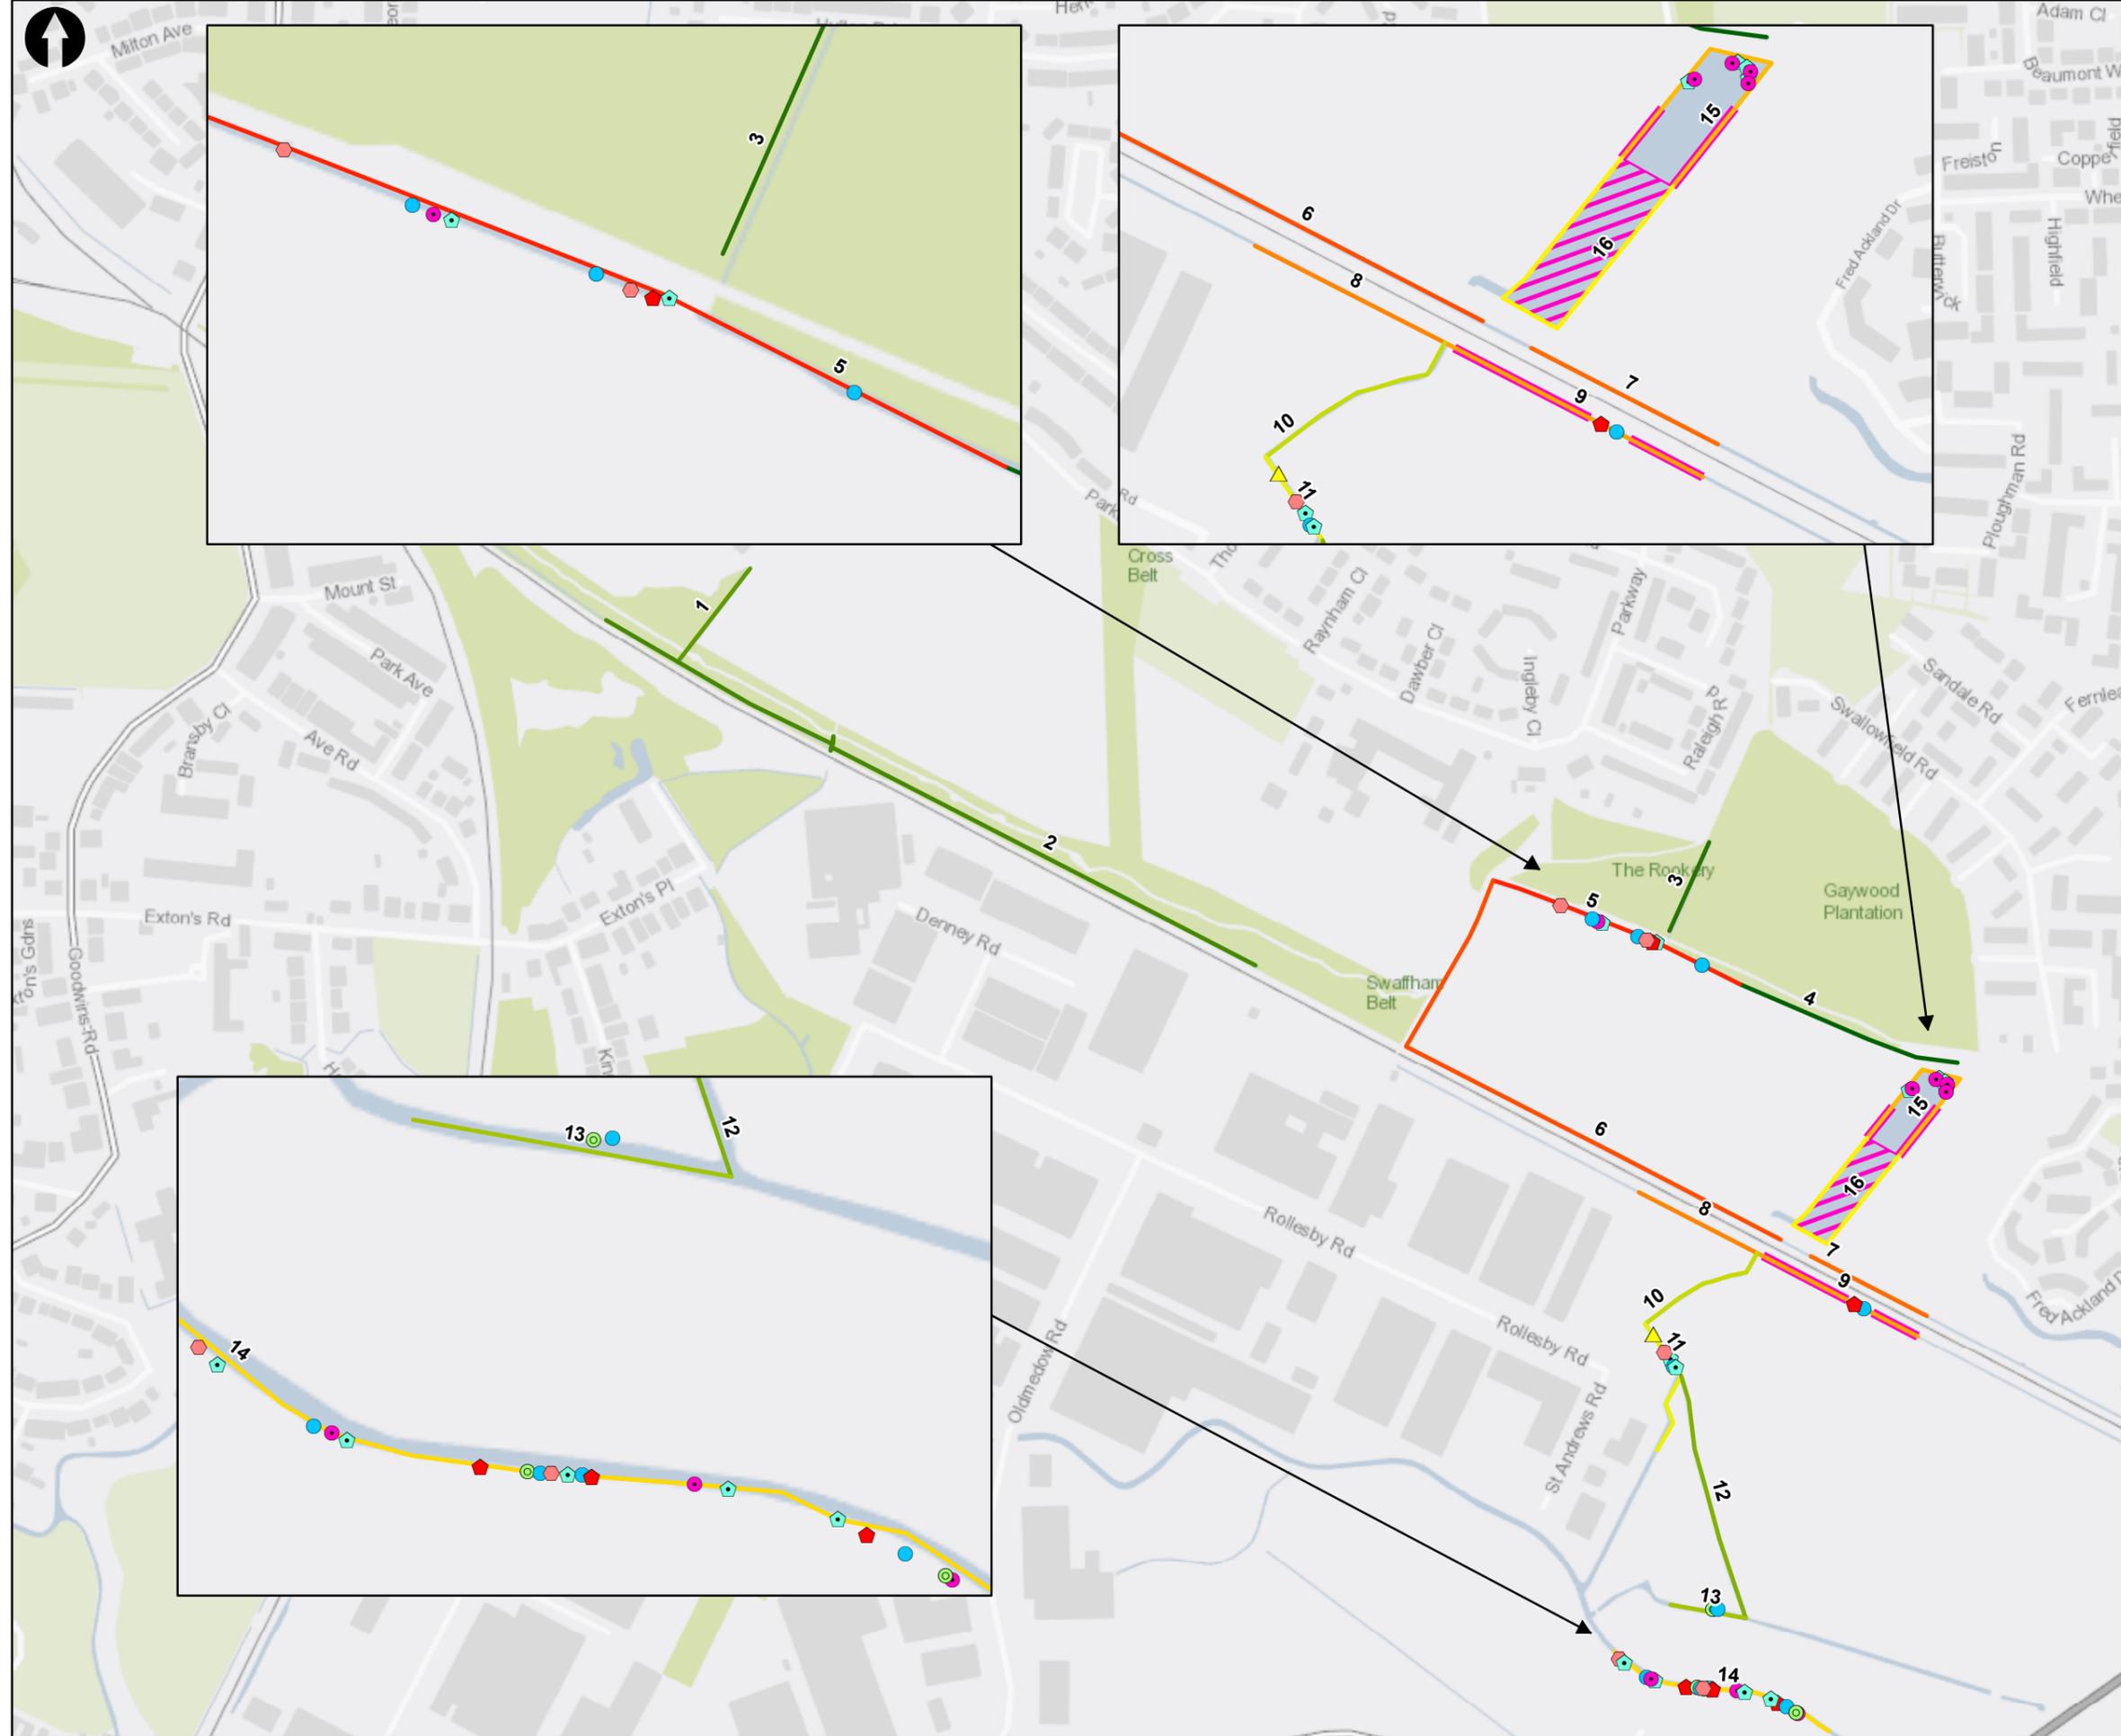
Title
Water vole field signs

Signs of water vole were identified in six sections of ditch. Table 3.3 shows results for each survey section. A map of water vole signs is shown in Appendix C.

Section	Field signs identified?	Number and type of field signs identified	Access notes	Number of visits	Estimated water vole numbers
1	No	None	All sections of the ditch were accessed.	2	N/A
2	No	None	All sections of the ditch were accessed.	2	N/A
3	No	None	All sections of the ditch were accessed.	2	N/A
4	No	None	All sections of the ditch were accessed.	2	N/A
5	Yes	2 latrines, 1 feeding station, 3 burrows and 3 runs.	All sections of the ditch were accessed.	2	3
6	No	None	Some southern sections of the ditch were heavy with bramble making it impossible to conduct a thorough survey.	2	N/A
7	No	None	All sections of the ditch were accessed.	1	N/A
8	No	None	Some southern sections of the ditch were heavy with bramble making it impossible to conduct a thorough survey. In addition, steep banks and deep silt made other areas difficult to access due to safety concerns.	2	N/A
9	Yes	1 burrow and 1 feeding station.	Some southern sections of the ditch were heavy with bramble making it impossible to conduct a thorough survey.	1	N/A

10	No	None	Deep silt/water and steep banks made some areas difficult to survey.	1	N/A
11	Yes	2 latrines, 2 burrows and 1 run.	All sections of the ditch were accessed.	1	3
12	No	None	Deep silt/water and steep banks made some areas difficult to survey.	1	N/A
13	Yes	1 burrow, 1 latrine.	All sections of the ditch were accessed.	1	3
14	Yes	4 burrows, 2 droppings, 6 feeding stations, 5 latrines and 2 runs.	Only the southern bank of the ditch was accessed.	1	5
15	Yes	4 latrines and 4 feeding stations.	Approximately half of the bank was inaccessible.	1	5
16	N/A	N/A	Inaccessible for survey in October 2019 due to dense vegetation within the pond and on the banks.	1	N/A

Section 16 could not be surveyed due to safety concerns associated with dense vegetation within the pond and deep silt. However, given water voles are present in Section 15, which is part of the same waterbody, and there is no physical barriers present, it is likely that water voles are also present in Section 16.
