Contaminated Land Inspection Report

Lime Kiln Road
Gayton

Reference no. 20/001

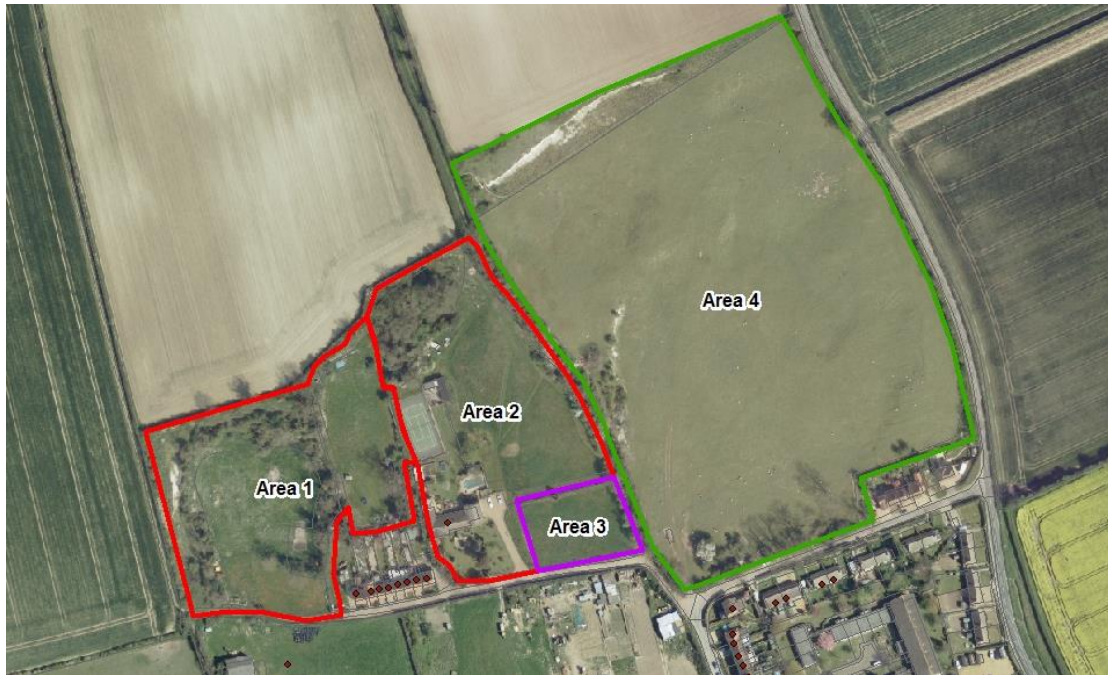
Figure 1: Site layout – recent

The site is formed of four adjacent parcels of land on Lime Kiln Road, situated approximately 200m to the north of Gayton Village. The location is shown in figure 1 below. The grid reference for the centre of the site is 572553 319708. The nearest postcode is PE32 1QT.

The site plan below (figure 1) shows aerial photography of the site with the site outlined in red. Following a review of the information submitted with a 2015 application for planning consent an additional area was added to the site and this is shown in purple. Plan 1 in Appendix B shows the site in more detail. Further photographs of the site are in appendix A.

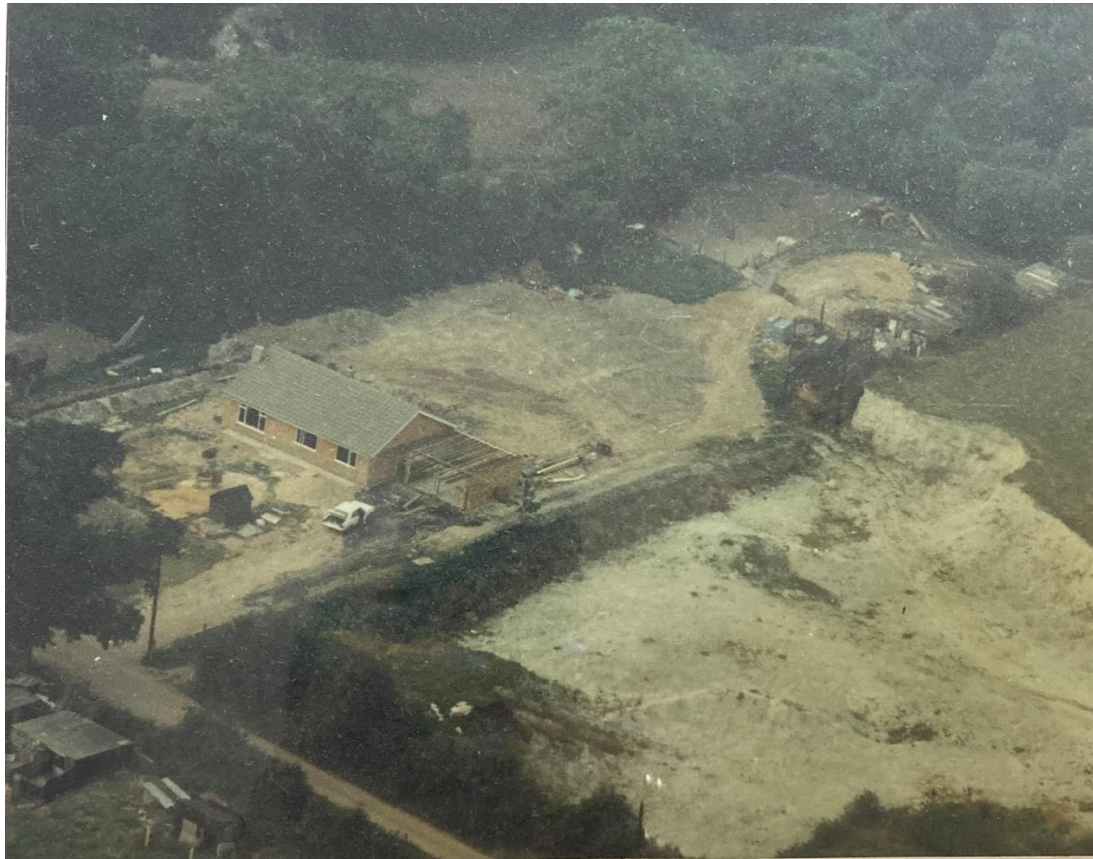
1970's – Oblique aerial photograph supplied by resident.

1970's – Oblique aerial photograph supplied by resident (below). The photograph shows the original 'Meadowvale' bungalow and an assumed garage under construction or car port. A telegraph pole in the foreground also helps to locate features as it remains in position today. Access to the house is to the west of the pole. A pit is located to the east of the house and access track. A bare chalk face is exposed on the north of this pit. There appears to be some spoil or fill material in the south-western corner of the pit.

Land to the north, at the rear of the bungalow appears to consist of exposed chalk with some potential remnant structures below the quarry face which runs north-south. The shape of the quarry faces matches that on the 1945 – 1970 historical maps.

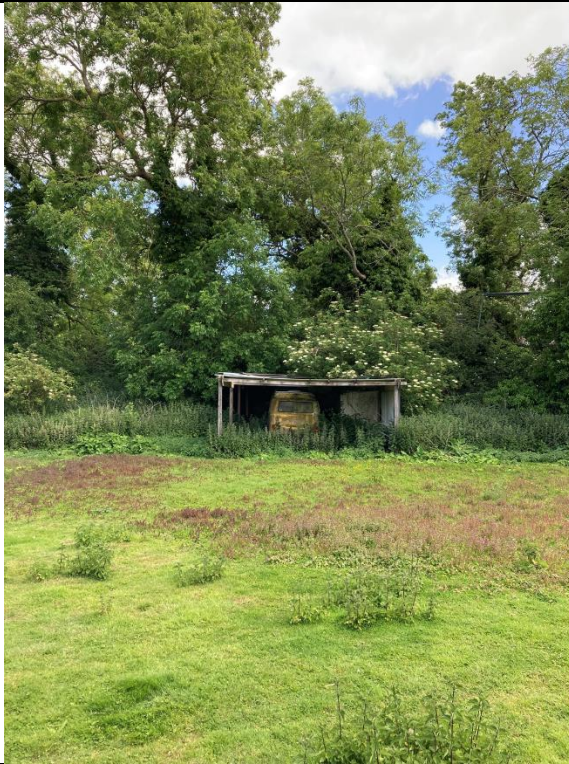
Photograph 1:

The site appears to be free-draining. One small ephemeral pond was noted (photo 4) evidenced by some changes in vegetation. There was a campervan (photo 1), a tractor (photo 5) and two cars (photo 6) stored on site but no evidence of pollution arising from these. The site is lower than the cottages to the south (photo 5) which may indicate that the site has not been filled. The site slopes downward to the north and east in the wooded area (photos 7 & 8) where it is reported that there is another pond, which would correspond with the earliest excavations depicted on the historical maps. There was no evidence of any fill materials on the surface or within molehills or rabbit burrows. Soils were light coloured sandy loam with chalk fragments.

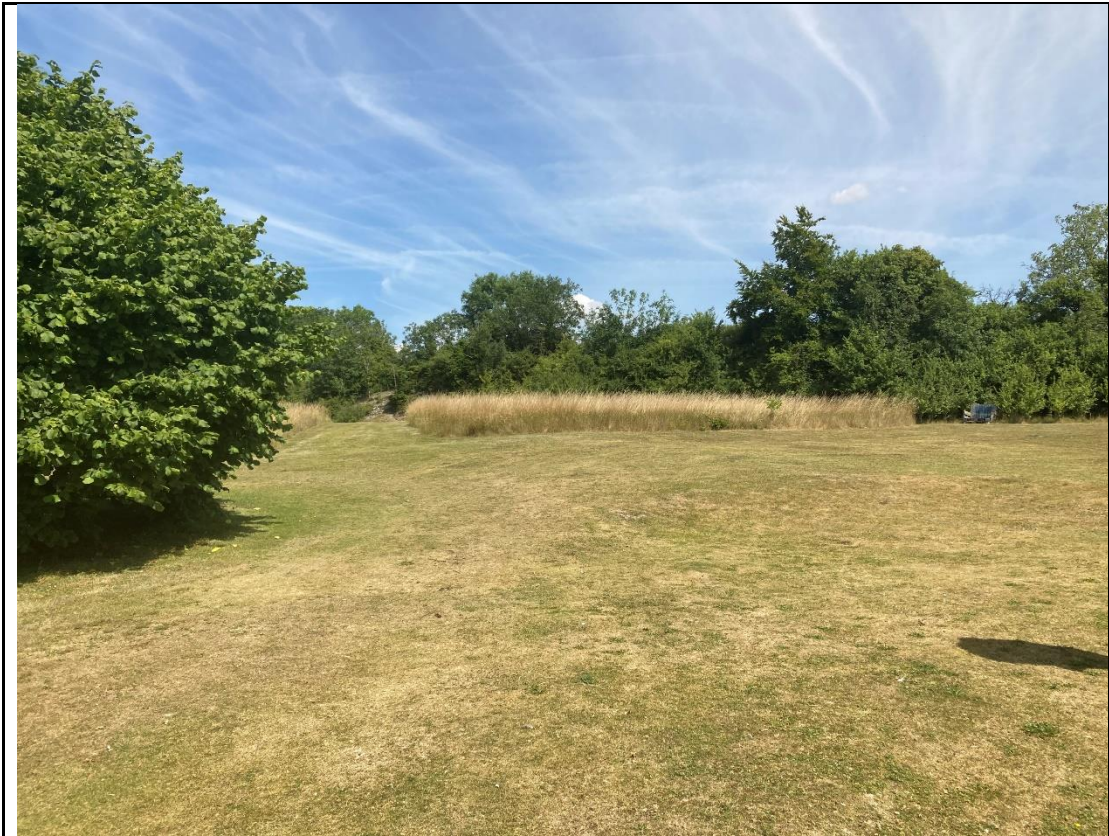
Photograph 11

To the north of the paddock, the site slopes gently upwards to the north as partly mown meadow grassland (photo 11). The surface appears more even than in the paddock. The ground in the garden is lower than the adjacent to the eastern border with a footpath (photo 12).

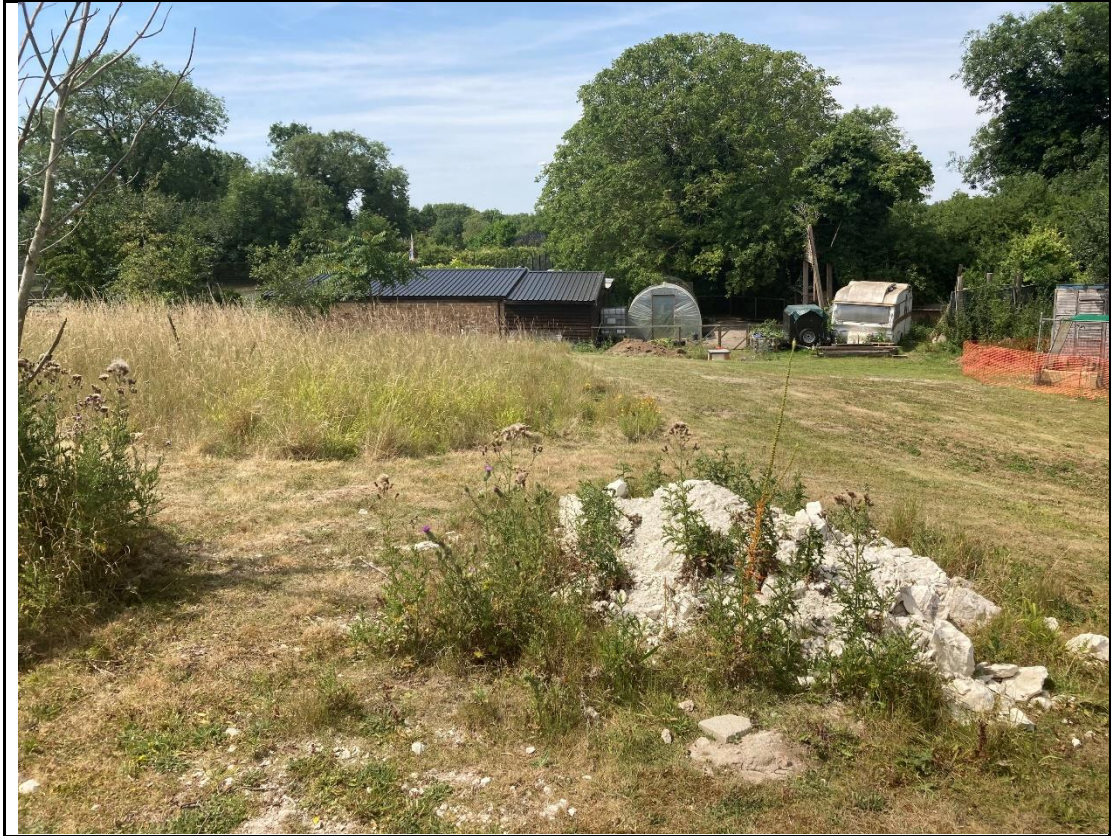
Photograph 13:

From the highest point on the meadow, the site slopes gently downwards again to the outbuildings to the west (photo 13), and mature woodland to the north (14). There was no surface evidence of fill materials. It appears possible that the slopes were formed from site-won material. Beneath the thin topsoil, chalk was noted. Chalk rubble was visible where a hole had been dug to plant a tree (photo 13). The tree was reported not to have thrived.

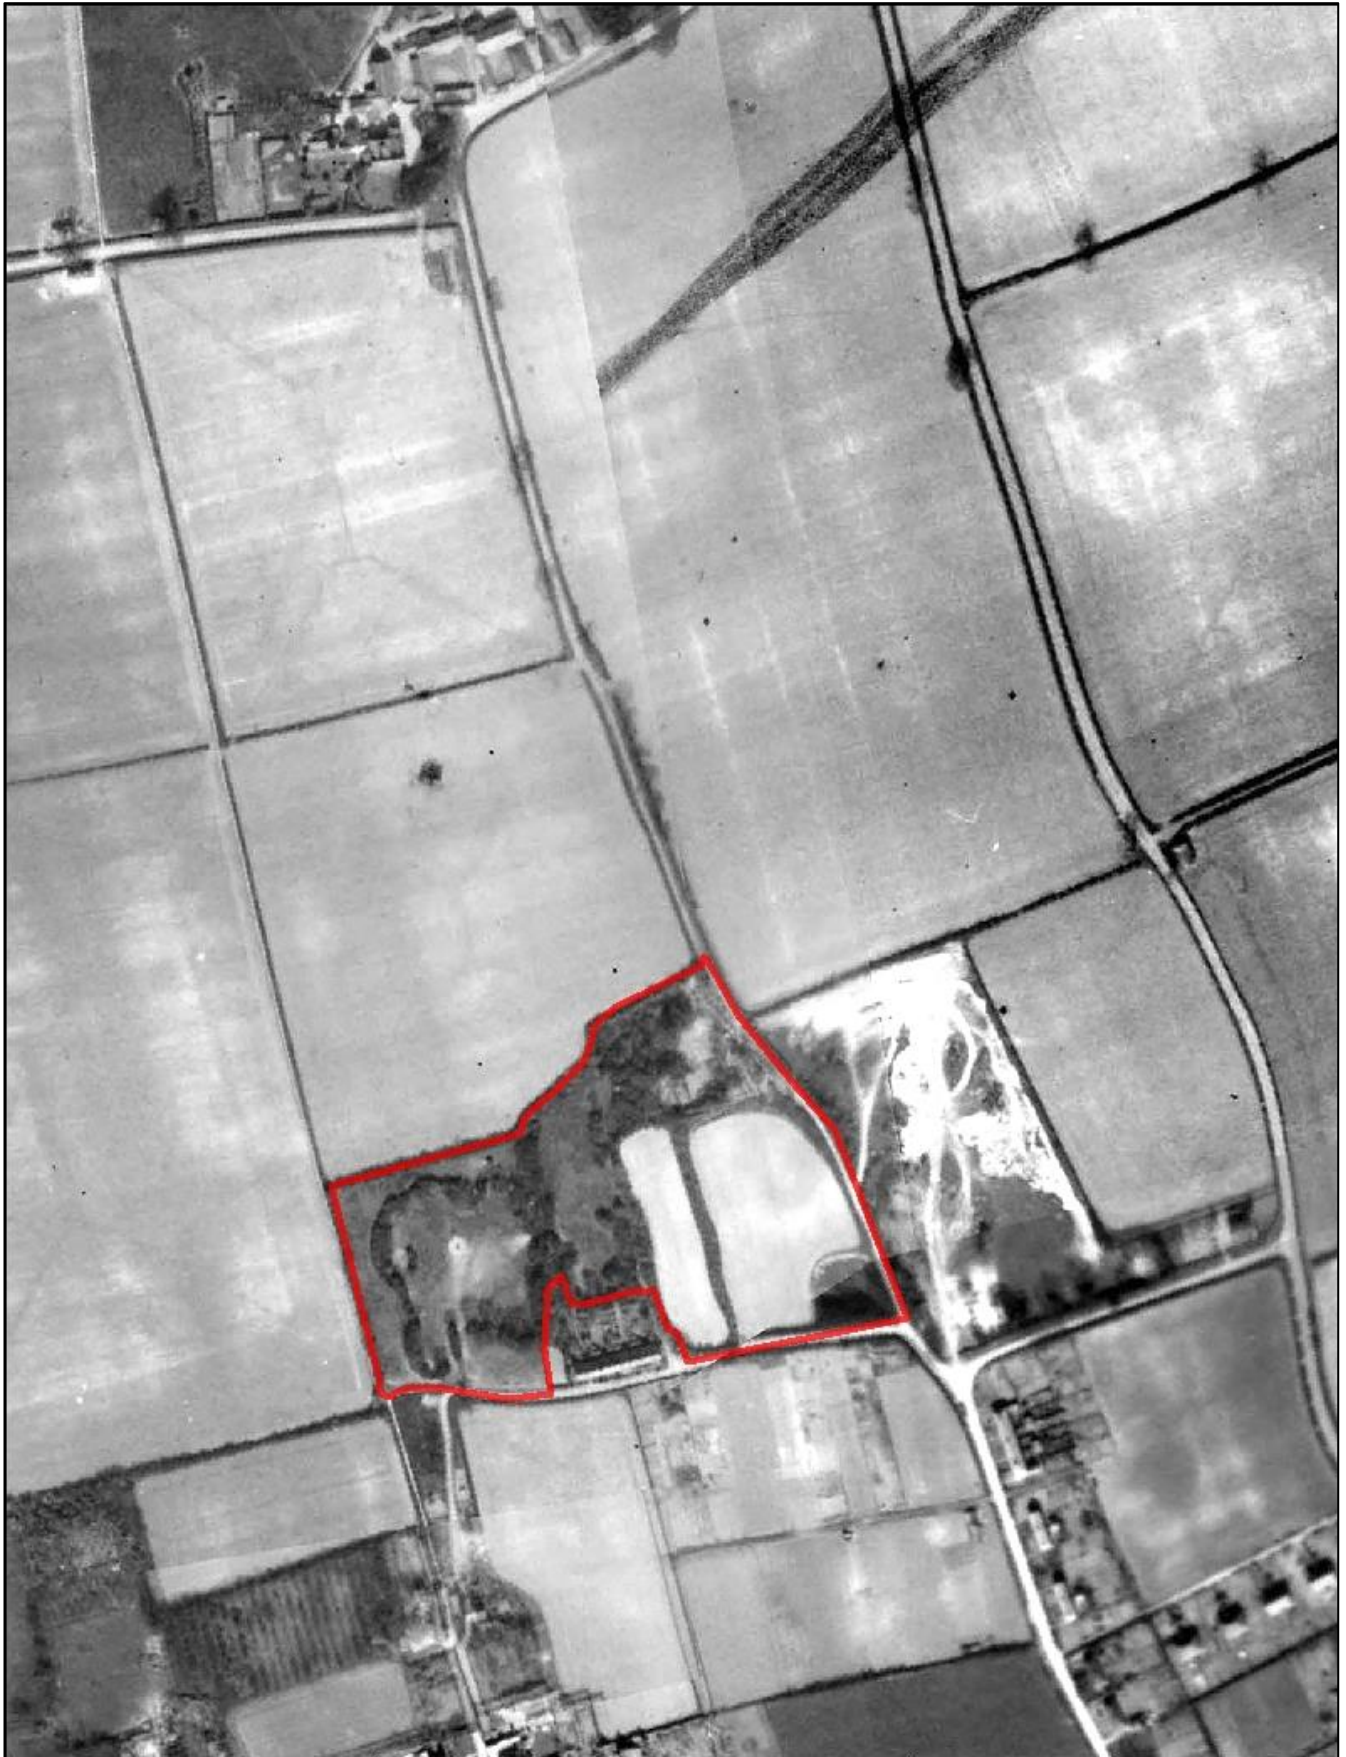
1945 – 1946 MOD Aerial Photograph – Map 4 shows the site to consist of disused pits. The western part of the site appears to be vegetated, but the shape of the pit sides can be seen. The eastern part of the site appears to have been filled or levelled in places and appears as a regular lighter surface. The northern section of this part of the site appears vegetated. The outline of Ebenezer cottages can be seen and the patchwork pattern of the allotments to the south. A number of houses to the southeast along Lime Kiln Lane. The buildings and trees of Well Hall Farm can be seen to the north. The pits to the east appear to be potentially still active and appear as pits connected by tracks within the lighter soil surface. The surrounding area is predominantly arable fields and grassland with occasional wooded areas.

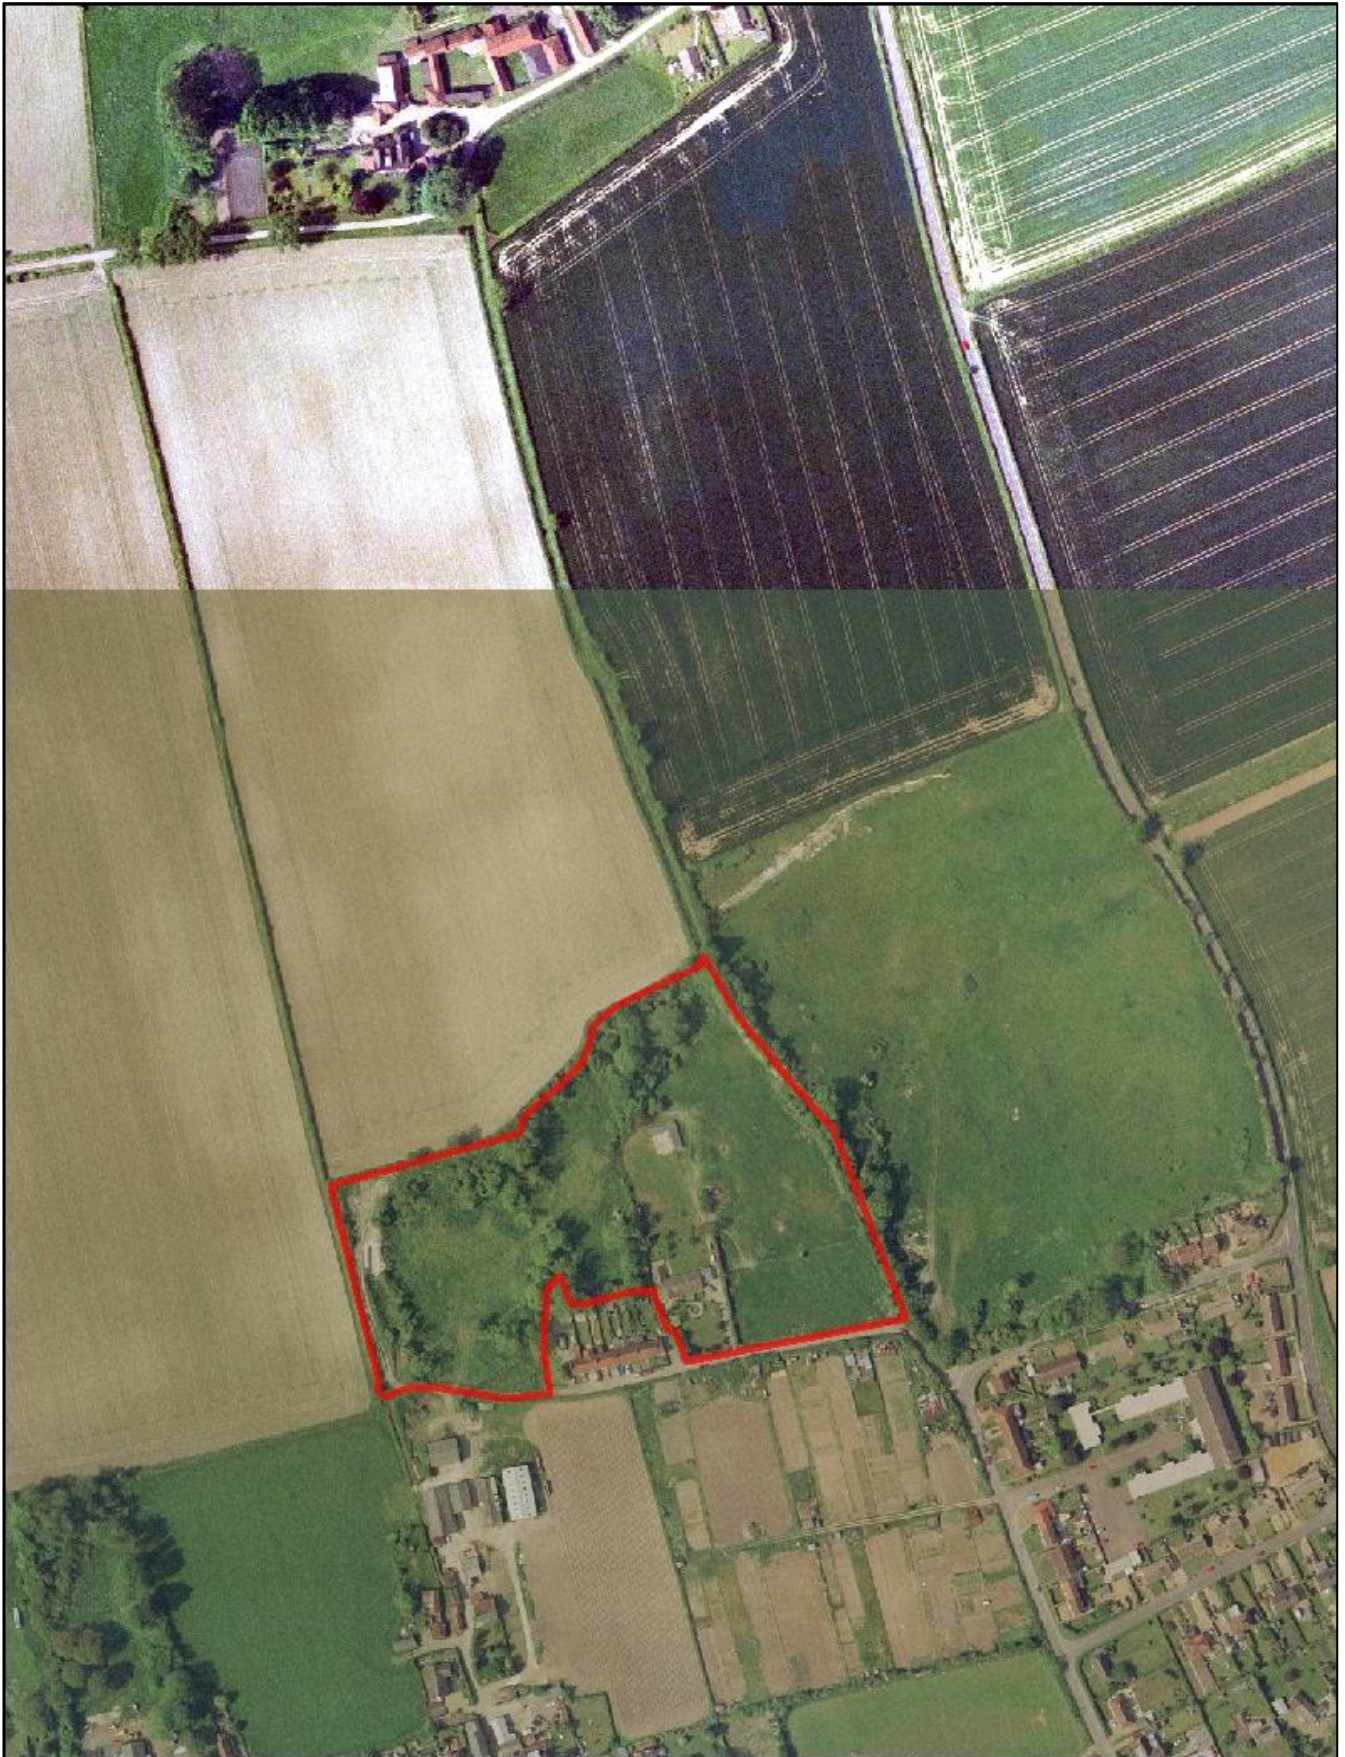
Title Lime Kiln Rd Gayton 1999 Aerial Photograph	Project / Details Part 2A	Drawn by FAP	Date August 2022	Scale 1:3,000
	© Crown copyright and database rights Ordnance Survey 100024314	Drawing / Reference Number Map 5

1999 – Map 5 shows the site to be well vegetated with open grassland, gardens, trees, and hedges. The buildings of Ebenezer Cottages and a large house (Meadowvale) are visible along the central southern area. Some slopes are visible following the shape of the former pits. The surrounding area appears to be similar to the previous map with the residential areas, allotments and Jubilee Farm to the south.

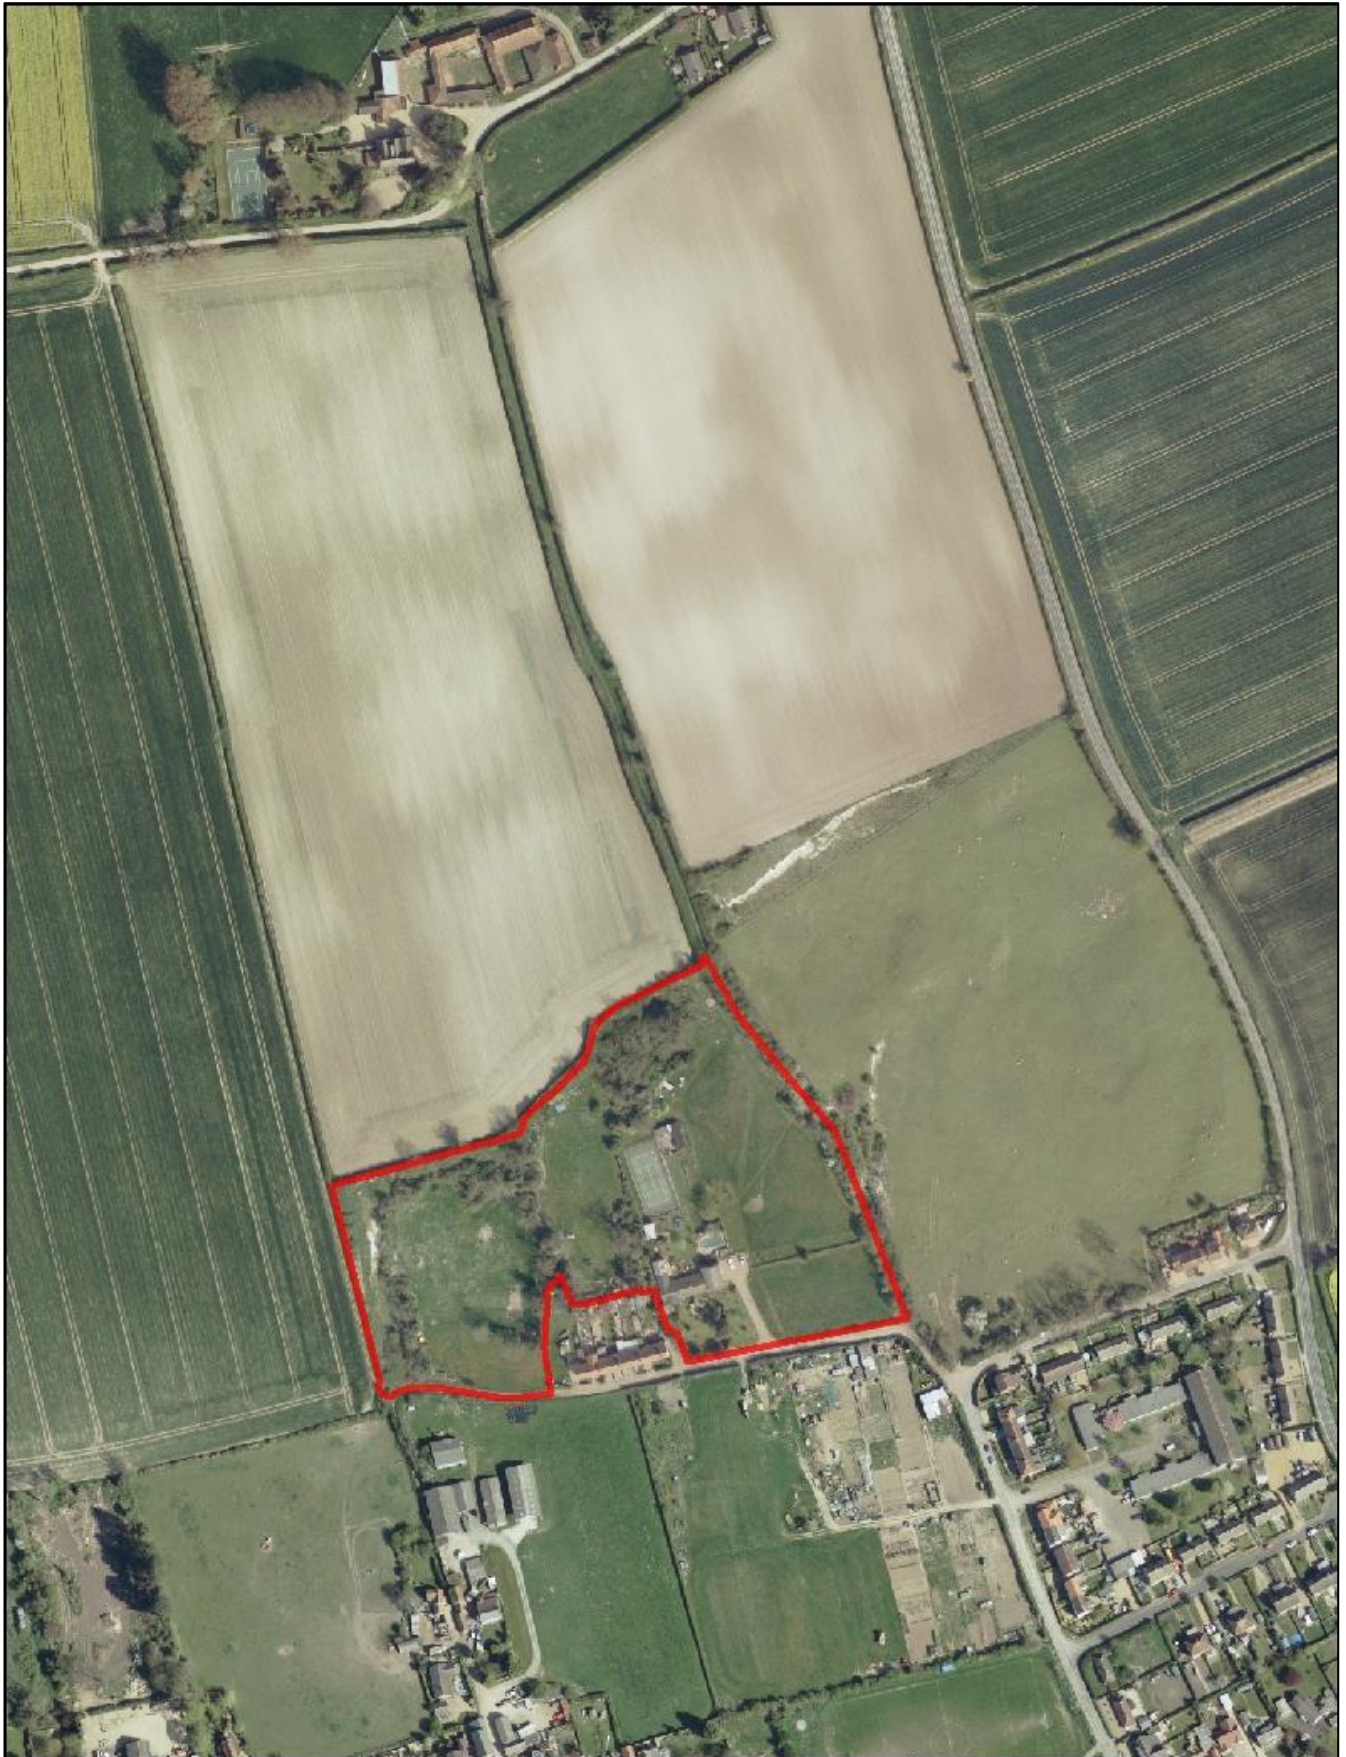
Title Lime Kiln Rd Gayton 2006-09 Aerial Photograph	Project / Details Part 2A	Drawn by FAP	Date August 2022	Scale 1:3,000
	© Crown copyright and database rights Ordnance Survey 100024314	Drawing / Reference Number Map 6

2006-09 - Map 6 shows the site to have been further developed in the eastern part (Meadowvale). An additional wing is included on the house and a tennis court and swimming pool added together with several outbuildings. The driveway to the house has been moved to the east and widened. The western part of the site (Area 1) also appears to contain several small structures. The area used for allotments to the south has been reduced and returned to arable use. The field to the east (area 4) appears to be used for grazing.

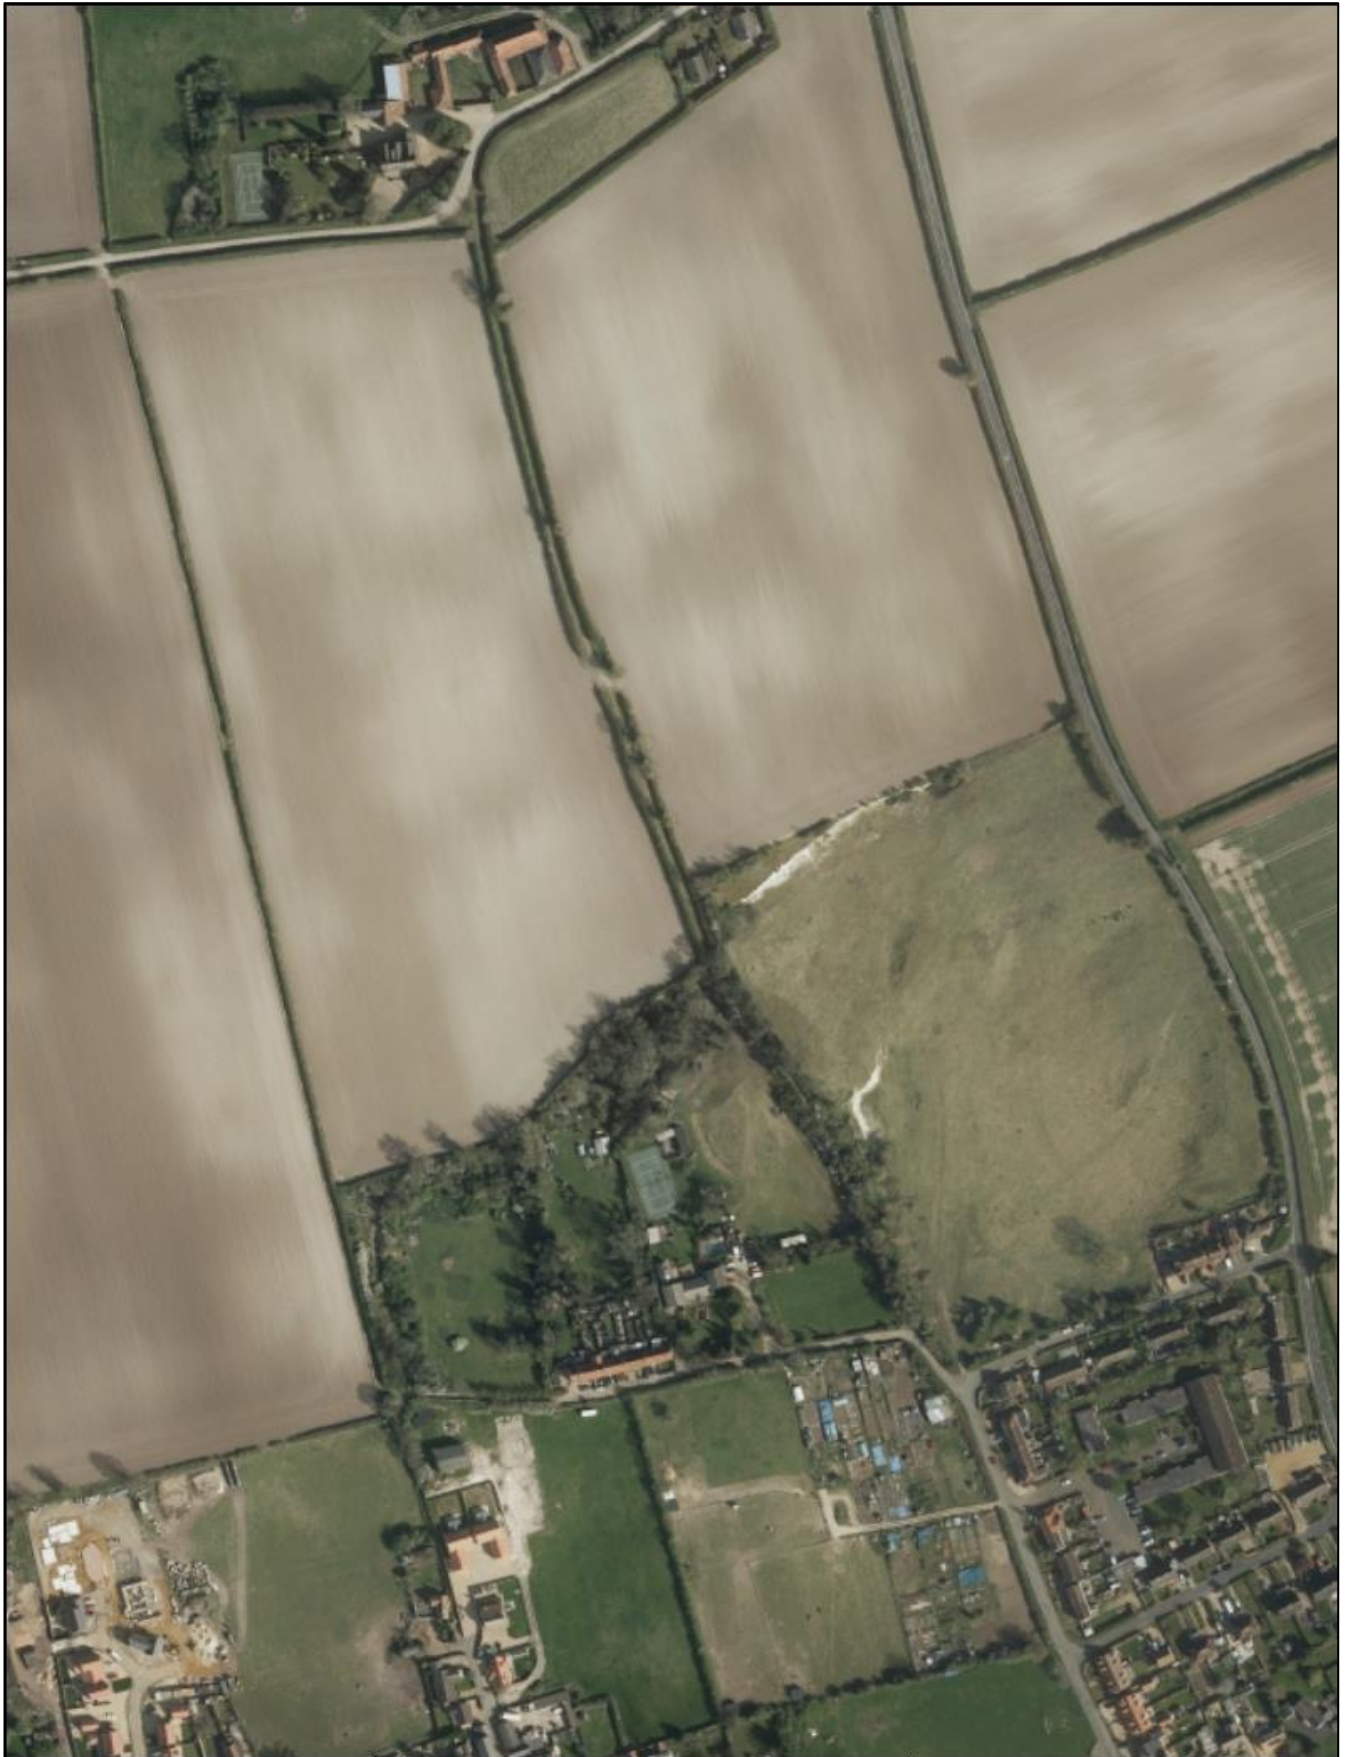
2017 - Map 7 shows the most recent aerial photography. The site and surrounding area is similar to the previous image but with additional tree growth on site and some further outbuildings or field shelters at the rear of Ebenezer Cottages in the north of the site.
