Coastal Trends Reports

Borough Council of
**King's Lynn &
West Norfolk**

Wash Trends Report (2021)

Unit B - Hunstanton

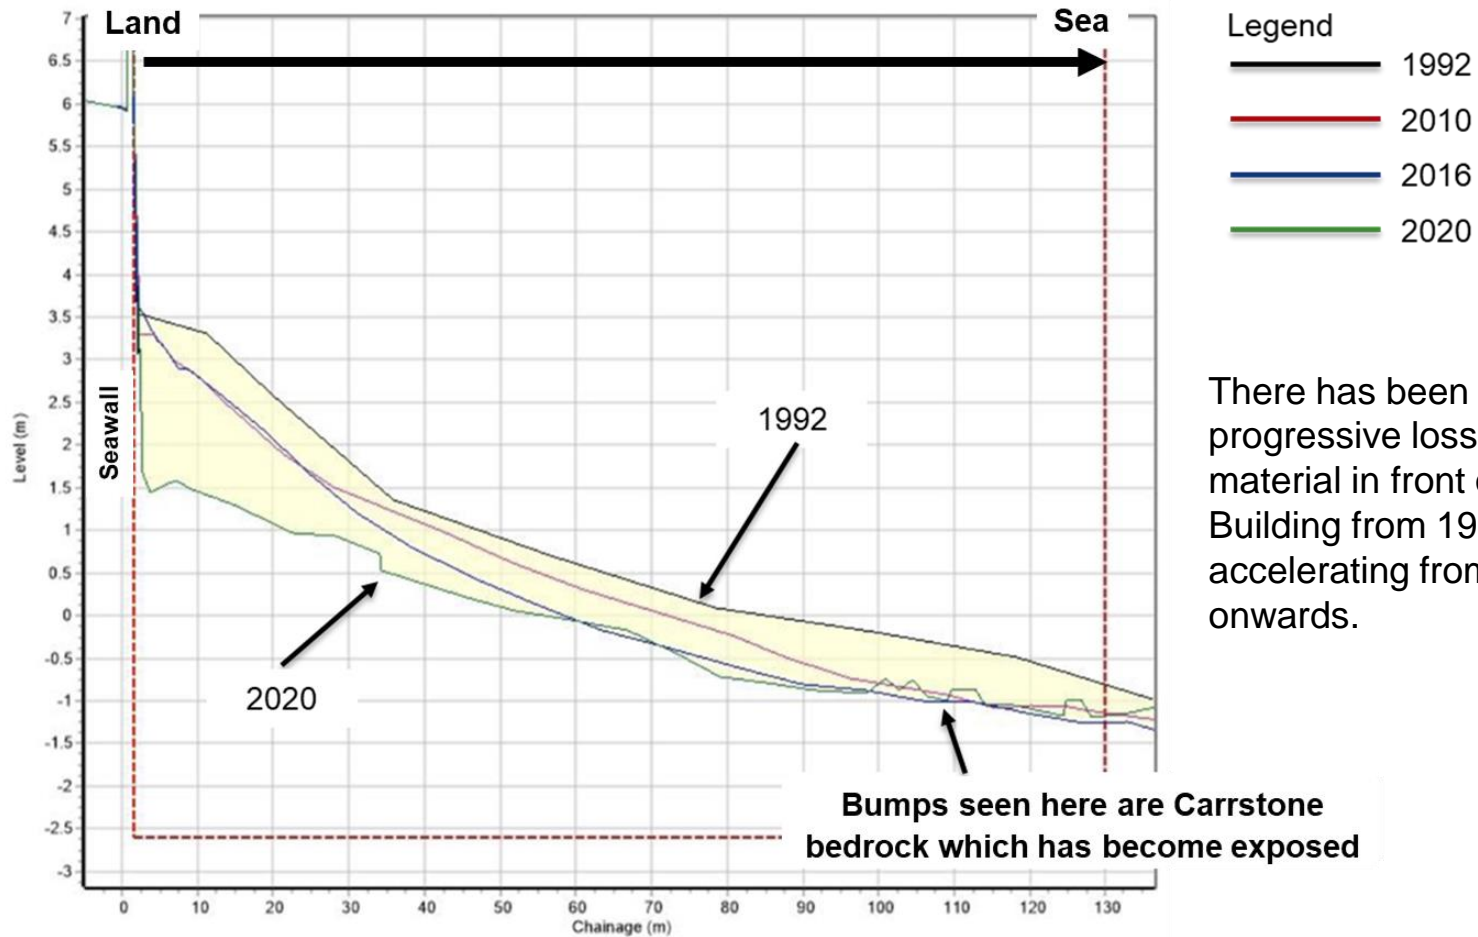
There has been a progressive loss of beach material in front of the Pier Building from 1992-2020, accelerating from 2016 onwards.

Beach profile opposite Pier Building from 1992 (black line) to 2020 (green line)

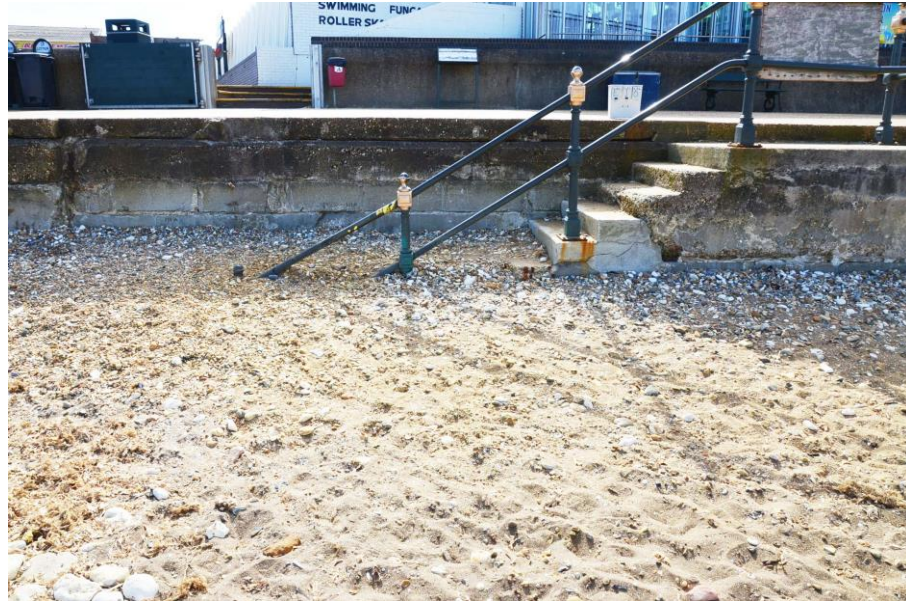
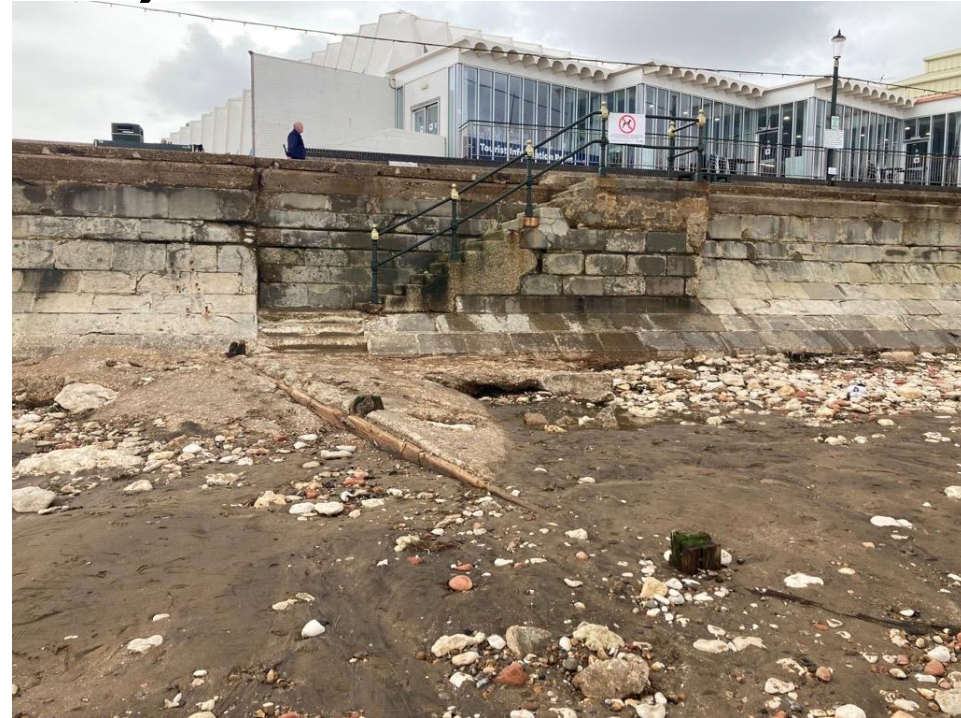
Section E (2017 vs 2022)

March 2017

September 2022

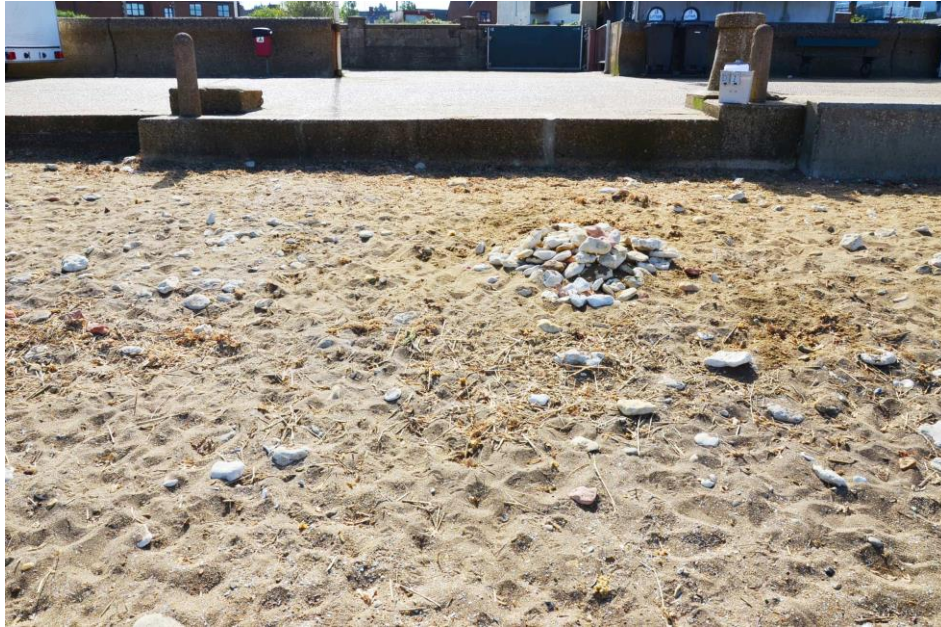
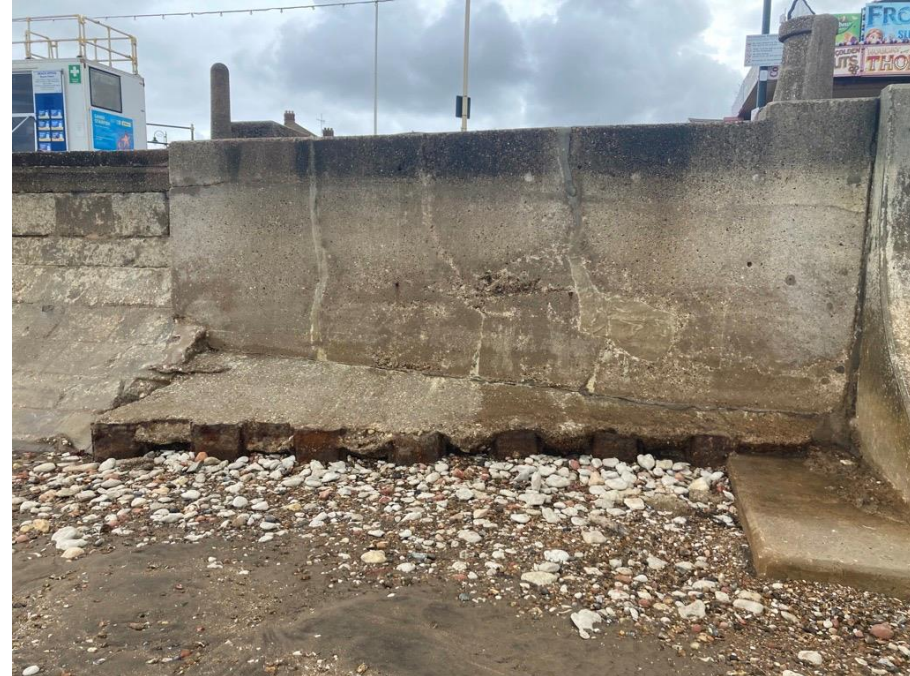
Section D (2017 vs 2022)

March 2017

September 2022

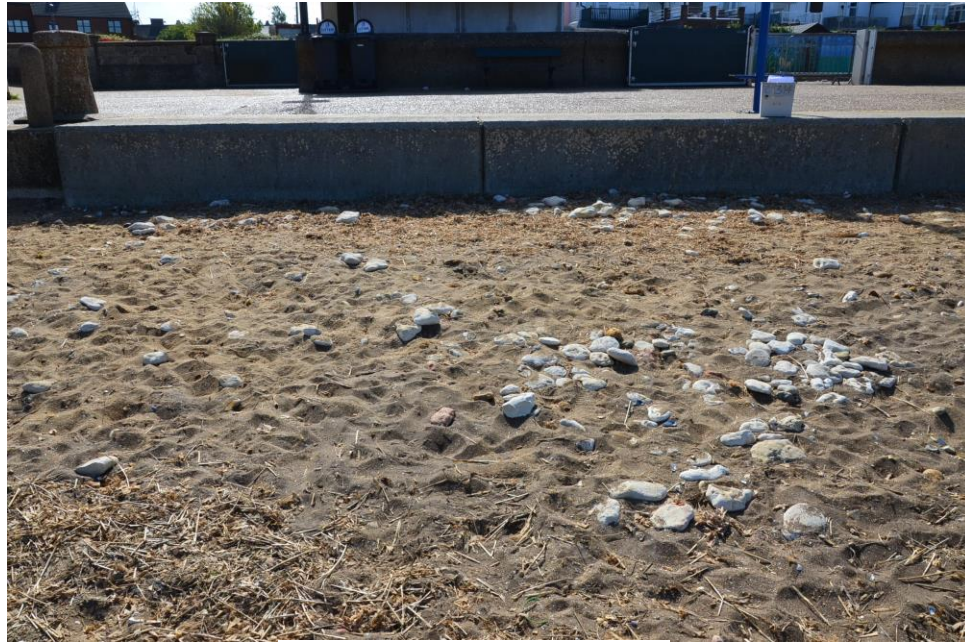
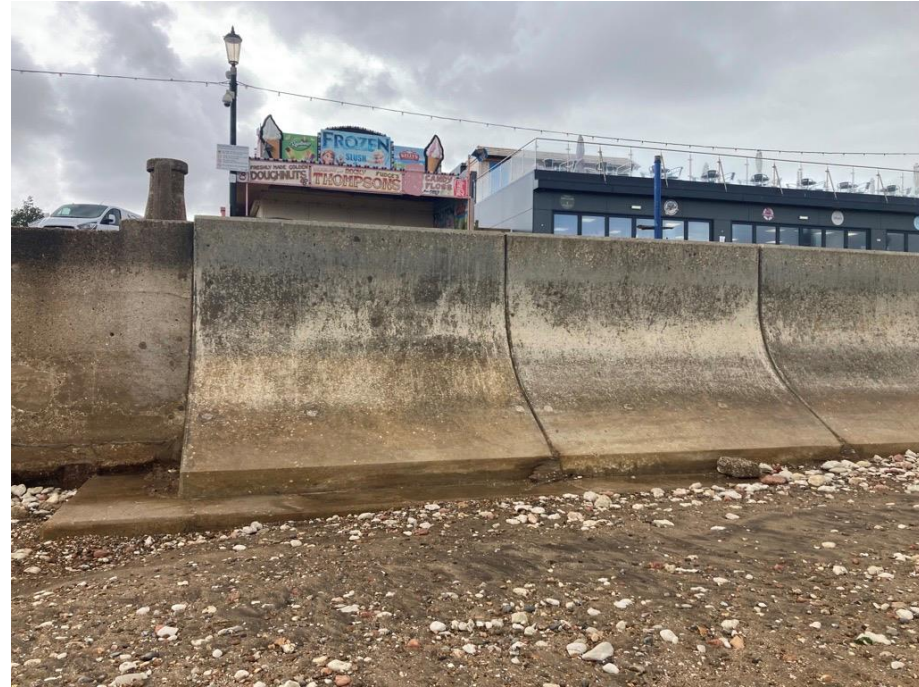
Section C (2017 vs 2022)

March 2017

September 2022

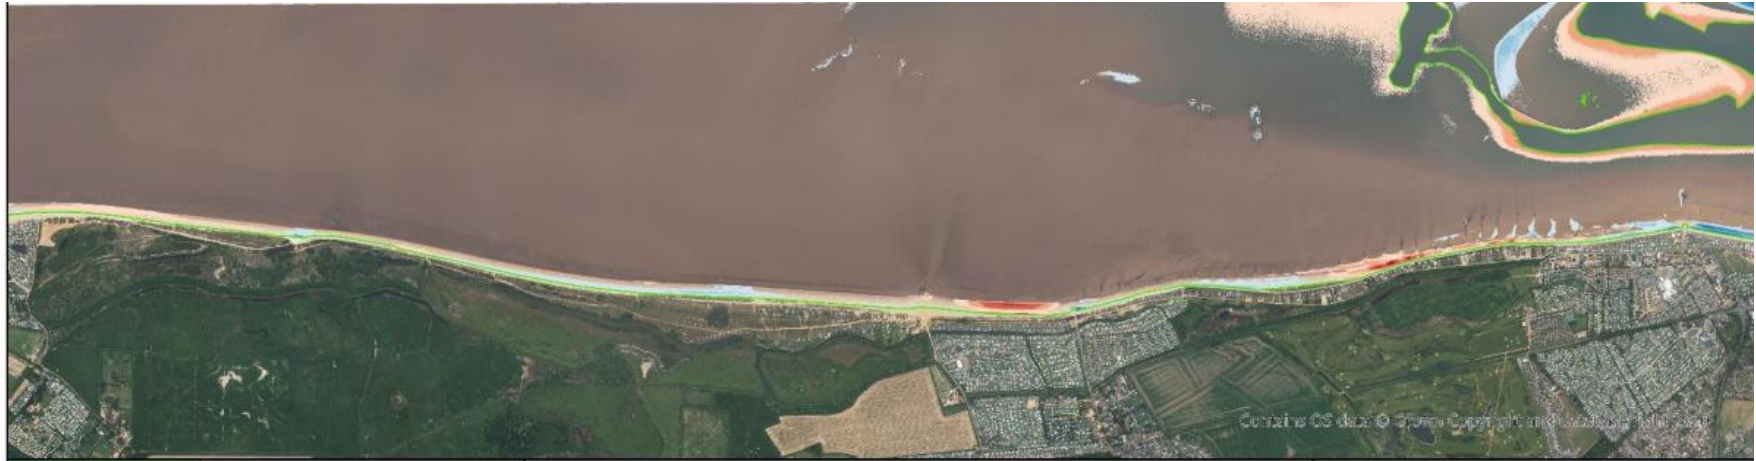
LiDAR Data 2016-2020

- The trend since 1992 shows that beach volumes have been stable but there has been some changes in profile.
- The largest areas of accretion are at the Scalp with a increase since 1992.
- The most recent trends (2016-2020) shows a small loss of material.
