# Hunstanton Groyne Fields: appraisal of groyne effectiveness

## Appendix A. Review of coastal processes and shoreline change

Environment Agency

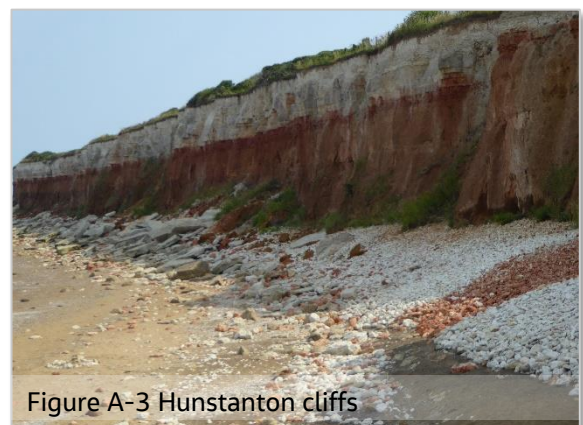
Figure A-3 Hunstanton cliffs

In terms of morphology, however, the Hunstanton-Heacham coastline is distinctly different from the south or west coasts of The Wash, where there are extensive saltmarshes. Instead, the frontage is characterised by the dramatic Hunstanton chalk cliffs to the north (Figure A-3) to the low-lying plain of Heacham to the south, fronted by beaches consisting of gravels and sands and lower sandflats.

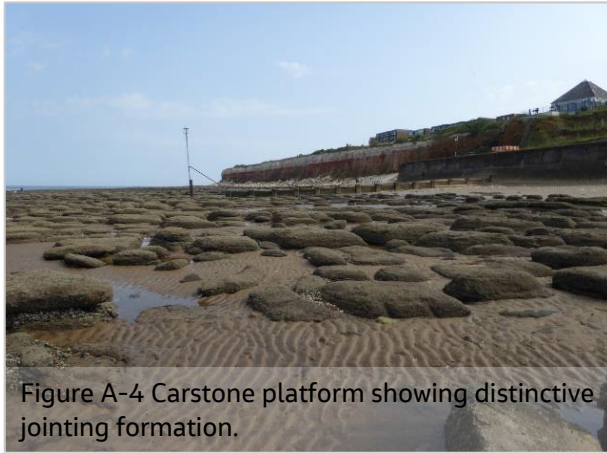
Figure A-4 Carstone platform showing distinctive jointing formation.

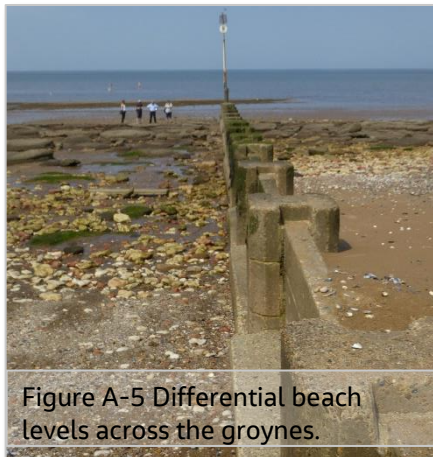
Figure A-5 Differential beach levels across the groynes.

At the time of the site visits (July and November 2021) it was evident that the upper gravelly-sand beach was constrained to the top of the concrete groyne bays and whilst there was only minor differential in beach level evident at some of the more northern groynes (up to groyne 5), this was typically less than half a metre at its maximum in July (and even less in November) and only extended up to 20 metres from the seawall (Figure A-5). The build-up of sediment in November 2021 was generally over a metre below the top of the groynes. Between Groyne 5 and Groyne 9 the beaches were observed to be lower, with gaps beneath the groynes evident. Cobbles derived from erosion of Hunstanton cliffs form a linear deposit along the toe of the upper beach. The position of this interface does not appear to be much influenced by the groynes.

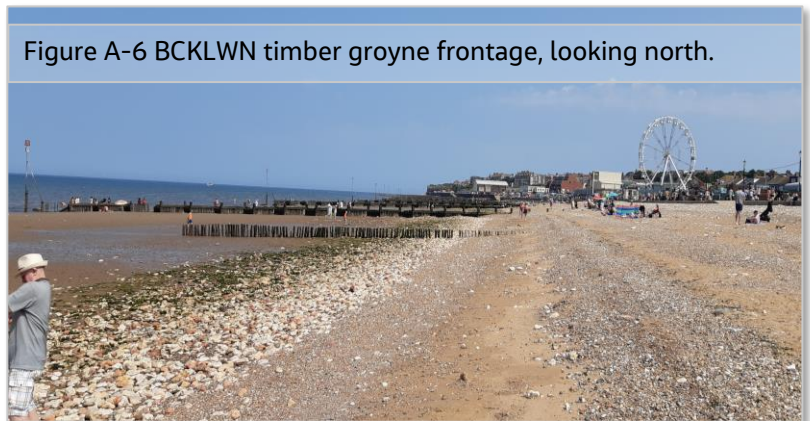
Figure A-6 BCKLWN timber groyne frontage, looking north.

Moving south, along the BCKLWN timber groyne frontage, south of Groyne 12 the morphology of the beach changes, characterised by a wider upper gravelly sand beach which transitions to a lower sand beach, fronted by a sandflat below - 1 mOD (beyond the end of the groynes) (Figure A-6). At the time of the site visits the upper sections of the groynes were buried, with generally around 50 to 65 m of the groyne length still exposed.

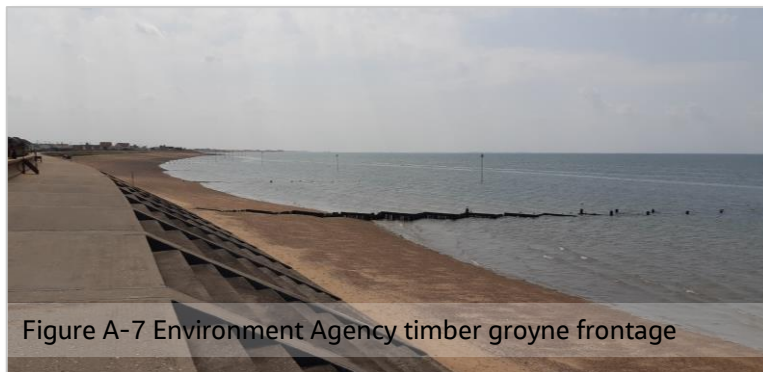
Figure A-7 Environment Agency timber groyne frontage

To the south of the Power Boat Ramp, along the Environment Agency frontage, the morphology of the beach varies along shore, which is likely to relate changes in the alignment of the coast, the nearshore and also beach management (Figure A-7). Along some stretches, the beaches are similar to those along the BCKLWN timber groyne frontage; characterised by an upper sand and gravel beach, fronted by a more gently sloping lower sand beach and sandflat. Elsewhere the distinction between upper and lower beach is not so

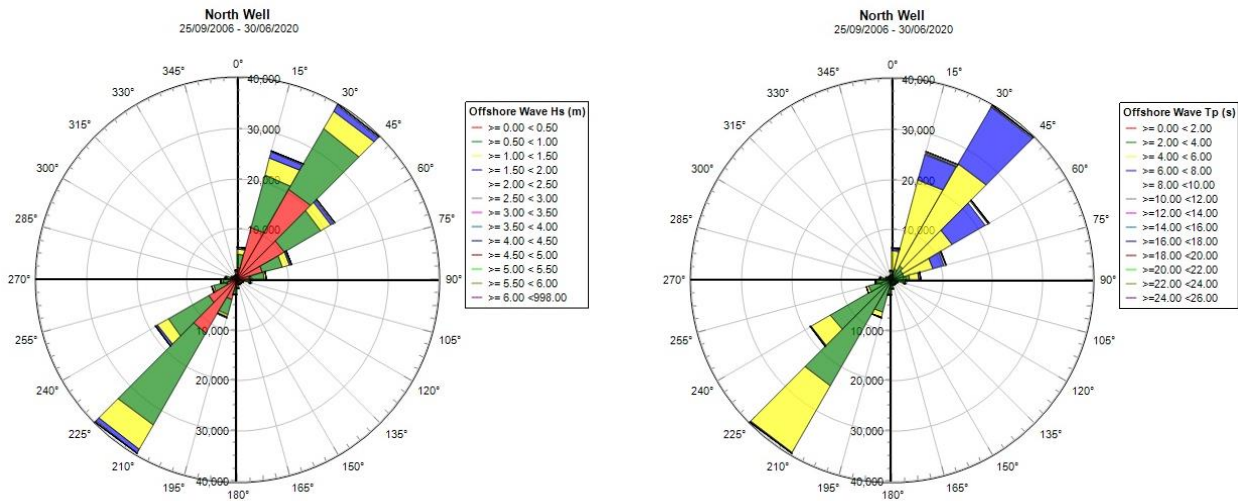
Figure A-10 Offshore wave rose generated for data from North Well wave buoy: left - significant wave height (Hs), right - wave period (Tp).

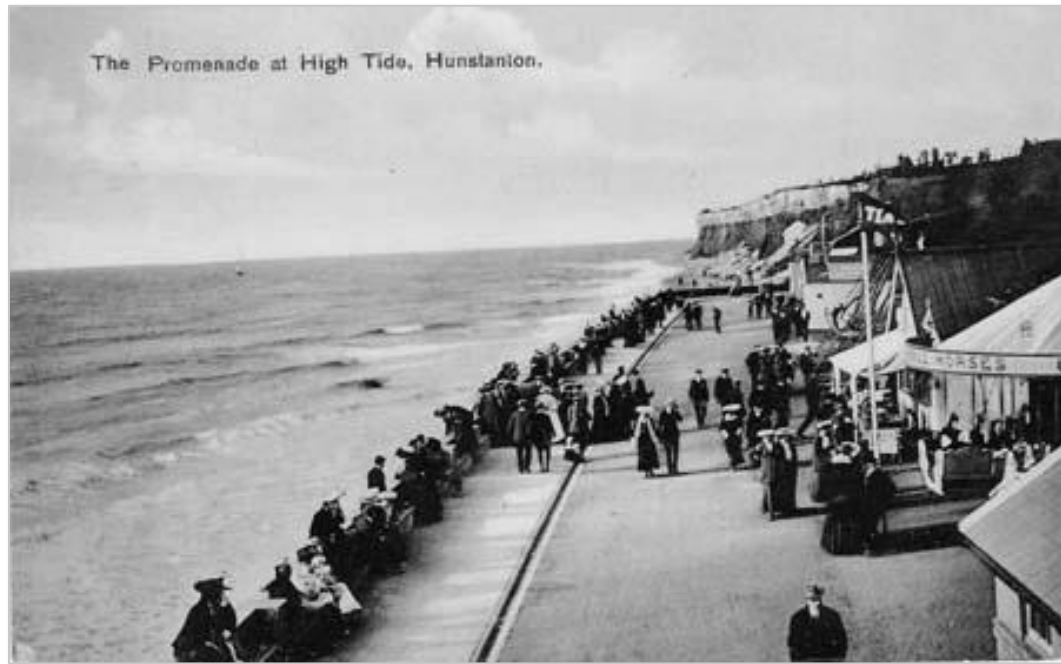
Photographs from the early part of the twentieth century show that at this time wider beaches were present to the south of the Pier, compared to the north, but the images suggest that beaches were coarser in nature, with a photograph from 1907, in front of the former Sandringham Hotel (which was located in the vicinity of the Central Car Park), illustrating a fairly steep interface between an upper gravel-rich beach and lower sandflat (<https://www.francisfrith.com>).

Figure A-13 Hunstanton at high tide: date of photograph not known but assumed to be early twentieth century.  
Source: <http://www.hunstantoncivicsociety.org.uk>.

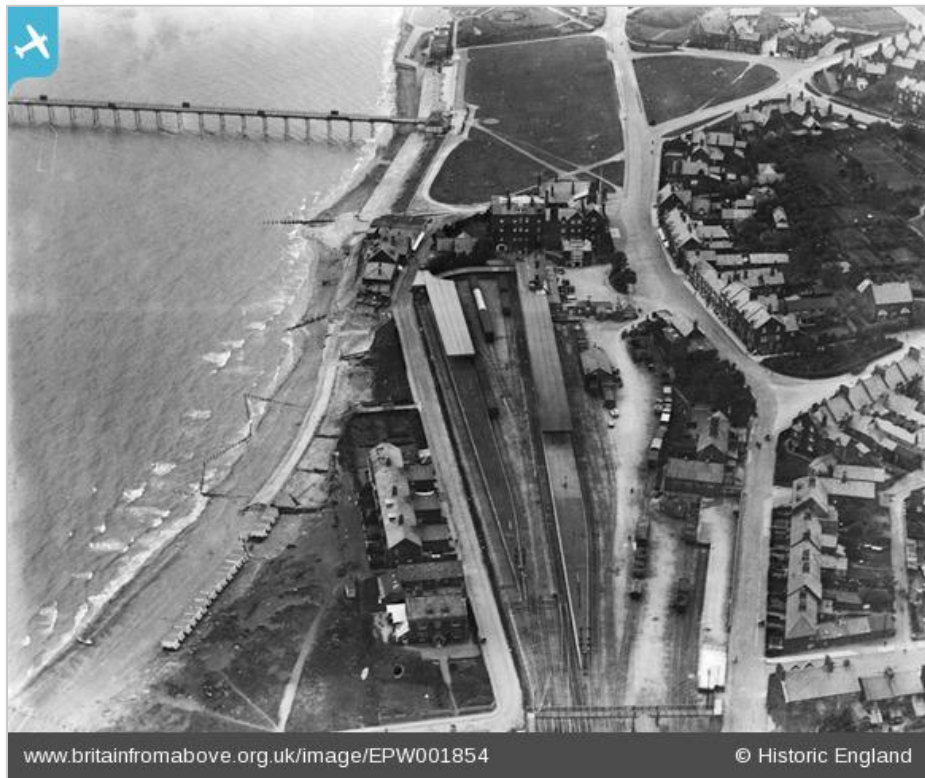
Figure A-14 Hunstanton Pier, 1920, illustrating some of the groyne structures in place by this time. Source: [www.britainfromabove.org](http://www.britainfromabove.org).

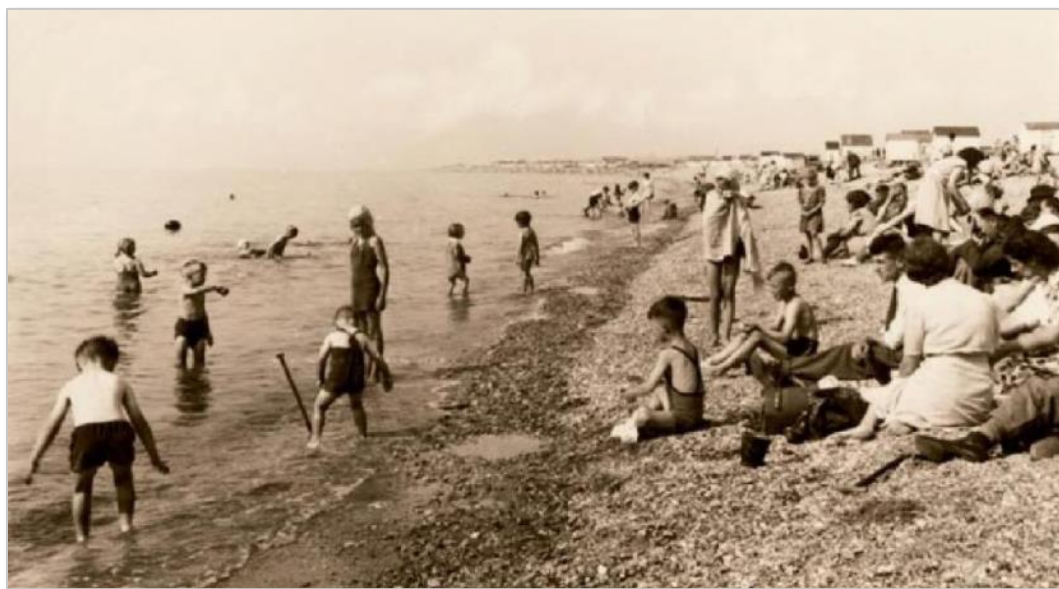
Figure A-15 Heacham Beach. Date unknown, but assumed to be around the 1930s/1940s. Source: M Rouse (2013).

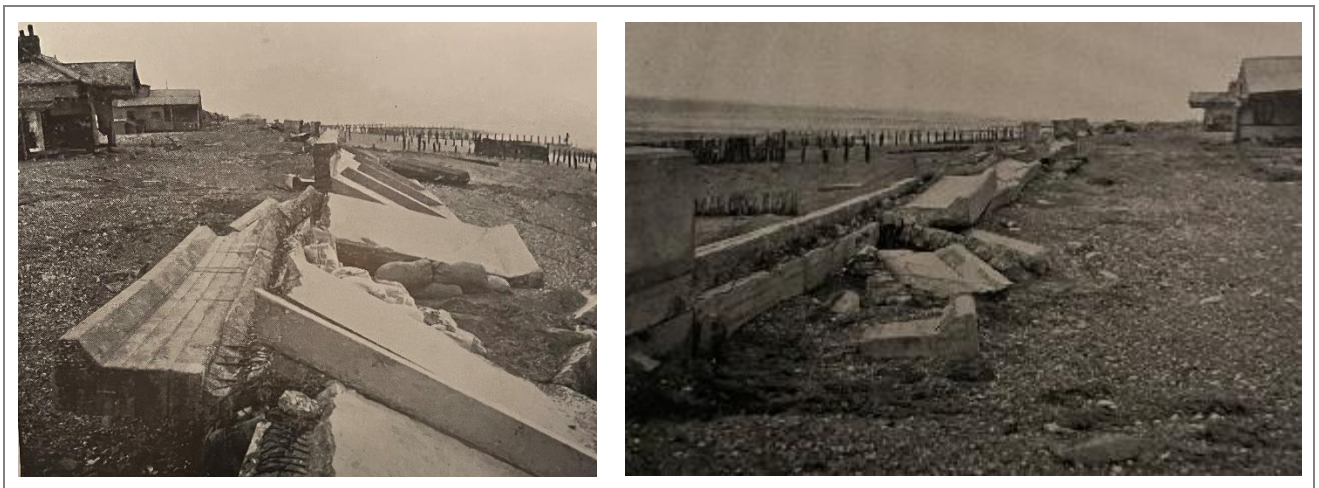
Figure A-16 Damage to Heacham North Beach Wall following 1953 storms, noting the timber groynes that were present at this time. Taken from ICE Conference on the North Sea Floods (1954).

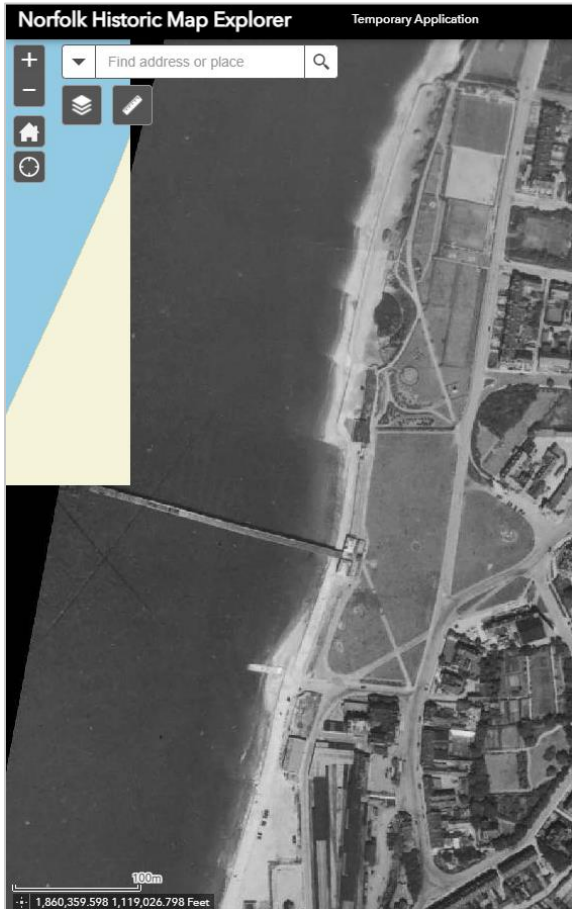
Figure A-17 Aerial photograph of the concrete groynes frontage. Exact date of the photograph is unknown, but taken between 1945-6 and 1960-1965. Crown Copyright, source: <http://www.historic-maps.norfolk.gov.uk>

Figure A-17 is an aerial photograph of the frontage post-war (exact date unknown), which shows the six original groynes. At the time, these appear to be retaining a beach, but it appears that a consequence is very low beach levels to the north and south of the pier (the Amusement Arcade today). The second photograph (Figure A-18 is from 1956; it is, however, uncertain whether this pre or post-dates Figure A-17. This shows exposure of Carstone at the norther end of the promenade and also possibly just north of the pier. Beaches to the south of the pier were, however, fuller at this time compared to Figure A-17.

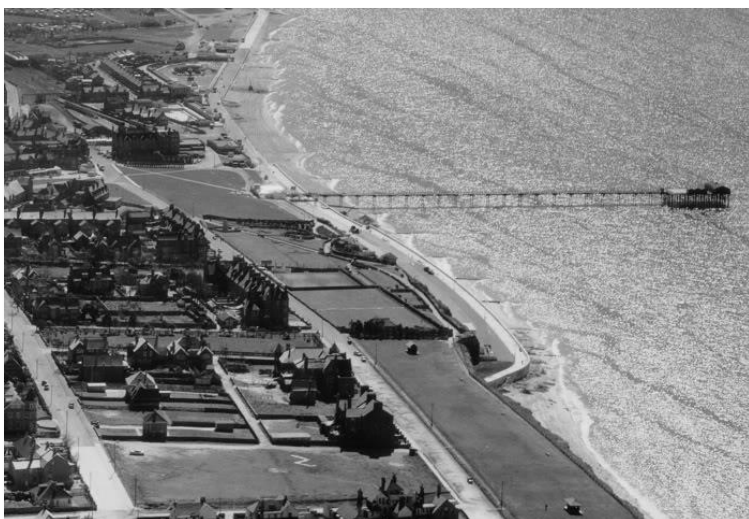
Figure A-18 Hunstanton in the 1950s. Exact date of photograph is unknown. Source: <https://www.kingslynn-forums.co.uk>

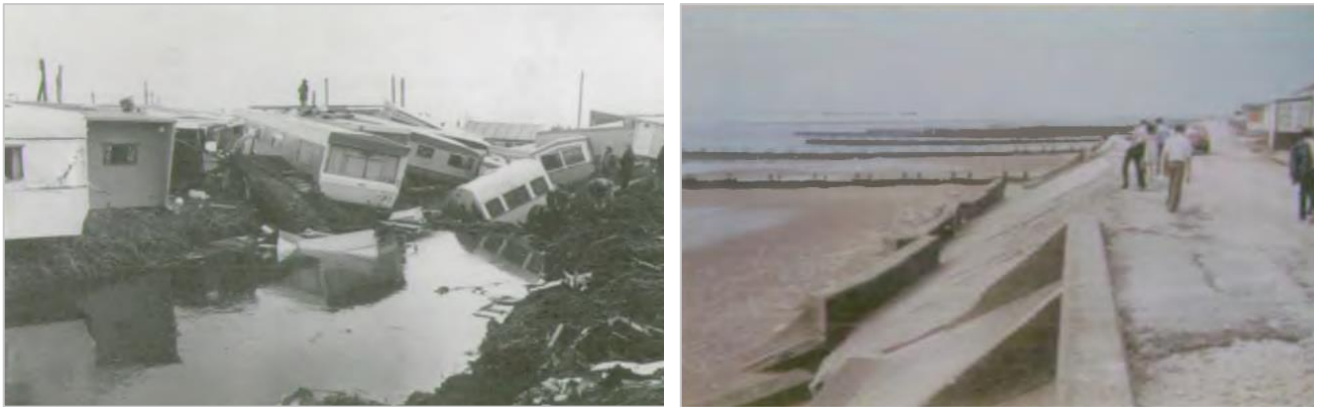
Figure A-19 Damage caused by breach of sea defences at Heacham in 1978. Source: Environment Agency (date unknown, but possibly 1998).

The coastline was hit by a further storm surge in January 1978. This resulted in higher water levels than during the 1953 storm in The Wash, due to funnelling on winds and waves onshore (Steers et al., 1979), and caused breaches in the shingle barrier south of Heacham and in the Heacham South wall (Figure A-19), and resulted in most of Hunstanton Pier being destroyed. This storm prompted further repair work, including an additional wave return wall added to the Hunstanton sea wall, at the front of the promenade at the north and at the rear of the promenade to the south (Royal HaskoningDHV, 2015) and construction of a stepped concrete seawall at Heacham in 1981/2. This seawall stopped just north of North Beach Heacham, but a report by HR Wallingford (1987) records that '*despite the installation of additional timber groynes, the shingle ridge continued to erode rapidly ... in February 1983, a freak surge tide caused severe erosion*'. This prompted the construction of a block revetment along the 418 m stretch of coast north of Jubilee Bridge, which was completed in June 1984.

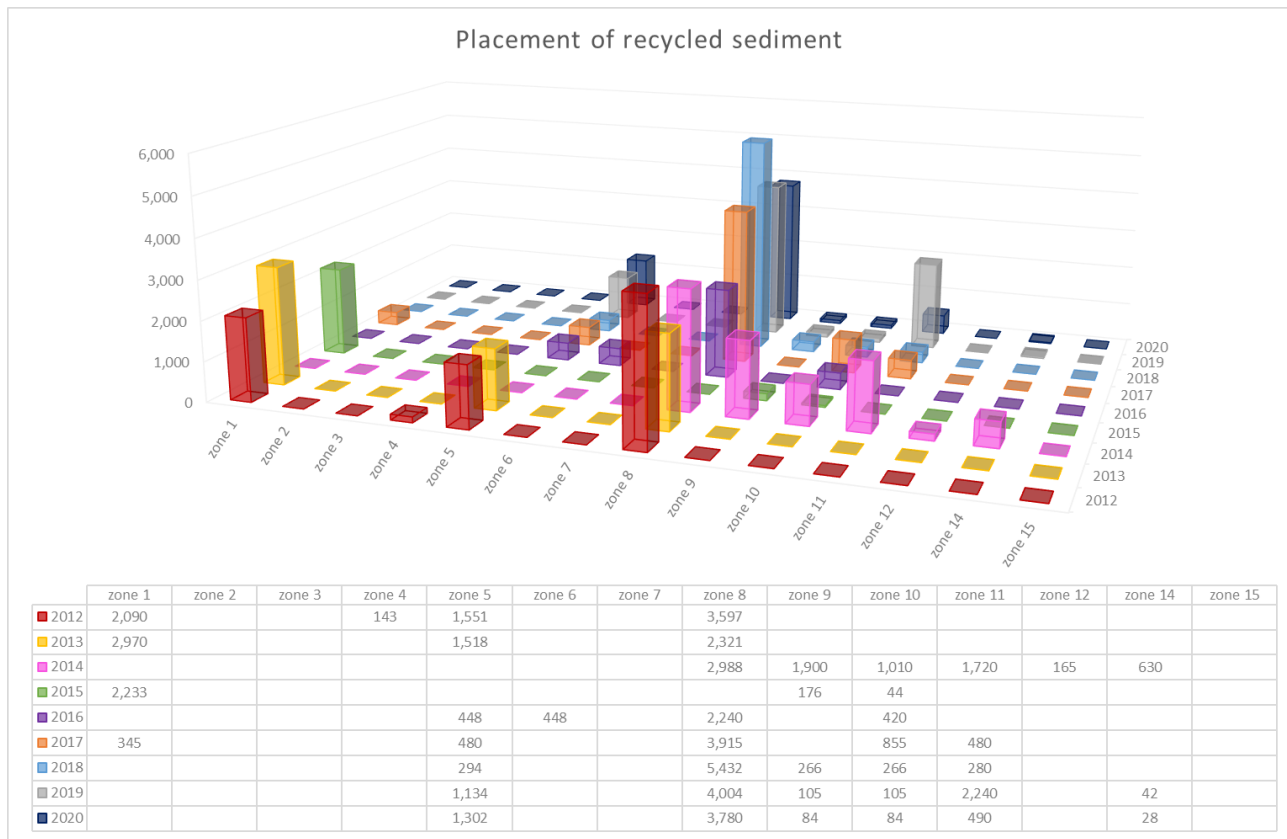
Figure A-20 Placement of recycled sediment since 2012, by year. Data extracted from Annual Beach Survey Monitoring Reports (e.g. Jacobs, 2021). Figure A-34 shows location of zones: Zone 1 starts at the Power Boat Ramp, with Zone 15 ending at Wolferton Creek.

The majority of material is extracted from Snettisham Scalp (in Zone 13), but placement, in terms of both volumes and location, varies slightly from year to year, as shown in Figure A-20. There have been two years where material has been taken from Zone 3, along the north Heacham frontage: 2009 and 2010. Placement tends to be in February/ March of each year, following a scheduled beach survey. The majority of the recycled sediment is placed to the south of the groyne frontage, but there have been a number of years when sediment has been placed in Zone 1, i.e. immediately south of the Power Boat Ramp, or just to the south of the groyne frontage in Zone 5.

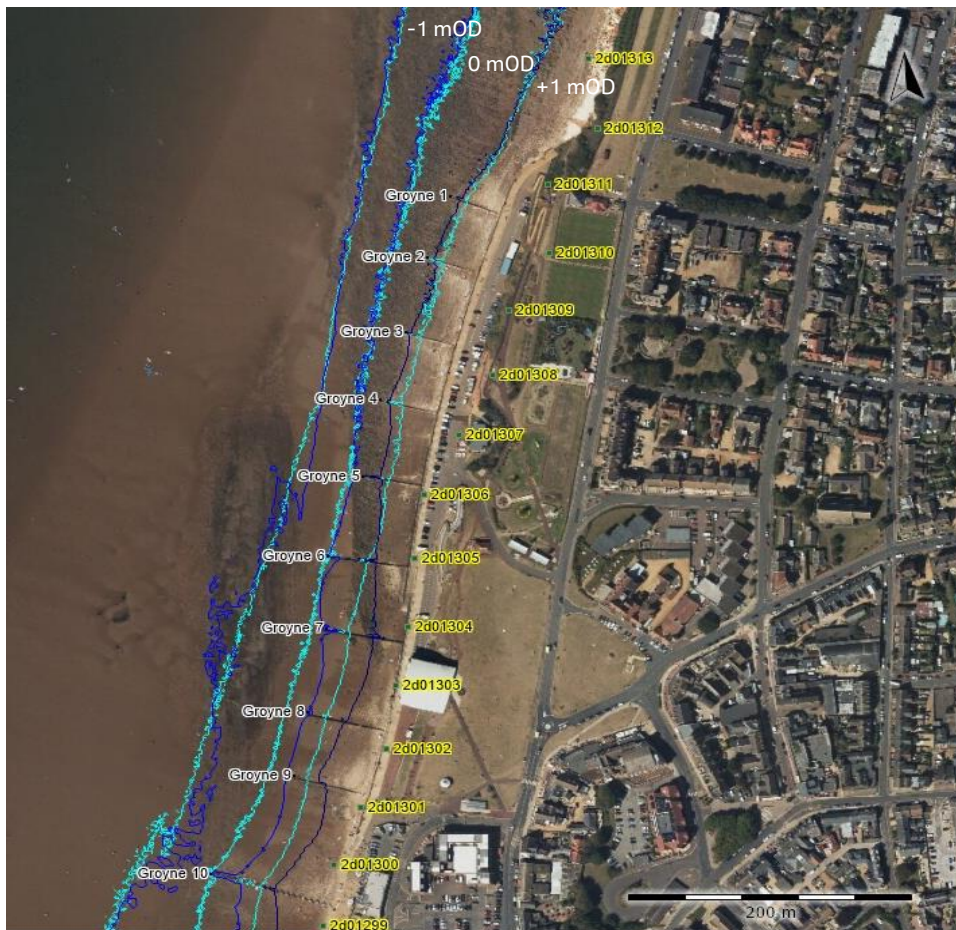
Figure A-25 BCKLWN concrete groyne frontage, with the position of the 0 mOD, +1 mOD and -1 mOD contours generated from 2012 (light blue) and 2020 (blue) LiDAR data. Also shown are the beach transect locations.

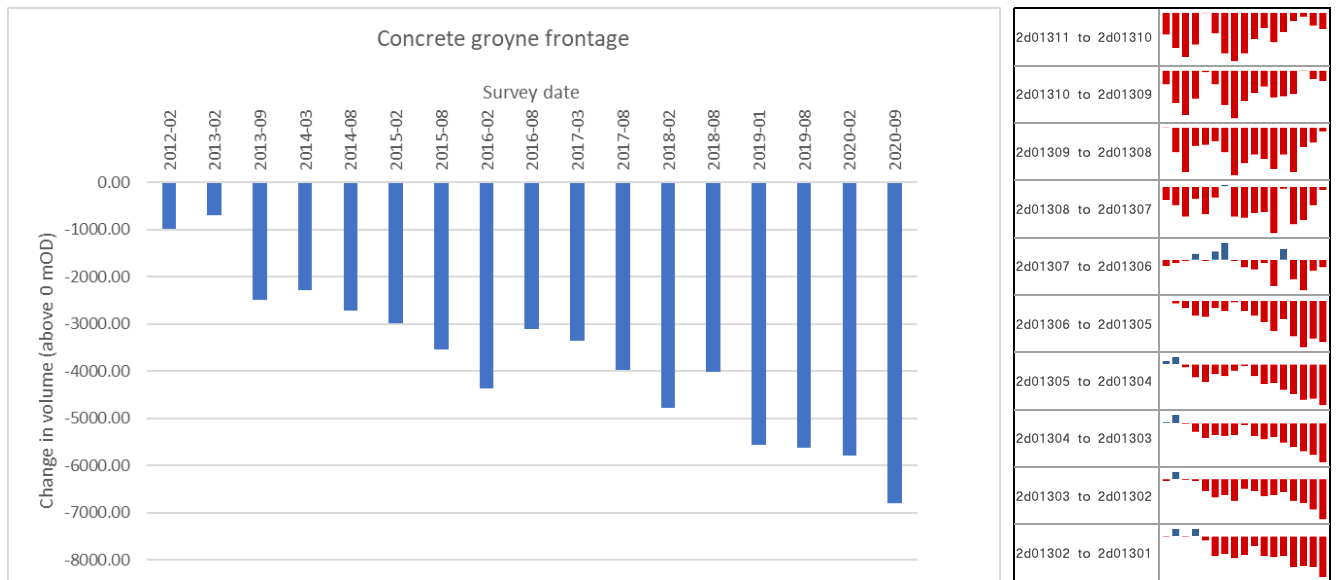
Figure A-28 Change in calculated beach volume above 0 mOD, along the concrete groyne frontage relative to September 2011. The sparklines to the right illustrate the same data for each set of beach transects, moving from north to south.

A simple calculation of 'beach' volume above 0 mOD has been undertaken using a function within SANDS; this calculates a cross-section area for each transect and extrapolates between adjacent transects to derive an estimated volume. It should be noted that this does not equate to the actual volume of mobile sediment on the beach, as no assessment has been made of the underlying bed level. Figure A-28 illustrates this data and shows the change in calculated volume relative to the earliest common survey date of September 2011; also shown are sparklines illustrating the relative change between each transect.

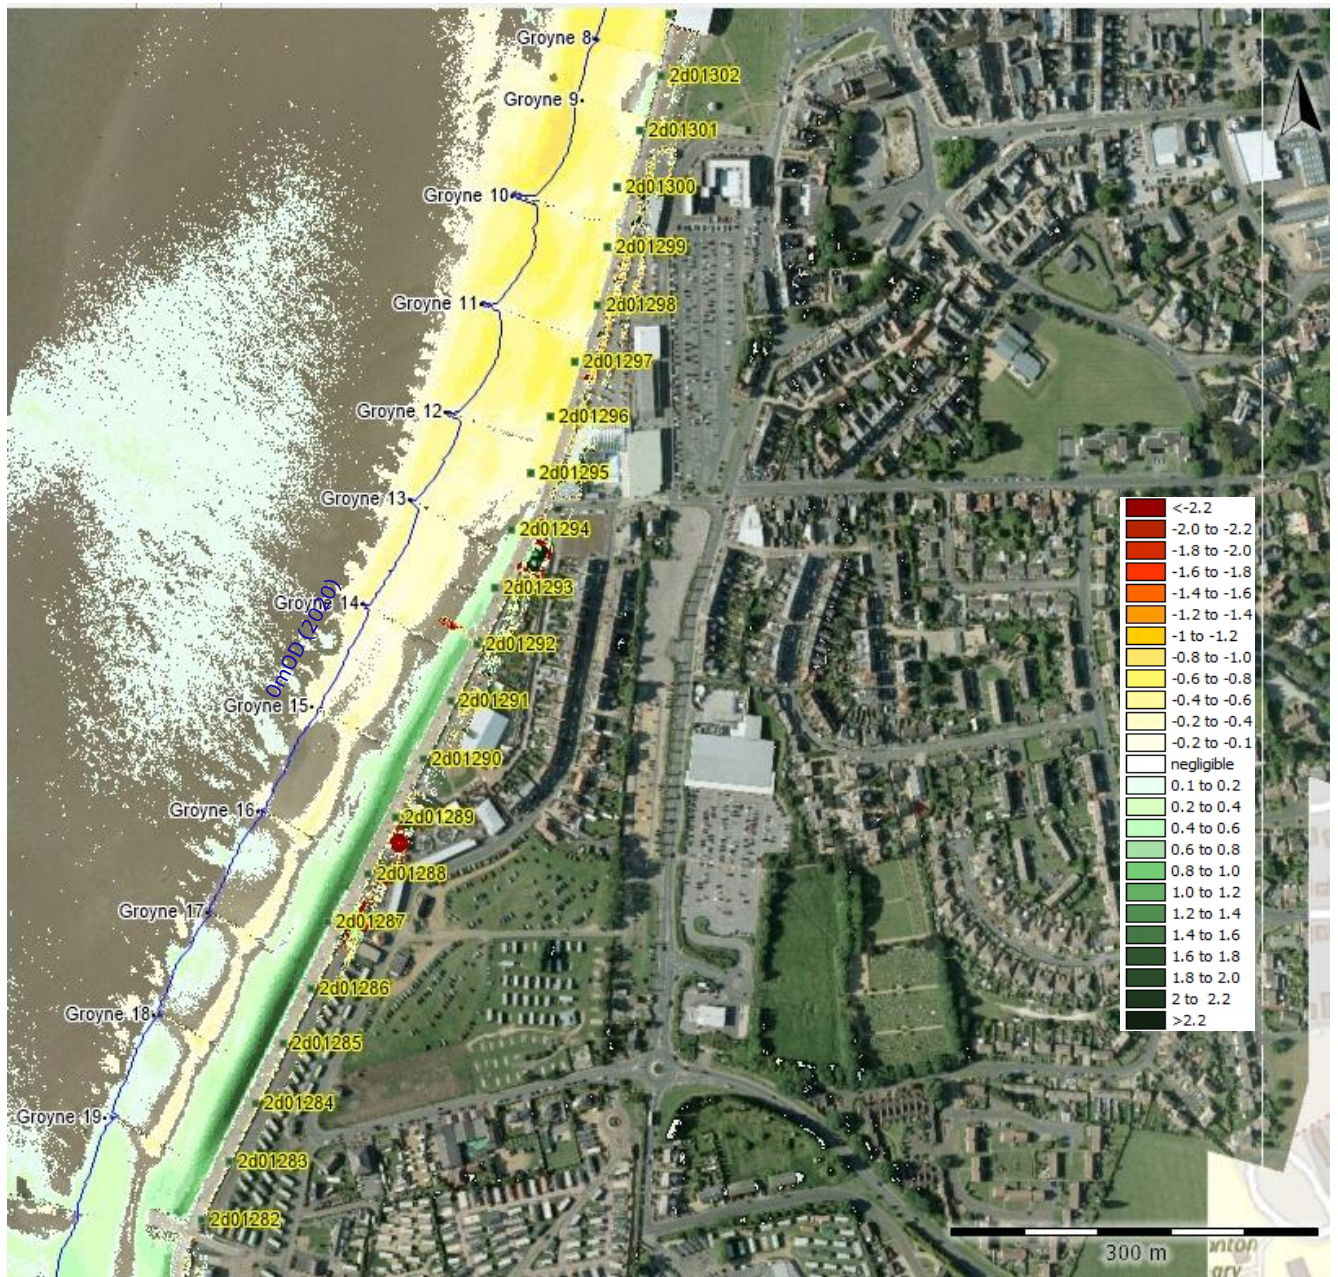
Figure A-31 Difference plot for the BCKLWN timber groyne frontage, generated from LiDAR data from 2020 and 2011, with change in beach level in m. (data courtesy of ACM). Negative values (green) mean that there has been a drop in level in 2020, and positive values (red and yellow) indicate an increase in level.

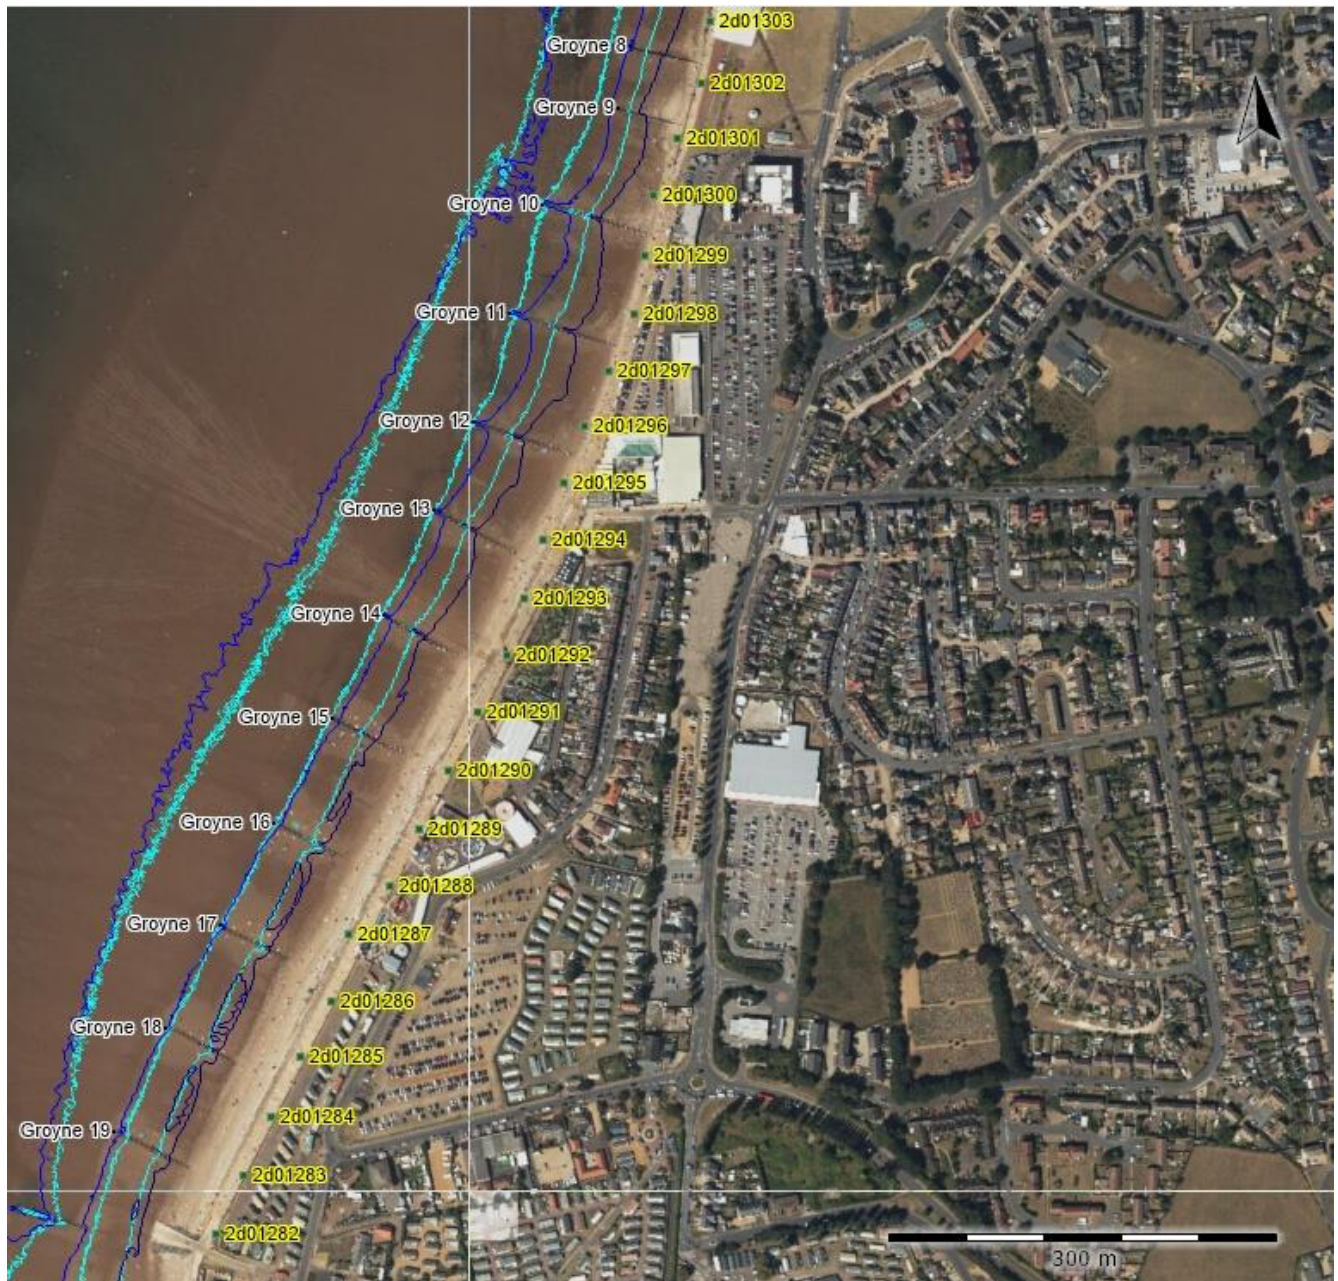
Figure A-32 BCKLWN timber groynes frontage, with the position of the +1 mOD, 0 mOD and -1 mOD contours generated from 2012 (light blue) and 2020 (blue) LiDAR data. Also shown are the beach transect locations. 2020 aerial image courtesy of ACM.

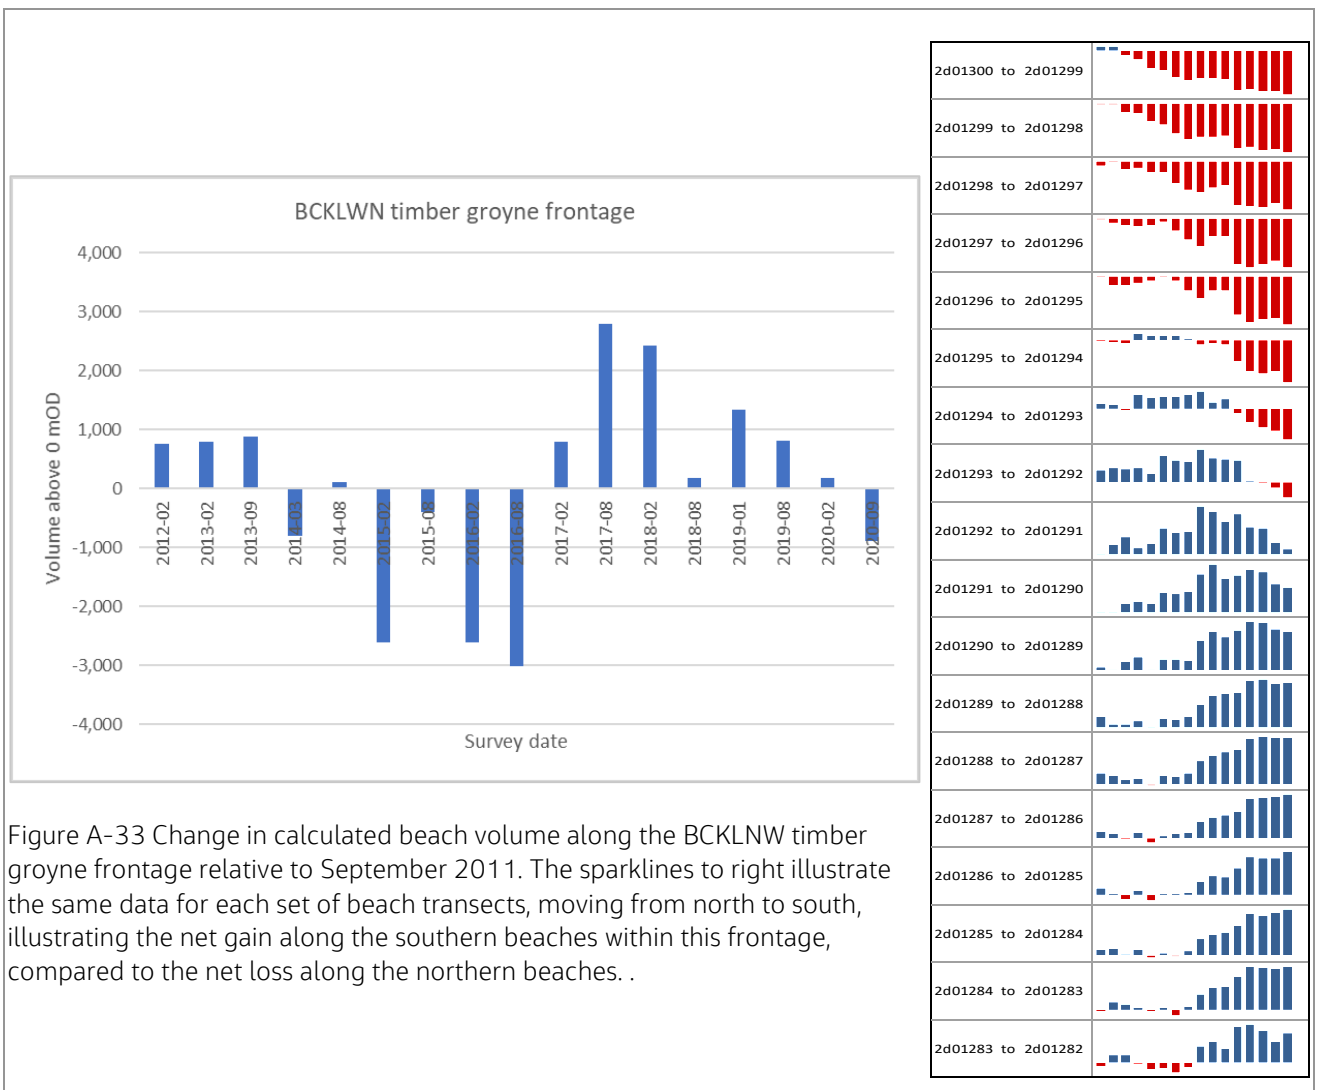
Figure A-33 Change in calculated beach volume along the BCKLWN timber groyne frontage relative to September 2011. The sparklines to right illustrate the same data for each set of beach transects, moving from north to south, illustrating the net gain along the southern beaches within this frontage, compared to the net loss along the northern beaches. .

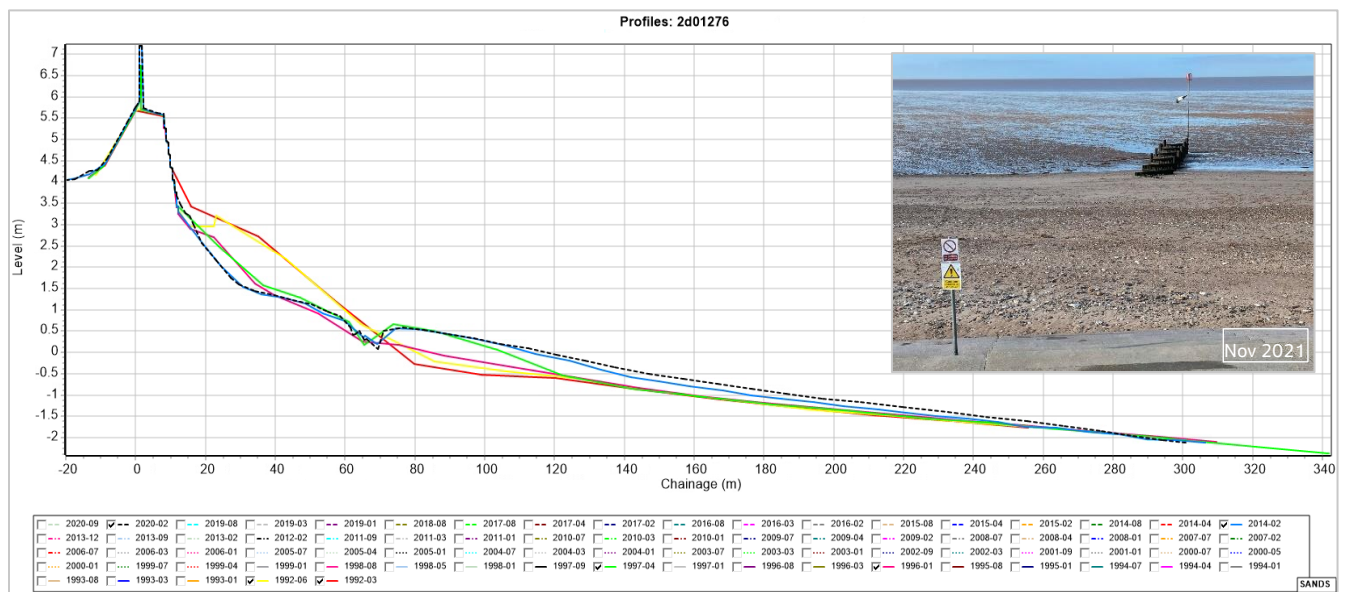
Figure A-37 Typical changes in beach shape along the EA timber groyne frontage: Zone 1 (Groyne EA3). Selected beach survey dates shown: Feb 2020 (black dashed), Feb 2014 (blue), April 1997 (green), June 1992 (yellow) and Mar 1992 (red).

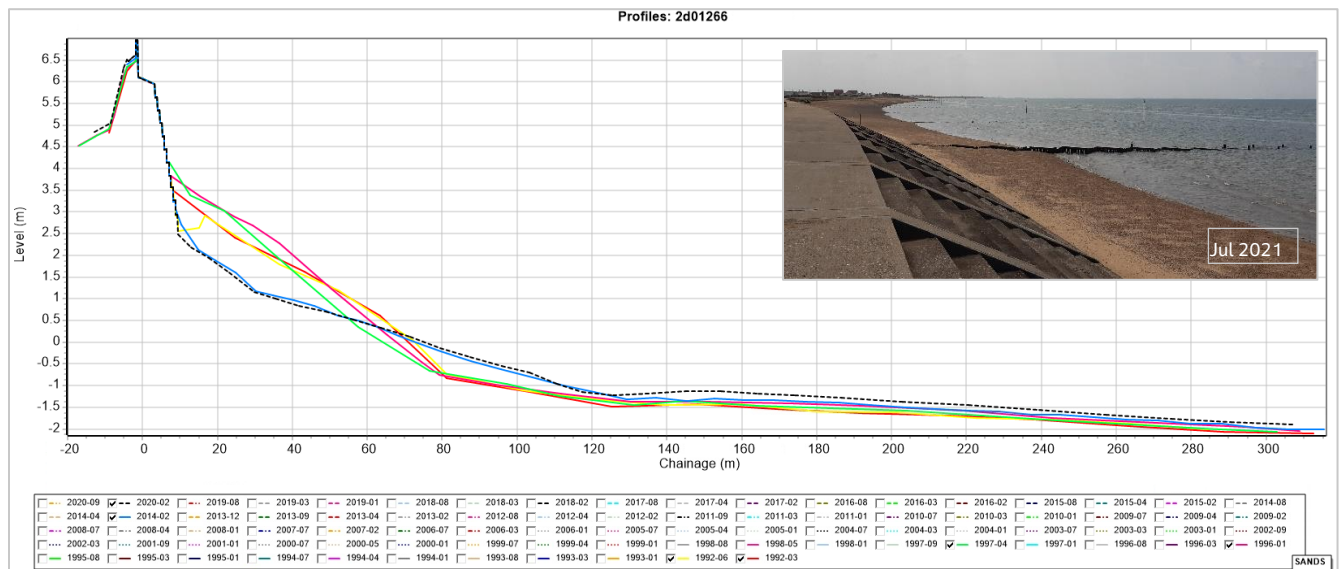
Figure A-38 Typical changes along the EA timber groyne frontage: Zone 2 (Groyne EA10). Selected beach surveys dates shown: Feb 20 (black dashed), Feb 14 (blue), April 97 (green), June 92 (yellow) and Mar 92 (red).

Figure A-38 shows typical observed changes, which illustrate the change in beach profile shape. There was a drop in upper beach levels (above MSL) from around 1997 and since this time levels have tended to fluctuate within a fairly small margin. As observed in Zone 1, the upper beach has narrowed and steepened over time; this represents the coarser mixed sediments which are constrained to the top of the beach. In contrast there has been accretion of the lower sandy beach. The loss of upper beach material is also shown by the increasing exposure of groynes captured by aerial photographs (Figure A-39). It is not thought that this frontage has received any direct nourishment from recycling.

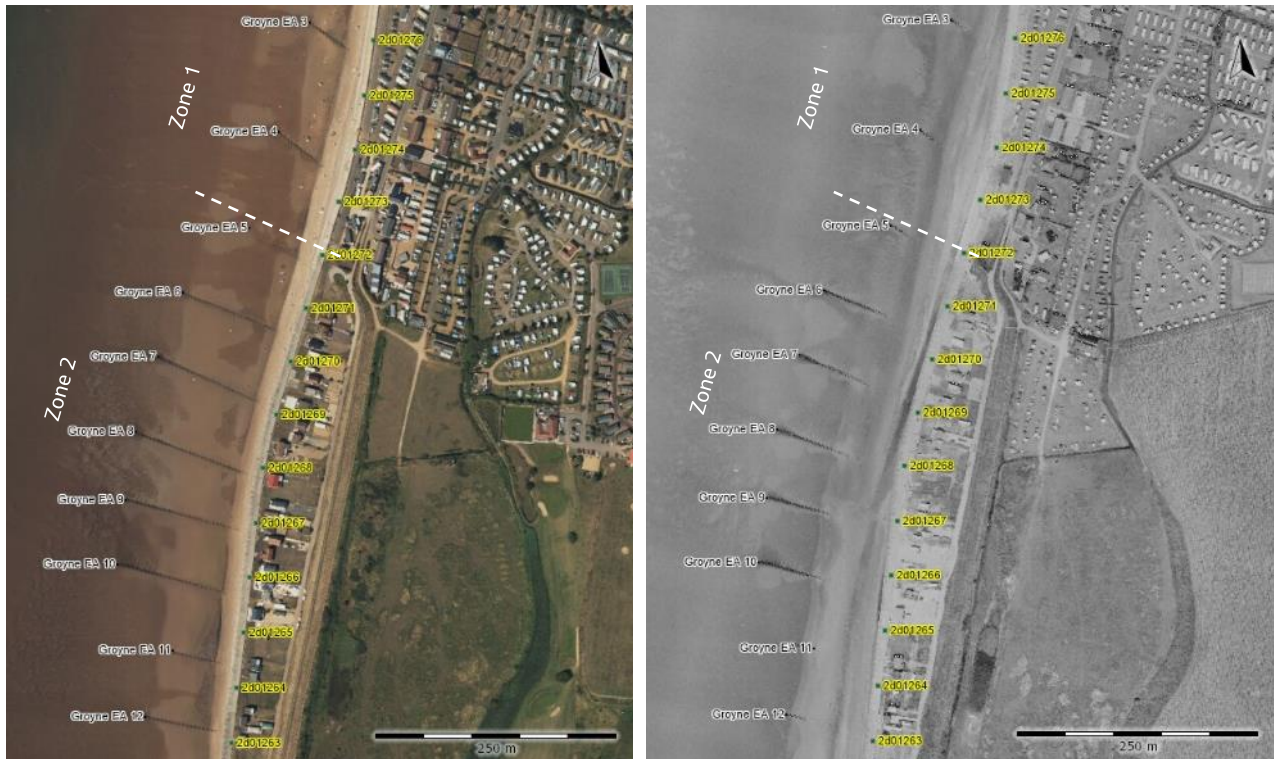
Figure A-39 Change in groyne exposure illustrating the change in the upper beach over time: left is 2020, right is 1992. Aerial images courtesy of ACM.

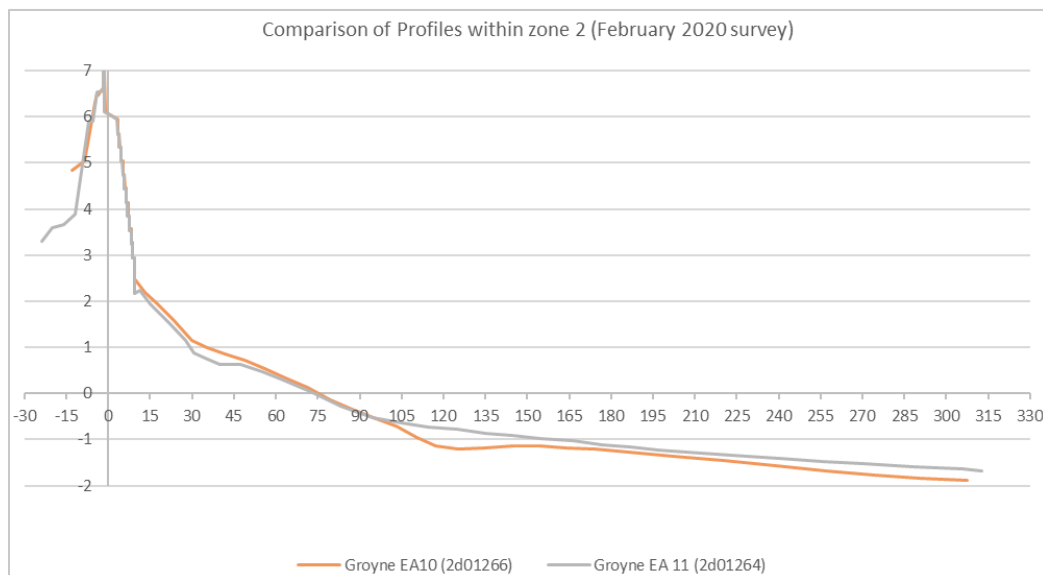
Figure A-40 Comparison of profiles along the longer groyne frontage (represented by Groyne EA10) and the shorter groyne frontage (represented by Groyne EA11) within Zone 2.

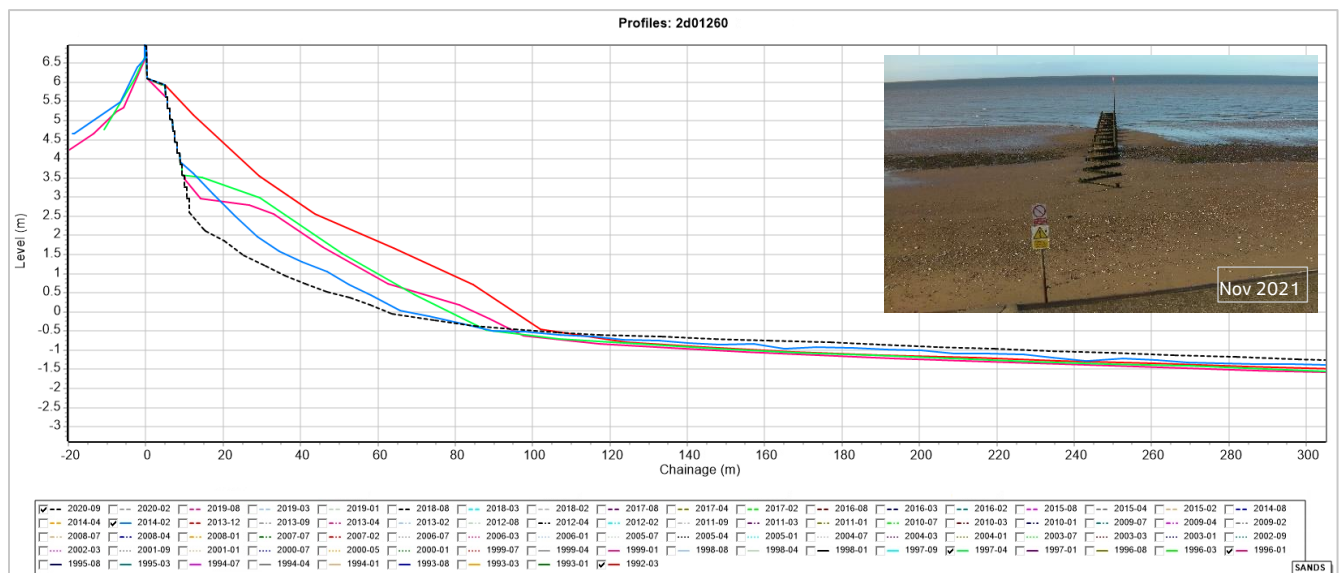
Figure A-41 Changes along the EA timber groyne frontage: northern part of Zone 3 (Groyne EA15). Selected beach surveys dates shown: Sept 20 (black dashed), Feb 14 (blue), April 97 (green), June 92 (yellow) and Mar 92 (red).

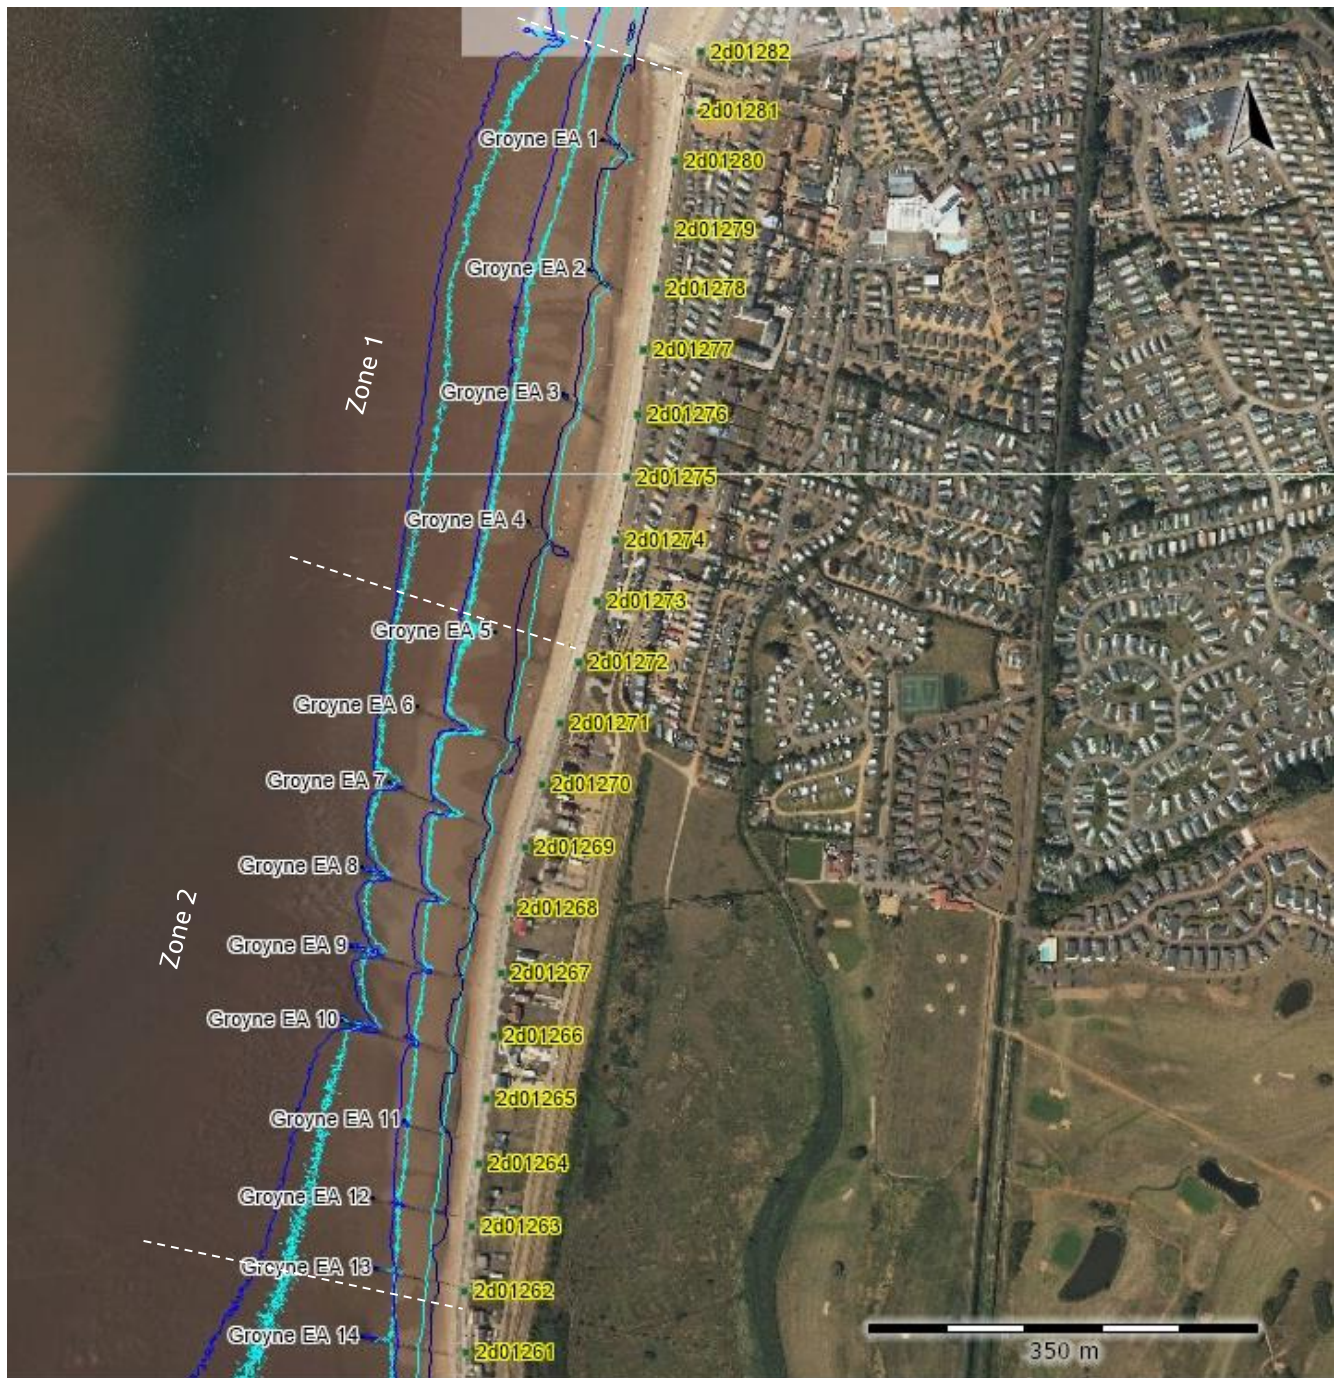
Figure A-44 Environment Agency timber groyne frontage Zones 1 and 2, with the position of the 0 mOD, +1 mOD and -1 mOD contours generated from 2012 (light blue) and 2020 (blue) LiDAR data. Also shown are the beach transect locations. 2020 aerial image courtesy of ACM.
