THE WASH EAST COASTAL MANAGEMENT STRATEGY STAKEHOLDERS FORUM

**Minutes of the Meeting of the above held on Tuesday, 18th October, 2022
at 1.00 pm in the Offices at Valentine Road, Hunstanton and also as a Microsoft
Teams Meeting**

Jacobs Groyne Effectiveness Report

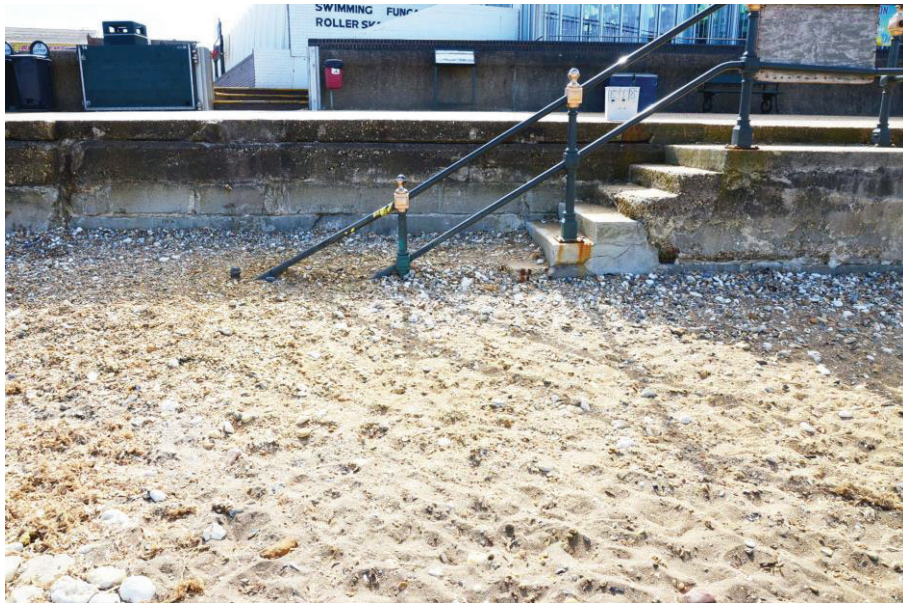
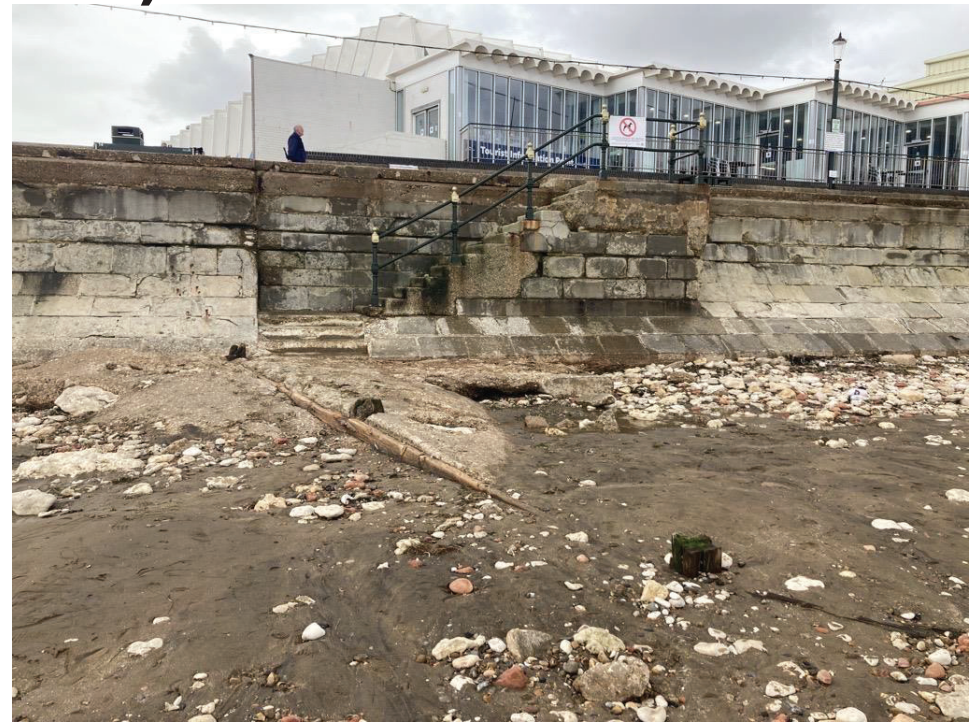
Section E (2017 vs 2022)

March 2017

September 2022

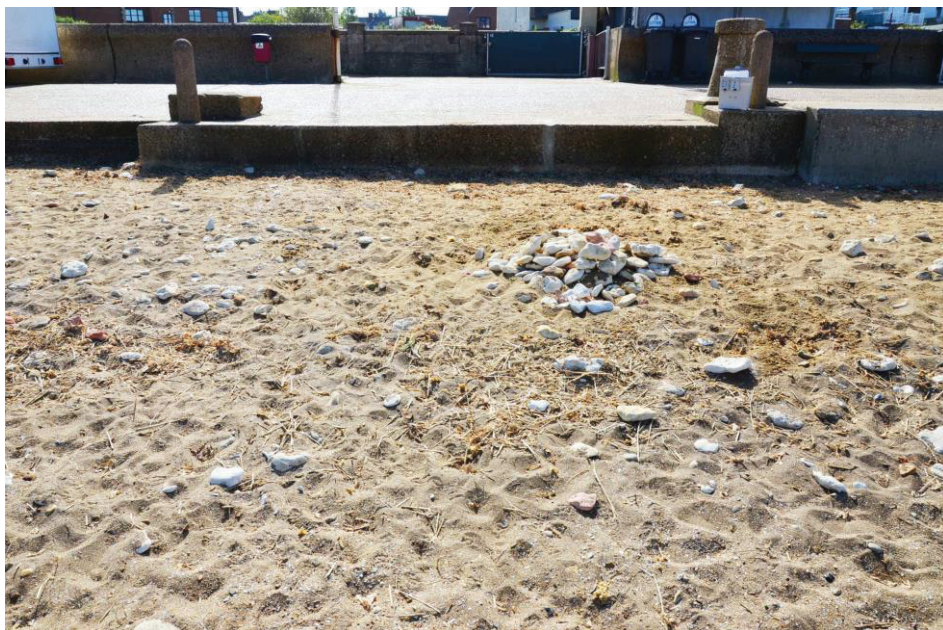
Section D (2017 vs 2022)

March 2017

September 2022

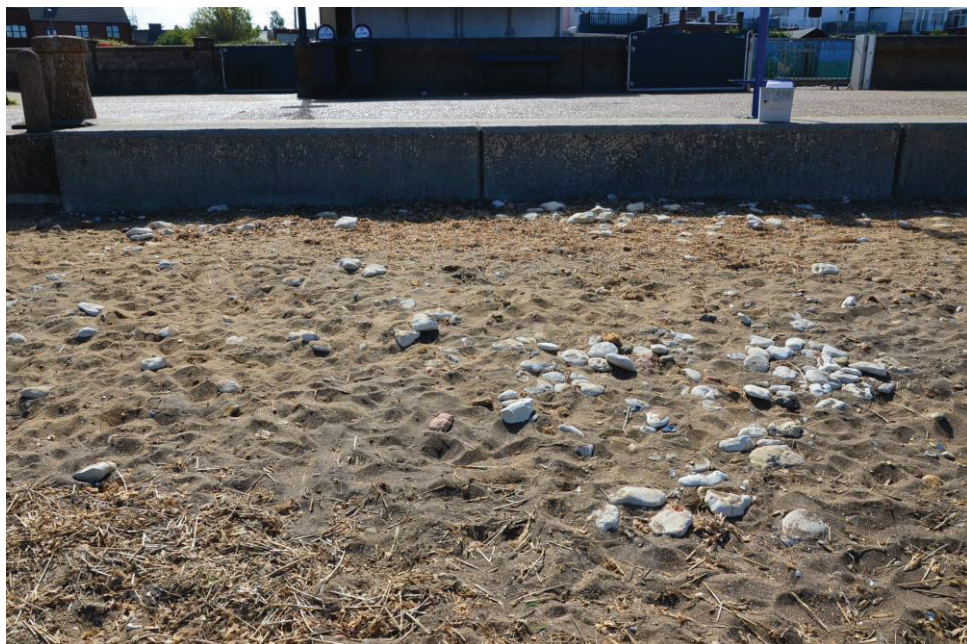
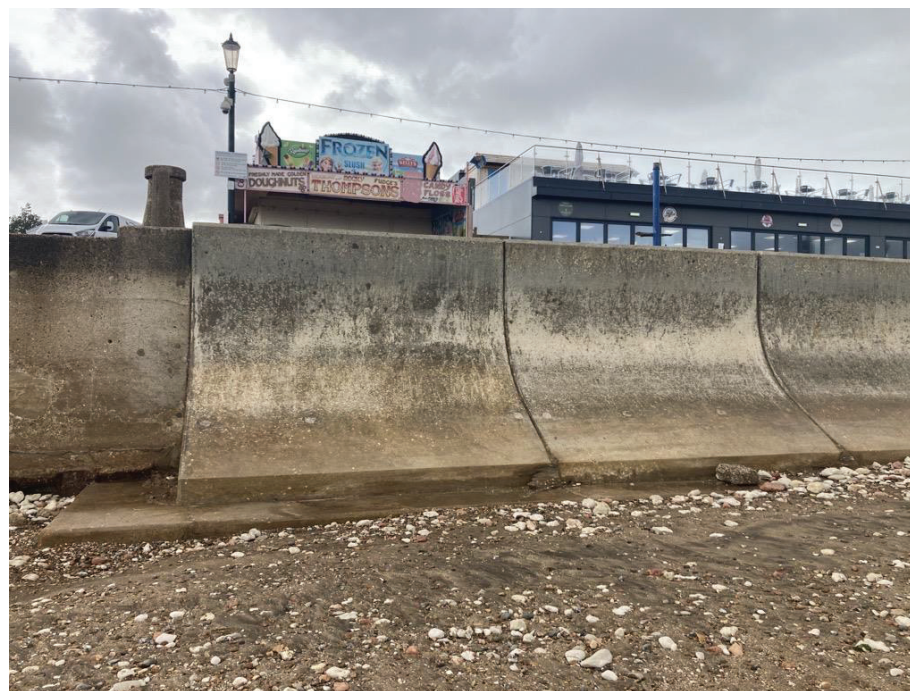
Section C (2017 vs 2022)

March 2017

September 2022

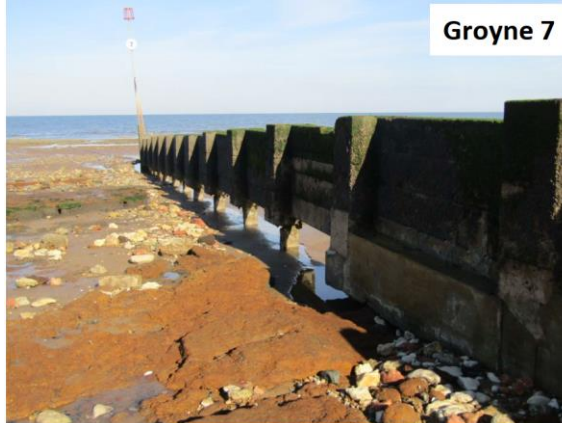
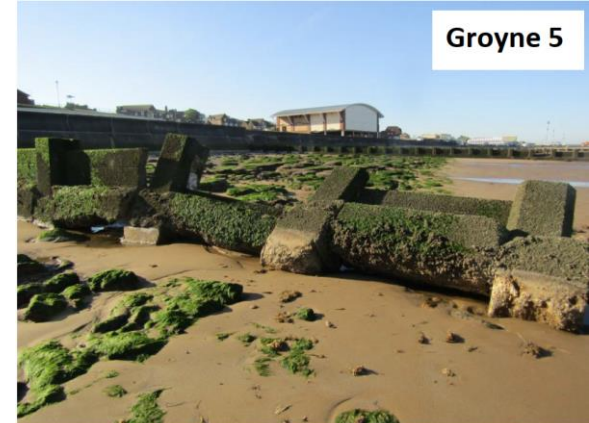
- Concrete – unusual material choice
- Condition 'Poor' to 'Very Poor' throughout
- Missing planks etc but main structural issue is due to beach lowering below design levels, and abrasion

Groyne 4

Groyne 7

Groyne 5

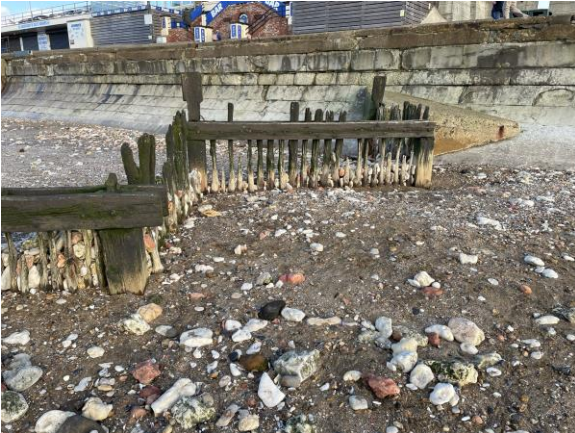
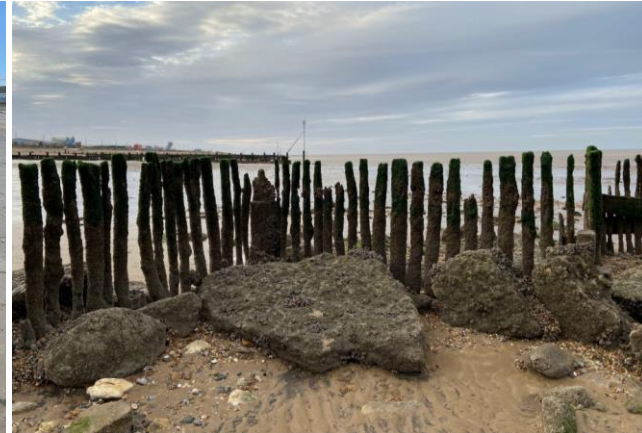
- Permeable timber structures
- Condition 'Poor' to 'Very Poor' throughout
- Main structural issue is due to beach lowering and abrasion
- Rock has been added in places

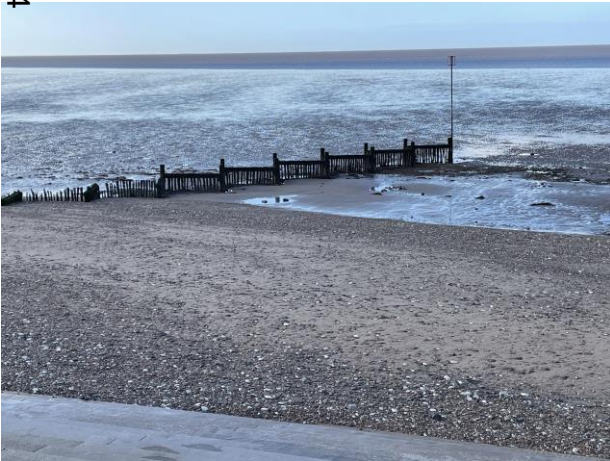
- Same design as those on Hunstanton town frontage
- Condition similarly 'Poor' to 'Very Poor' throughout
- More sand (in places) – but this frontage is also recharged annually
