### Appendix B Non-Designated Heritage Assets

**B.2** Non-Designated Heritage Assets: Gayton

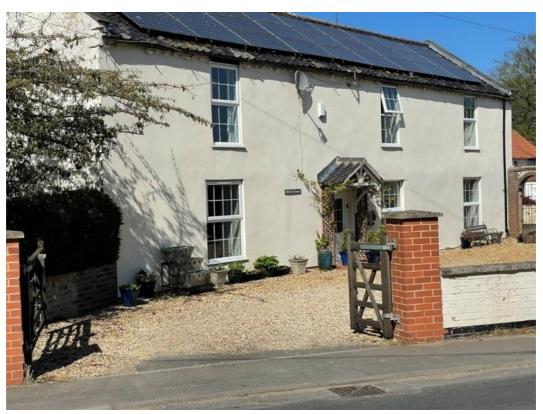
Figure 41: Mill End House, Lynn Rd -B1145/Grimston Rd -B1153

**Description:** White Norfolk brick, flint and chalk property with pantile roof, circa 1840-1914 **Significance:** Of local historic interest and association. Having a valued past life and association with the once thriving Milling industry in Gayton.

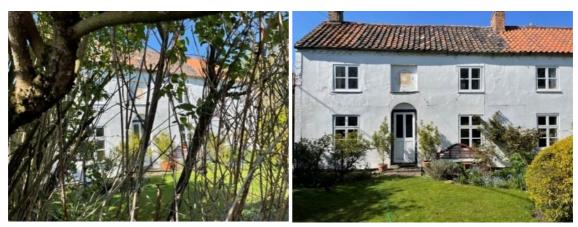
Figure 42: Rose Cottage, Lynn Road/Orchard Rd, circa 1820-1840.

**Description:** Lime washed brick, flint and chalk property with Norfolk pantile roof and surrounding flint wall.

**Significance:** In a landmark position and of architectural and aesthetic value being a distinctive looking cottage with large Tudor Rose painted emblem in red and blue on front facing wall.

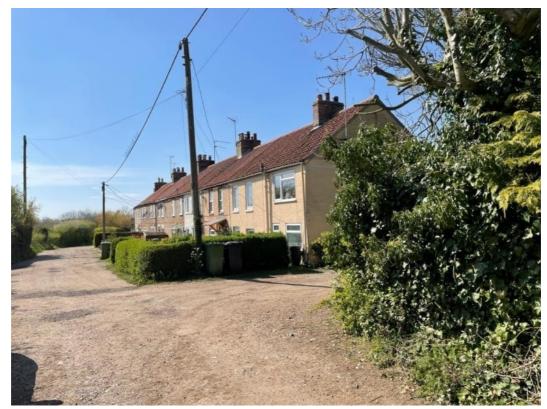
Figure 43: Ebenezer Cottages. Lime Kiln Rd, circa 1840-1914

**Description:** Row of workers cottages built of brick and flint with Norfolk pantile roofs.

**Significance:** Of local interest due to having a valued past life as housing for the workers at the lime/chalk quarry.

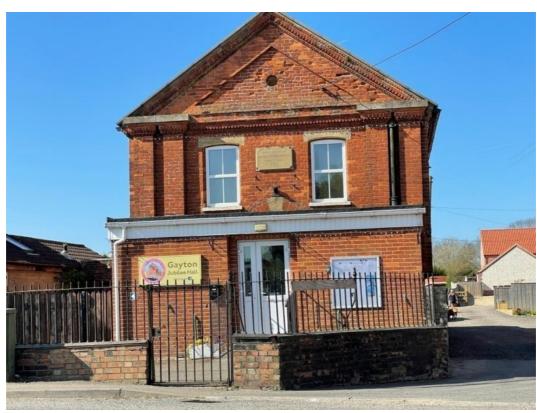
Figure 44: Jubilee Hall, Lynn Rd, circa late 1800's

**Description:** Gayton Village Hall former 'Friends in Need Lodge,' built late 1800's, (stone inset 1887) red brick with slate roof. Front and rear amenity additions made 1900's. Sited on corner of Lynn Rd/B1145 and Jubilee Lane.

**Significance:** A building of local historic interest and association that is reasonably unaltered and the style, form and construction of the building is easily identifiable.

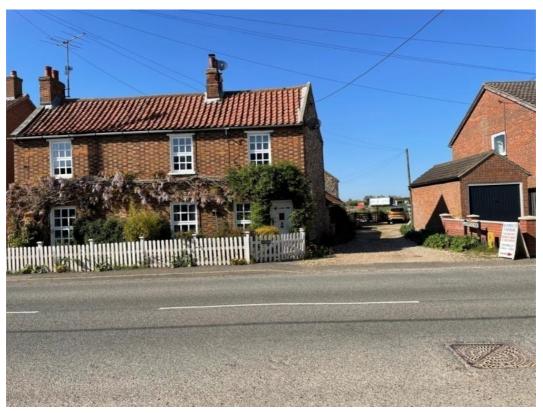
Figure 45: The Old Smithy, Lynn Road and Blacksmiths Row, circa mid 1800's

**Description:** Red brick triple fronted house with pantile roof and clapboard fencing to front. Side elevations are of flint construction. Property originally three separate one down—one up cottages with a stable and blacksmiths attached to the cottage bordering Blacksmiths Row. Older parts of property are judged to have been built around 1800.

**Significance:** Of local historic interest and association. The building is largely unaltered and its style, form and construction is easily identifiable.

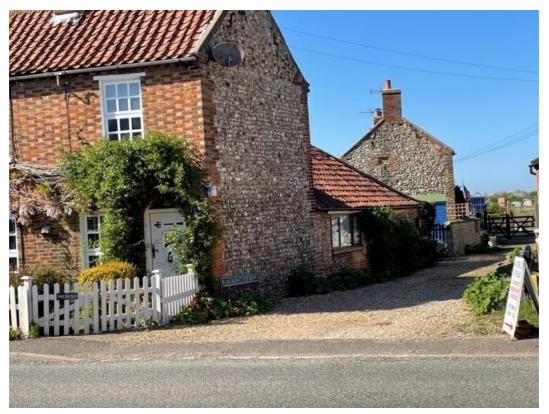
Figure 46: Row of Classic Terraced Cottages at Blacksmiths Row and at rear of The Old Smithy, circa mid 1800's **Description:** Red brick and Flint construction with pantile roofs.

**Significance:** Of local historic interest and association. A surviving row of workers cottages overlooking a chalk-built outhouse and horse paddock. The form and construction of the buildings is easily identifiable.

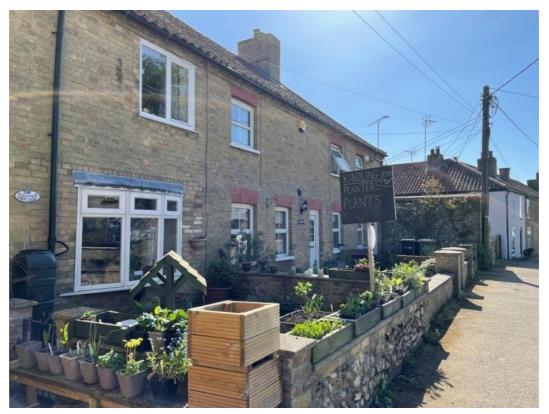
Figure 47: Row of Classic Terraced Cottages, Lynn Road, circa late 1800's. Situated opposite the Old Doctors house dated 1880.

**Description:** 'The Cottage'/'Mabeldene' etc Yellow brick built construction with red brick decoration and pantile roofs.

**Significance:** Of local historic interest. Formerly known locally as 'Robert Hill Cottages' sited along the south boundary of Lynn Road. The cottages are largely unaltered and the style, form and construction is easily identifiable.

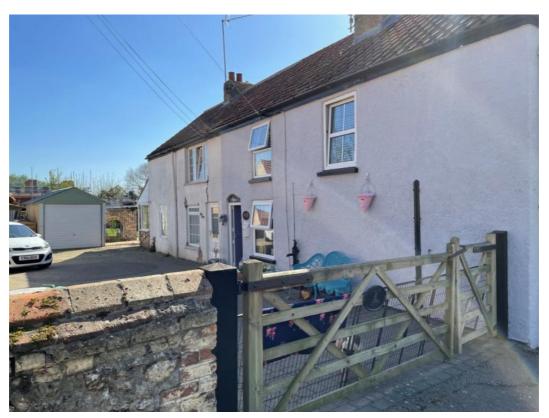
Figure 48: Pump Yard, Lynn Road, circa late 1700's

**Description:** Modern render covered brick and clunch cottage (appears to be several cottages now forming one residence) with pantile roof. Side facing Lynn Road.

**Significance:** Of local historic interest and association. Was known to be a watering hole and wash house for the drovers who would stop here before taking their sheep through the attached land, across to Back Street on the south side of Gayton village. The building is largely unaltered, except for an extension to the rear and the style and form is easily identifiable.

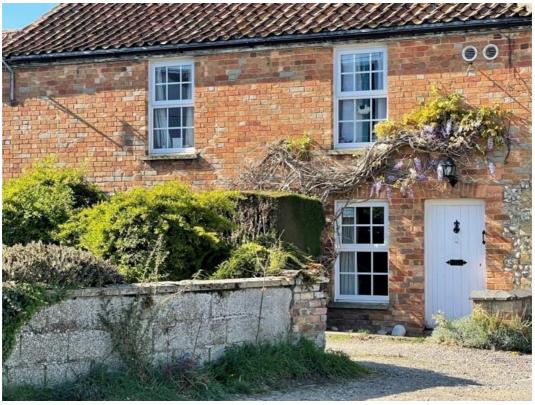
Figure 49: Pelham House, Winch Road, circa 1800's

**Description:** Red brick dwelling with flint and brick gable ends, pantile roof and rear extension. Side facing onto Winch Road

**Significance:** Of local historic interest. It is a vernacular house contributing to the character of the northern end of Winch Road.

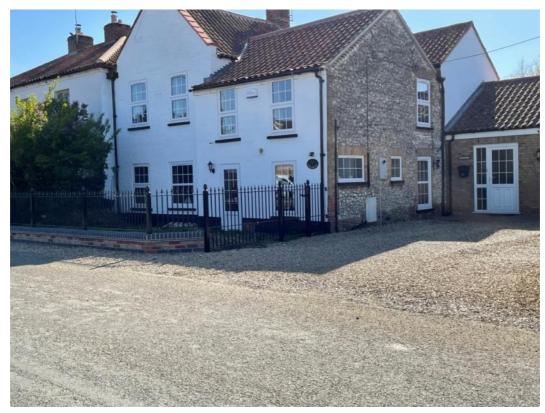
Figure 50: Oakdene, Winch Road, circa mid to late 1800's

**Description:** Brick, chalk and flint dwelling, with pantile roof and several extensions, recently renovated.

**Significance:** Of local historic interest. It is a vernacular house contributing to the character of Winch Road.

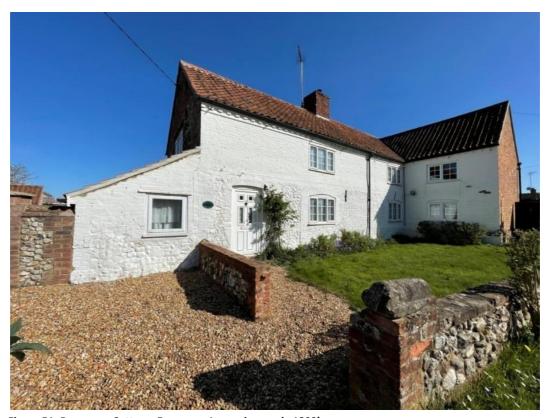
Figure 51: Rosemary Cottage, Rosemary Lane, circa early 1800's

**Description:** Built of brick, chalk and flint with gable ends mainly of carrstone, with pantile roof and side extensions.

**Significance:** Of local historic interest and association. It is a vernacular house that is reasonably unaltered and the style, form and construction of the building is easily identifiable.

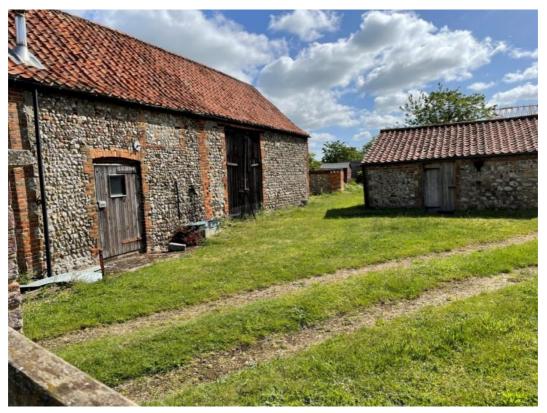
Figure 52: Barns to Rosemary Cottage, Rosemary Lane, circa early 1800's

**Description:** Both barns are built of chalk and flint with brick inclusions. Pantile roofs, oak doors and frames.

**Significance:** Of local historic interest and association. They are good examples of smallholders Barns, once common in the area. The style, form and construction of the buildings is easily identifiable.

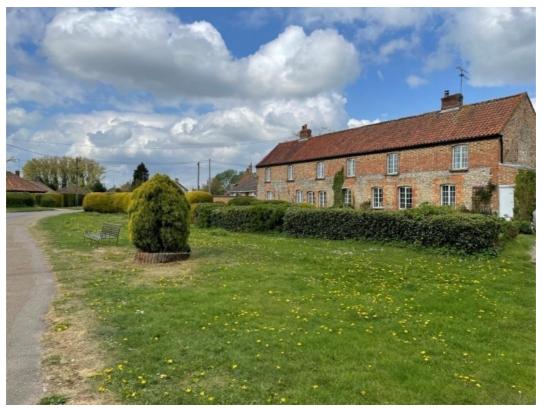
Figure 53: Church Cottages, Back Street circa late 1800's

**Description:** Red brick and flint built terrace of workers cottages with pantile roof and later additions of small extensions to side and rear.

**Significance:** Of local historic interest and association. It is the only example of a terrace of workers cottages fronting Back Street, which once would have been common in Gayton. The style, form and construction of the buildings is easily identifiable.

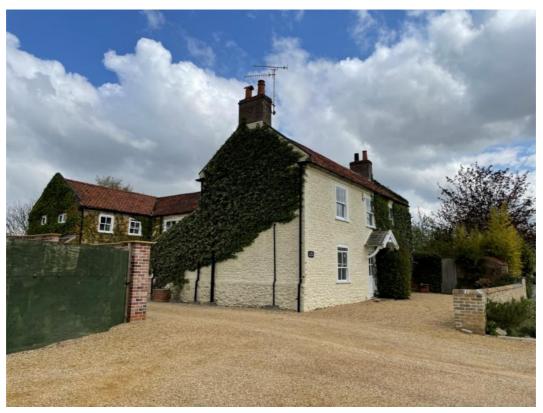
Figure 54: Manor Farmhouse, Back Street late 1700's - 1800

**Description:** The frontage is mostly chalk lump (clunch in the vernacular) with the single storey northern end being flint outside and chalk inside. The smaller barn to the west is carrstone and brick and is thought to be the oldest building on the site. The whole house and barn were fully renovated in 2000 with UPVC sash windows replaced with timber, original buff pantiles sourced and used and chalk walls in what is now the drawing room, renovated solely with existing materials from the site. A further significant extension was added in 2005.

**Significance:** Of local historic interest and association. It is a distinctive vernacular house, in a prominent landmark position, contributing to the rural community of Back Street. The style, form and construction of the building is easily identifiable.

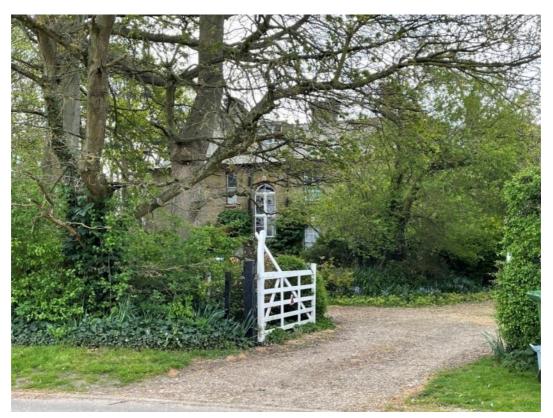
Figure 55: The Old Vicarage, Vicarage Lane, Lynn Road circa 1800's

**Description:** Former vicarage, built from yellow brick with slate roof and architecturally distinctive double height front facing window. The property is now a private dwelling.

**Significance:** Of local historic interest and association and can be identified as a Landmark. The building appears largely unaltered and the style, form and construction of the building is easily identifiable.

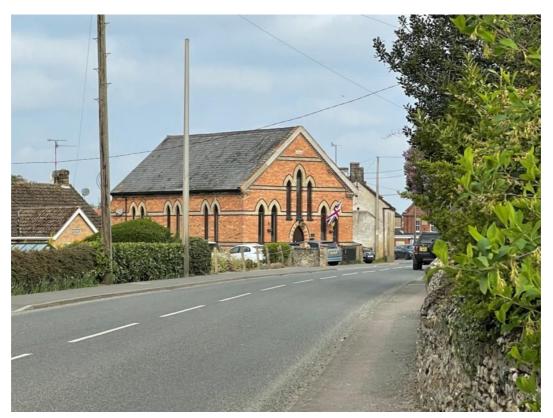
Figure 56: The Old Chapel, Lynn Road circa 1870

**Description:** Former Primitive Methodist Chapel built from red brick with distinctive yellow brick decoration around the arched windows and slate roof. It was extended in 1883. The Chapel was sold in 2015 and converted to a private dwelling.

**Significance:** A building of local historic interest and association that is reasonably unaltered and the style, form and construction of the building is easily identifiable. The property sits in a landmark position and can be seen by all who travel along the B1145.

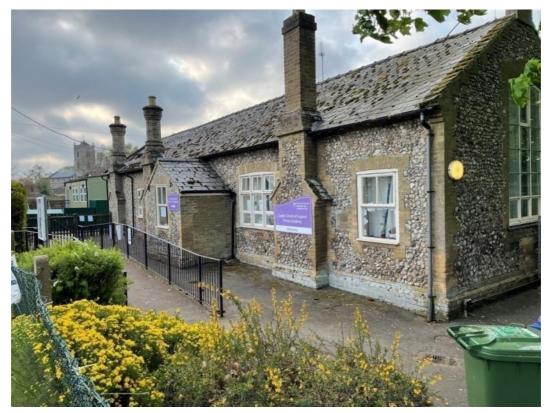
Figure 57: Gayton Church of England Primary Academy, Lynn Road, circa 1800's

**Description:** Brick and flint built main body of school with slate roof tiles. Distinctive single storey height building, with front porch and three tall chimney stacks. To the side and rear of main school are several nondescript portacabin buildings providing for overspill.

**Significance:** The current main School is considered a Landmark building and of architectural and aesthetic value whilst also being of local historic interest and association. The style, form and construction of the building is easily identifiable.

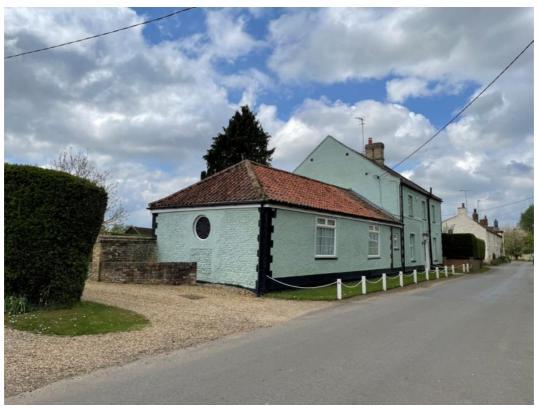
Figure 58: Lattice House, Back Street, circa 1750

**Description:** Main body is brick built and render, gable ends are flint and render, possible sub level in chalk and flint. The oldest part of the building is single storey, circa 1750 and had been a Chapel. The dwelling is now privately owned but historically was one of several Public Houses along Back Street.

**Significance:** Of local historic interest and association. It is a distinctive vernacular house contributing to the rural community of Back Street. The style form and construction of the building is easily identifiable.

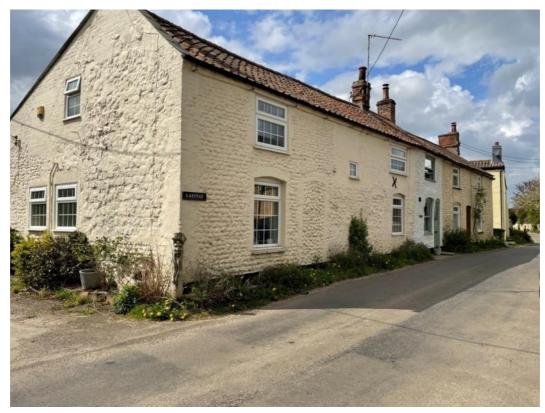
Figure 59: Latitat Cottage to Sunshine Cottage, Back Street circa 1800's

**Description:** Built of chalk and flint with brick additions and pantile roofs. Row of properties directly abut the road. Possible workers' cottages at one time. Sunshine Cottage circa 1700's is mainly render faced with later brick-built additions with modern windows to rear.

**Significance:** Of local historic interest. Although altered in parts, ie. entrances removed, extension added, the façade of the buildings remains attractive and its distinctive vernacular contributes to the rural setting of Back Street. The style, form and construction of the buildings is easily identifiable.

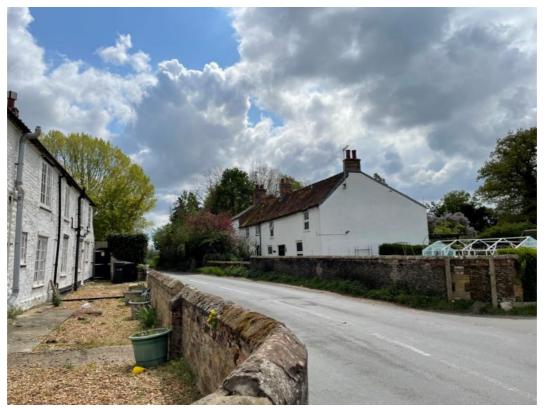
Figure 60: Cluster of Estate Cottages, East Walton Road and Back Street circa mid 1800's (B1153)

**Description:** White rendered brick and chalk dwellings with pantile roofs. Later addition of brick extension to rear of properties.

**Significance:** Of local historic interest and association. The style, form and construction of the buildings is easily identifiable.

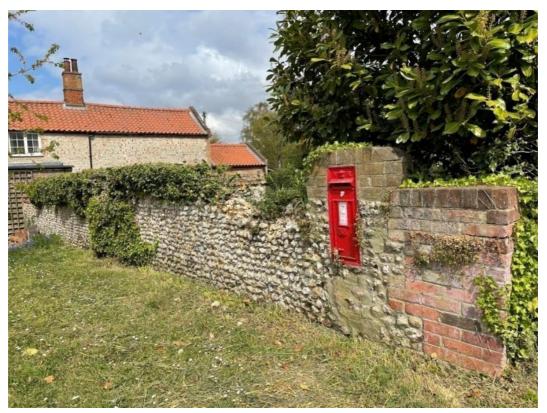
Figure 61: Antique Royal Mail Post Box inset into wall, junction of Lynn Road/B1145 and Grimston Road/B1153. Circa 1850's

**Description:** In service Royal Mail post box, with letters VR (Victoria Regina), signifying Queen Victoria was Monarch when it was installed.

**Significance:** Of local historic interest. A surviving working post box set into a boundary wall, easily identifiable by style, form, construction and colour.

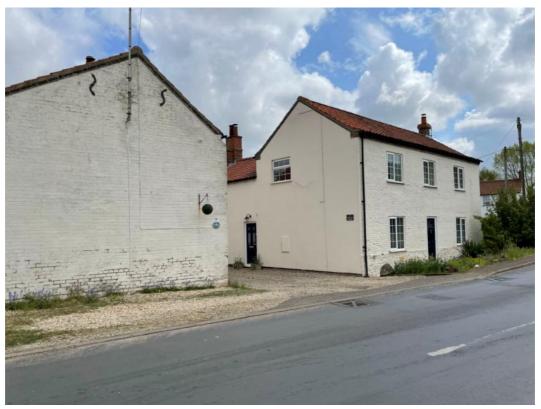
Figure 62: Mill End Cottages Numbers 1, 2 and 3, circa mid 1800's, Grimston Road

**Description:** Whitewashed brick and chalk construction artisan cottages, with pantile roofs and arranged around area of land to the rear.

**Significance:** Of local historic interest and association. The style, form and construction of the buildings is easily identifiable.

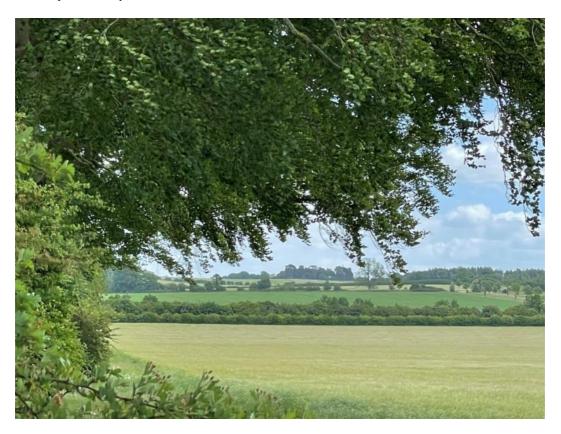
Figure 63: Gayton Clump, off Litcham Road (B1145)

**Description:** Rising open farm land and chalk-belt leads to the eastern side of Gayton where a copse of Scots Firs, known locally as Gayton Clump can be seen. Historically, the Gayton Clump has been used to set a beacon to celebrate jubilees.

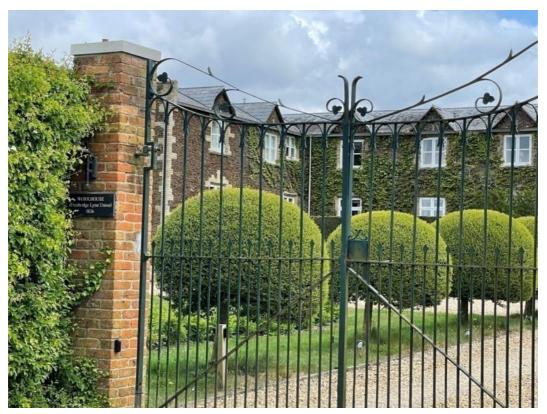
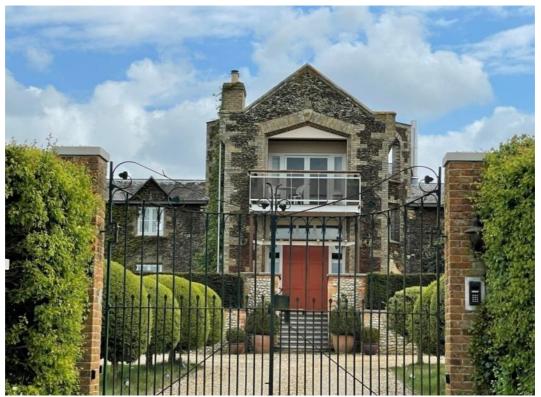
Figure 64: Eastgate House, Eastgate Drove, former Freebridge Lynn Union Workhouse, circa 1836, designed by Donthorne. North Wing.

**Description:** Substantial structure built of brick, carrstone and stone with slate tile roof, sited on an elevated position some miles from all community. Former Freebridge Lynn Union Workhouse. It later became an Old Peoples' Home 1948 – 1963. (Ref www.heritage.norfolk.gov.uk). The property is now privately owned and has been sympathetically remodelled and split into several homes.

**Significance:** Of local historic interest and association. It remains a good example of a building that had been a Workhouse. Although altered in parts with front extension and window additions, the façade of the building is attractive. The roof appears unaltered and the style, form and construction of the building is easily identifiable.

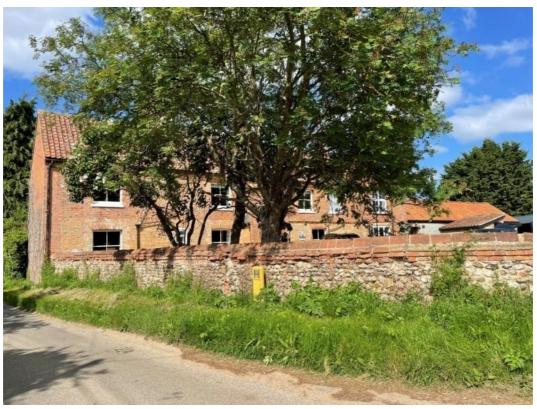
Figure 67: Manor Farm, Common Lane, circa late 1700's

**Description:** Large double fronted property built of red brick with pantile roof and attached barn also of brick with chalk and pantile roof. Sited at the western end of Common Lane behind a brick, flint and chalk boundary wall with wide and open access frontage to the main house.

**Significance:** Of local historic interest and association. One of few remaining working Manor Houses in the area and remains under ownership of West Acre Estates Ltd. It is a landmark building being in a prominent position, contributing to the rural community of the hamlet. The style, form and construction of the building is easily identifiable.

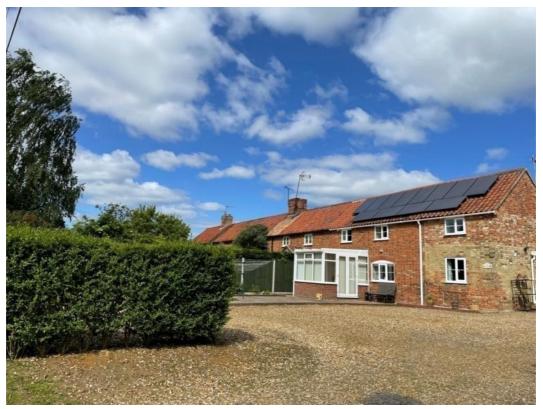
Figure 68: Well Yard Cottages, Common Lane, circa 1800's (Possible late 1700's)

**Description:** Originally terrace of four Estate cottages built from red brick with pantile roof, all with small casement windows.

**Significance:** Of local historic interest and association. The style, form and construction of the building is easily identifiable and most likely built with bricks locally sourced from Brickyard Lane works.

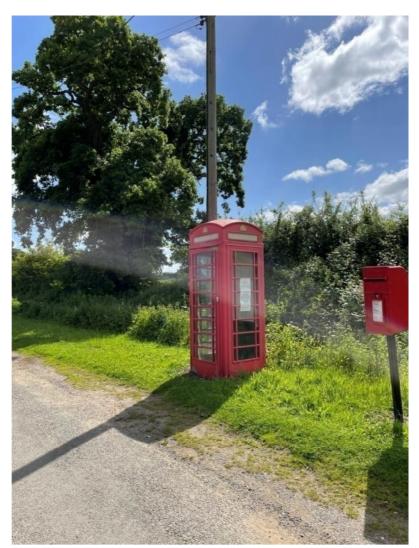
#### 28. Red GPO Telephone Box circa early 1900's

**Description:** Red GPO Telephone box, now out of service. Known as the K2 model, made of cast iron and designed by Sir Giles Gilbert Scott. The colour red was used to make them easy to spot. From 1926, the fascias of the kiosks were emblazoned with a prominent crown, representing the British Government. In 2006 the K2 telephone box was voted one of the top 10 British design icons.

**Significance:** Of local historic interest. The style form and construction of the Telephone box, often seen as representing a British cultural icon, is easily identifiable.

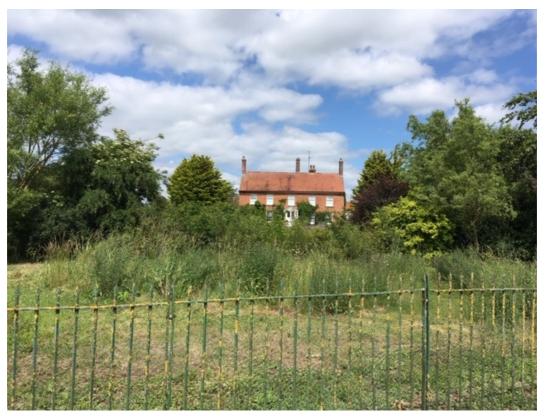
29. Great Barn Farmhouse - Old Norwich Road circa 1700's to 1830's

**Description:** Large farmhouse built of red brick and pantile roof, erected during the Georgian period when trade expanded along with consumerism and popular culture blossoming. This house is a beautiful representation of a Georgian property, being double fronted with many sash windows bringing balance to its façade. There appear to be some later additions, such as the porch which opens onto a small patio leading to the lawns.

It is set in abundant land and is close to converted farm buildings comprising, the stable, piggery and tack room. One of the most important listed buildings in Gayton Thorpe is attached to this Farmhouse and is known as The Great Barn.
