HABITAT MANAGEMENT PLAN
LAND TO THE WEST OF QUEEN ELIZABETH WAY
KINGS LYNN, NORFOLK

Prepared for Kings Lynn and West Norfolk Borough Council

By A.T. Coombes Associates Ltd.

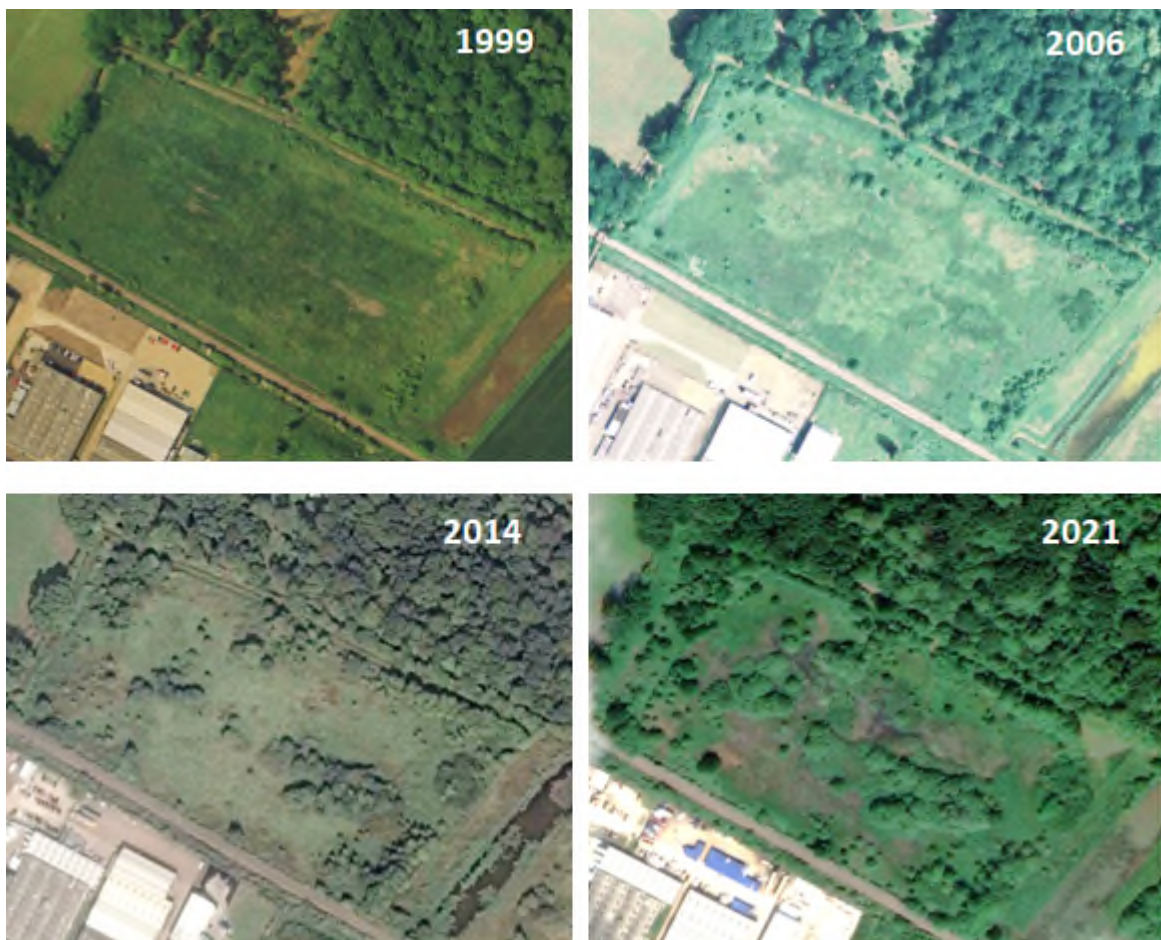
Figure 1. Historic satellite imagery of the site from 1999-2021 (Google Earth, 2022)

- 2.3 According to satellite imagery (GoogleEarth, 2022), the site has changed significantly throughout the past 30 years (Fig1). In 2009 the site appears most dry, with grassland habitat covering most of the land and minimal scrub and woodland encroachment. By 2021, the site had varied soil conditions and a swamp area that has been encroached upon by *Salix* species. It is apparent that the site now has significant scrub encroachment, which is beneficial for warblers and other breeding bird species but left unmanaged will ultimately the whole site would be likely to become wet woodland. This process can already be seen in parts of the site. Although wet woodland is not detrimental to the site, it is preferred to have a mixed broadleaved species woodland, with various habitats to maximise the site for wildlife. The plan will incorporate some of the sites new characteristics and manage the site accordingly to limit the encroachment.

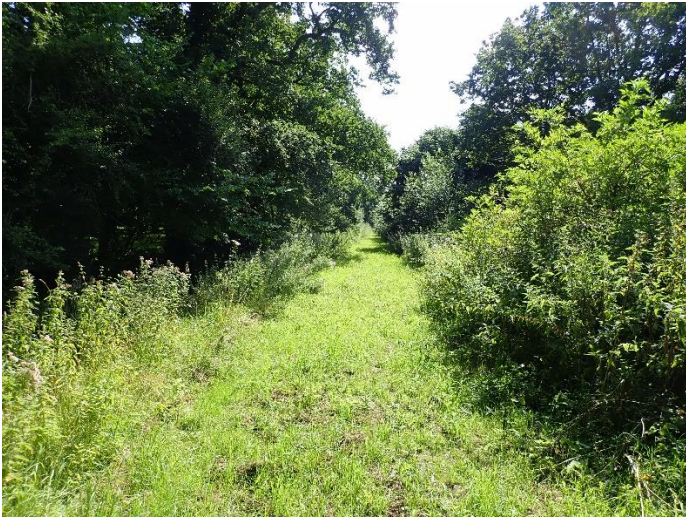
Fig. 1. Path south of Ditch A taken from NW corner & looking East

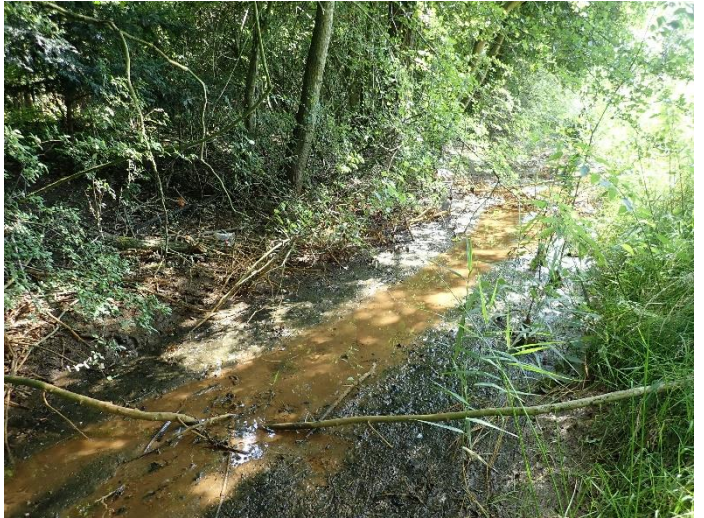
Fig. 2. Far east part of Ditch A where heavily silted up & looking East

It is deeply sedimented and especially east of the bridge and on the survey it contained shallow water along its length which averaged approx. 15cm and was clear. Water starwort *Calitriche* sp. was the only floating aquatic plant observed and which was locally frequent. Where it is less shaded the channel is heavily vegetated with lesser pond sedge and reedmace *Typha latifolia* and which are locally frequent forming dense patches and greater pond sedge occasional. Reed occurs within ditch and along the bank and is occasional west of bridge but frequent east of bridge. Other frequent species along the southern bank include hemp agrimony, great willowherb, bramble, creeping thistle, cocksfoot, false oat grass, and false fox sedge. Soft rush is rare.

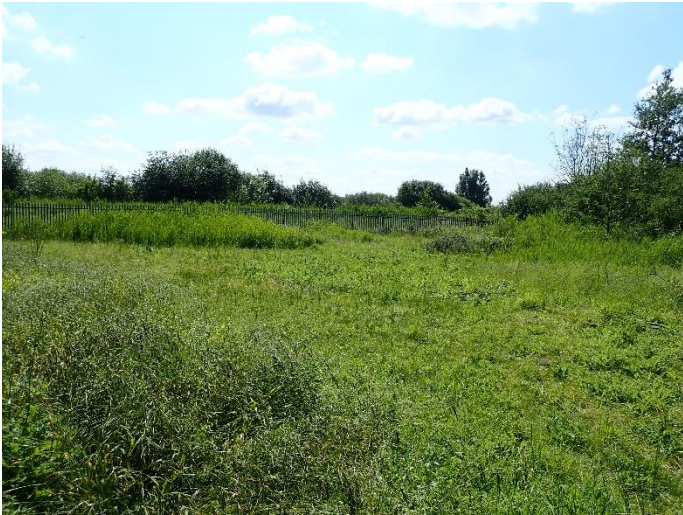
Fig. 3. Area A within West Part looking east toward AW compound

This forms a mosaic of distinct stand types dominated by individual grass species (see table below and Fig. 3,5,6,7) and consisting of common couch *Elymus repens*, reed *Phragmites*

Some scrub clearance has occurred in the far north east and adjacent to the concrete track (Area B, Fig. 3), this area being isolated from other areas of grassland by dense scrub. Here the vegetation is quite diverse with many species associated with disturbed ground. Black bent, creeping bent *Agrostis stolonifera*, rough meadow grass *Poa trivialis*, common couch, Yorkshire fog, toad rush *Juncus bufonius*, field forget-me-not *Myosotis arvensis*, soft rush, scarlet pimpernel *Anagallis arvensis*, and reed sweet grass are all locally frequent. Scentless mayweed *Tripleurospermum inodorum*, feverfew *Tanacetum parthenium* are occasional, and reed frequent to locally abundant. False fox sedge *Carex otrubae* and bristly oxtougue *Helminthotheca echioides* are frequent, and hemp agrimony and creeping thistle locally

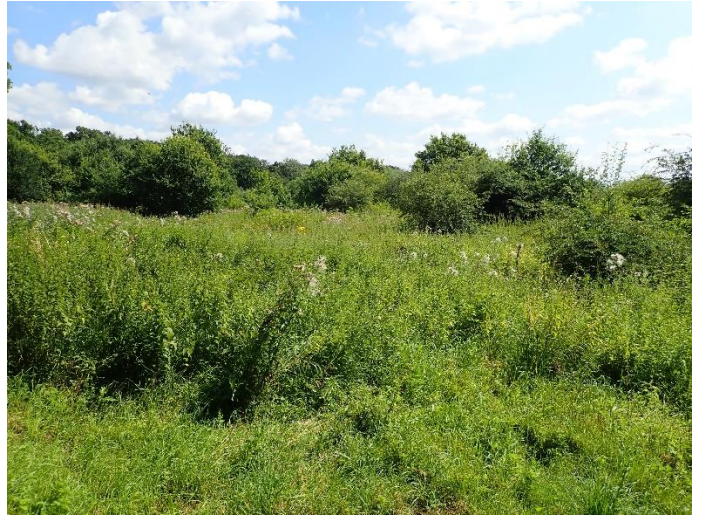
Fig. 4. Tall herb vegetation in west part of West Part looking east

A mosaic of very dense tall herb vegetation and young mixed scrub occurs within a wide band to the west of the site (Fig.4). Nettle, creeping thistle, field rose *Rosa arvensis*, hemp agrimony, bramble, bittersweet are all frequent to locally abundant. Great willowherb *Epilobium hirsutum*, ground ivy *Glechoma hederacea*, and dog's mercury *Mercurialis perennis* are frequent, and common ragwort occasional. Scrub consists of hawthorn willow sp. *Salix* sp., and oak.

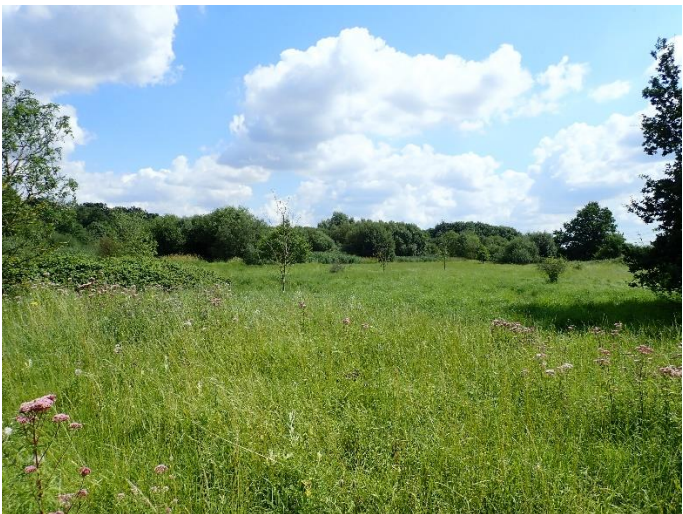
Fig. 5. South west part of West Part looking east

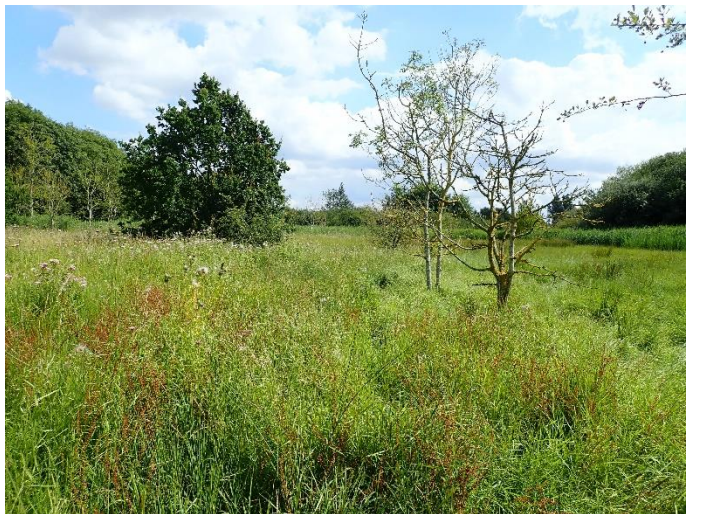
Fig. 6. North east part of West Part looking east toward reed bed

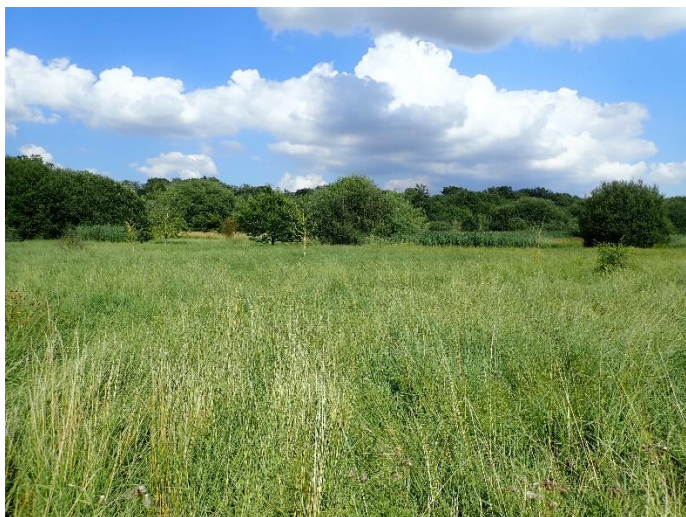
Fig.7. West Part looking north and taken in west half near sth boundary

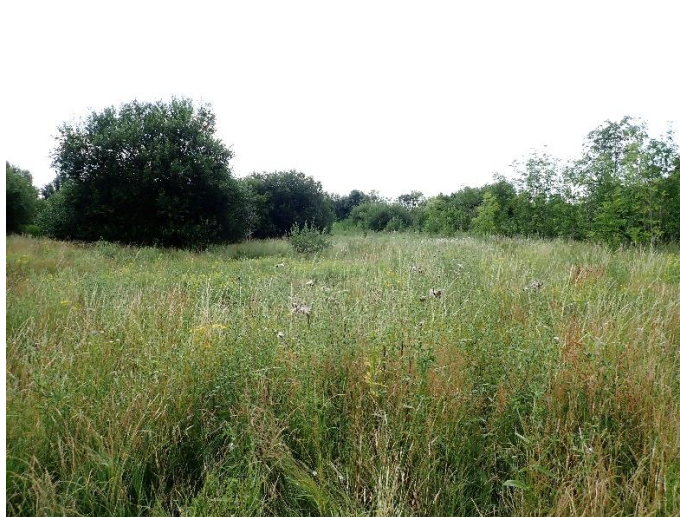
Fig. 7. Northern part of East Part looking south

This is a mosaic of tall rank grassland and scrub and with the grassland proportionally more diverse than the West Part. The scrub is much more dense than in the West Part (Fig. 8,9,10). Grey willow is dominant, with occasional oak, ash and blackthorn. The northern 2/3 is the most diverse area with frequent species including bristly oxtongue *Helminthotheca echioides*, black bent, Yorkshire fog, false oat grass, creeping thistle, hoary ragwort, reed,

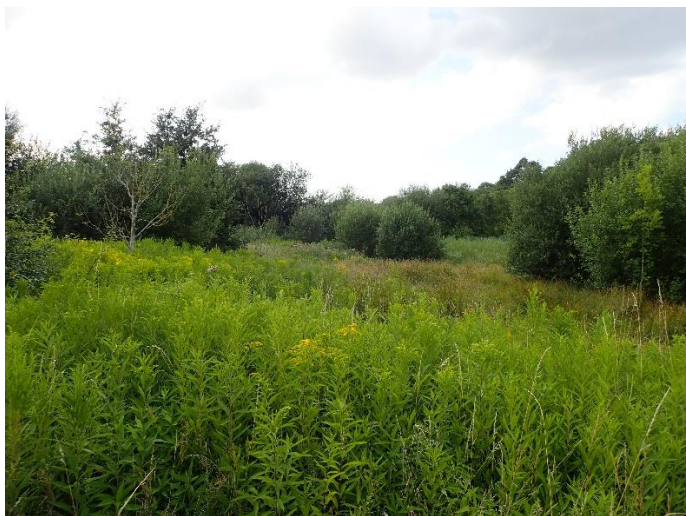
Fig. 8. Southern half of East Part looking east where goldenrod LD

Non-native and invasive species goldenrod was found to be locally dominant within the East Part and is rapidly spreading across the site. One patch was also observed in the West Part.

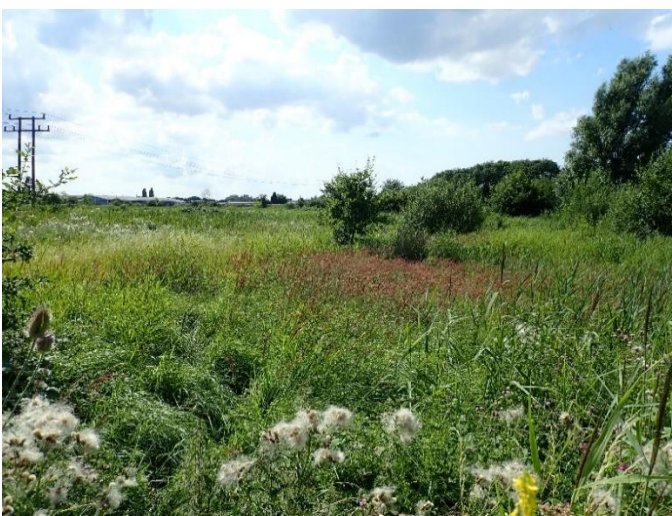
Fig. 9. Far south part of East Part looking west

Goldenrod is rapidly spreading across the site. In the top third it is occasional, and across the remainder of the site except the final quarter (where it is absent) it ranges from frequent to locally dominant, with many large stands occurring (Fig. 9). The site gets distinctly damper in the final third with tall vegetation throughout where the diversity decreases but many of the species further north still occur. Both reed and hemp agrimony are frequent to local dominant with large stands occurring, common ragwort and teasel *Dipsacus fullonum* are also locally frequent here. The final quarter is where it is wettest and here reed is the most dominant grass, and wood small reed, and false oat grass locally dominant (Fig. 10).
