Appendix B Non-Designated Heritage Assets

B.2 Non-Designated Heritage Assets: Gayton

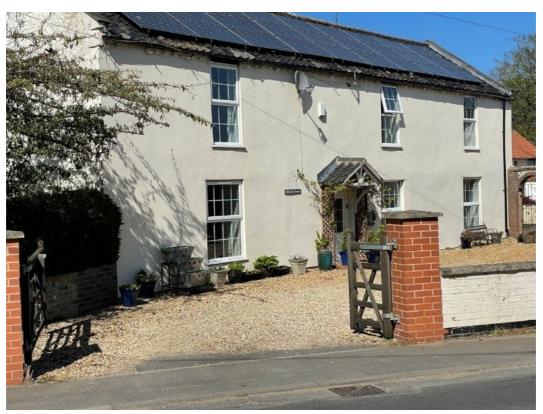
Figure 41: Mill End House, Lynn Rd -B1145/Grimston Rd -B1153

Description: White Norfolk brick, flint and chalk property with pantile roof, circa 1840-1914 **Significance:** Of local historic interest and association. Having a valued past life and association with the once thriving Milling industry in Gayton.

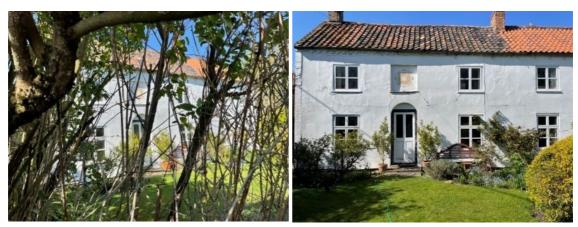
Figure 42: Rose Cottage, Lynn Road/Orchard Rd, circa 1820-1840.

Description: Lime washed brick, flint and chalk property with Norfolk pantile roof and surrounding flint wall.

Significance: In a landmark position and of architectural and aesthetic value being a distinctive looking cottage with large Tudor Rose painted emblem in red and blue on front facing wall.

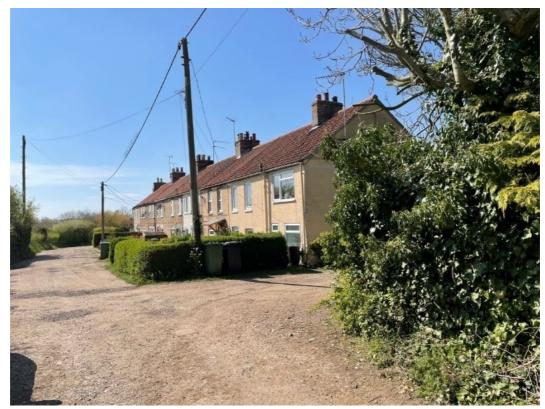
Figure 43: Ebenezer Cottages. Lime Kiln Rd, circa 1840-1914

Description: Row of workers cottages built of brick and flint with Norfolk pantile roofs.

Significance: Of local interest due to having a valued past life as housing for the workers at the lime/chalk quarry.

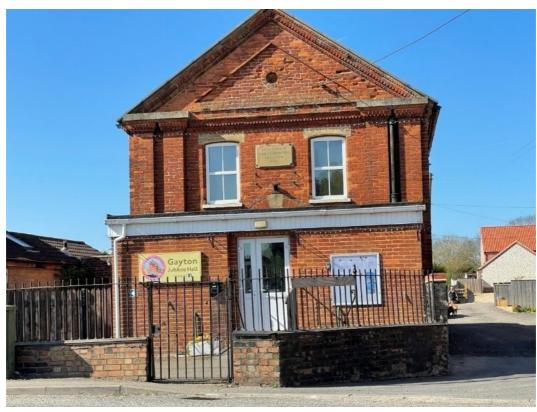
Figure 44: Jubilee Hall, Lynn Rd, circa late 1800's

Description: Gayton Village Hall former 'Friends in Need Lodge,' built late 1800's, (stone inset 1887) red brick with slate roof. Front and rear amenity additions made 1900's. Sited on corner of Lynn Rd/B1145 and Jubilee Lane.

Significance: A building of local historic interest and association that is reasonably unaltered and the style, form and construction of the building is easily identifiable.

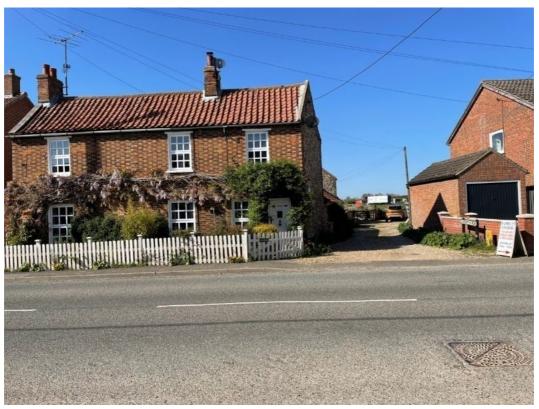
Figure 45: The Old Smithy, Lynn Road and Blacksmiths Row, circa mid 1800's

Description: Red brick triple fronted house with pantile roof and clapboard fencing to front. Side elevations are of flint construction. Property originally three separate one down—one up cottages with a stable and blacksmiths attached to the cottage bordering Blacksmiths Row. Older parts of property are judged to have been built around 1800.

Significance: Of local historic interest and association. The building is largely unaltered and its style, form and construction is easily identifiable.

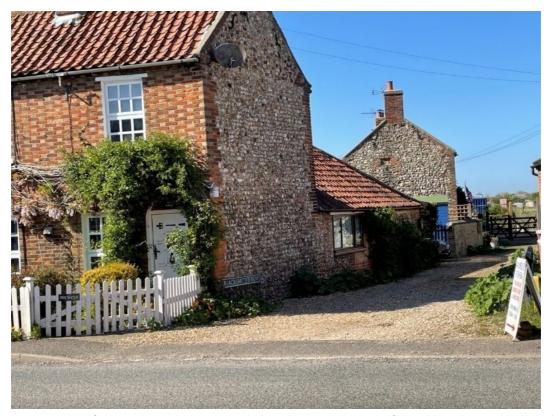
Figure 46: Row of Classic Terraced Cottages at Blacksmiths Row and at rear of The Old Smithy, circa mid 1800's **Description:** Red brick and Flint construction with pantile roofs.

Significance: Of local historic interest and association. A surviving row of workers cottages overlooking a chalk-built outhouse and horse paddock. The form and construction of the buildings is easily identifiable.

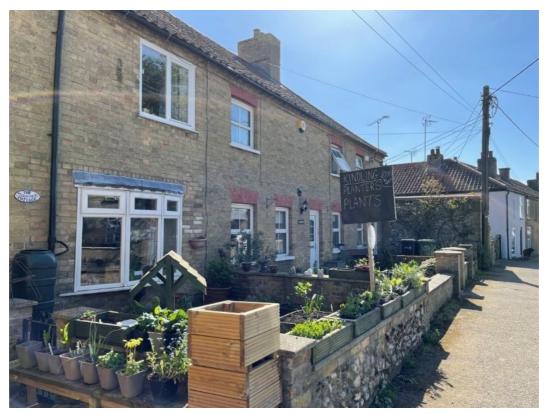
Figure 47: Row of Classic Terraced Cottages, Lynn Road, circa late 1800's. Situated opposite the Old Doctors house dated 1880.

Description: 'The Cottage'/'Mabeldene' etc Yellow brick built construction with red brick decoration and pantile roofs.

Significance: Of local historic interest. Formerly known locally as 'Robert Hill Cottages' sited along the south boundary of Lynn Road. The cottages are largely unaltered and the style, form and construction is easily identifiable.

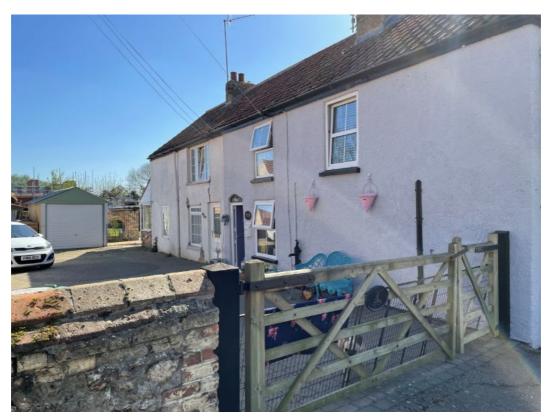
Figure 48: Pump Yard, Lynn Road, circa late 1700's

Description: Modern render covered brick and clunch cottage (appears to be several cottages now forming one residence) with pantile roof. Side facing Lynn Road.

Significance: Of local historic interest and association. Was known to be a watering hole and wash house for the drovers who would stop here before taking their sheep through the attached land, across to Back Street on the south side of Gayton village. The building is largely unaltered, except for an extension to the rear and the style and form is easily identifiable.

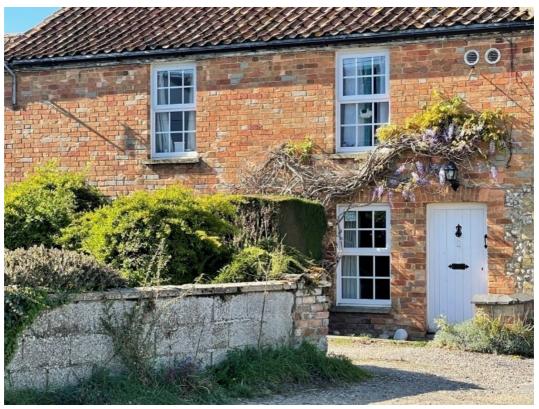
Figure 49: Pelham House, Winch Road, circa 1800's

Description: Red brick dwelling with flint and brick gable ends, pantile roof and rear extension. Side facing onto Winch Road

Significance: Of local historic interest. It is a vernacular house contributing to the character of the northern end of Winch Road.

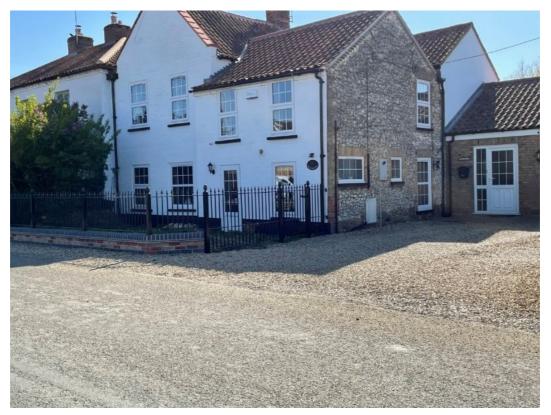
Figure 50: Oakdene, Winch Road, circa mid to late 1800's

Description: Brick, chalk and flint dwelling, with pantile roof and several extensions, recently renovated.

Significance: Of local historic interest. It is a vernacular house contributing to the character of Winch Road.

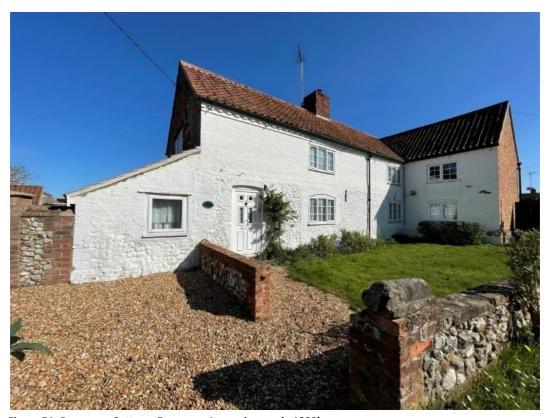
Figure 51: Rosemary Cottage, Rosemary Lane, circa early 1800's

Description: Built of brick, chalk and flint with gable ends mainly of carrstone, with pantile roof and side extensions.

Significance: Of local historic interest and association. It is a vernacular house that is reasonably unaltered and the style, form and construction of the building is easily identifiable.

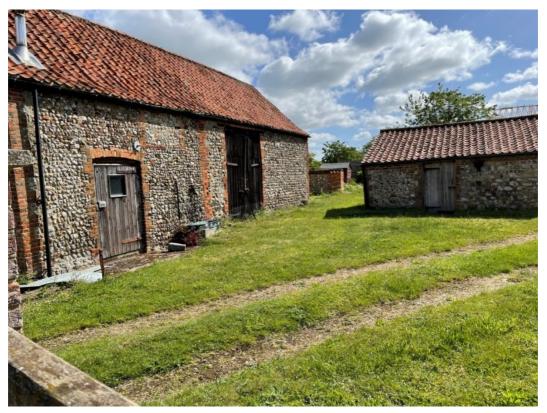
Figure 52: Barns to Rosemary Cottage, Rosemary Lane, circa early 1800's

Description: Both barns are built of chalk and flint with brick inclusions. Pantile roofs, oak doors and frames.

Significance: Of local historic interest and association. They are good examples of smallholders Barns, once common in the area. The style, form and construction of the buildings is easily identifiable.

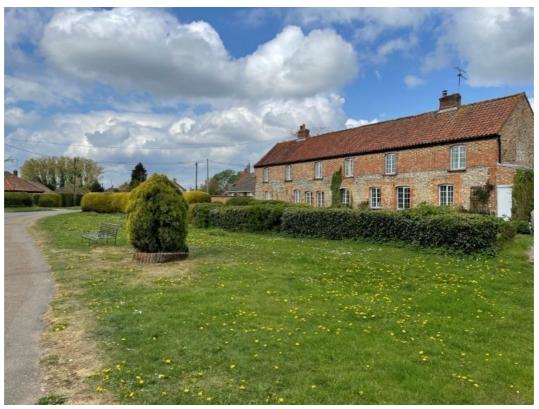
Figure 53: Church Cottages, Back Street circa late 1800's

Description: Red brick and flint built terrace of workers cottages with pantile roof and later additions of small extensions to side and rear.

Significance: Of local historic interest and association. It is the only example of a terrace of workers cottages fronting Back Street, which once would have been common in Gayton. The style, form and construction of the buildings is easily identifiable.

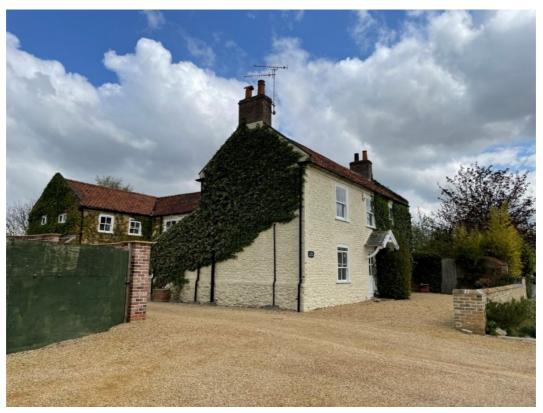
Figure 54: Manor Farmhouse, Back Street late 1700's - 1800

Description: The frontage is mostly chalk lump (clunch in the vernacular) with the single storey northern end being flint outside and chalk inside. The smaller barn to the west is carrstone and brick and is thought to be the oldest building on the site. The whole house and barn were fully renovated in 2000 with UPVC sash windows replaced with timber, original buff pantiles sourced and used and chalk walls in what is now the drawing room, renovated solely with existing materials from the site. A further significant extension was added in 2005.

Significance: Of local historic interest and association. It is a distinctive vernacular house, in a prominent landmark position, contributing to the rural community of Back Street. The style, form and construction of the building is easily identifiable.

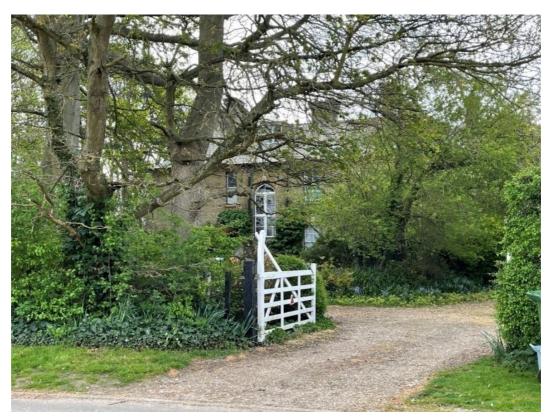
Figure 55: The Old Vicarage, Vicarage Lane, Lynn Road circa 1800's

Description: Former vicarage, built from yellow brick with slate roof and architecturally distinctive double height front facing window. The property is now a private dwelling.

Significance: Of local historic interest and association and can be identified as a Landmark. The building appears largely unaltered and the style, form and construction of the building is easily identifiable.

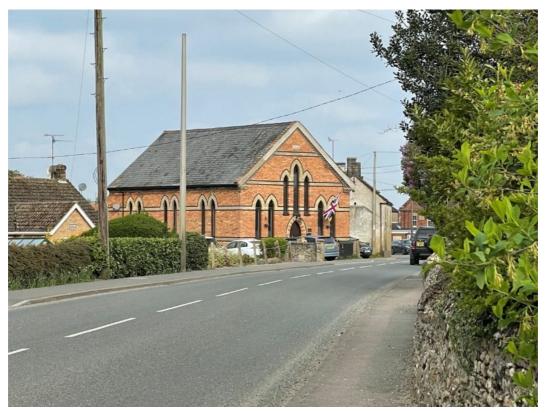
Figure 56: The Old Chapel, Lynn Road circa 1870

Description: Former Primitive Methodist Chapel built from red brick with distinctive yellow brick decoration around the arched windows and slate roof. It was extended in 1883. The Chapel was sold in 2015 and converted to a private dwelling.

Significance: A building of local historic interest and association that is reasonably unaltered and the style, form and construction of the building is easily identifiable. The property sits in a landmark position and can be seen by all who travel along the B1145.

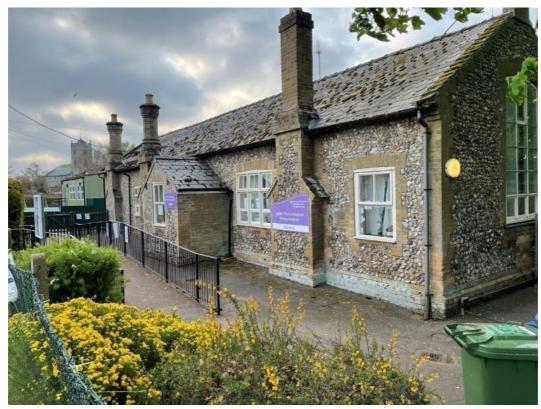
Figure 57: Gayton Church of England Primary Academy, Lynn Road, circa 1800's

Description: Brick and flint built main body of school with slate roof tiles. Distinctive single storey height building, with front porch and three tall chimney stacks. To the side and rear of main school are several nondescript portacabin buildings providing for overspill.

Significance: The current main School is considered a Landmark building and of architectural and aesthetic value whilst also being of local historic interest and association. The style, form and construction of the building is easily identifiable.

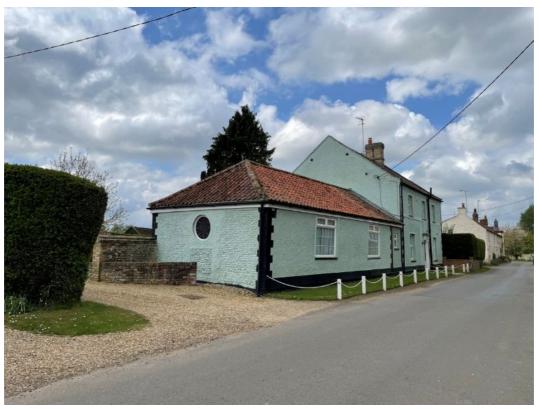
Figure 58: Lattice House, Back Street, circa 1750

Description: Main body is brick built and render, gable ends are flint and render, possible sub level in chalk and flint. The oldest part of the building is single storey, circa 1750 and had been a Chapel. The dwelling is now privately owned but historically was one of several Public Houses along Back Street.

Significance: Of local historic interest and association. It is a distinctive vernacular house contributing to the rural community of Back Street. The style form and construction of the building is easily identifiable.

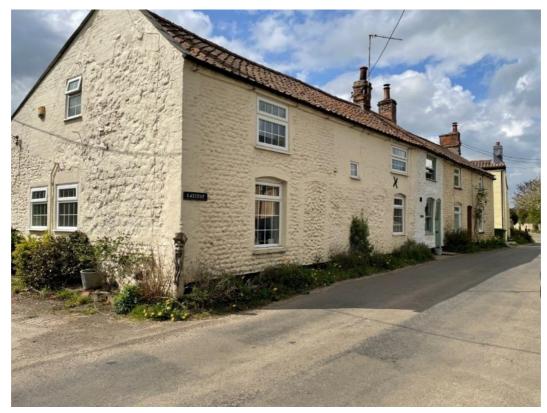
Figure 59: Latitat Cottage to Sunshine Cottage, Back Street circa 1800's

Description: Built of chalk and flint with brick additions and pantile roofs. Row of properties directly abut the road. Possible workers' cottages at one time. Sunshine Cottage circa 1700's is mainly render faced with later brick-built additions with modern windows to rear.

Significance: Of local historic interest. Although altered in parts, ie. entrances removed, extension added, the façade of the buildings remains attractive and its distinctive vernacular contributes to the rural setting of Back Street. The style, form and construction of the buildings is easily identifiable.

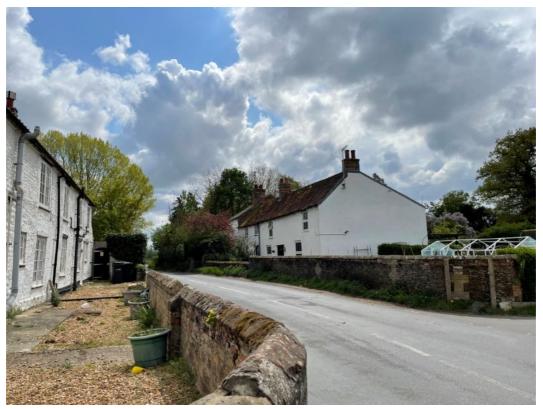
Figure 60: Cluster of Estate Cottages, East Walton Road and Back Street circa mid 1800's (B1153)

Description: White rendered brick and chalk dwellings with pantile roofs. Later addition of brick extension to rear of properties.

Significance: Of local historic interest and association. The style, form and construction of the buildings is easily identifiable.

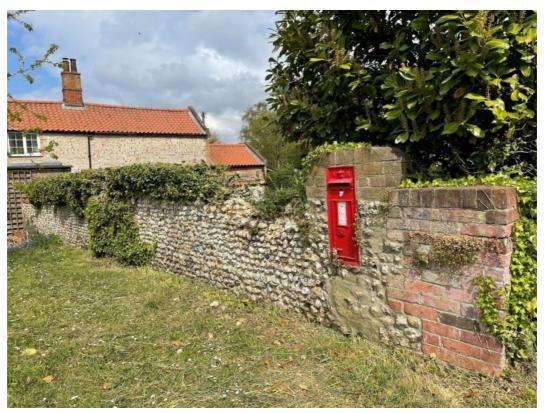
Figure 61: Antique Royal Mail Post Box inset into wall, junction of Lynn Road/B1145 and Grimston Road/B1153. Circa 1850's

Description: In service Royal Mail post box, with letters VR (Victoria Regina), signifying Queen Victoria was Monarch when it was installed.

Significance: Of local historic interest. A surviving working post box set into a boundary wall, easily identifiable by style, form, construction and colour.

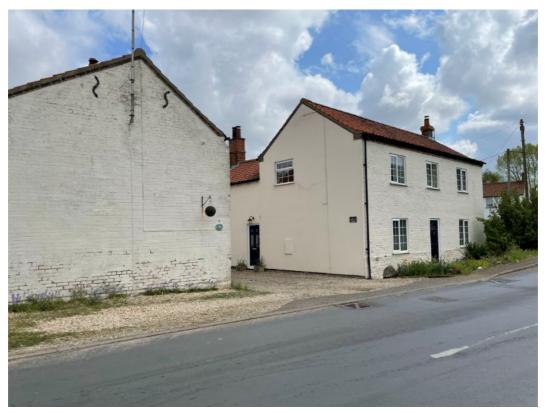
Figure 62: Mill End Cottages Numbers 1, 2 and 3, circa mid 1800's, Grimston Road

Description: Whitewashed brick and chalk construction artisan cottages, with pantile roofs and arranged around area of land to the rear.

Significance: Of local historic interest and association. The style, form and construction of the buildings is easily identifiable.

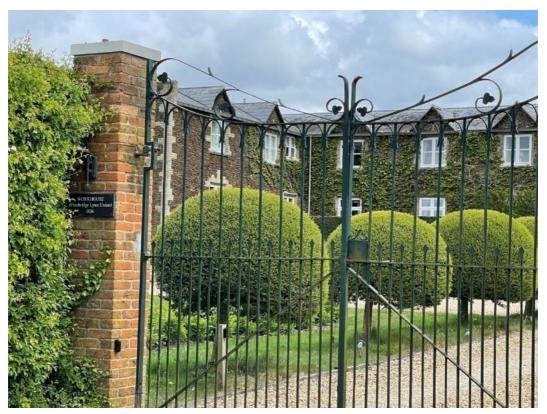
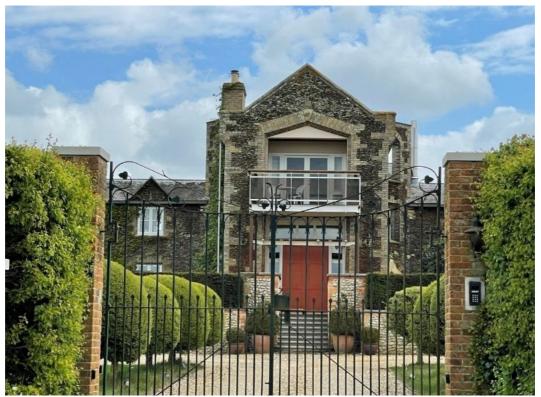
Figure 64: Eastgate House, Eastgate Drove, former Freebridge Lynn Union Workhouse, circa 1836, designed by Donthorne. North Wing.

Description: Substantial structure built of brick, carrstone and stone with slate tile roof, sited on an elevated position some miles from all community. Former Freebridge Lynn Union Workhouse. It later became an Old Peoples' Home 1948 – 1963. (Ref www.heritage.norfolk.gov.uk). The property is now privately owned and has been sympathetically remodelled and split into several homes.

Significance: Of local historic interest and association. It remains a good example of a building that had been a Workhouse. Although altered in parts with front extension and window additions, the façade of the building is attractive. The roof appears unaltered and the style, form and construction of the building is easily identifiable.

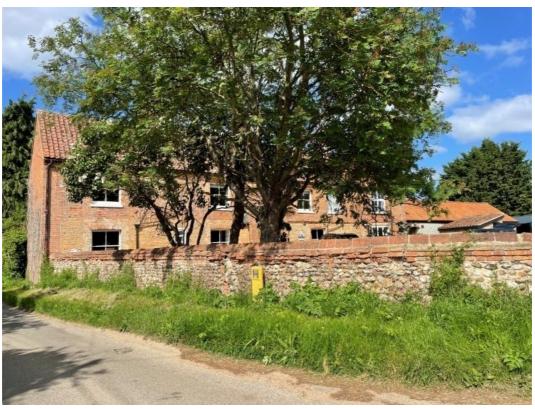
Figure 67: Manor Farm, Common Lane, circa late 1700's

Description: Large double fronted property built of red brick with pantile roof and attached barn also of brick with chalk and pantile roof. Sited at the western end of Common Lane behind a brick, flint and chalk boundary wall with wide and open access frontage to the main house.

Significance: Of local historic interest and association. One of few remaining working Manor Houses in the area and remains under ownership of West Acre Estates Ltd. It is a landmark building being in a prominent position, contributing to the rural community of the hamlet. The style, form and construction of the building is easily identifiable.

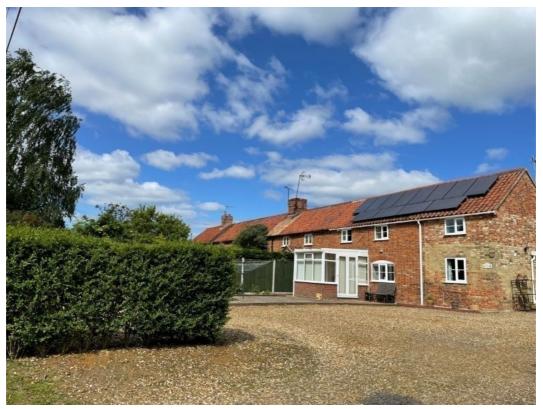
Figure 68: Well Yard Cottages, Common Lane, circa 1800's (Possible late 1700's)

Description: Originally terrace of four Estate cottages built from red brick with pantile roof, all with small casement windows.

Significance: Of local historic interest and association. The style, form and construction of the building is easily identifiable and most likely built with bricks locally sourced from Brickyard Lane works.

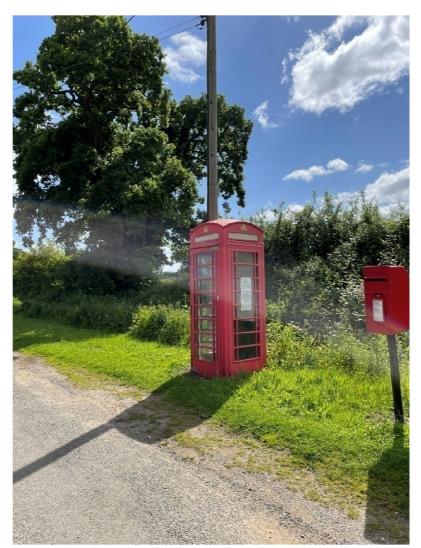
28. Red GPO Telephone Box circa early 1900's

Description: Red GPO Telephone box, now out of service. Known as the K2 model, made of cast iron and designed by Sir Giles Gilbert Scott. The colour red was used to make them easy to spot. From 1926, the fascias of the kiosks were emblazoned with a prominent crown, representing the British Government. In 2006 the K2 telephone box was voted one of the top 10 British design icons.

Significance: Of local historic interest. The style form and construction of the Telephone box, often seen as representing a British cultural icon, is easily identifiable.

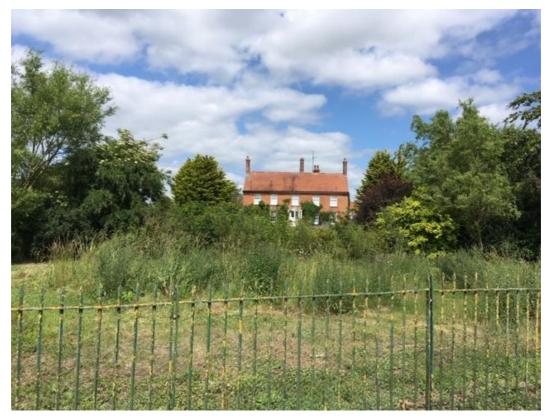
29. Great Barn Farmhouse - Old Norwich Road circa 1700's to 1830's

Description: Large farmhouse built of red brick and pantile roof, erected during the Georgian period when trade expanded along with consumerism and popular culture blossoming. This house is a beautiful representation of a Georgian property, being double fronted with many sash windows bringing balance to its façade. There appear to be some later additions, such as the porch which opens onto a small patio leading to the lawns.

It is set in abundant land and is close to converted farm buildings comprising, the stable, piggery and tack room. One of the most important listed buildings in Gayton Thorpe is attached to this Farmhouse and is known as The Great Barn.

Significance: Of local historic interest and association. It is a landmark building being in a prominent position, contributing to the rural community of the hamlet. The style, form and construction of the building is easily identifiable.
