**THE WASH EAST COASTAL MANAGEMENT STRATEGY –
STAKEHOLDERS FORUM**

THE WASH EAST COASTAL MANAGEMENT STRATEGY

**Minutes of the Meeting of the above held on Thursday, 2nd March, 2023
at 2.00 pm in the Offices at Valentines Road and Microsoft Teams**

4. Hunstanton Coastal Management Plan:

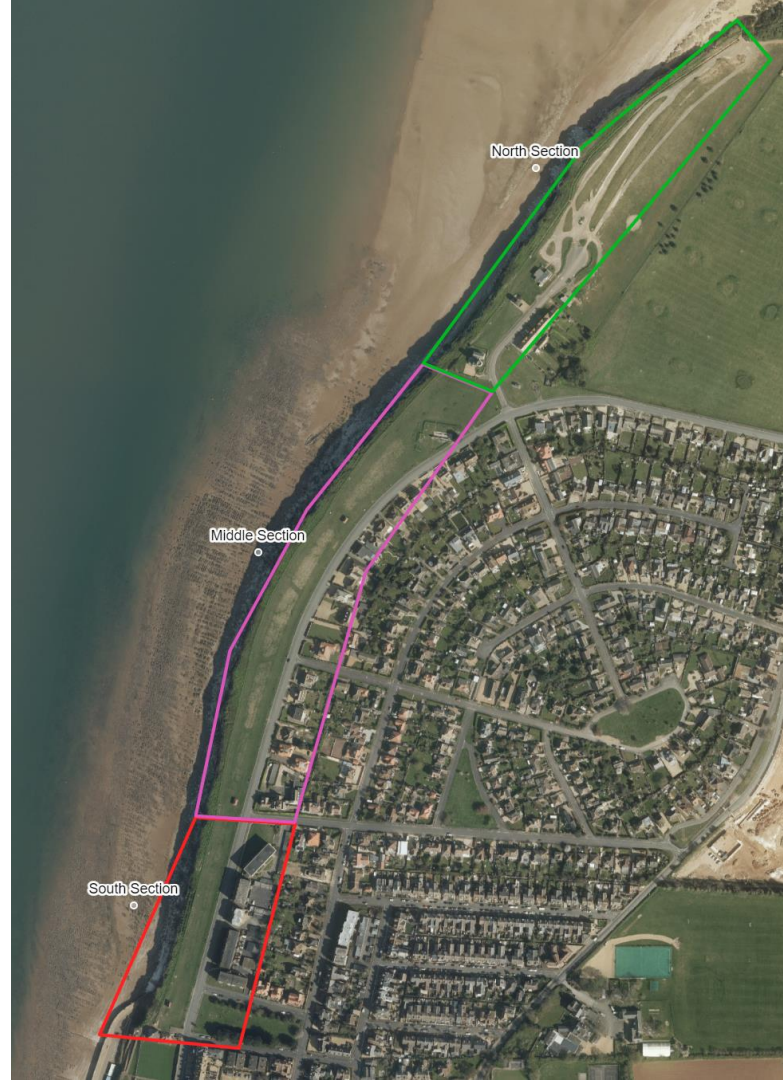
North Section

- Terrestrial LiDAR survey undertaken in April 2022.
- Report finalised in December 2022. Key findings include:
 - ⇒ Slight acceleration in the rate of erosion, especially for the northern section.
 - Northern section now most active area.
 - Erosion of the southern and middle sections remains in-line with previous reports.
 - Mean cliff recession rate has increased from 0.10m (2021) to 0.11m (2022).

Analysis of Change (2010-2022)

- Between 2010-2022 two locations have observed blockfalls.
- These blockfalls have a depth between 3.5 meters & 4 meters.
- The material lost from the cliff face has accumulated on the beach at the base of the cliffs.

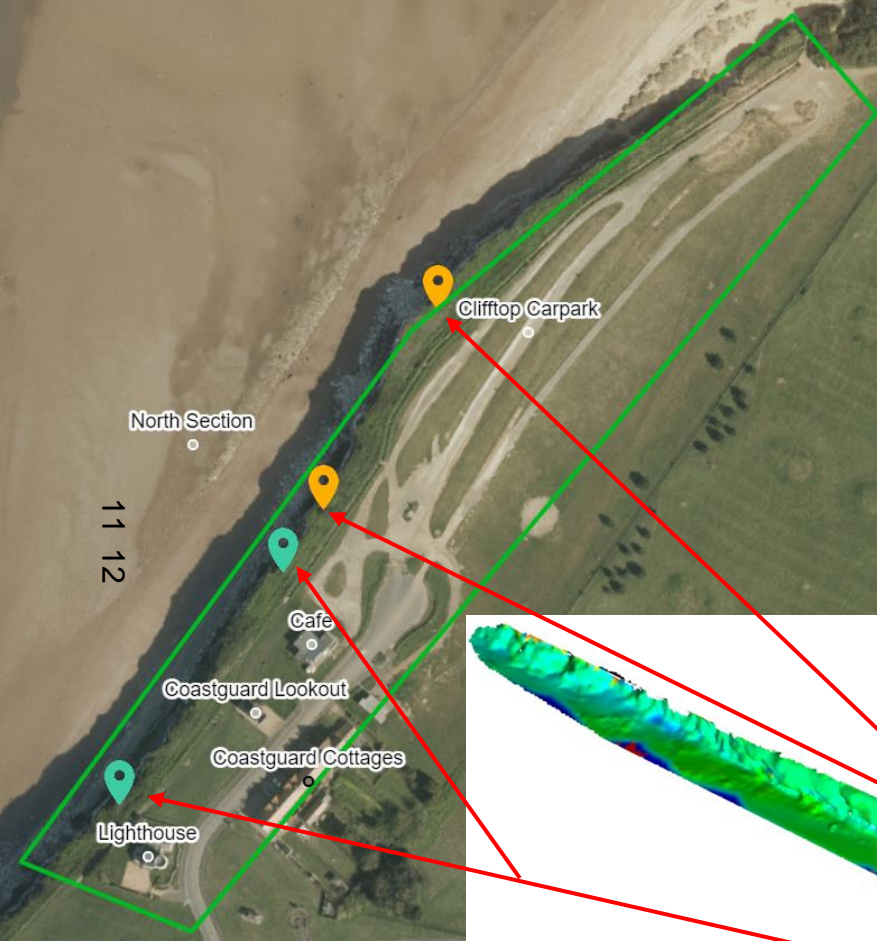
Red = Accumulation (up to 3.5m)
Blue = Erosion (up to 3.5m)

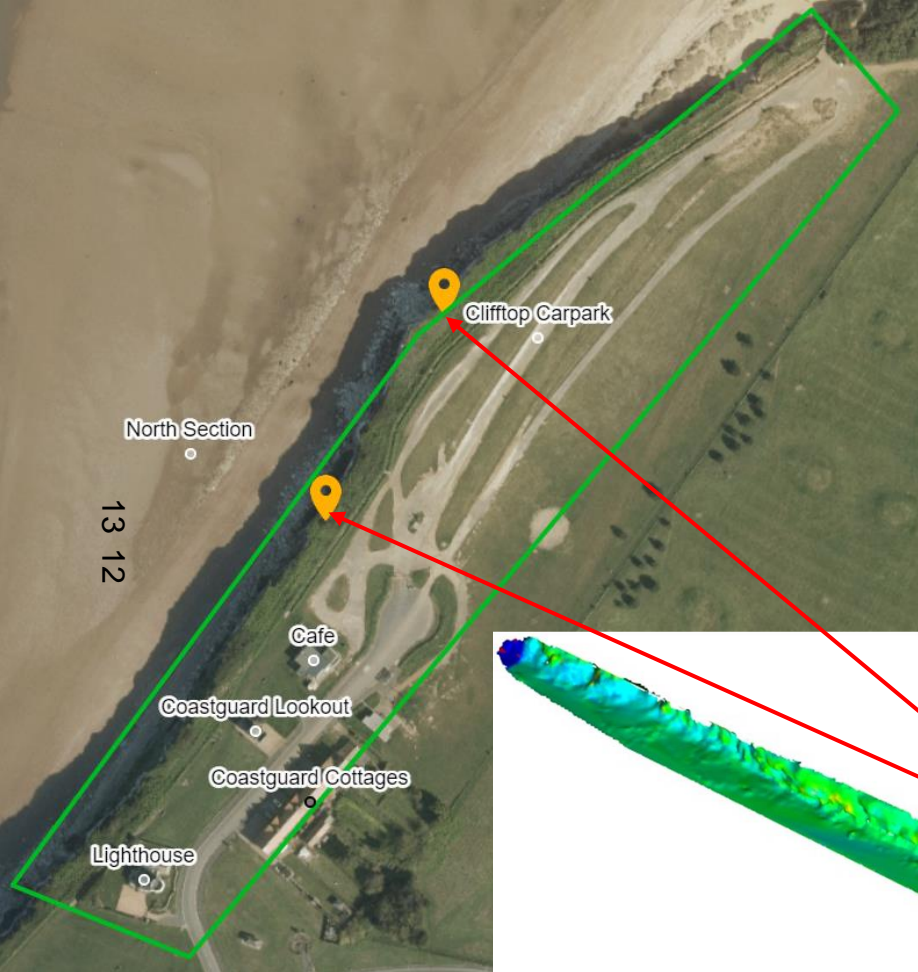
North Section

Analysis of Change (2021-2022)

- Between 2021-2022 one location has observed a blockfall.
- The blockfall had a depth of approx. 2 meters.
- The material lost from the cliff face has accumulated on the beach at the base of the cliffs.
- Vegetation presence increasing.

Red = Accumulation (up to 2m)
Blue = Erosion (up to 2m)

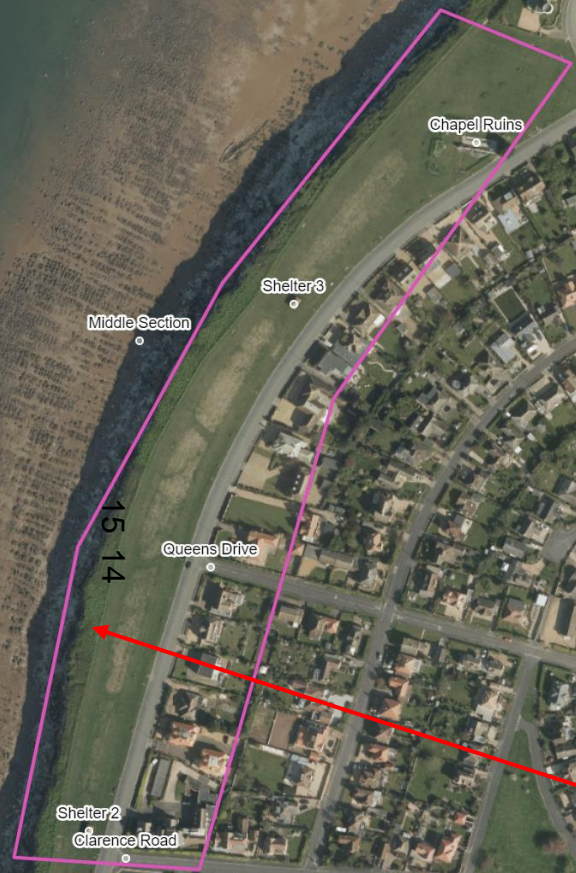
Middle Section

Analysis of Change (2021-2022)

- Between 2021-2022 one location has observed a blockfall.
- The blockfall had a depth of between 1-2 meters.
- The material lost from the cliff face has accumulated on the beach at the base of the cliffs.
- The remainder of the cliff section has observed minor changes and vegetation presence has increased.

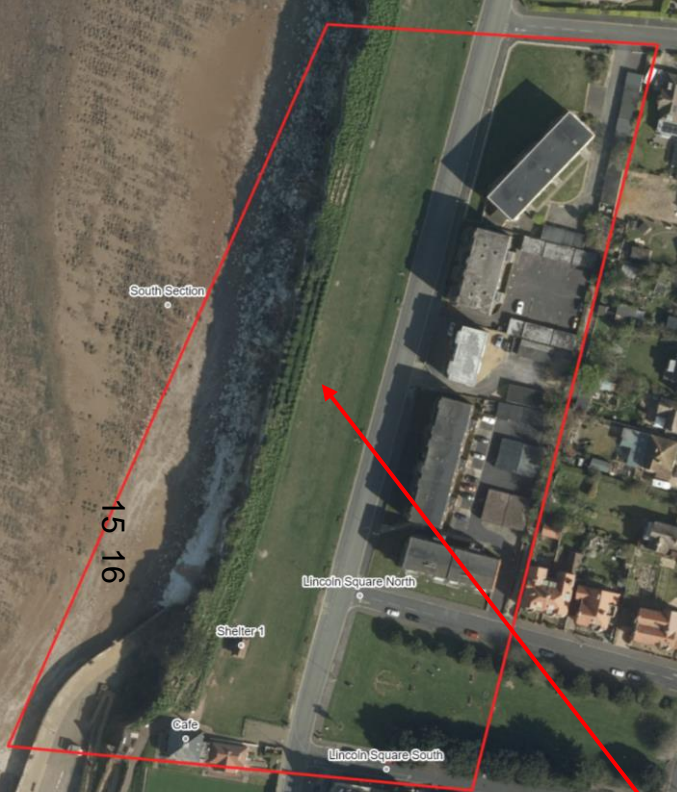
South Section

Analysis of Change (2010-2022)

- Between 2021-2022 one location has observed a blockfall.
- The blockfall had a depth of approx. 4 meters.
- The material lost from the cliff face has accumulated on the beach at the base of the cliffs.

Red = Accumulation (up to 4.5m)

Blue = Erosion (up to 4.5m)

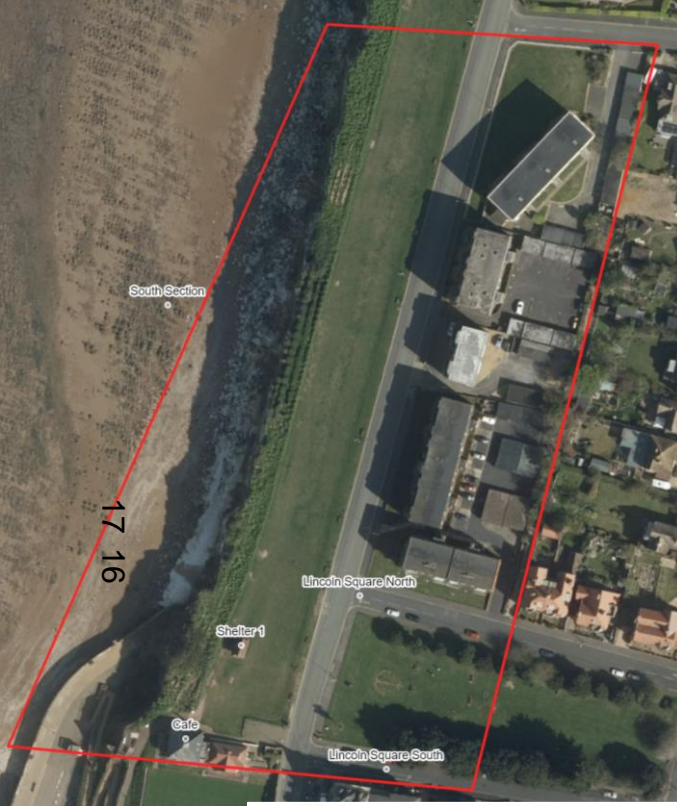
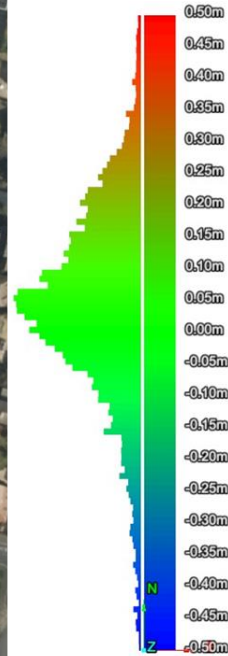
South Section

Analysis of Change (2021-2022)

- Between 2021-2022 there have been isolated areas of loss of up to 0.5m.
- Numerous areas have observed vegetation presence increase.
- Erosion at the base of the cliffs is indicative of beach material being removed from the frontage.

Red = Accumulation (up to 0.5m)
Blue = Erosion (up to 0.5m)

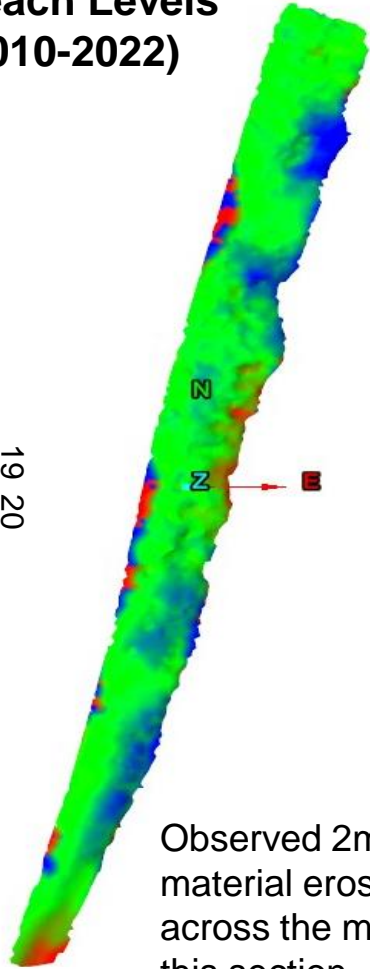
Beach Level Change Middle Section

Beach level change in front of the Hunstanton Cliffs between 2010-2022.

Between 2021-2022 there was limited change observed.

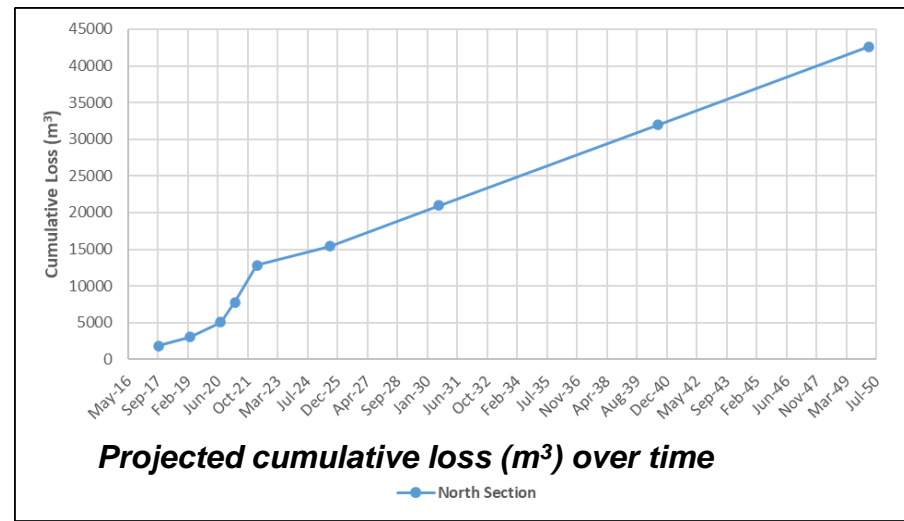
Trigger Level Pilot

- Completed for the north section between the Coastguard Lookout and Lighthouse from 2010-2050.
- Potential future cliff erosion rates were projected for 2025, 2030, 2040 & 2050.
- Preferred trigger level is when the closest cliff edge is less than 10m away.
- Outcomes are a projection only. Actual rates of erosion may vary.
- As data collection continues, future erosion projections will become more accurate.

Estimated cliff recession projections (m³ and tonnes).

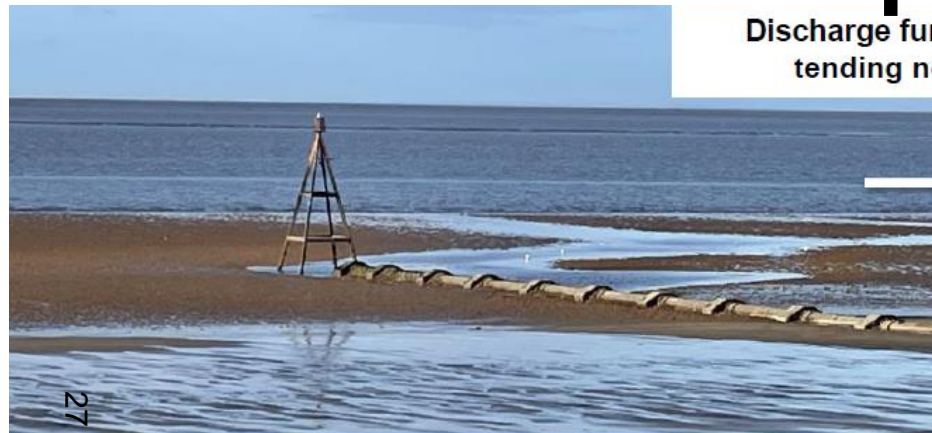
Discharge further seaward
tending northwards

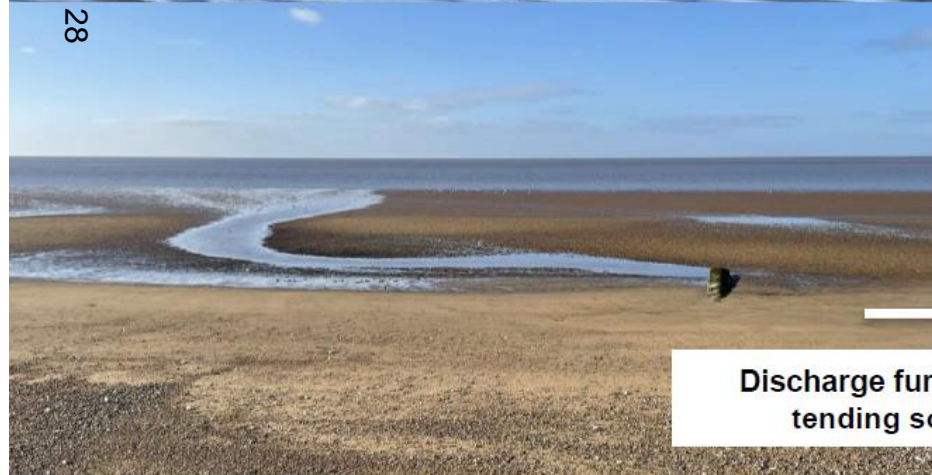
Discharge further up beach
tending southwards

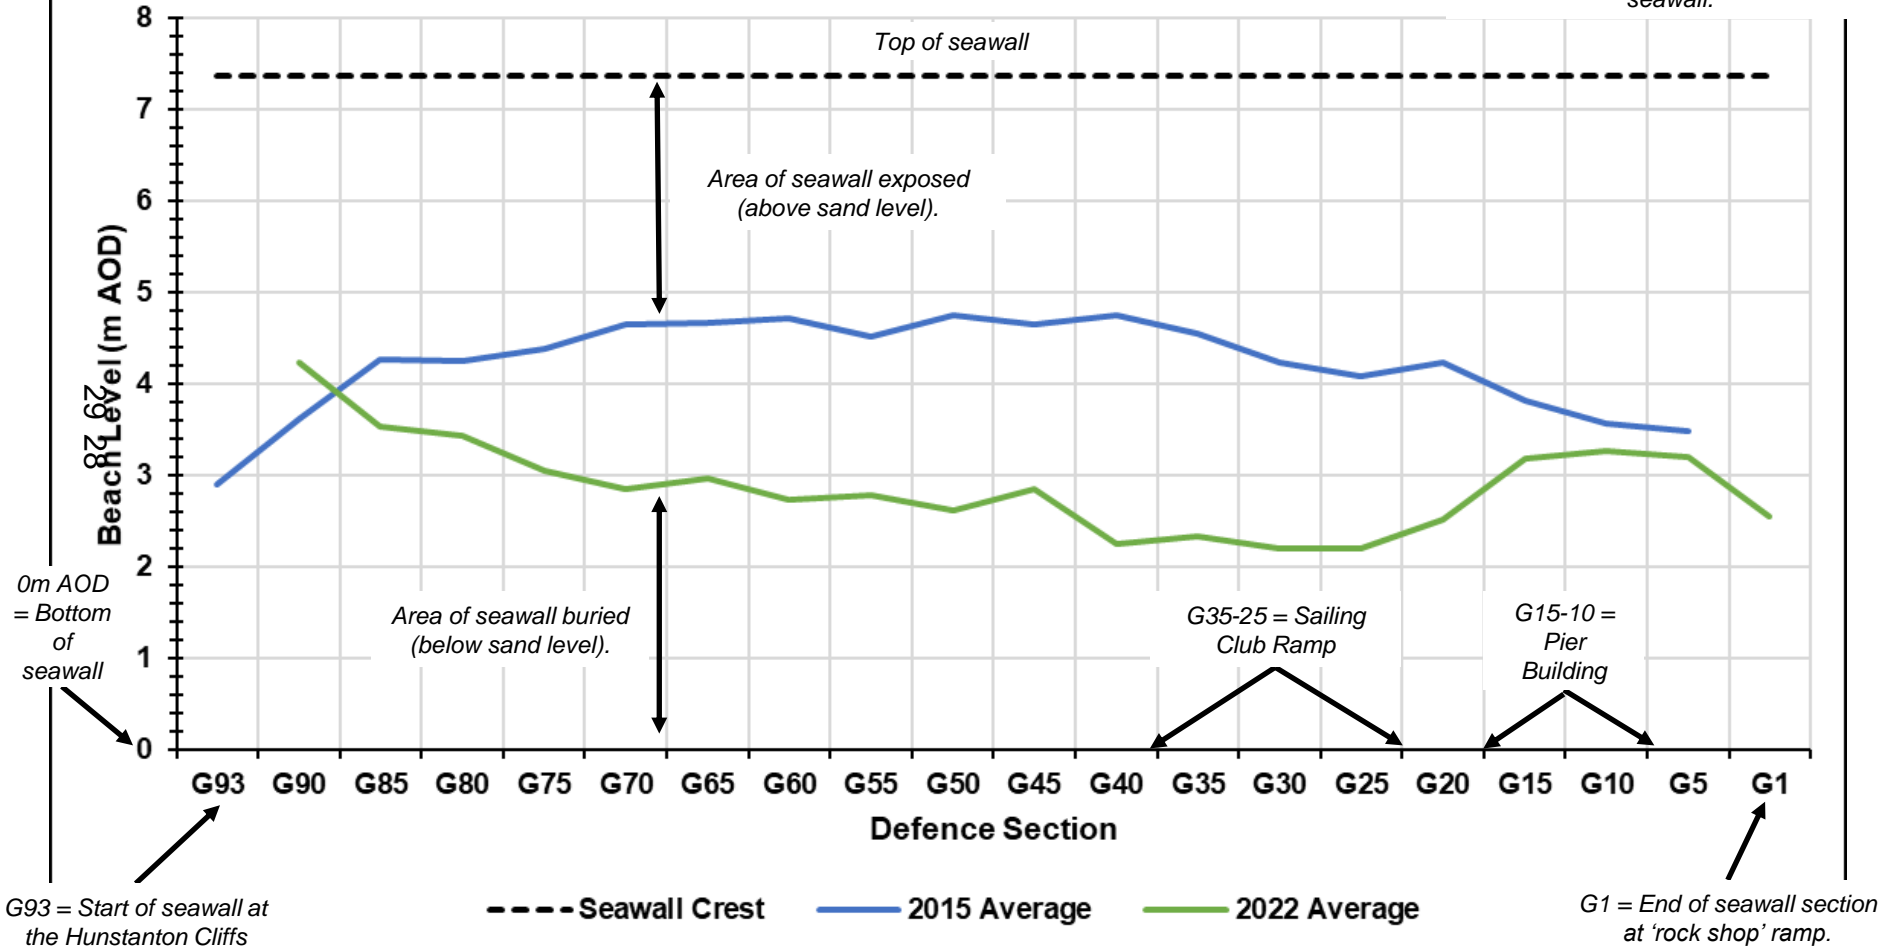
Section G Average Beach Levels (2015 & 2022)

Coloured lines = Height of beach material against the base of the seawall.

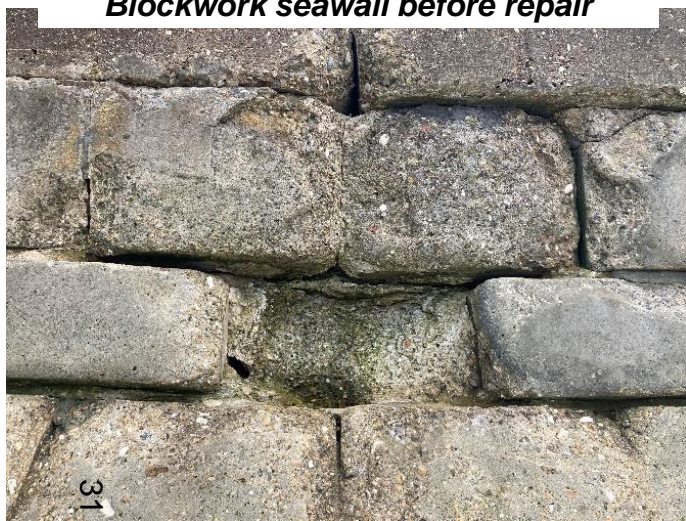
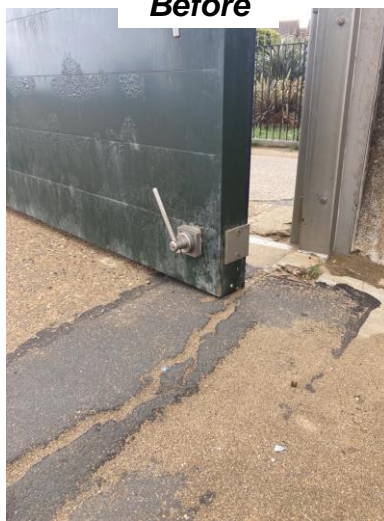
Blockwork seawall before repair

Before

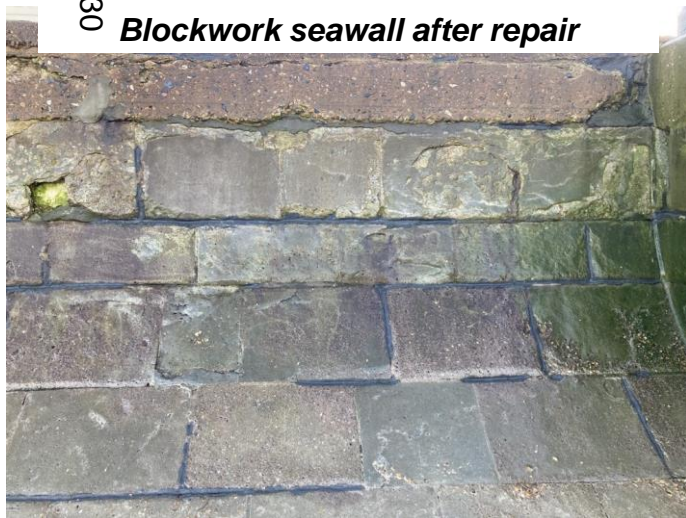
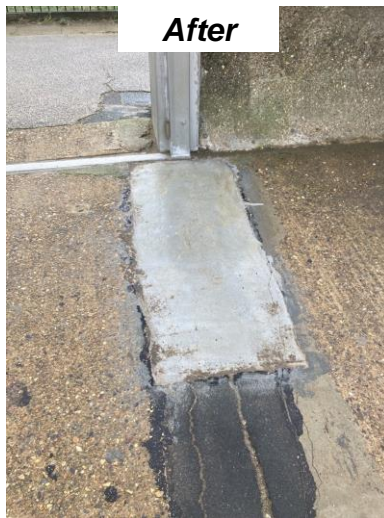
Blockwork seawall after repair

After

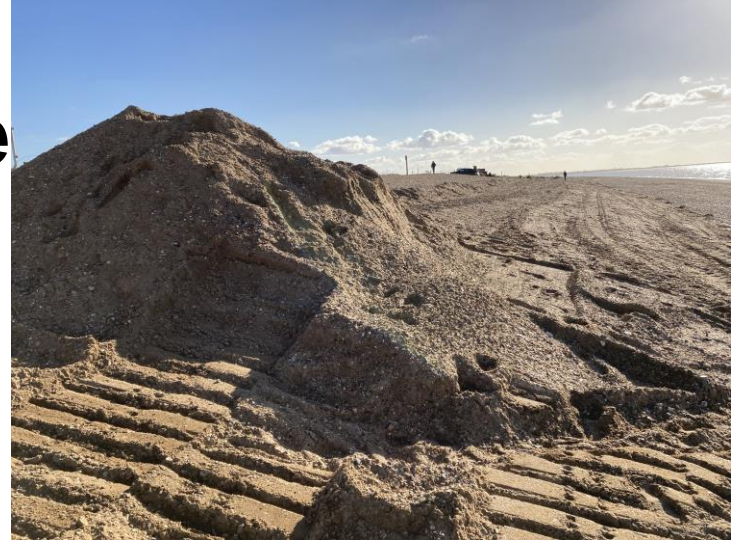
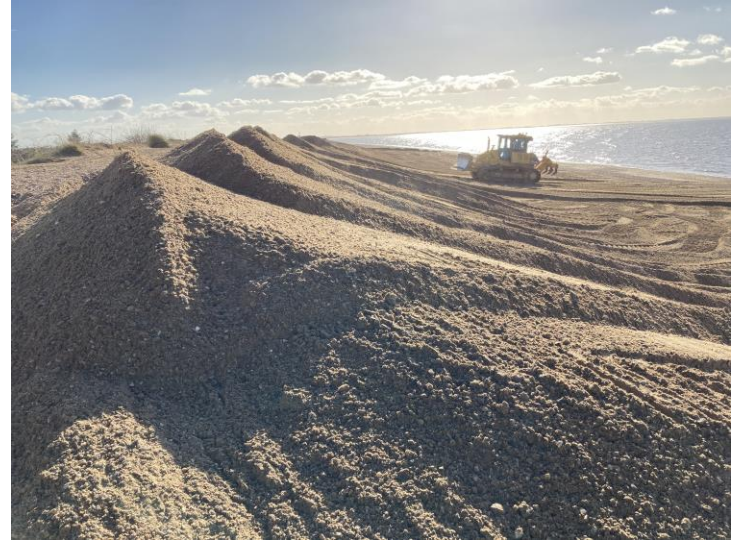
Beach Recycling & Recharge

- Funding group meetings continue.
- Annual beach recycling commenced on 13th February.
- Funds continue to be successfully raised by the CIC.
- Beach recharge likely to be required in the next 2-3 years.
