**THE WASH EAST COASTAL MANAGEMENT STRATEGY –
STAKEHOLDERS FORUM**

**THE WASH EAST COASTAL MANAGEMENT STRATEGY STAKEHOLDERS
FORUM**

**Minutes of the Meeting of the above held on Tuesday, 18th October, 2022
at 1.00 pm in the Offices at Valentine Road, Hunstanton and also as a Microsoft
Teams Meeting**

Jacobs Groyne Effectiveness Report

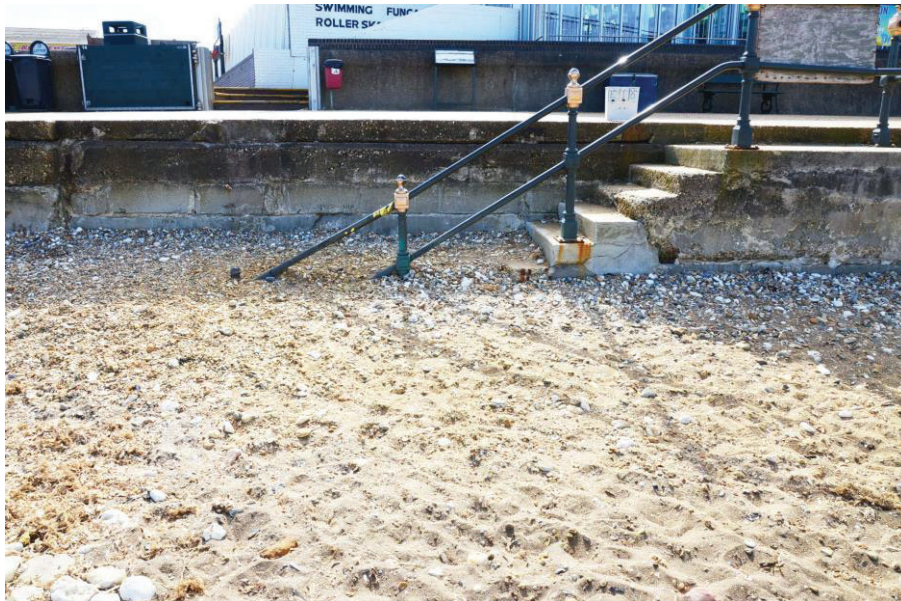
Section E (2017 vs 2022)

September 2022

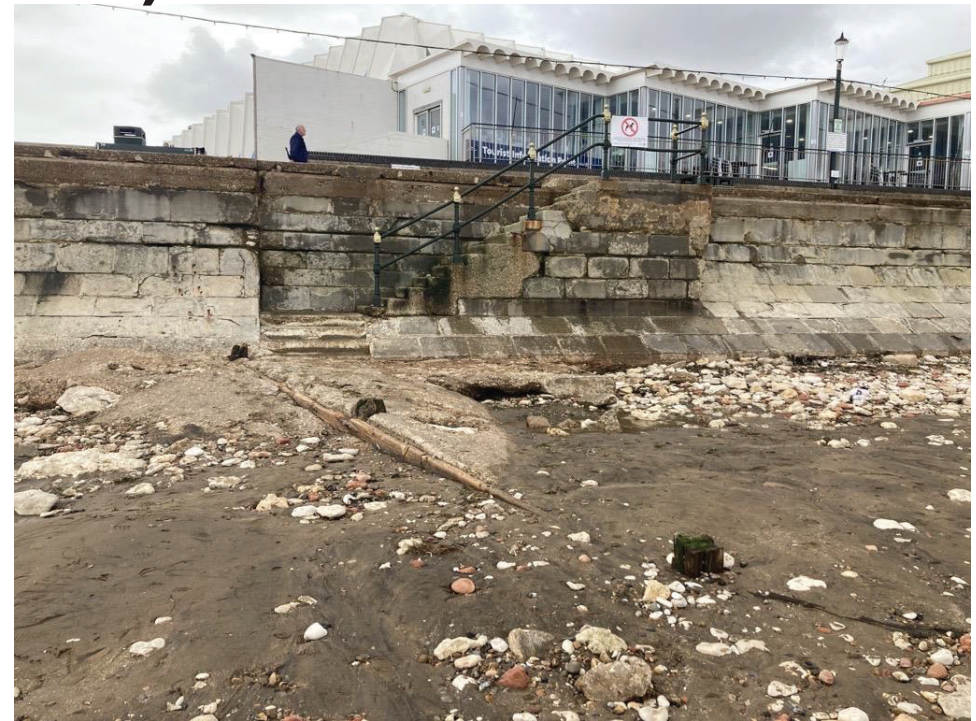
Section D (2017 vs 2022)

March 2017

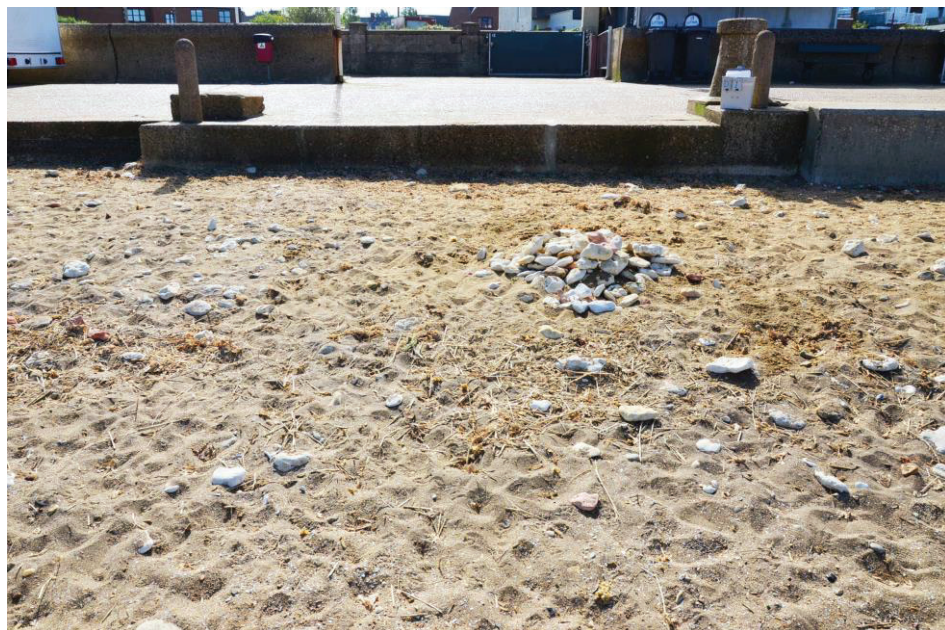
September 2022

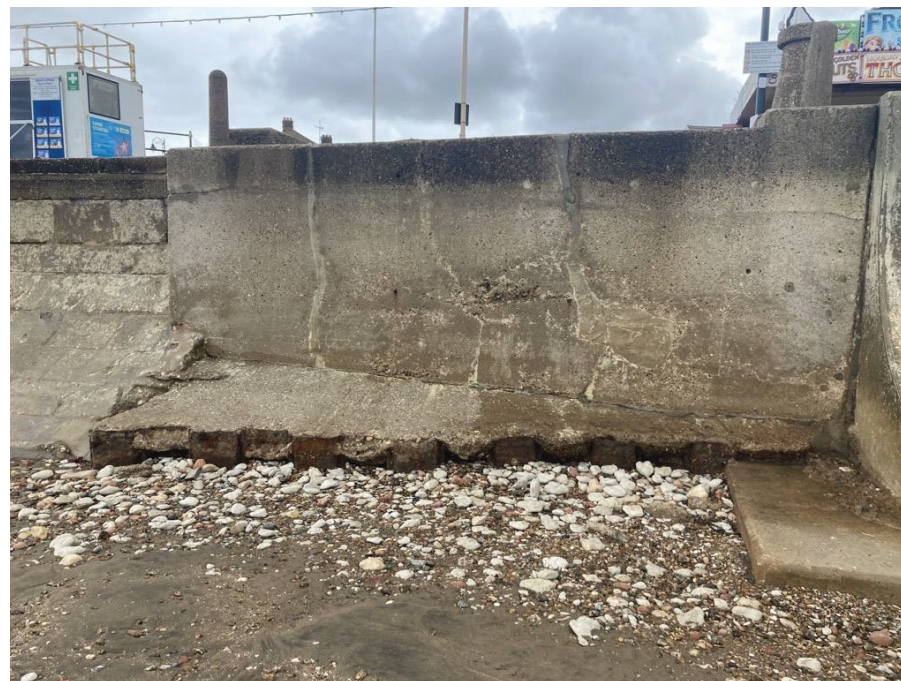
Section C (2017 vs 2022)

March 2017

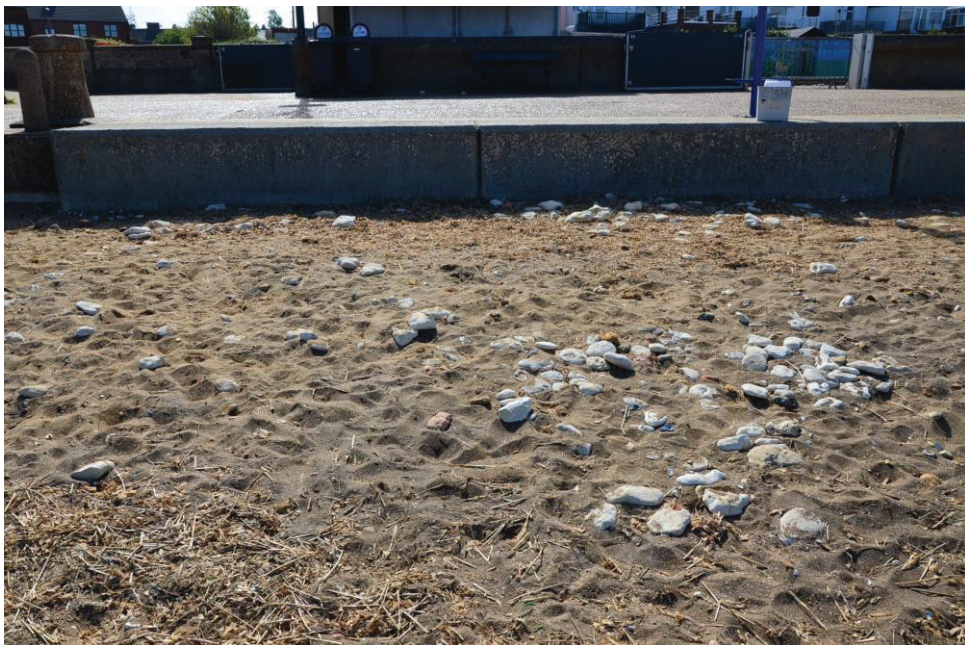
September 2022

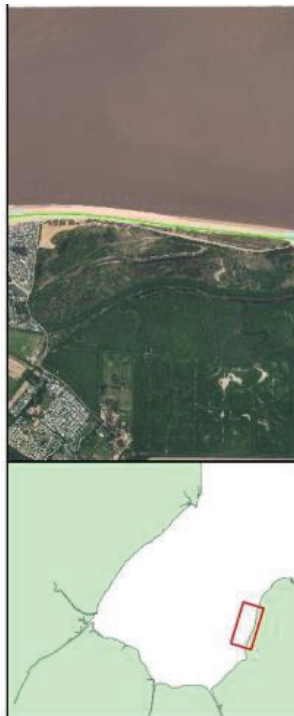
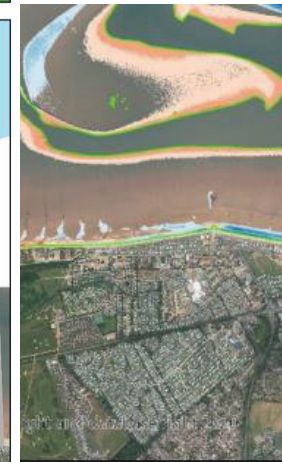
2dSU04HH • Hunstanton to Heacham (North) • Cross Sectional Area Change 1992 - 2020

- The trend since 1992 shows that beach volumes have been stable but there has been some changes in profile.
- The largest areas of accretion are at the Scalp with a increase since 1992.
- The most recent trends (2016-2020) shows a small loss of material.

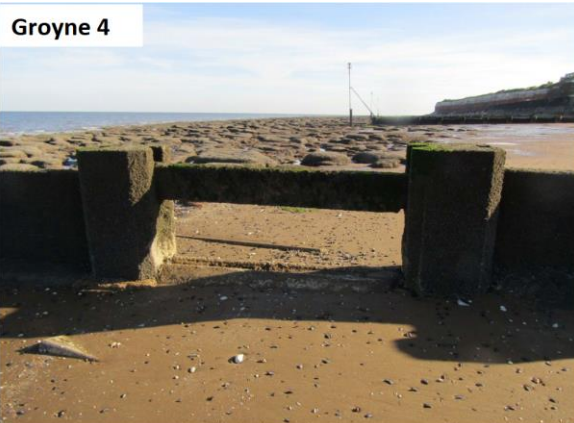
Groyne 4

- Concrete – unusual material choice
- Condition 'Poor' to 'Very Poor' throughout
- Missing planks etc but main structural issue is due to beach lowering below design levels, and abrasion

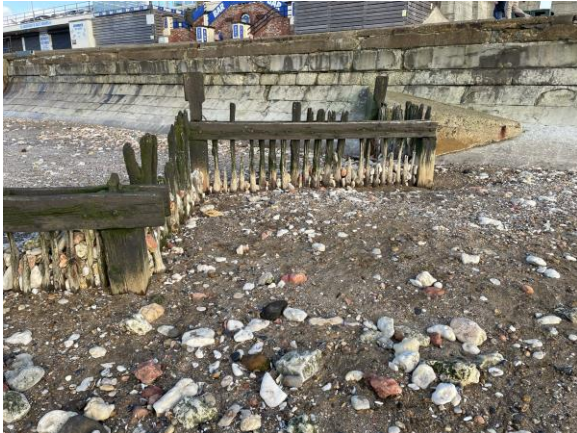
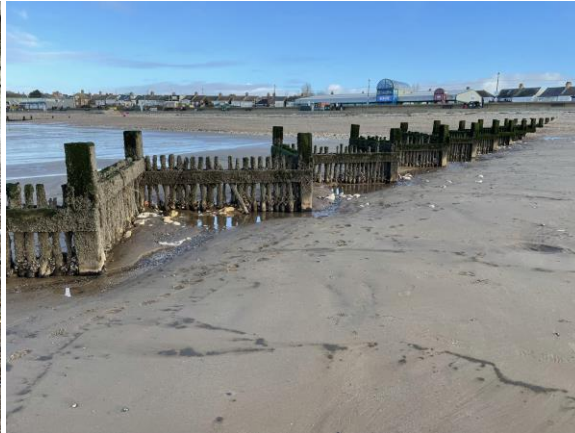
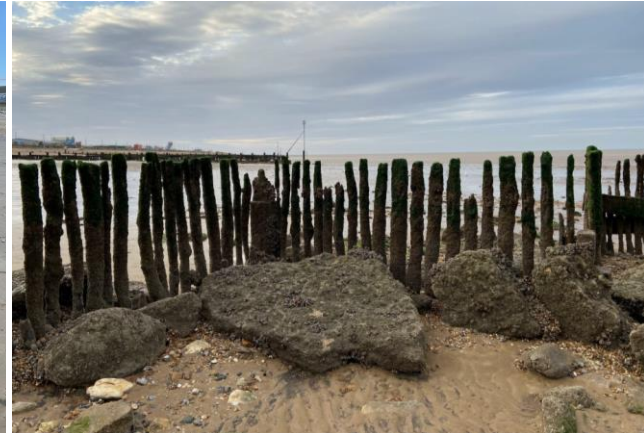
- Permeable timber structures
- Condition 'Poor' to 'Very Poor' throughout
- Main structural issue is due to beach lowering and abrasion
- Rock has been added in places

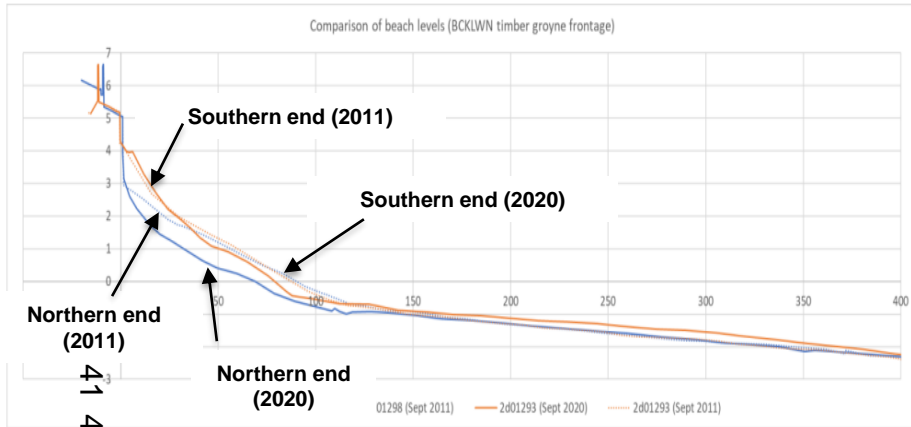
Timber groyne frontage

Contrast in beach response

Position of -1mOD, 0mOD and +1mOD contours in 2012 (light blue) and 2020 (dark blue)

Sparklines show changes over time north to south for upper beach (above MSL)

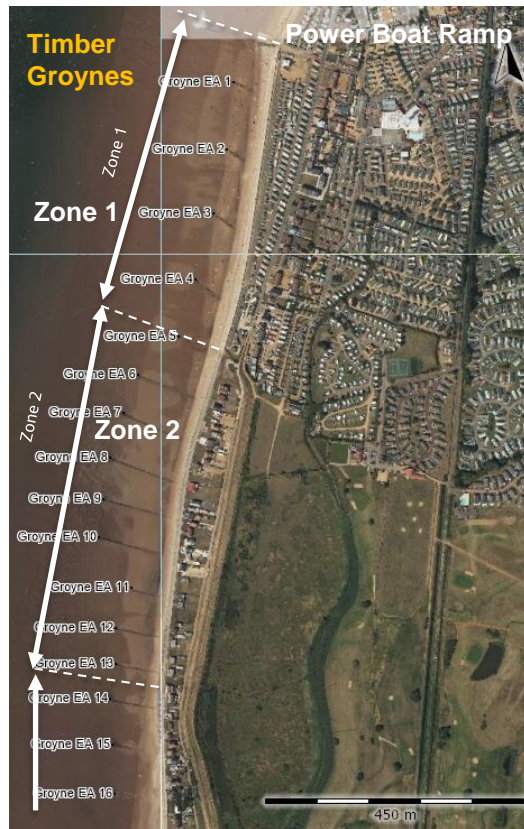
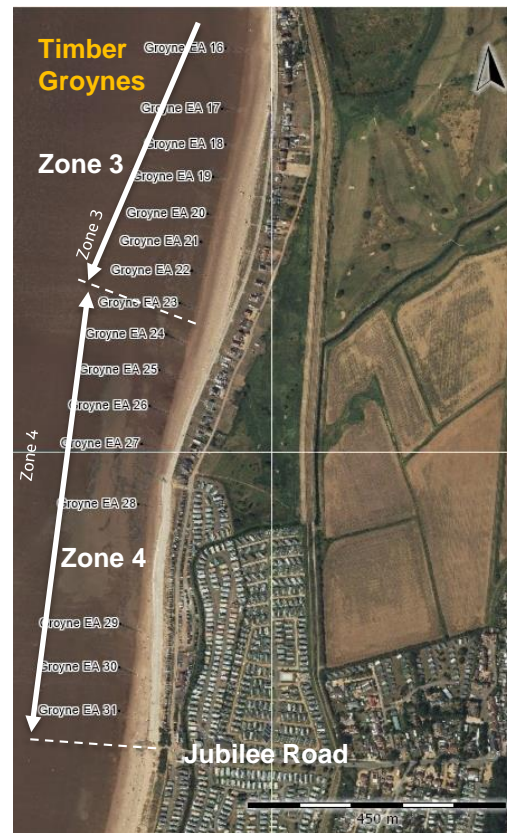
Timber Groyne Frontage (Env Agency)

- Same design as those on Hunstanton town frontage
- Condition similarly 'Poor' to 'Very Poor' throughout
- More sand (in places) – but this frontage is also recharged annually

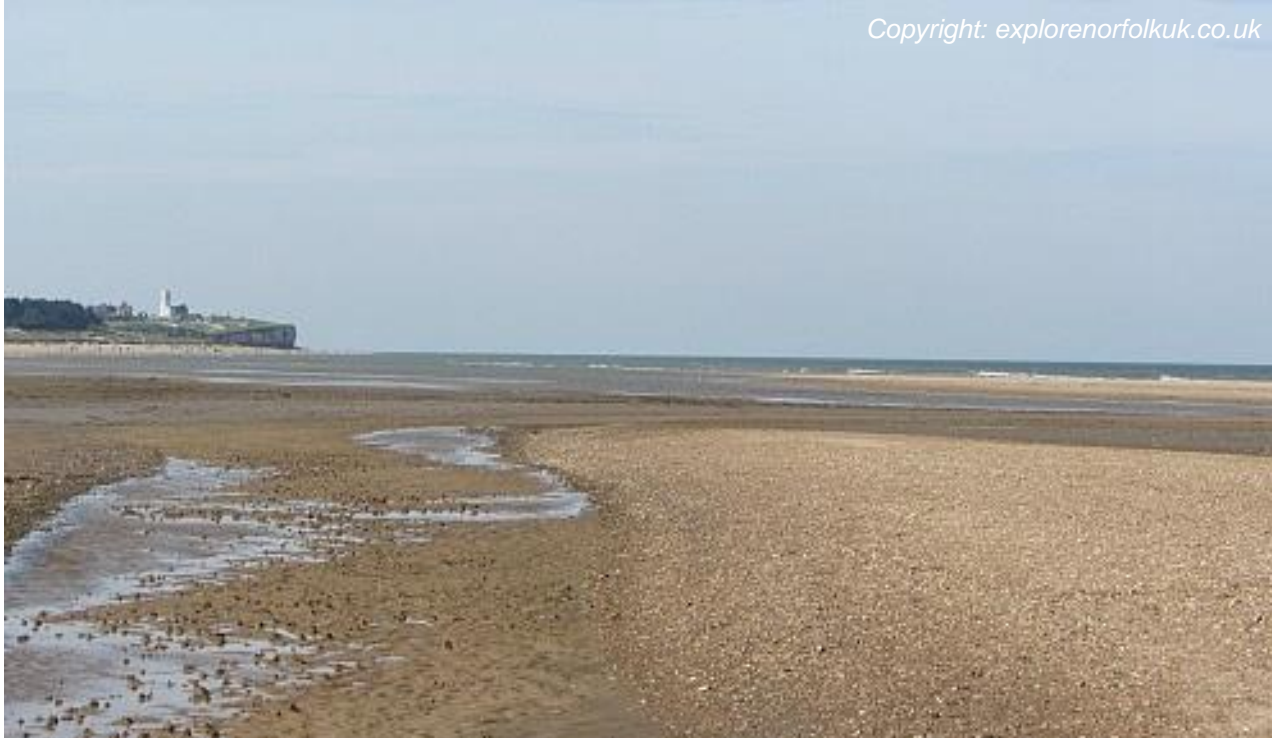
Why does sand not reach Hunstanton beaches?

Being pushed
back north

Evidence of sand
being moved
southwards

Waves

Currents

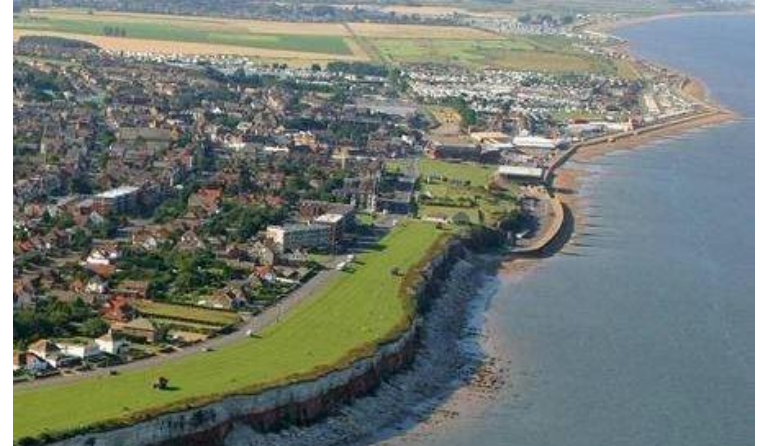
Conclusions

- 1) The groynes present along this frontage are largely ineffective in their current state.
- 2) Although groyne condition is a factor, their design, combined with an absence of sediment supply, means that effectiveness would remain limited even if rebuilt to an improved standard.
- 3) To have larger sandier beaches along Hunstanton frontage will require a different approach.

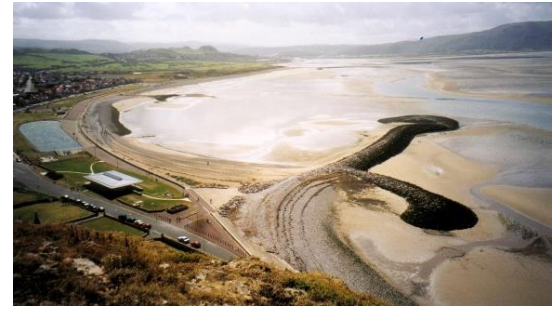
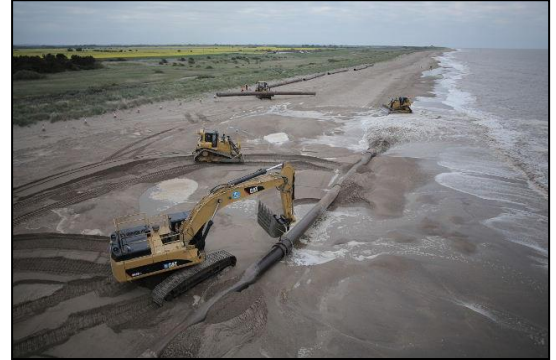
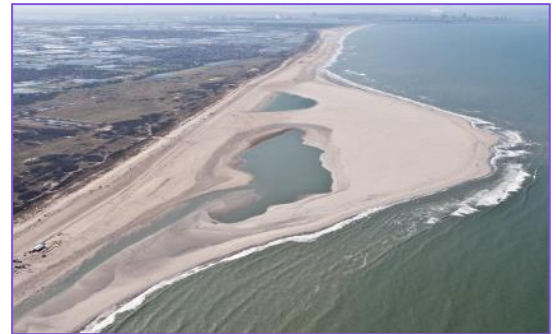
Other options for a beach

If beaches required, then different and more effective options will be needed – for example:

- Larger and different structures to control the waves and currents that affect stability of the beach, e.g. to create more stable 'embayments'
- But lack of natural sediment supply will almost certainly also require beach nourishment
- Also ways to recharge without structures, e.g. mega-nourishment schemes

Note that these would required comprehensive assessments to determine likely effectiveness, costs, and potential implications of the redistribution of the sediment across the sensitive environmentally sites within The Wash
