LOCAL SEA DEFENCES

WOLFERTON CREEK TO SOUTH HUNSTANTON

WINTER 2023 UPDATE

UNIT C: SOUTH HUNSTANTON TO WOLFERTON CREEK

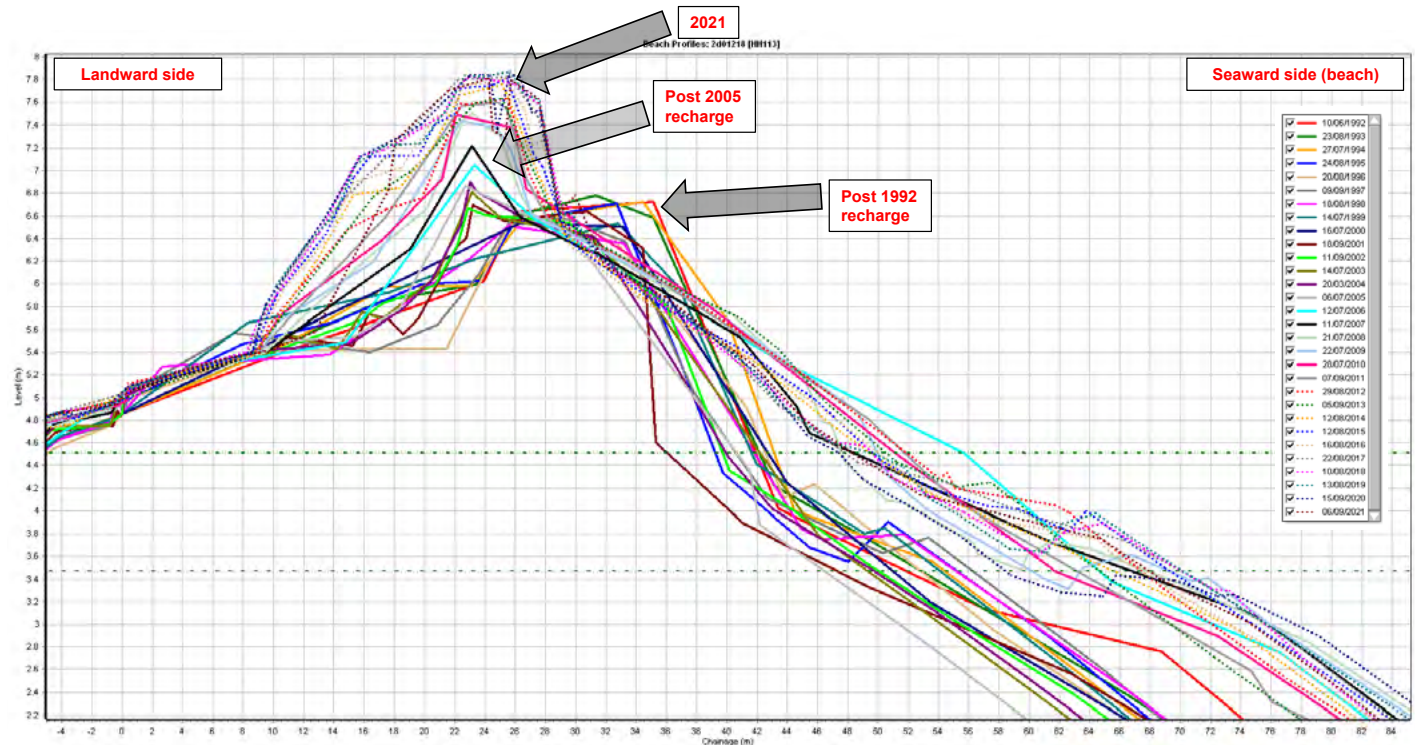
The graph below shows monitoring data of one section of the shingle ridge undertaken on an annual basis by the Environment Agency between 1992 to 2021. The coloured lines show the profile of the shingle ridge taken

each year and depict how the shingle ridge has changed over time. The right-hand side of the graph represents the seaward side of the ridge (the beach) while the left-hand side represents the landward side of the ridge.

The bottom arrow shows the profile of the ridge following recharge in 1991-92. The middle and top arrows show the profile of the ridge in 2005 and 2021 and show that this section of ridge has moved landwards by approximately 8-10 metres and grown in height by approximately 1.5 metres.

Monitoring data of the shingle ridge undertaken by the Environment Agency has identified that since 1992 the shingle ridge has been moving landward and growing in height. In some locations, the crest (top) of the shingle ridge is now approximately 8-10 meters further back and approximately 1.5 metres higher than it was in 1992.
