**Contaminated Land  
Inspection Report**

**Mill Road,  
Burnham Overy Town**

**July 2025**

**Reference no. 022134**

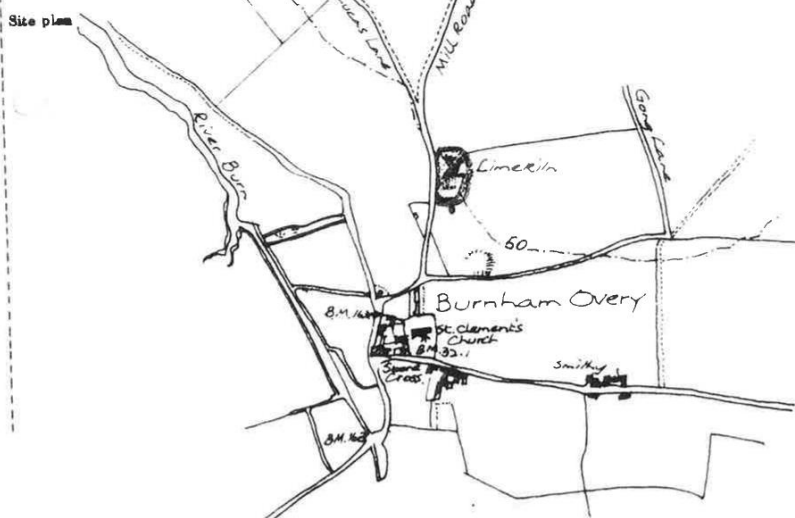
Disused chalk pit; sides and floor of pit in Upper Chalk which is probably hydraulically linked to the alluvium of the River Burne which flows 1/3 mile west of the pit.

(9) Original surface elevation of a point marked on diagram in feet AOD = 72  
 (10) Approximate maximum original depth at tip:- 65 FT  
 (11) Site area: 3 acres  
 Scale:- 1:10000
