Hunstanton Coastal Defence Emergency Works FAQs

A series of frequently asked questions (FAQs) have been produced by the Borough Council of King's Lynn and West Norfolk following a large void developing beneath the Hunstanton Coastal Defences, resulting in a subsequent collapse of part of the asphalt surfaced promenade.

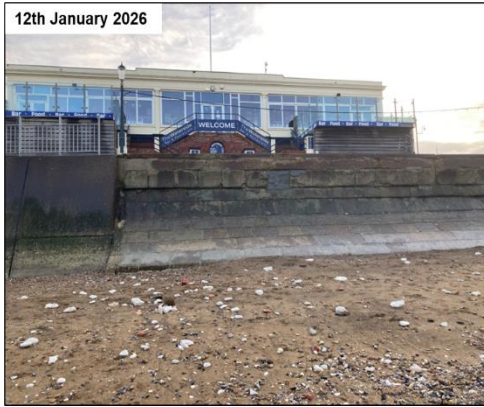
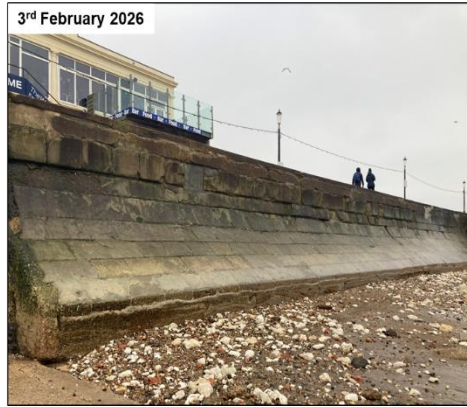
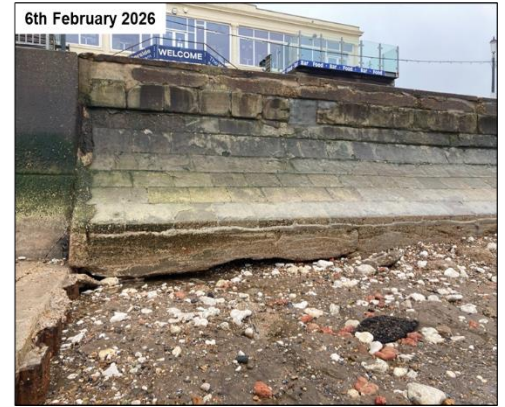
High tides combined with strong winds resulted in further erosion of beach material at the base of the Hunstanton Coastal Defences. This resulted in a further 20cm to 30cm of beach material erosion leading to the base of the seawall becoming exposed.

This meant waves were able to travel beneath the base of the seawall and washout internal fill material leading to a void developing. This void resulted in a lack of structural support to the promenade deck above, leading to its collapse and a hole at the surface forming.

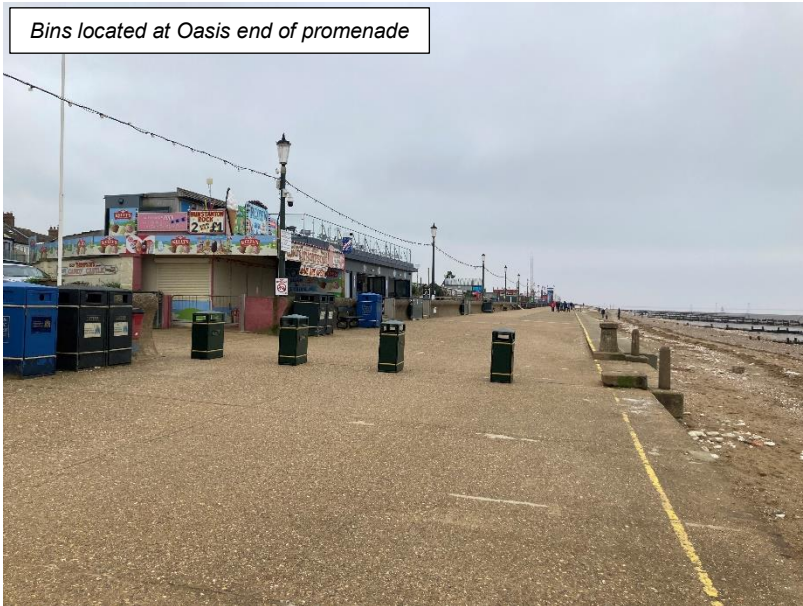
Bins located at Oasis end of promenade

It will take 28 days for the large volume of concrete used to fill the void to fully cure and reach its maximum designed strength. Litter bins have been placed on the promenade to act as a barrier prevent vehicle access along this section of promenade during this period.
