HUNSTANTON HERITAGE GARDENS

CONDITION SURVEY

HERITAGE LOTTERY FUND
PARKS FOR PEOPLE PROGRAMME

ROUND 2 APPLICATION FEBRUARY 2016

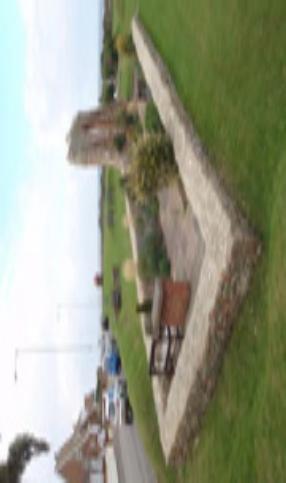
Item	Element and Description	Condition and Recommendation	Repair Category	Photograph
CLIFF PARADE STRUCTURES				
3.1 St. Edmund's Chapel Ruins	<p>Generally; roof less masonry ruin oriented east to west.</p> <p>Repaired and tiled arch installed in the early 20C using some original masonry. The plan form is assumed to be defined by extant, dressed, Barnack masonry at the locations identified on plan and archaeological evidence. Photographic evidence shows that the perimeter walls were reduced, buttress B3 added and the south face of the south wall re-faced in the late 20C.</p>	<p>Mixture of mortars, lower walling has received most attention. Larger masonry units to interior. Limestone shaded on bedding plane. Gritty mortar more visually successful.</p> <p>Develop a palette of repair mortars with a prescribed mix, aggregate and particle size and record for use/replication in future repairs.</p>	2

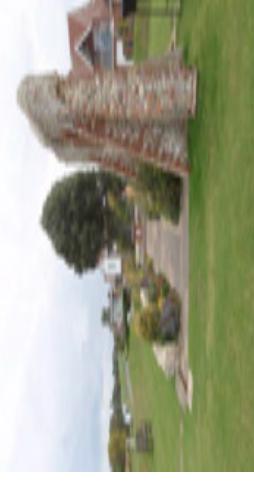
3.1.5	B2., As B1., 1 moulded stone to east, redressed.	Sound, repoint east face.	2	
3.1.6	B3., Mixed brick quoins and brick "tie" course at approx mid-height. Mortar skirt.	Pocket at north east and vegetation growth at low level. Eroded at head north-east & west. Unsupported at base to west. Insert masonry to fill pockets and re-support. Repoint at head to weathering profile.	2

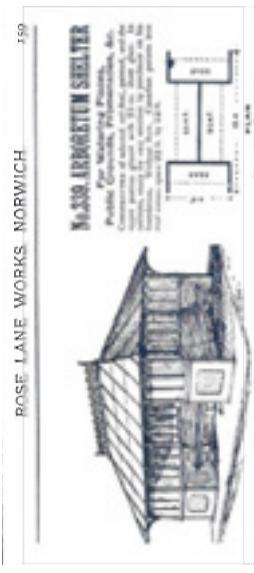
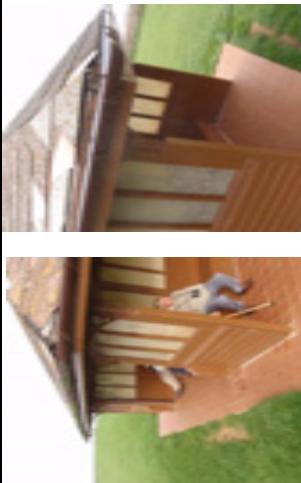
3.3.1

3.3.2	Roof; Approx. 30° pitch. Covered with fibre cement slates - original/earlier ones are pink, repairs in smooth grey. Slates mitred only at hips. No ridge capping.	6 slates missing to south slope and 6 mismatched. 3 slates missing to north west hip, west pitch and 14 mismatched. 2 slates missing to hips and 1 mismatched north slope. 5 slates missing south east hip + 6 + 4 mismatched to east pitch. Weathering to hips and ridge suspect, flash band in evidence. Very little projection of slates at eaves. Roofing felt perished and not dressed over eaves or into eaves gutter. Strip and replace roof covering, inspect and repair roof structure.	1

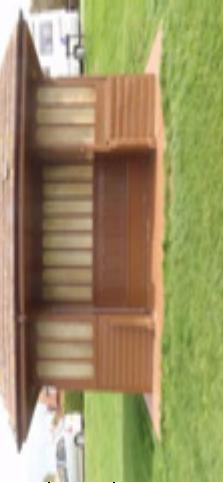
Item	Element and Description	Condition and Recommendation	Repair Category	Photograph
3.3.4	<p>Timber structure and boarded roof soffit. Divided into bays by moulded plates. Outer moulded plate to perimeter.</p> <p>Cast Iron brackets support beams/plates at roof soffit. Structure formed of braced panels rather than substantial posts.</p> <p>Moulded posts, 4No. at low level mounted over masonry (concrete?) plinths and bolted to panels.</p> <p>Ship lap boarding panels to north east & south east, north west & south west. South west panel possibly original.</p>	<p>Fair. Painted timbers cover decayed sections. Research system/sectional building type and repair to original form.</p> <p>Some cusping missing to cast iron brackets. No action.</p> <p>South east post split and decayed. Repair/replace in selected durable timber.</p> <p>Poor. Repair all to match the section size and profile of the original and in selected durable timber.</p>	3

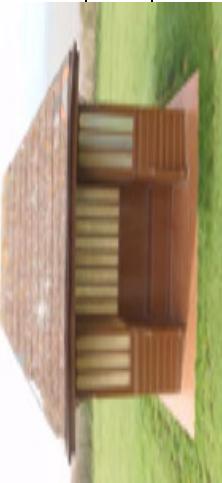
3.3.5	<p>Straight panelled backs to seats, and vertical boarding to stall risers.</p> <p>? Steel pipe/conduit at internal corners.</p> <p>Reinforced polycarbonate/glassfibre, translucent glazing in narrow vertical panels, arch headed, above dado level.</p>	<p>Mis-matched vertical boarded back to south. Low level boarding to south stall riser, end grain vulnerable. Replace to match remainder.</p> <p>Yellowed with age shabby and unsightly. Durable replacement panels desirable.</p>	2

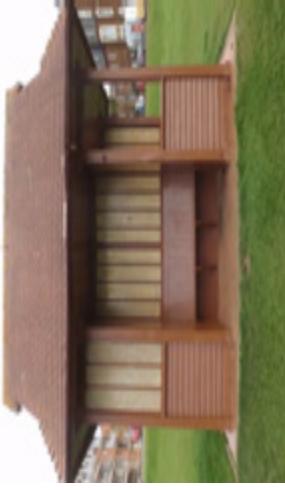
Item	Element and Description	Condition and Recommendation	Repair Category	Photograph
3.4	South Shelter			
3.4.1	Roof; Concrete machine made tiles + bonnet hips and half round ridge. Approx. 40° pitch with boarded gablets to north & south. Copper apron flashings to base of boarding. Fibres cement eaves soffit to gablets.	5 missing tiles east pitch. 9 mismatched and 1 missing to west pitch. 1 broken to north pitch. Roofing felt not seen. Replace missing, broken and mismatched tiles.	2

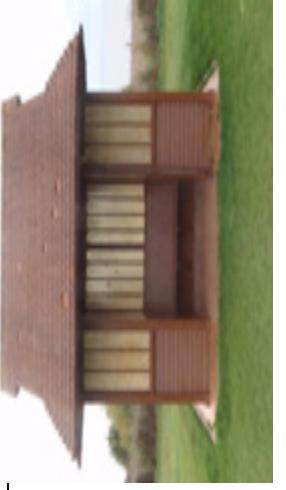
3.4.2	Rw goods; plastic. [brown]	West rwp broken and discharges at high level. East rwp is without a shoe to divert discharge at the base. Consider removal or replacement with cast aluminium rw goods.	2

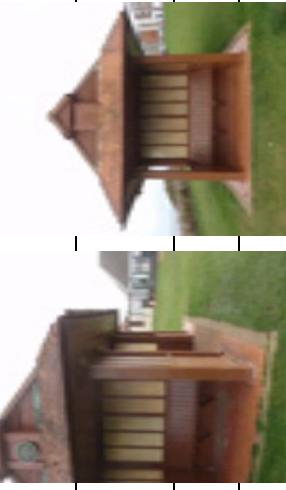
3.4.3	Timber structure; 8no. timber posts to main structure set over 100mm x 225x 225 sandstone plinths. 160x160 timber posts with moulded caps. Vertical boarding to dado/cill & raking seat backs panelled below. Boarded soffit to roof overhang. Ship lap boarding over timber sole plate to east & west panels. Plain panels to north & south internally.	In good order. Timber sole plate suspect at south east. Remove paint and repair in selected durable timber.	3

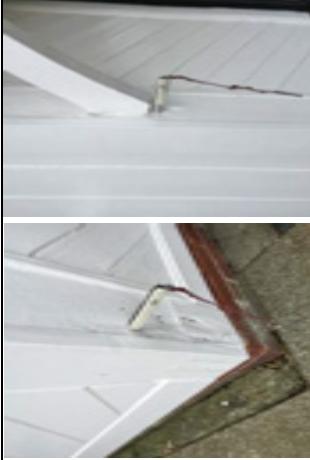
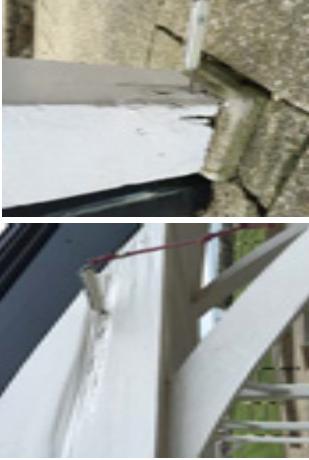
Item	Element and Description	Condition and Recommendation	Repair Category	Photograph
3.5.3	<p>Timber structure; 4No. verandah posts with arch braces and shaped timber fascia.</p> <p>Central door to west. Diagonal boarding to panels between posts with planted edge beads to west elevation, 4 panels either side of door. Vertical boarding to north, east [narrower/original] and south elevations. Pent roof bracketed off south elevation over hatch opening.</p> <p>Profiled gable barge boards.</p> <p>Boarded sloping soffit to verandah.</p>	<p>Corner post and boarding decayed at north west and diagonal boarding added to north elevation at NE and NW. Remove additional elements and repair original fabric in selected durable timber to original profile.</p> <p>Decay at mortices to arch braces, remove paint for inspection, allow to piece in, insert boron rods and monitor.</p> <p>Verandah posts set over stone plinths. North west verandah post base decayed. Repair original fabric in selected durable timber to original profile.</p> <p>Some decay at end grain and disruption at change of pitch. Repair original fabric in selected durable timber to original profile.</p> <p>Decorations in good order, paint build up masks decay and retains moisture, periodic removal desirable. Black and white paint scheme questioned. See early photograph above.</p>	2 3 3 4

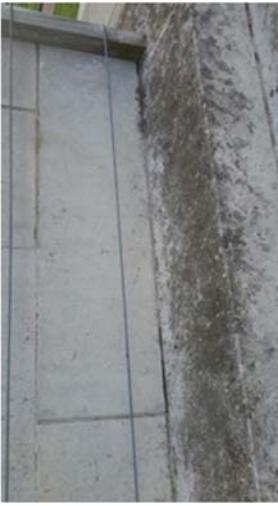
Lichen growth to base

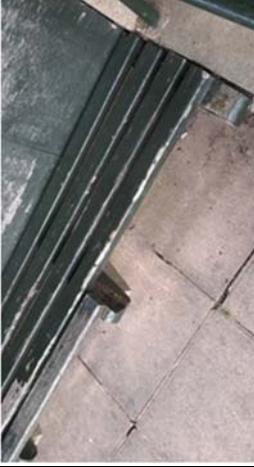
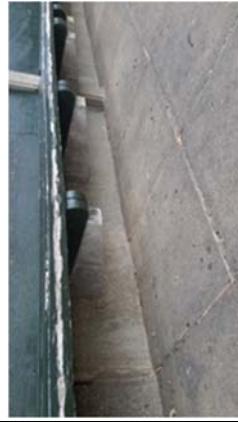
Item	Element and Description	Condition and Recommendation	Repair Category	Photograph
3.10.3	Benches: Painted dark green timber boarded benches supported on cantilevered concrete supports sat on concrete block wall at base. Back of bench formed in painted plywood with timber deck capping. See comments under roof 3.10.2a for replacement strategy or 3.10.2b for repair.	Timber boards in poor repair with paint flaking and boarding missing in certain locations. Timber profiled brackets which support slats are rotting in areas where slats are missing. See comments under roof 3.10.2a for replacement strategy or 3.10.2b for repair.

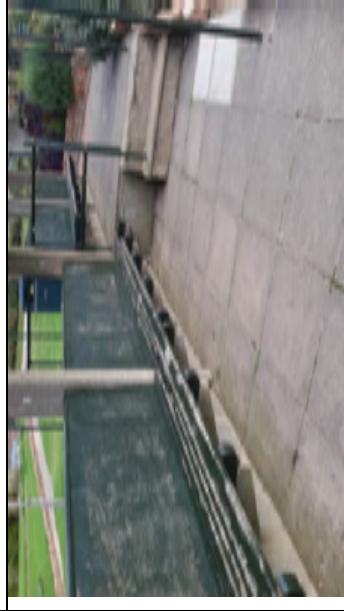
3.10.4	External areas: Concrete 600 mm square paving slabs with 2 no. cast concrete steps and green painted key clamp style railings where there is a level change. Pink carstone retaining wall with no capping and hard mortar.	See comments under roof 3.10.2a for replacement strategy or 3.10.2b for repair.

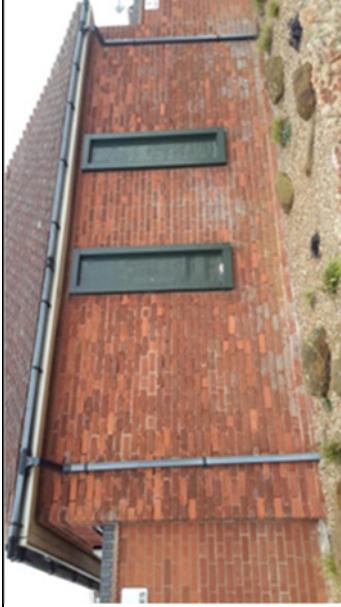
3.11.2	<p>Walls:</p> <p>Red brick stretcher bond brickwork with hard coloured cement pointing. Green painted concrete (?) inset panels to all 4 elevations (2 no. large door sized panels to east elevation, 2 no. thin slot type panels to west elevation, 2 no. joined long horizontal panels to south elevation, 3 no. joined long horizontal panels to north elevation). Note: no windows. Ladies metal sign mounted to north elevation.</p> <p>Separate external walls to shelter WC entrances. These are red brick with engineering brick on edge coping and 2 course plain tile creasing. Ladies and gents metal signs mounted to west elevation brick wall. These are a later addition to the Toilets, presumably to provide increased privacy (built after 1978).</p> <p>The Disabled WC appears to be a later addition – could have been introduced at the same time as the out of hours W/C to the East elevation.</p>	<p>Mortar pointing to the west elevation bricks (facing the sea) are eroded and open. Evidence of previous repairs to pointing can be seen. Area to rhs is likely to have been exacerbated by downpipe not being connected to swan neck. Upon completion of rainwater pipe replacement works, repoint open joints.</p> <p>The green painted panels have areas of paint failing. Opportunity for interpretation panels? As a minimum, a thorough preparation and redecoration scheme needed.</p> <p>To South elevation, area of poor repair has been carried out near the entrance to the Male WC. This looks unsightly, and could be repaired to match existing brickwork.</p>	<p>1</p> <p>2</p>

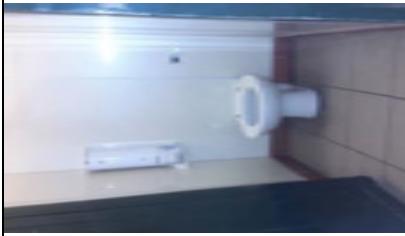
Item	Element and Description	Condition and Recommendation	Repair Category	Photograph
3.11.6	<p>Internal female toilets:</p> <p>Tiled ceramic floor 300 mm square with SS Wade gullies (2 no.).</p> <p>Red tile skirting and laminate panel easy clean wall panels with vertical jointing strip.</p> <p>White UPVC ceiling boarding with 16 no. Ceiling mounted plastic bulkhead lights. 2 no. not functioning at time of inspection.</p> <p>6 no. separate WC cubicles.</p> <p>Cubicles formed in wall construction as before with painted green timber boarded ledged and braced doors. Cubicle walls do not go up to ceiling. Cubicles have white ceramic back to wall WC with automatic flush sensor to back wall and white painted metal toilet roll dispenser mounted to back wall.</p> <p>Baby change facilities consist of laminate counter top with baby change table with strap.</p> <p>2 no. Inset wall mounted SS automated soap dispenser, hand wash and dryer.</p> <p>1 no. Wall mounted bin.</p>	<p>All in good order.</p> <p>1 hand wash station has note "hand dryer of short duration". Carry out check of unit.</p> <p>Bin is rusting and looks poor. Replace.</p> <p>Timber cubicle doors to be redecorated.</p>	<p>1</p> <p>1</p> <p>2</p>

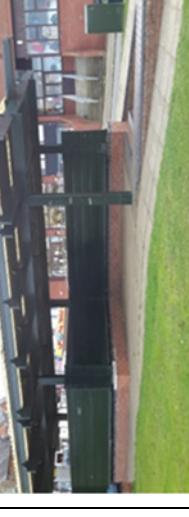
3.12	South Shelter and seating	
3.12.1	Roof Profiled single layer plastic sheeting roof with felt lined centre gutter with fall to west end discharging over steps.

<p>Originally translucent sheeting has moss growth and rusting fixings throughout. Section of roof broken and missing to west elevation. Unable to see inside central timber gutter but likely to have moss and general build-up of detritus based on condition of roof sheeting.</p> <p>Given the issues with the roof, replacement of the roof covering and support is recommended using a new zinc lining for the gutter and new GRP sheeting.</p> <p style="text-align: center;">1</p>

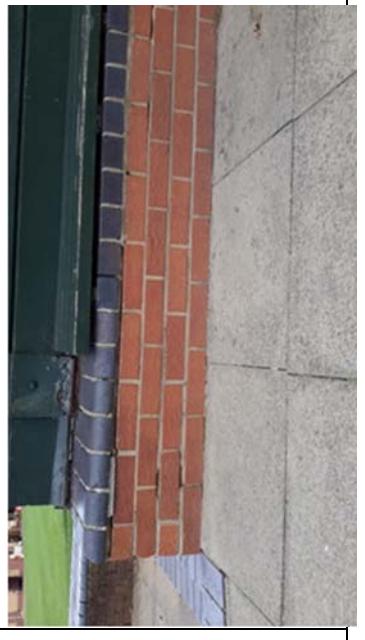
3.12.4	Benches Painted timber benches (205 x 45 mm slats) supported on timber bearers and engineering brick and red brick base (4 courses red brick in stretcher bond and single engineering brick header course) with cementitious mortar. Where brickwork extends beyond bench locations, engineering brick has bullnose profile.	Evidence of red brick corner repairs to 4 column locations and cracks have appeared 1 brick further from repair area to south side. Extensive movement with joints open up to 20 mm between engineering brick course and red brick course, particularly on south elevation. Without significant investigations and review of existing foundations, movement can only be monitored rather than arrested. Locally repoint and re-bed loose bricks. Timber forming seats has exposed areas where paint is failing and has rotated in some areas so does not sit horizontally. Locally lift and re-fix to sit horizontally. Allow	1 1

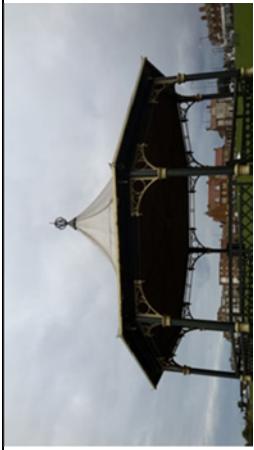
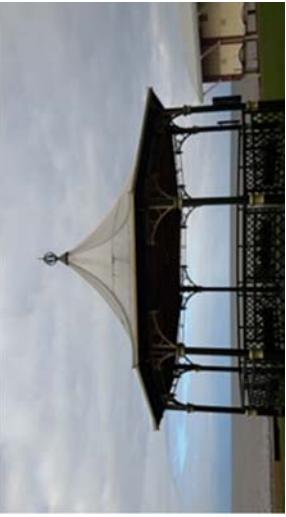
3.13	Bandstand	Some staining apparent between uppermost and middle sheet and water run off marks. Top capping has rust staining. Painted eaves trim and soffit to elevations closest to sea has rust marks and areas of flaking paint. These would benefit from thorough preparation and redecoration scheme.	5 2

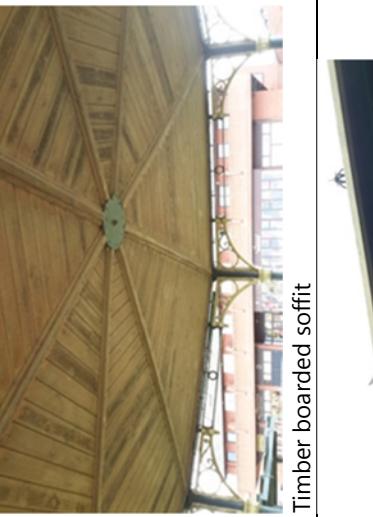
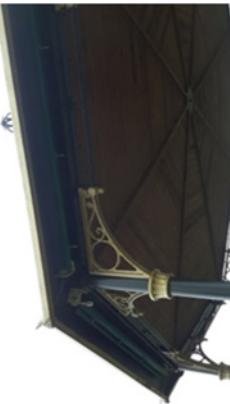
Item	Element and Description	Condition and Recommendation	Repair Category	Photograph
		Timber soffit generally appears sound with some mould evident but no damp stains suggesting roof does not leak (note: no rain at time of inspection). Centre fixing plate has exposed rusting cross head screws and flaking paint exposing rusting metal plate beneath. The plate would benefit from thorough preparation and redecoration scheme.	2

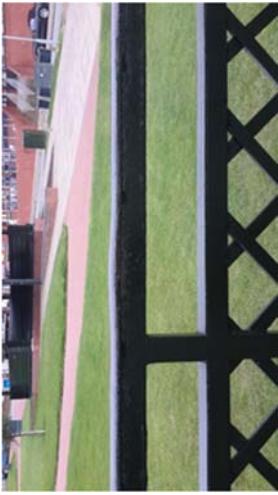
3.13.2	<p>Painted metal columns and infill railings.</p> <p>Columns (8 no.) have patterned metal panels spanning between each column to support roof structure and "ollerton preston..." inscription at base. South East column has padlocked access panel facing internally within bandstand.</p> <p>Railings have diagonally painted metal pattern and bolted to columns. 2 no. Support brackets fix to railings for green plastic planters.</p> <p>Roller blinds to 6 facets (not over entrance). Roller blinds were not checked for operation.</p>	<p>Generally in good condition with minor areas of rust staining from failing paint finish. These would benefit from thorough preparation and redecoration scheme.</p> <p>Rust affecting 1 capping to railings causing minor delamination. These would benefit from thorough preparation and redecoration scheme.</p>	3

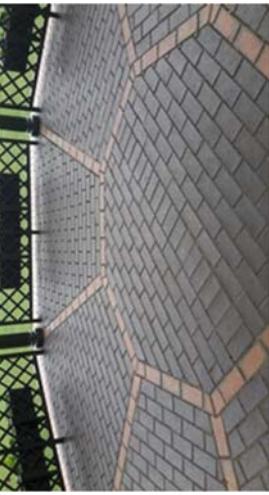
Item	Element and Description	Condition and Recommendation	Repair Category	Photograph
	<p>Block paving finish internally with red inlaid stretcher pattern to match facets of roof above. Cementitious mortar joints.</p> <p>First 2 joints to the edge are generally open where rain likely to wash out mortar jointing. These would benefit from repointing.</p>	<p>Grass and plant growth forming in open joints particularly around column bases. Joints to be cleaned and treated with biocide and local repointing where necessary.</p> <p>First 2 joints to the edge are generally open where rain likely to wash out mortar jointing. These would benefit from repointing.</p>	2

<p>Vegetation growth to block paving</p>

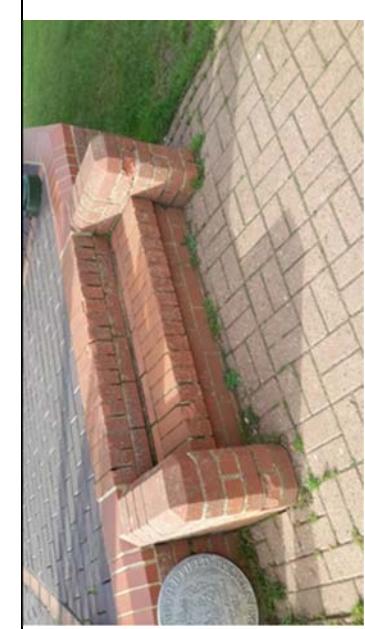
3.13.4	<p>Steps and block paving Softer red brick steps up to bandstand platform, with brick on edge detailing and 2 dwarf walls.</p> <p>Block paving laid in square pattern with open joints.</p>	<p>Bricks are eroded on their exposed external corners from wear and tear. Moss growth to joints. Treat with biocide and clean off. In the long term, the steps should be replaced.</p> <p>Block paving has grass growing through joints. Treat with biocide and clean off.</p>	<p>2</p> <p>2</p>

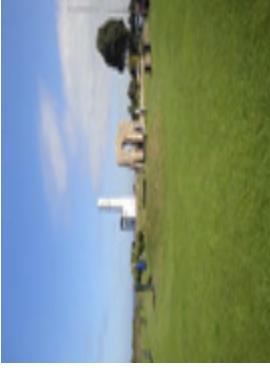
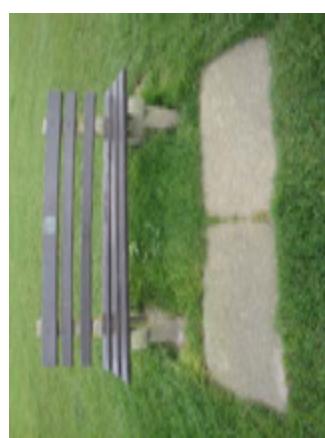
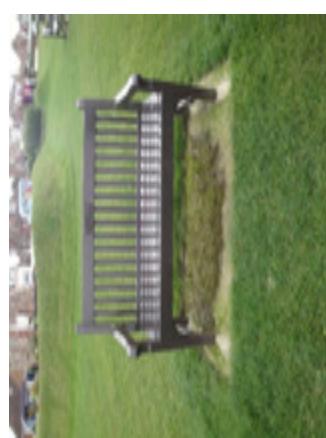
Item	Element and Description	Condition and Recommendation	Photograph
EXTERNAL			
4.1	CLIFF PARADE The Cliff Parade is a long narrow area of grass at the north of the site, on top of the cliffs. It leads from the Salad Bowl Café at the most northerly end of the Esplanade gardens, to the Lighthouse. This area is mostly open grass with scattered benches and three small pavilion buildings. At the northern end there are the ruins of St. Edmunds Chapel.	<p>The benches all appear to be different ages, however none is in a poor condition, and all could be remedied with small interventions.</p> <p>The bases of some of the benches require some attention. Some of the PCC slab bases are not level, and some concrete bases are developing a large amount of moss.</p> <p>Many benches are close to the cliff edge and will need to be relocated if they are not to be lost when further erosion occurs. Any changes to memorial benches should be carried out in consultation with those who donated the bench.</p> <p>There are five timber benches around the outside of the ruins facing in. These are generally of a similar style and condition to those along Cliff Parade.</p> <p>There are two benches within the ruins themselves, these are also timber but are of different styles, one which is a smaller bench dedicated to Captain Fryatt, and one which is a large curved bench dedicated to Edith Cavell. The smaller bench has some signs of rot.</p>

4.1.1	Bench Seating There are 30 benches along Cliff Parade, the majority of which face towards the sea. The benches are predominantly timber garden benches, the majority of which are for memorial. Although being of a similar style, the timber benches are not all the same design. Only one is not a timber garden bench, but has a concrete frame and timber seat and back. All benches are mounted on either a concrete or PCC slab base, with the exception of the concrete frame bench.

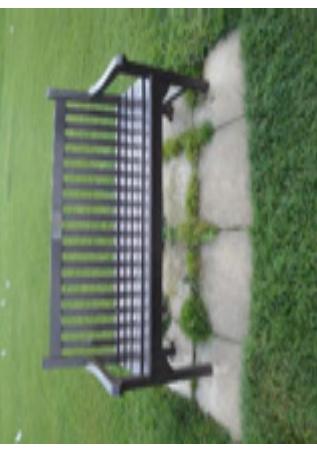
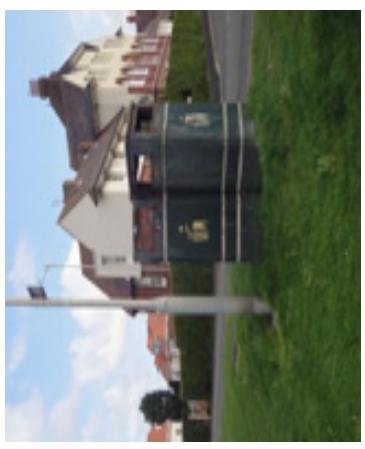
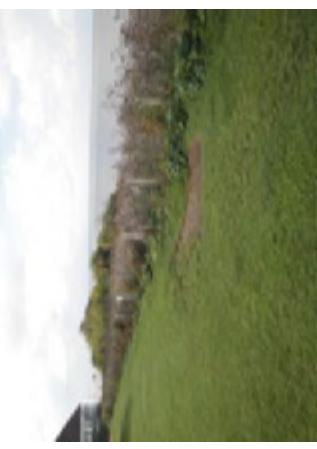
4.1.2	<p>There are three litter bins adjacent to the road along Cliff Parade.</p> <p>There are also eight dog bins in this area which are along the fence line. These are not the same traditional style which are in The Green, but are the modern red type.</p>	<p>One litter bin is in a poor condition and will require replacement.</p> <p>The fences are in fair condition although overgrown with climbers in places.</p> <p>As the fence is a short-term solution to the receding coastline, a higher quality solution is not appropriate.</p> <p>The scrub behind the fence is difficult to manage as it is a hazard to access for maintenance. The scrub is also beneficial to wildlife and should be retained.</p> <p>The cliff edge is protected by a low concrete post and chain-link fence. There is a small section of the fence which is concrete post and wire, and a small section which is timber post and chain-link.</p> <p>The area between the fence and the cliff edge is unmanaged and predominantly scrub. As the cliffs are eroded and recede, new fences are put up, leaving several lines of old fencing behind the main fence line.</p> <p>There is also a bird knee rail around the parking area behind the Salad Bowl Cafe.</p>

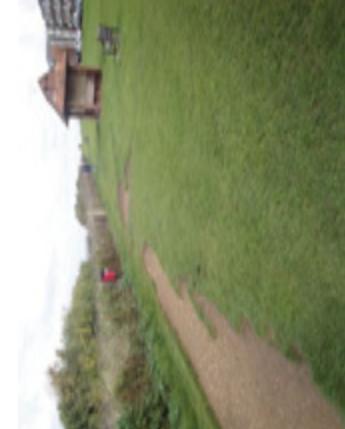
Item	Element and Description	Condition and Recommendation	Photograph
4.1.4	<p>The Wolf Trail starts at the Esplanade Gardens and runs through Cliff Parade, concluding at St. Edmunds Chapel where there is a statue of the wolf. The trail consists of timber posts which are numbered and each contain an image and caption denoting a part of the story of St. Edmund.</p> <p>The starting post is in the Esplanade Gardens, the remaining five posts are along the Cliff Parade.</p> <p>This trail runs in conjunction with a leaflet which has a map and more information on St Edmund generally, and specific information about each trail point.</p>	<p>This boundary could be improved by installing a new line of fencing, away from the cliff edge, and planting a hedge behind this.</p> <p>The posts themselves are in good condition, as is the wolf statue. Improvements to consider would include: making the trail more visually appealing to children; adding play elements into the trail points; and displaying concise information at the trail points themselves, so they could be informative without the leaflet.</p>

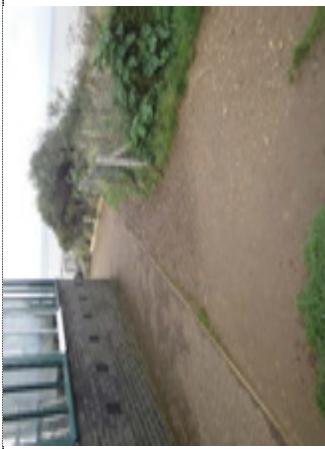
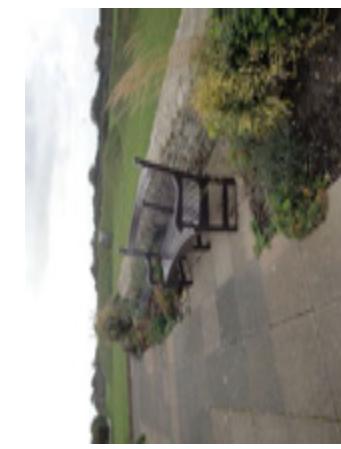
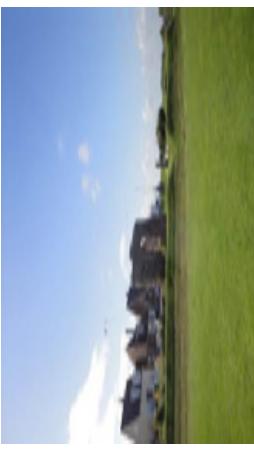
Item	Element and Description	Condition and Recommendation	Photograph
4.1.6	St Edmund's Chapel Garden For information on the structure itself and paving, please refer to the Architect's Conditions Survey. The garden consists of some planted beds within the chapel ruins, a planting bed outside the chapel ruins where the wolf statue is situated, and bench seating. The area is enclosed by grass mounds.	Access to the ruins is down steps, and there is also a stepped area within the ruins themselves. The planting area could be extended and enhanced inspired by historic photographs.

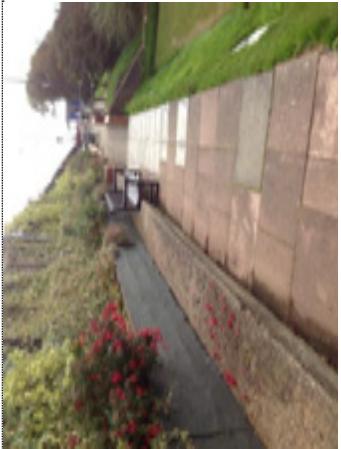
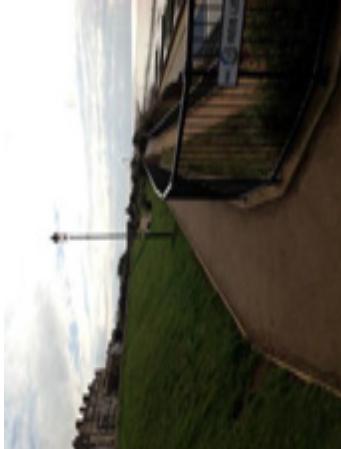
Note: move large boulder located in paving at base of bowling green steps

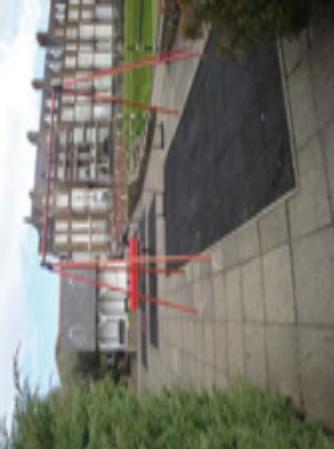
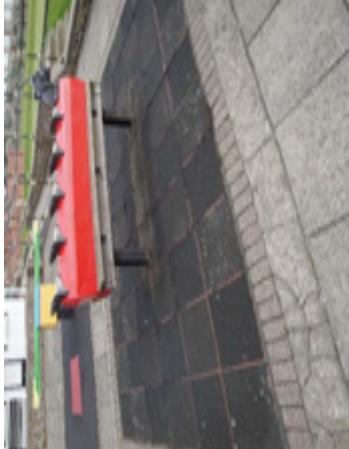
Item	Element and Description	Condition and Recommendation	Photograph
4.2.11	<p>Children's Play Area</p> <p>The play area has three pieces of equipment: a 3m set of two swings, a Wicksteed Rocking Horse – Heritage, and a Wicksteed See-Saw – Heritage.</p> <p>These each have a perimeter of rubber tiles, whilst the rest of the area is paved in PCC slabs.</p> <p>There are three benches within the play area, and one outside the entrance to the pavilion, which also looks onto the play area.</p>	<p>Both PCC slab paving and rubber tile paving are in need of repairs.</p> <p>The pieces of play equipment are old and the three disparate elements make the space quite static and uninspiring. The layout of equipment is also not good from a safety point of view, and the area is quite constrained.</p> <p>The design of alternative play facilities in a larger area is recommended.</p>

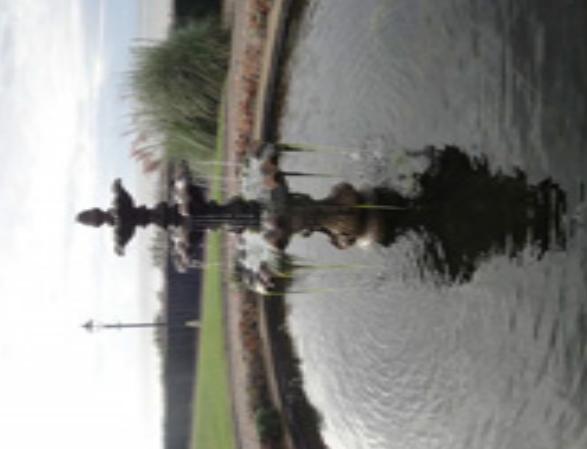
Item	Element and Description	Condition and Recommendation	Photograph
4.2.12	Fountain The fountain dates from the late 1920's, although the fountain structures has been replaced since that time. Photos dating from the 1930's show a low wall and planted surrounds	The fountain is in a poor condition with a damaged liner and old pump system. It needs a total overhaul which means dismantling and reconstructing the liner, base and walls.

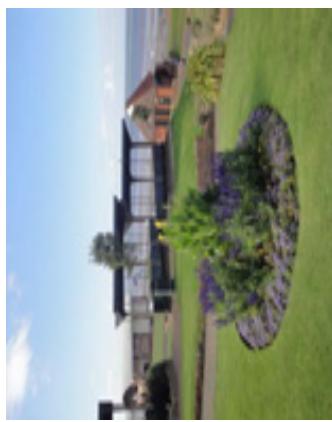
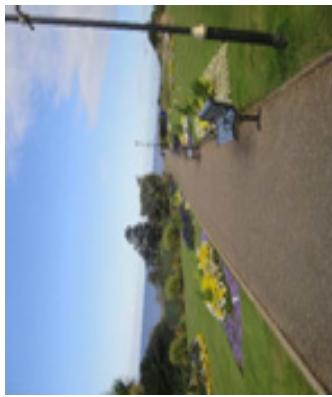
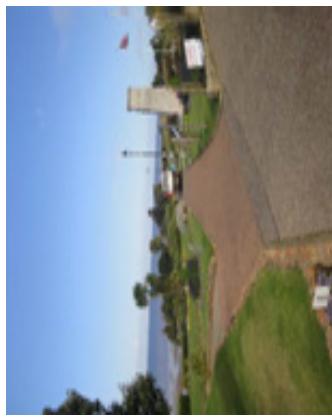
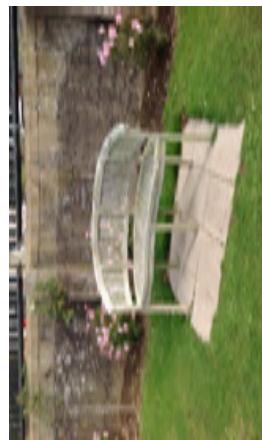
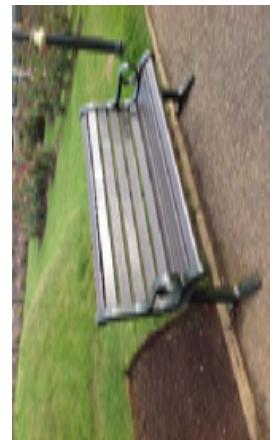
The seats are in varying conditions but are generally fair. It is however recommended that in some cases benches are changed to achieve more consistency in style. It may be appropriate to have different style benches in individual garden settings.

The recommended bench style for this area of the gardens is a timber garden bench.

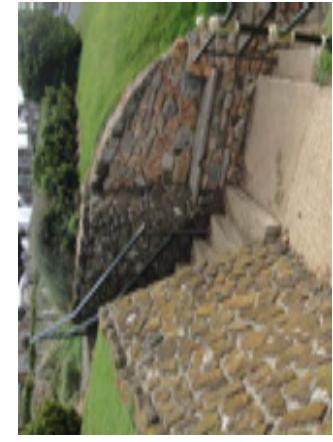
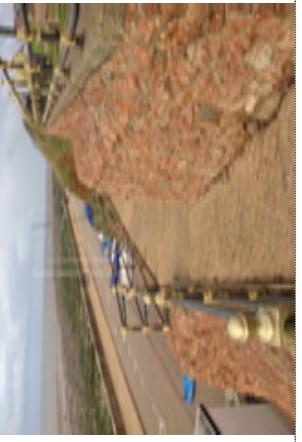
4.3.3	Railings & Fences The green and gold railings which are present on The Green and Seafront Slope are also present in the Esplanade Gardens. These are used as guarding at the cliff edge and also at the stepped and ramped areas down to the seafront. Also used in the stepped area is the box-section style of green railing that is present on the Seafront Slope. The railings used at the boundary with the Cliff Parade Road are different in style again, and are known as the 'toast rack', although these too are painted green and gold. There is a close-board timber fence which is in place around the Sailing Club to guard against the change in level. This timber fence is painted green.	The green and gold railings and the green box-section railings are showing signs of rust. It is recommended that the railings are replaced with a consistent style of railing as on the Seafront Slope. The timber fence is worn and damaged in places. It is also visually obstructive and not in keeping with the character of the gardens. It is recommended that this fence is replaced with a suitable alternative. Handrails are short and do not meet current accessibility standards. It is recommended that they are replaced.

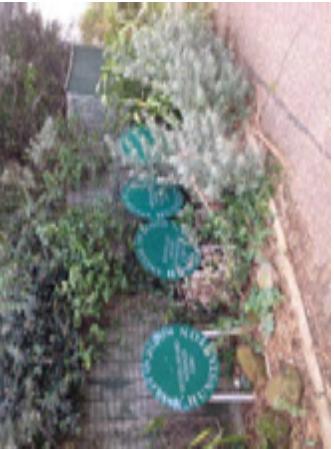
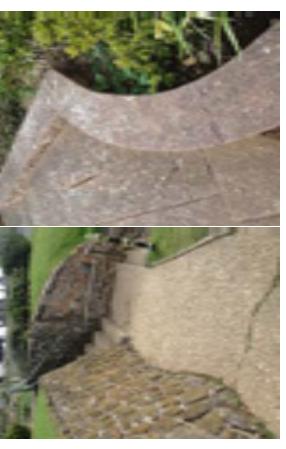
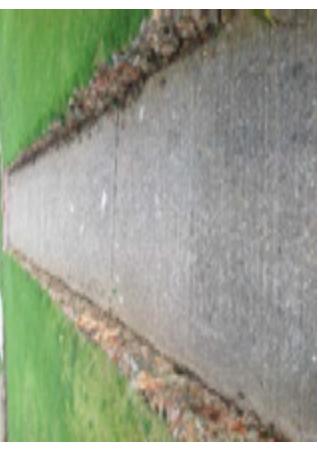
Item	Element and Description	Condition and Recommendation	Photograph
4.3.4	Walls	<p>In this area of the gardens, there are retaining walls on the western edge, leading down to the seafront.</p> <p>There are also low walls used to retain edges of lawn and planting beds.</p> <p>Most walls are constructed of carrstone, although red brick is also used in places. The coping of walls varies.</p> <p>Retaining walls look to be in a good condition generally, however this cannot be confirmed without inspection from a structural engineer. Refer to Appendix B for Engineer's Visual Inspection. Some areas of the walls require small repair, particularly to the coping.</p> <p>More damage is visible to the lower walls associated with the RNLI Garden. In some places repairs to coping will be necessary, other sections of wall may require replacing. More damage is visible in areas where there is no coping to walls.</p>

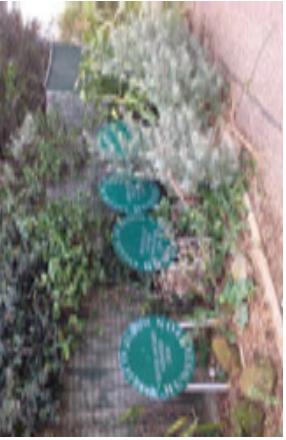
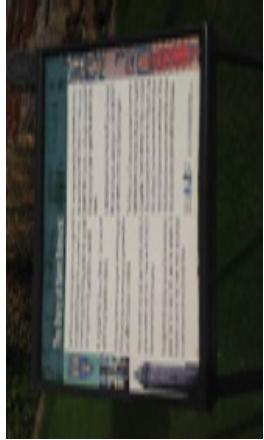
4.3.5	Signage	<p>There are two interpretation boards in this area of the Gardens. One of these is about St Edmund and marks the</p> <p>As in The Green, the interpretation boards are looking a little faded and worn and could do with replacement. The signage at</p>

Item	Element and Description	Condition and Recommendation	Photograph
	<p>beginning of the Wolf Trail and the other is part of the series of interpretation boards which is also within The Green and throughout the wider town.</p> <p>There is one Wolf Trail point immediately next to the St Edmund interpretation board.</p> <p>There are also a series of In Bloom award signs dating back many years. These are in the planting bed which is in front of the close board fence.</p>	<p>the beginning to the Wolf Trail could be rethought, to be more engaging for children.</p> <p>The 'In Bloom' signs make the area to the rear of The Sailing Club look quite cluttered, and some of the signs are starting to look faded. A better way of representing the awards won by the gardens should be sought.</p>

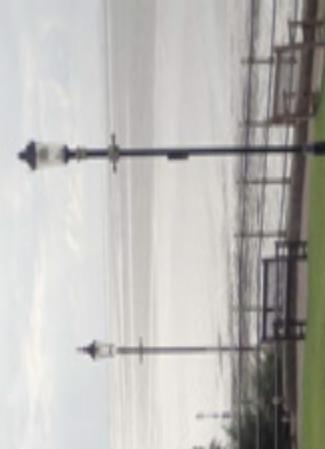
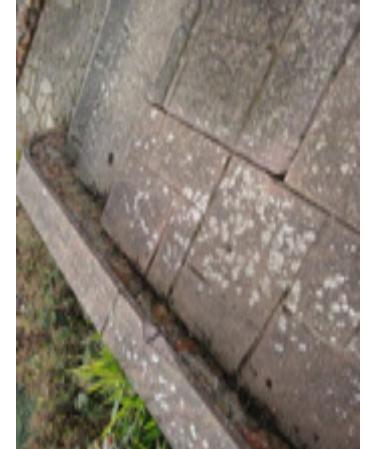
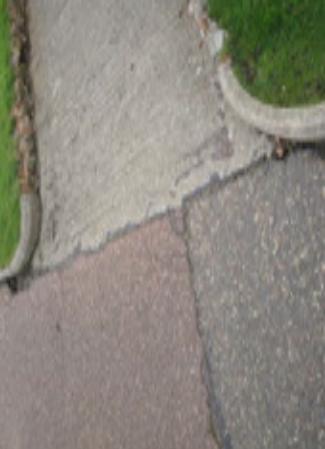
Item	Element and Description	Condition and Recommendation	Photograph
4.3.7	Paving As on The Green and the Seafront Slope, the paving is very varied. There are areas of patchwork paving, however there is sometimes logic to the change in paving, e.g. where there is a garden area or along some steps. Paving types include: tarmac of differing colours, crazy paving, PCC slab paving of varying styles, and concrete. Edging also varies, there are different PCC edging types used, and also carrstone is used as edging	Much of the paving is damaged and in need of repair. The logic of different paving styles needs to be given some thought, and where there are differing types, it would be better if these were consistent e.g. one colour of tarmac, one style of PCC slab. Edging also need to be replaced and a consistent strategy implemented. At the entrance to the gardens there is a dropped kerb between the road pavement and the path to the gardens, this should be resolved to improve accessibility.

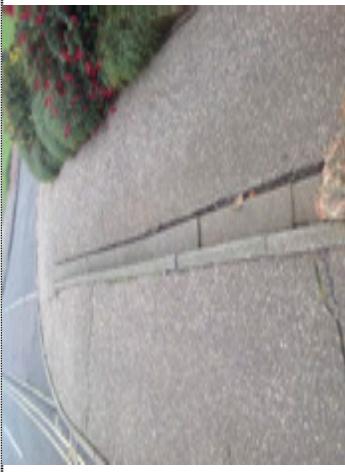
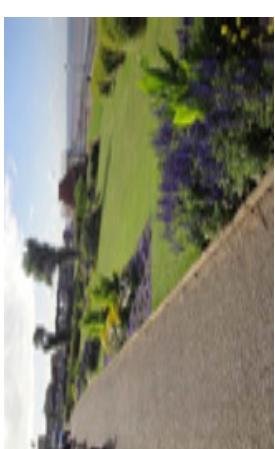
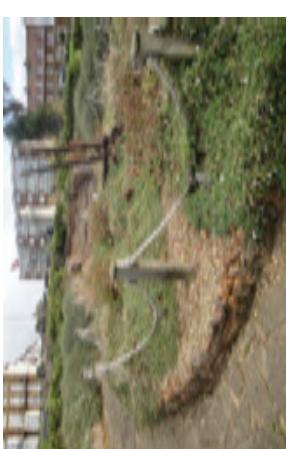
Item	Element and Description	Condition and Recommendation	Photograph
4.3.8	<p>Planting Beds</p> <p>There are many planting beds in this area of the Gardens, and also planting which forms individual garden areas within the space.</p> <p>Planting beds include: raised planting around the public toilets, a garden around the cenotaph, an RNLI garden, planting beds around the 'Butterfly Shelters', a small garden area adjacent to steps down to the seafront, planting beds along Reis Leming Way, boundary planting, as well as other planting beds which are in the lawn.</p>	<p>These are generally in a good condition and the adopt-a-bed scheme which is in place ensures that most of the planting is well maintained. The RNLI planting bed is looking worn and could benefit from repairs and redesign.</p> <p>The planting beds around the toilet block also need some attention, which would improve the setting of the building.</p> <p>There is the potential to develop more year-round interest and add interpretation, theming or significance to planting beds.</p>

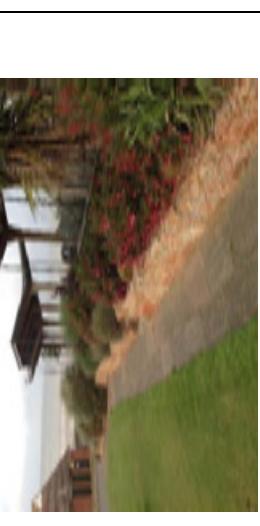
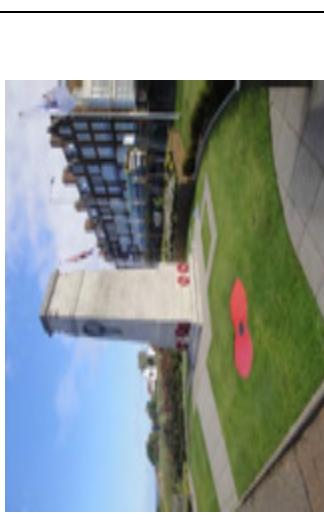
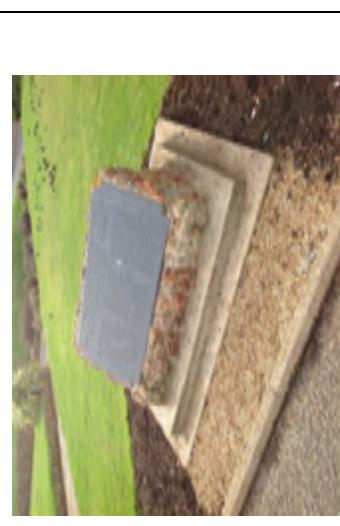
Item	Element and Description	Condition and Recommendation	Photograph
4.3.9	<p>Memorials</p> <p>There are two memorials in this area, the conditions of the physical structures themselves are covered in the architect's conditions survey.</p> <p>The Cenotaph is within a memorial garden, this consists of paving, border planting, a raised planting bed to the rear, and two concrete poppies which are painted red and black. There are two matching timber benches in this area.</p> <p>The second memorial is to those who lost their lives in the great flood of 1953. This is surrounded by a small planting bed.</p>	<p>The Cenotaph garden is generally in a good condition. However, the concrete poppies require regular painting and at the time of inspection were looking worn. The planting is vibrant in the summer but incorporation of year-round interest may be beneficial. The benches, which are different to others in the gardens are in good condition.</p> <p>The Flood Memorial is in a small area which could also benefit from more year-round interest. It could also be considered whether the Flood memorial should be relocated as it conflicts with use of this area during war memorial events.</p> <p>More could also be made of Reis Lening Way, which is currently denoted only by one signpost.</p> <p>There is currently a local proposal to name another path in the Gardens after another 1953 Flood hero, USAF Sgt. F.A. Kilpatrick, this is considered an appropriate way of commemorating the bravery of those who risked their lives for others.</p>

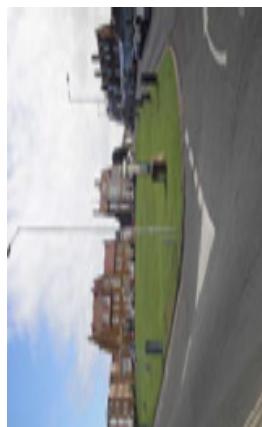
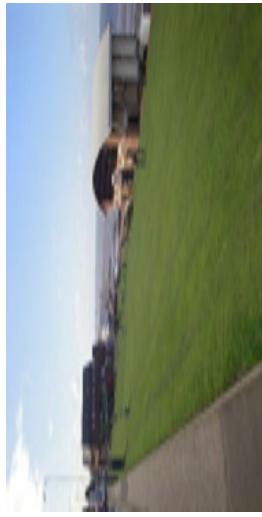
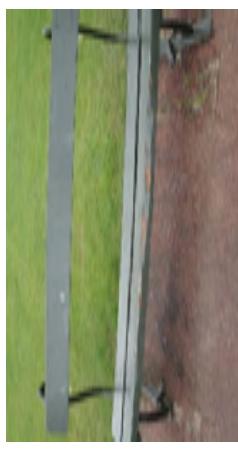
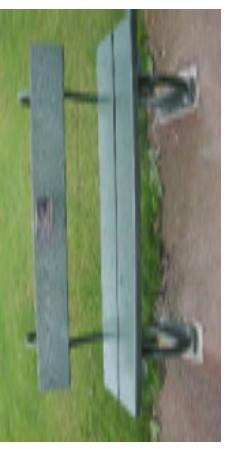
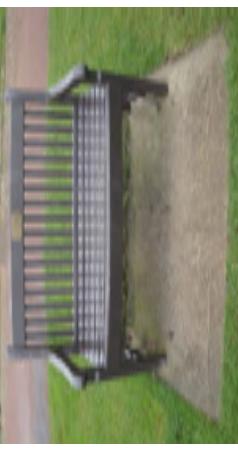
Item	Element and Description	Condition and Recommendation	Photograph
4.4	THE GREEN		
4.4.1	Bench Seating The Green is the southernmost area of the site. It is characterised as a large open space, sloping east to west towards the seafront. The Green is split in two parts, the Upper Green and the Lower Green, by the Cliff Parade road.	<p>Bench seating on the green is consistently of a similar style. The exceptions to this are: a timber garden bench which is painted brown, and a small seating area to the south-west of The Green.</p> <p>The majority of benches are timber seated and backed, with a steel frame which has a serpent design. These benches are painted green and gold but not in a consistent way.</p> <p>In the Upper Green benches are at the perimeter, whereas on the Lower Green most are alongside paths, with some in open lawn. Benches which are in the lawn area are mounted on concrete bases.</p> <p>The serpent benches, although being of similar design are not consistently the same size.</p> <p>Access is good for most of the benches which are alongside the path, access to benches on the lawn is impeded by the kerbing which edges the grass.</p> <p>8 benches have memorial plaques.</p>

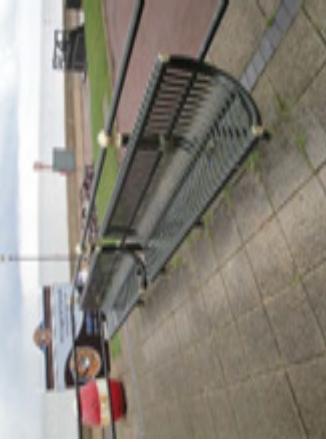
Item	Element and Description	Condition and Recommendation	Photograph
4.4.2	<p>Seating Area</p> <p>This is an area consisting of two benches surrounded by railings in the south-west of The Green, the area is laid on PCC slabs and is fully accessible.</p> <p>The benches are facing south towards takeaway kiosks.</p> <p>The benches and railings are made of mild steel and are of a modern design. They are painted green and gold.</p>	<p>Some paint is chipped on seats and railings but otherwise in good condition.</p> <p>Reconsider the use of benches in this position, possibility of replacing with serpent design seating for continuity.</p>

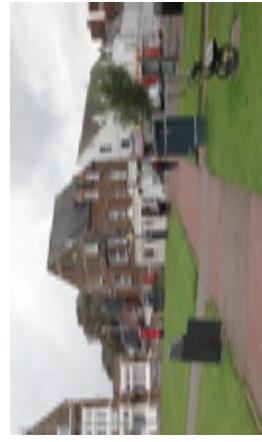
4.4.3	<p>Bins</p> <p>There are 28 bins on The Green. The majority are very large (each containing a wheelie bin) and are painted black and gold. The rest are dog bins, which are smaller but in a similar style.</p>	<p>Bins are mostly in a fair condition, and should be retained and refurbished. The Green would also benefit from the bins being relocated and clustered at the edges, to help restore the open uncluttered appearance.</p>

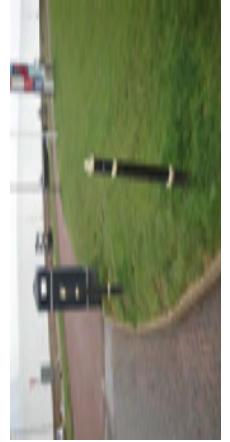
4.4.4	<p>Bollards</p> <p>Four types of bollards were noted on The Green, all within close proximity to one another – south-west of The Green, adjacent to the South Shelter seating area.</p> <p>Three of the bollard styles are made of cast iron and painted green and gold, and the fourth bollard type is made of concrete.</p> <p>The cast iron bollard types are different heights and some are of a similar style to each other and the railings to the seating area.</p>	<p>Cast iron bollards have chipped paint and are not all fully upright.</p> <p>The recommendation is that, in the long-term, bollards are removed and replaced with a unified style. The railings around the seating area should be considered at the same time, as a consistent style is recommended.</p>

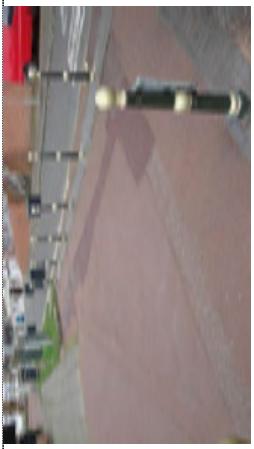
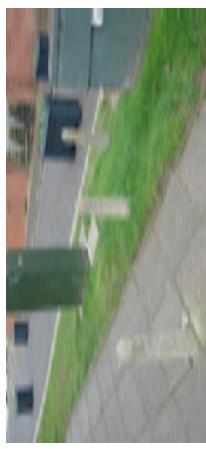
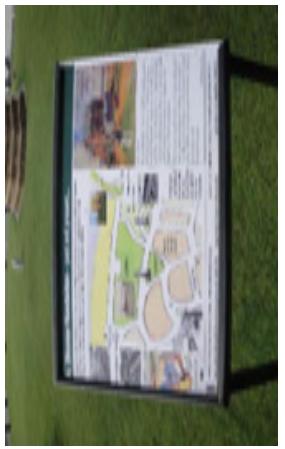
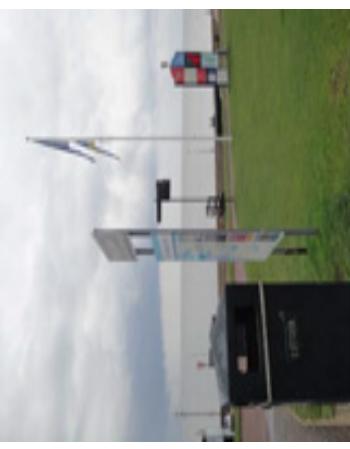
Item	Element and Description	Condition and Recommendation	Photograph
4.4.5	<p>The Town Sign is covered by the Architect's Conditions Survey.</p> <p>There are two (of eight) interpretation boards on The Green, one of which is on the Upper Green and the other on the Lower Green.</p> <p>Also in the south-west of the site is an information point sign, a digital beach information board, and a flag pole. Also in this area is a directional signpost.</p>	<p>The interpretation board on the Upper Green is damaged and the displays themselves are quite busy. It is recommended that the interpretation boards are redesigned and replaced.</p> <p>Thought should also be given to the southwest corner where there is a lot of different signage as well as other street furniture, this area should be arranged to be less cluttered.</p> <p>The posts to the information board have peeling paint and look to be rusting. This sign should be replaced with new signage.</p> <p>The interpretation strategy will address signage. All existing interpretation boards and fingerposts to be removed and replaced as part of the new interpretation strategy.</p>

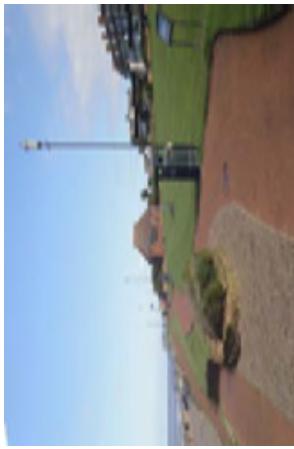
Item	Element and Description	Condition and Recommendation	Photograph
4.4.6	<p>Lighting</p> <p>Most of the lighting within The Green is street lighting, which will not be covered within the scope of this report.</p> <p>There are three Victorian-style black and gold lamps along the western and northern edge of the green.</p> <p>The Town Cross and Town Cross also have associated lighting, an appraisal of this is covered in the Architect's Conditions Survey.</p>	<p>All lanterns should be replaced so that they are consistent with those used in the Esplanade Gardens. There should be a long-term aspiration to replace the light columns with a continuous style also.</p> <p>Increased lighting to the south of The Green is also recommended</p>

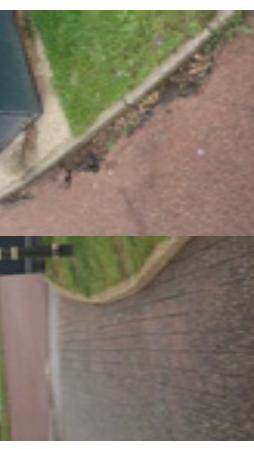
4.4.7	<p>Paving</p> <p>There is a variety of paving on The Green which includes PCC flags, brick, tarmac and coloured tarmac. There are also different types of edging to the paving throughout the area.</p>	<p>Paving shows signs of damage throughout including damage to edging. There are areas where paving is uneven, cracked, and draining poorly.</p> <p>It is recommended that a unified paving scheme is devised and implemented, where continuity in paving material and edging is used.</p>

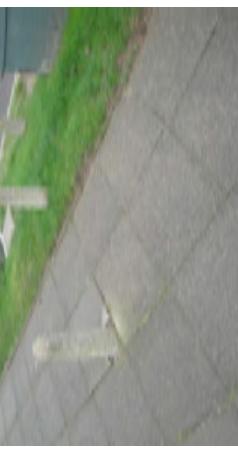
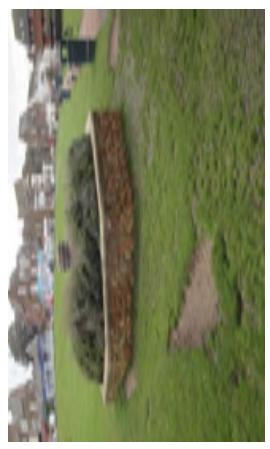
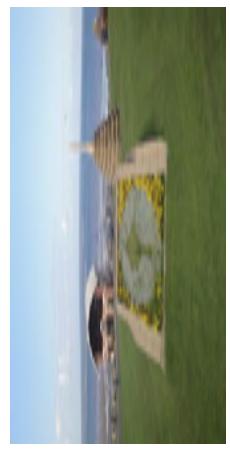
Item	Element and Description	Condition and Recommendation	Photograph
4.4.8	<p>Planting Beds</p> <p>There are two raised planting beds on The Green, one close to the Town Cross, and one close to the Pier Building. Both planters have carrstone walls.</p> <p>The planting bed adjacent to the Pier Building has an old drinking fountain at its centre and its walls function as seating.</p> <p>The planting bed adjacent to the Town Cross is used for Flower displays and has a stepped wall which also functions as seating.</p>	<p>The planting bed adjacent to the Pier Building is in a fair condition although there is some damaged coping. Grass around the base is worn, despite there being grass reinforcement in place.</p> <p>It is recommended that coping be repaired and an area of hard paving installed around the raised bed to allow better access. It is also recommended that the planting be redesigned so that the old drinking fountain is accentuated rather than hidden.</p> <p>The planting bed adjacent to the Town Cross is in a good condition and no work is recommended. The Planting bed does detract from the open quality of the Green so removal may be considered in the longer term.</p>

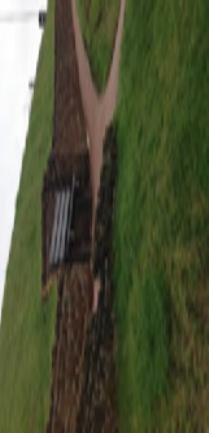
4.5.1	Bench Seating	<p>The Seafront Slope covers the area which grades down from east of The Green towards the seafront, and is south of North Promenade Road. It includes a series of paths, steps and seating areas, including areas on top of two bays of beach huts.</p> <p>At the bottom of the slope are two serpent benches recessed into the retaining wall, there is also a serpent bench positioned in a small private seating area adjacent to the beach huts. All serpent benches are painted gold and green in keeping with the benches on The Green.</p> <p>Part way down the slope from The Green there is one bench recessed into the retaining wall which has a concrete frame and has timber seat and back.</p>

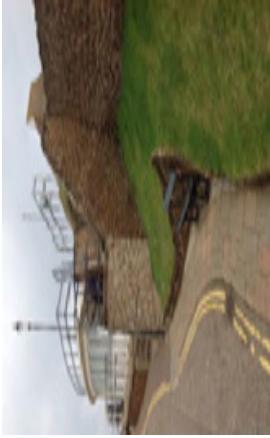
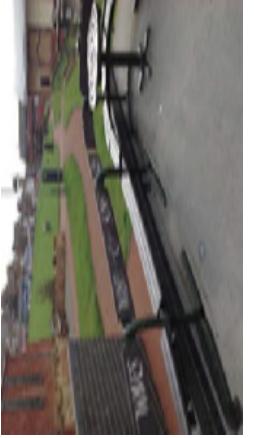
4.5.2	Seating Areas	<p>On top of one of the higher and northernmost beach hut bays is a modern seating area. The seating area consists of two rows of seating, each wrapping round a small table.</p> <p>Their construction is of a metal frame painted green, with brown painted timber seats, backs and table tops. On both rows of seating, the backs of the seats have text</p>

Item	Element and Description	Condition and Recommendation	Photograph
	<p>painted on them in white, reading "waves wash & sun's glaze".</p>	<p>There are signs of rust in some areas of the frame where paint is peeling off, especially around the bolts which fix the seating frame to the roof of the beach huts.</p> <p>Consideration needs to be given as to repairing or replacing these seating areas.</p> <p>Re-design of this space would make a good subject for the college/school design workshops (see Activity Action Plan item 7).</p>
