HUNSTANTON HERITAGE GARDENS

CONDITION SURVEY

HERITAGE LOTTERY FUND
PARKS FOR PEOPLE PROGRAMME

ROUND 2 APPLICATION FEBRUARY 2016

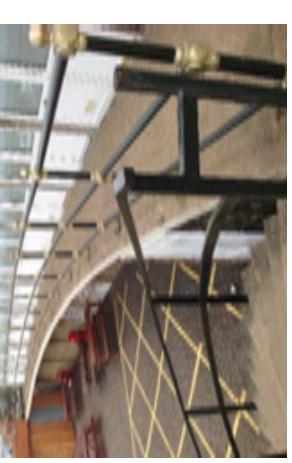
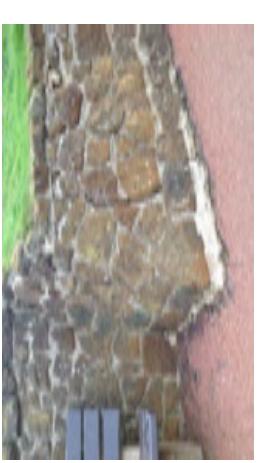
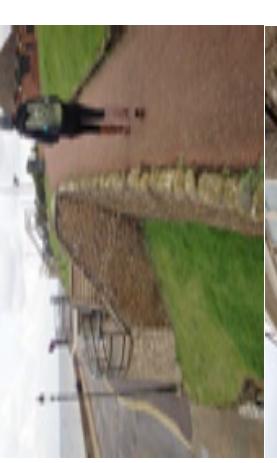
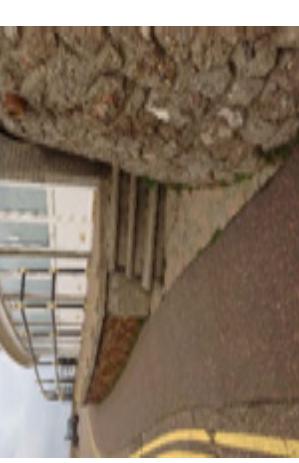
Item	Element and Description	Condition and Recommendation	Photograph
4.5.4	<p>to the beach huts described in 4.5.1; and alongside some of the steps leading down from the beach hut roofs.</p> <p>The slope and pathways are held in place with carrstone retaining walls, most of these walls are quite low. There is one area where the carrstone wall is relatively high and unguarded.</p> <p>At the end of the carrstone retaining wall, supporting the small seating area described in 4.5.1, the retaining wall becomes curved and appears to be made of recycled concrete blocks.</p> <p>Towards the north of this area, around the beach huts, brick walls are present and use a variety of different brick types. Bricks are also used for step risers and edging in this location.</p> <p>Some bricks match that of the beach hut walls, while blue engineering bricks are also regularly used. There are at least two other types of brick used.</p> <p>Carrstone is also used in the walls around the beach huts.</p>	<p>The walls look to be structurally sound on initial impression although further investigation is recommended, as cracks are evident on the walls themselves and the paving. Refer to Appendix B for Engineer's Visual Inspection.</p> <p>There are some areas which require repair work, where there is stone missing, damage to the mortar joints and damage to stone coping.</p> <p>The issue of guarding has been discussed with BCKLWN and it has been agreed that the use of temporary guarding will be sufficient at times when there are planned events in this area. BCKLWN will manage this issue.</p>

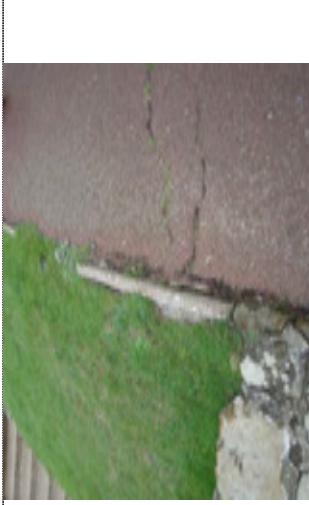
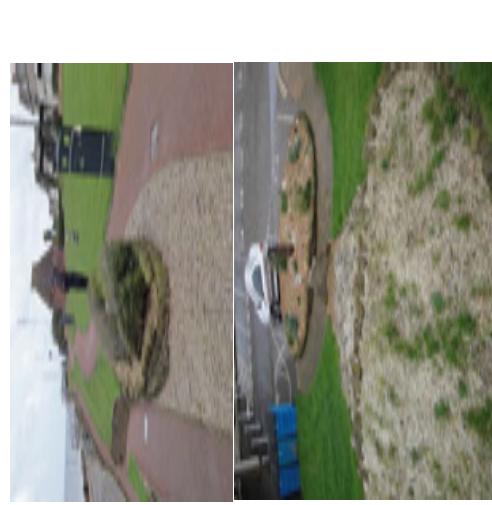
Item	Element and Description	Condition and Recommendation	Photograph
4.5.7	Planting Beds	<p>The main planting feature in this area is a relict waterfall feature, now called the waterfall bed. This consists of three beds which lead from the top of the slope to the bottom. Two paths separate the three beds and the middle section has a stone cascade down the slope.</p> <p>The top planting bed has the most substantial planting whilst the lower two beds mainly consist of gravel. The lowest of the beds has a remnant leg of the pier at its centre.</p>

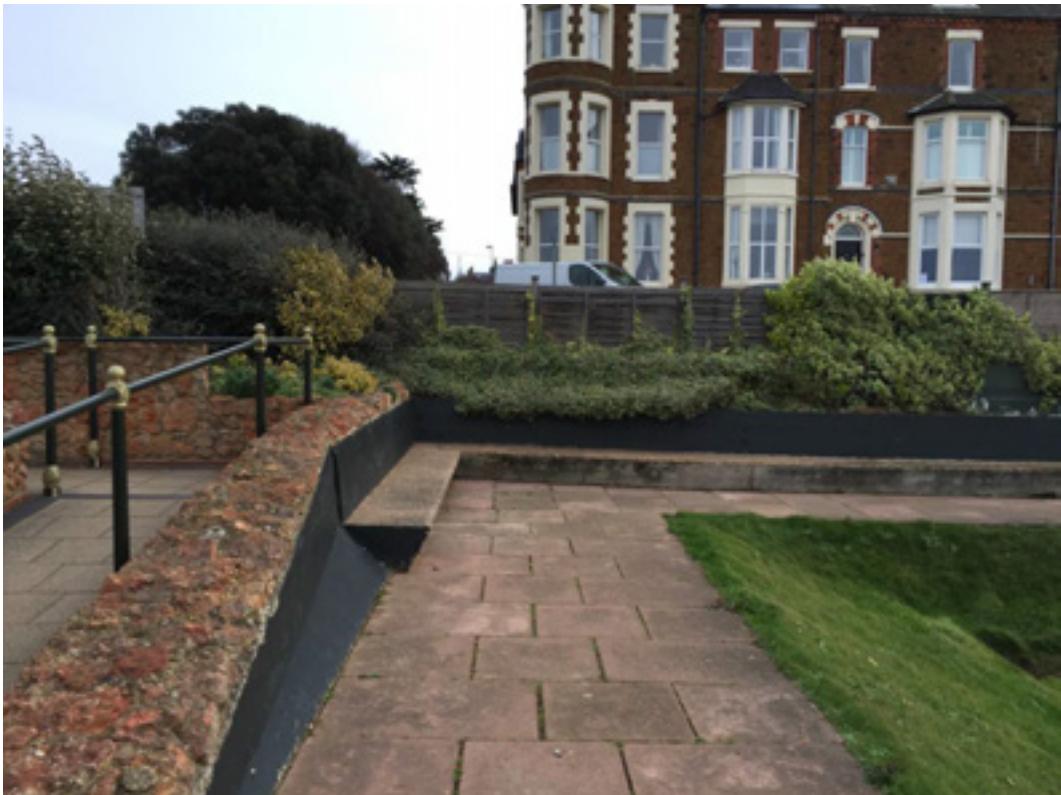
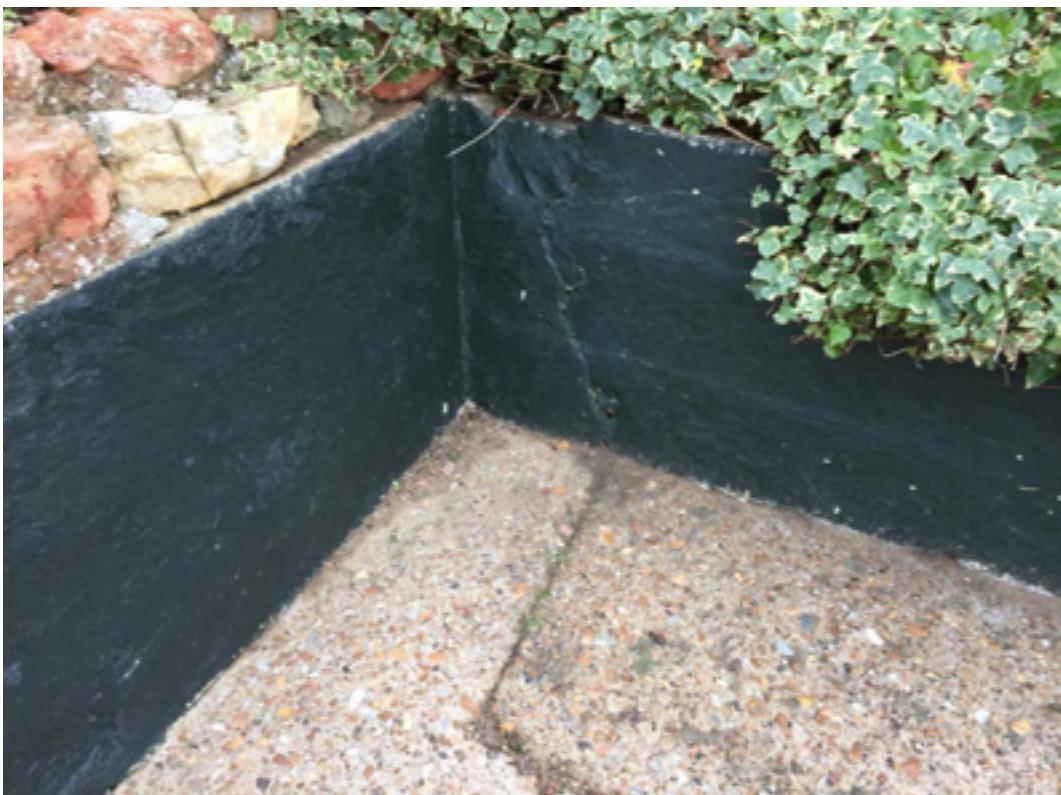
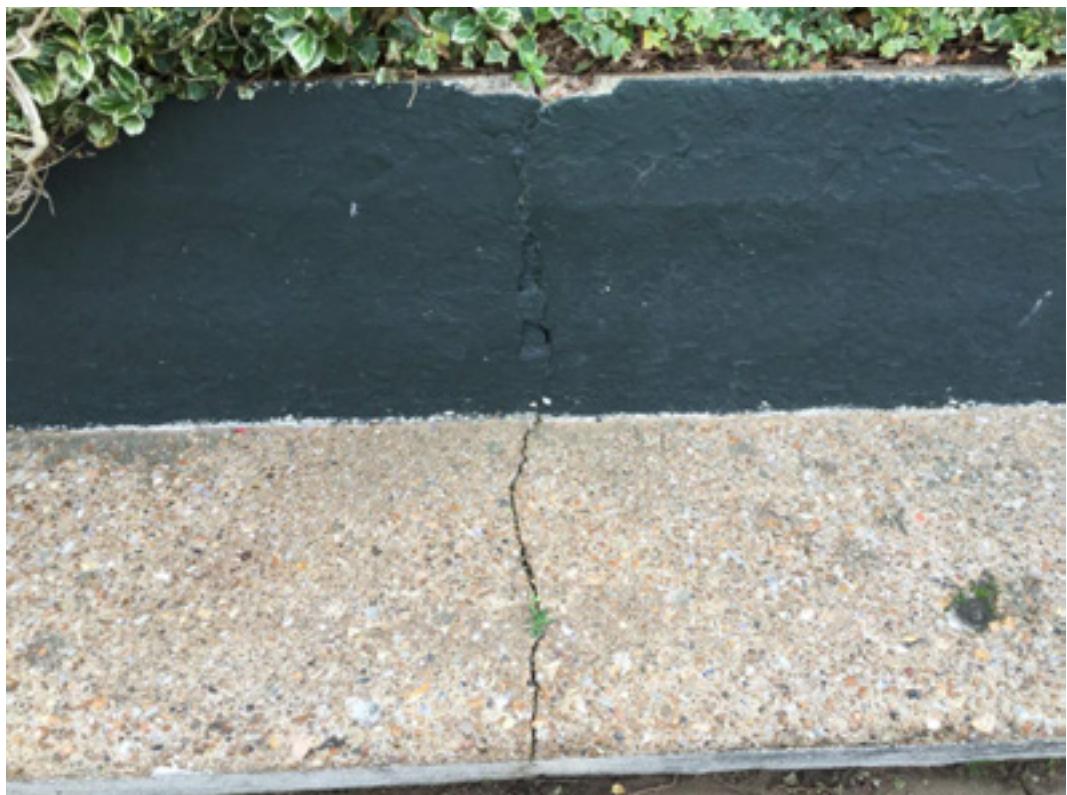
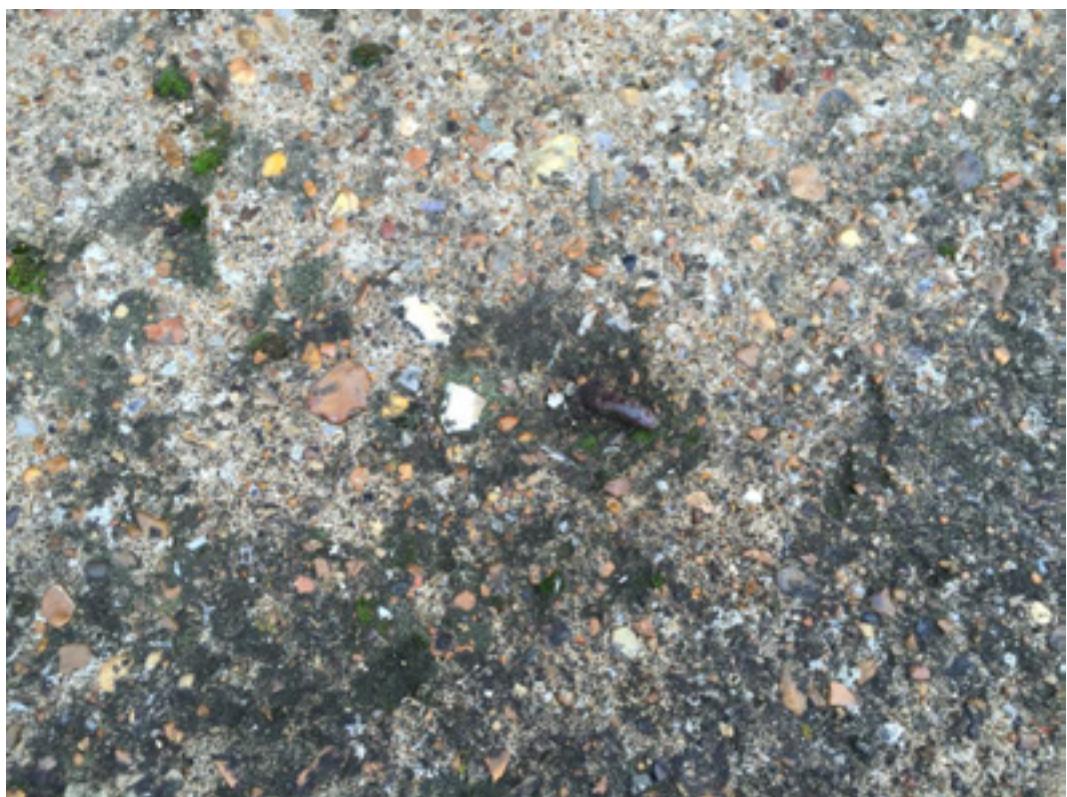
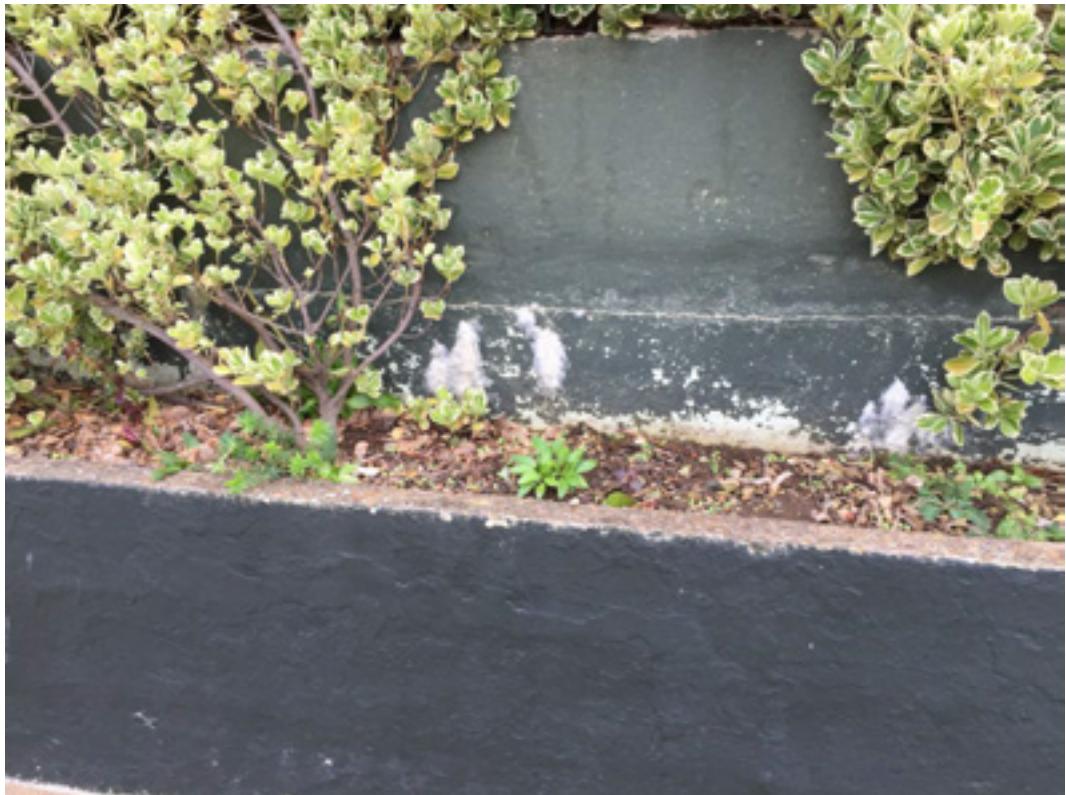
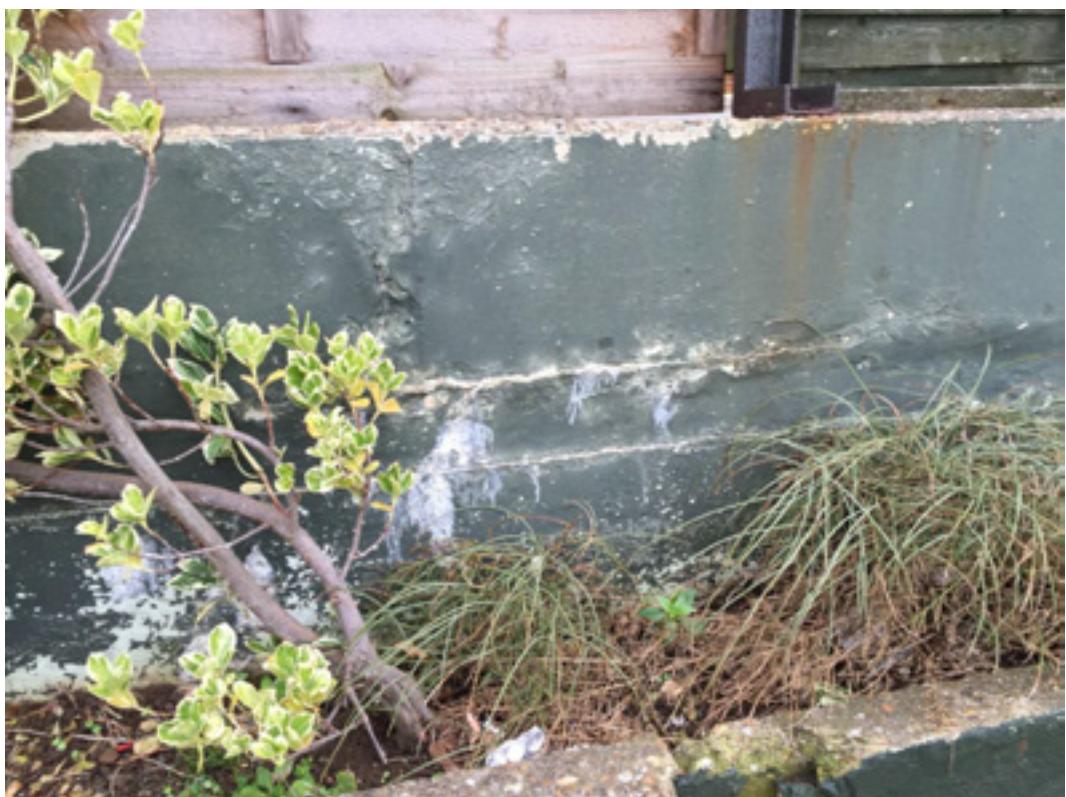
BOWLING GREEN AREA

- 6.01 The concrete retaining walls and the brick retaining walls along the west side of Cliff Parade are showing signs of very significant deterioration and are unlikely to be shown to be satisfactory under current standards. In order to determine the extent of deterioration and inadequacy it will be necessary to undertake a series of investigations by specialists to determine the concrete and reinforcement conditions as well as the original construction details of both the concrete and brick sections.

- 5.01 Addressing the concrete and brick retaining wall along Cliff Parade the form of construction is unknown at this time and following the investigations previously mentioned it will be necessary to undertake some calculations and assessment of their ability to meet modern day requirements. The results of the concrete testing proposed may indicate that the concrete sections have been sufficiently compromised to be unable to perform satisfactorily. Whilst it is possible to undertake repairs to reinforced concrete structures these can be very expensive and require a continuous long term maintenance programme to obtain any meaningful life extension. Clearly this cannot be determined until the results of the testing are available. However, bearing in mind the location of these retaining walls, the loading requirements to meet current standards are likely to be considerably in excess of the design parameters used at the time of construction. It is quite likely therefore that even if the walls were in good condition they could not be shown to be satisfactory by today's standards.

- 5.03 Clearly in both instances any repairs to the retaining walls will require a significant amount of construction input. In the case of the concrete retaining walls this will almost certainly mean the removal of the seat and planting area followed by significant repair/ strengthening works to the main retaining wall before any reinstatement of the walkway could be considered. As far as the brick retaining wall is concerned it is likely that significant areas of this will need to be rebuilt entirely and strengthened. In both instances undertaking this work immediately adjacent to a public highway will be difficult, costly and potentially very disruptive to traffic flows.

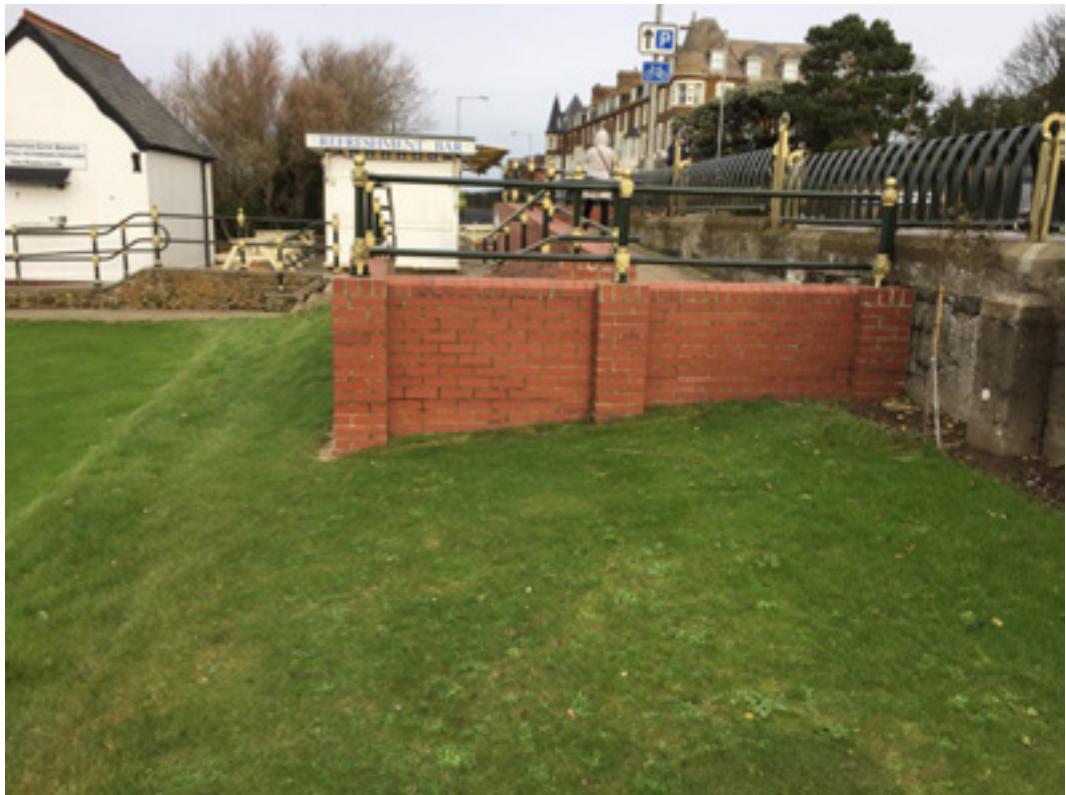
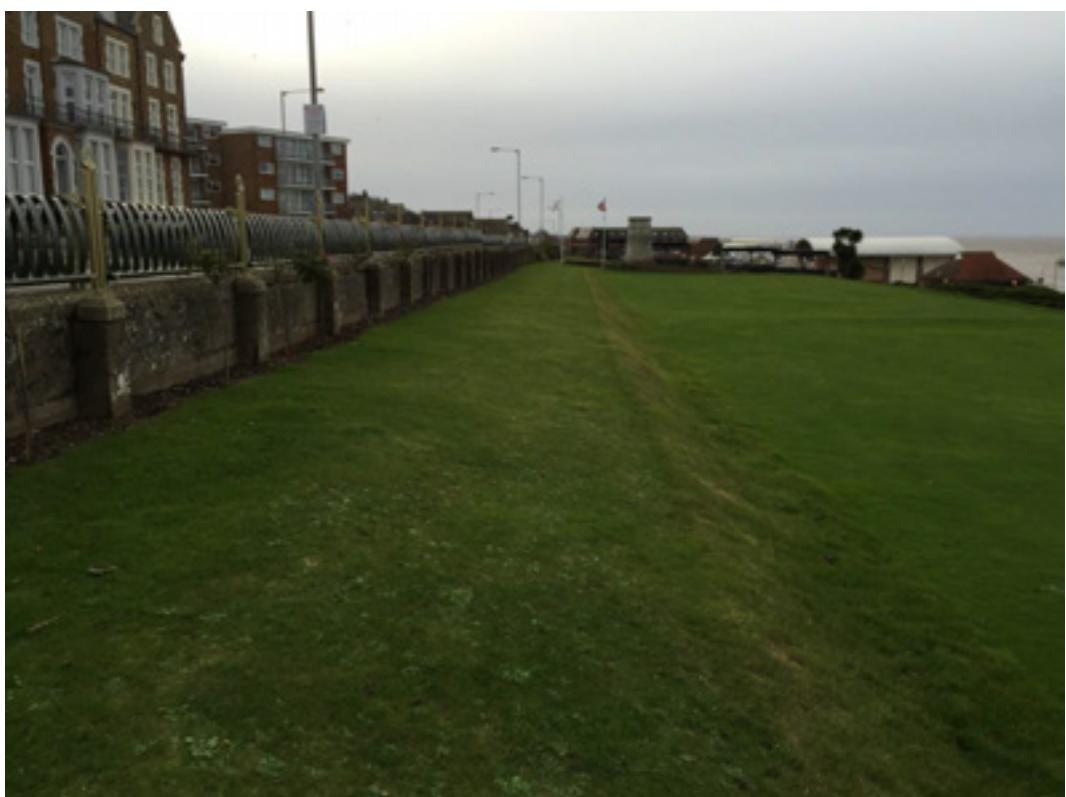
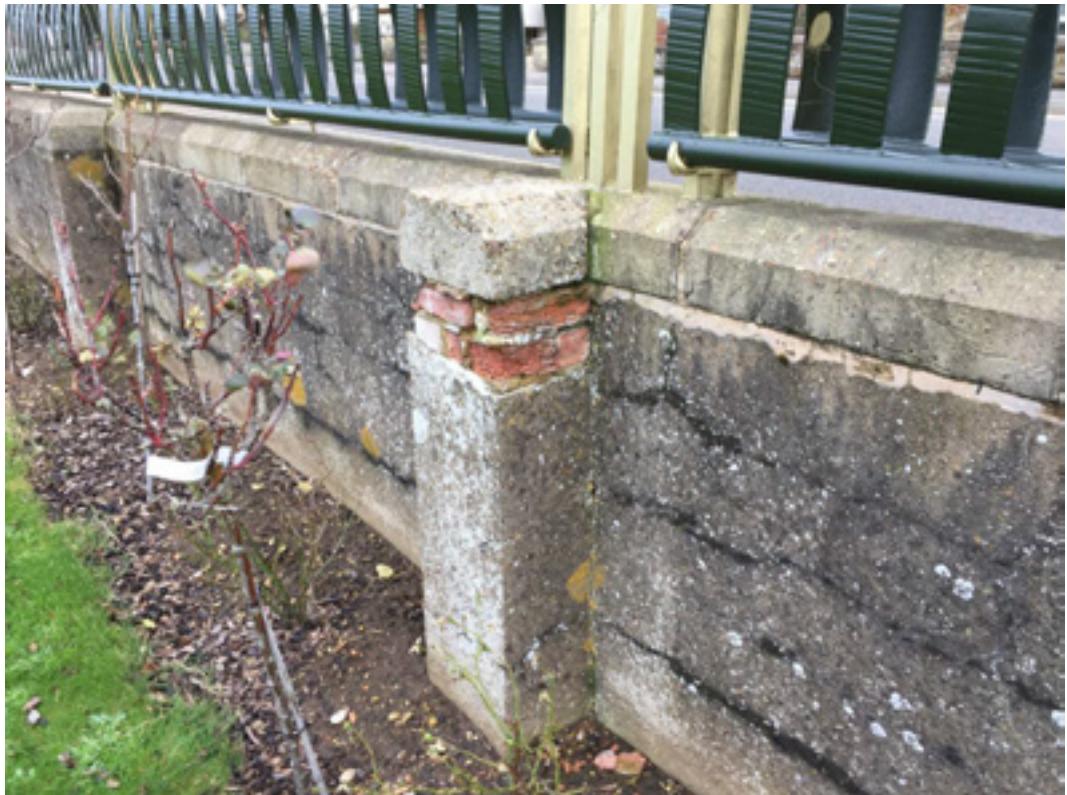
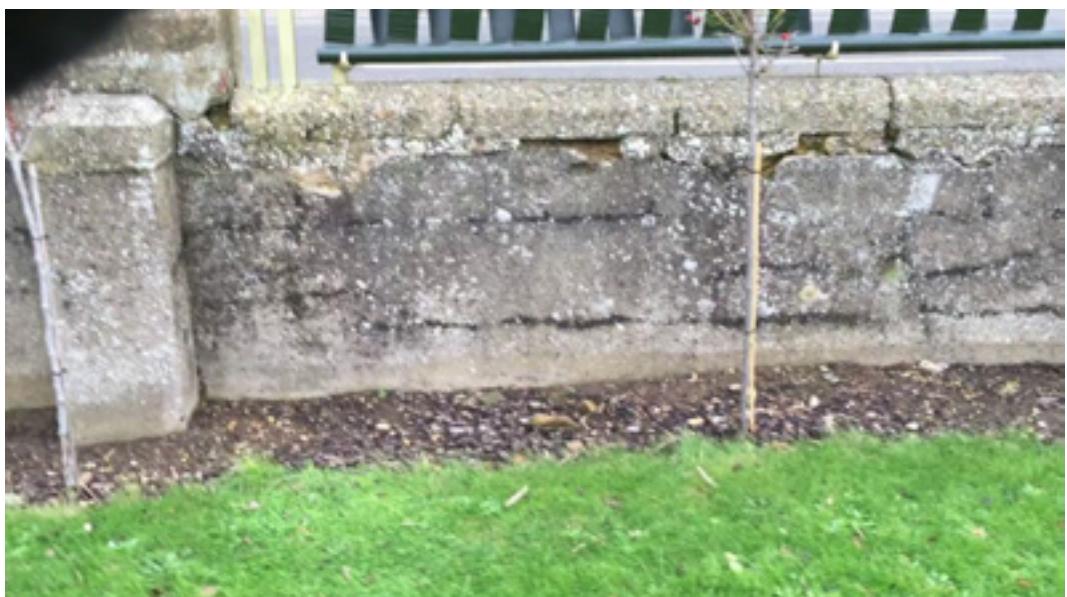
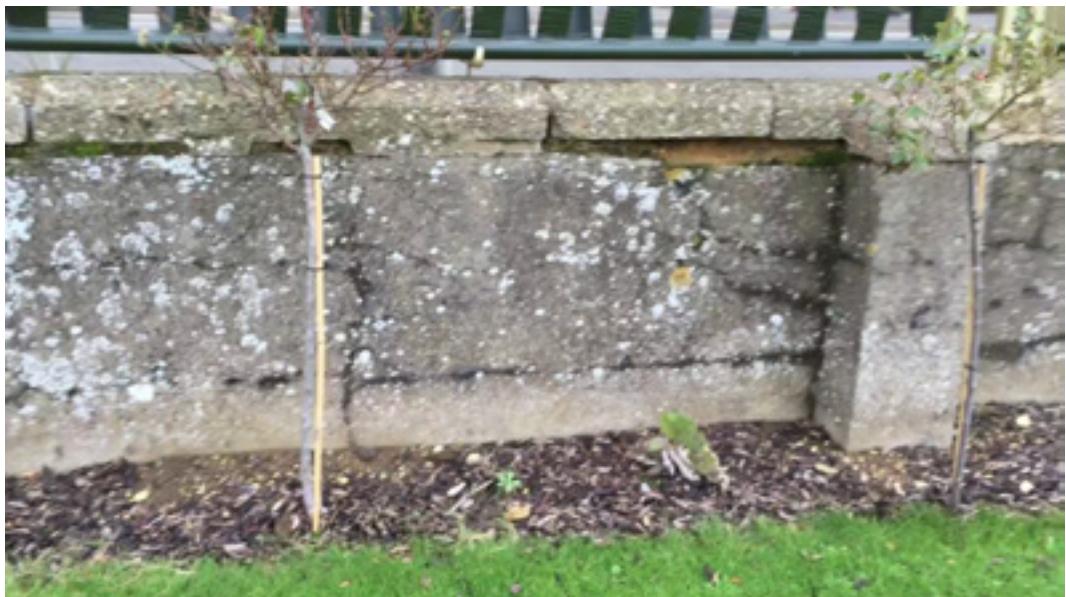
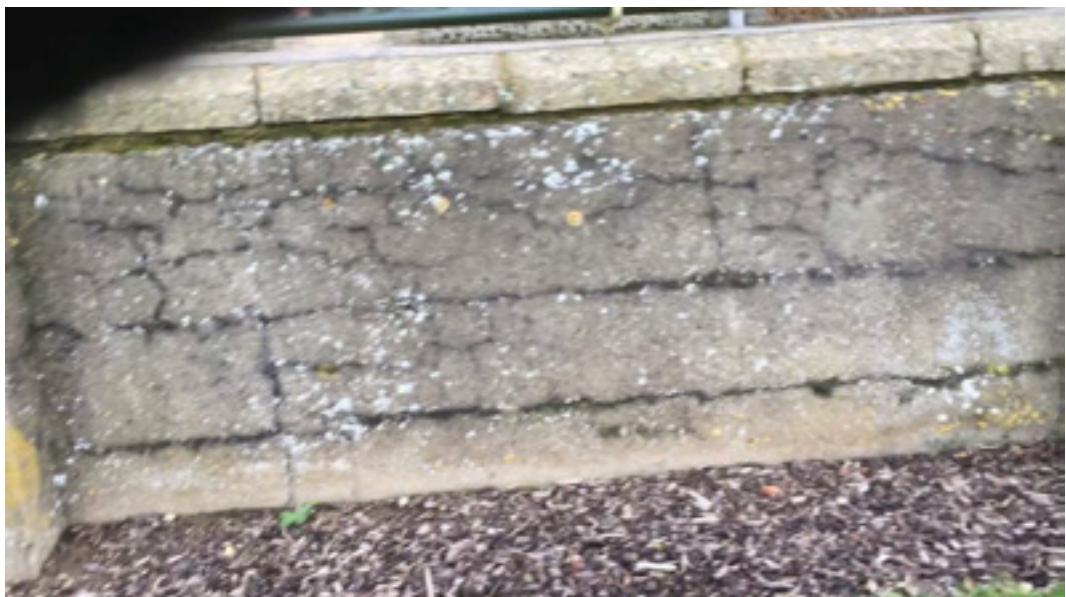
PUTTING GREEN AREA

- 5.02 Similarly the masonry retaining wall along Cliff Parade adjacent to the putting surface and the southeast end of the Heritage Gardens is also unlikely to be satisfactory when considered against modern standards. The brickwork panels in themselves are poorly constructed and have suffered serious deterioration in any event.

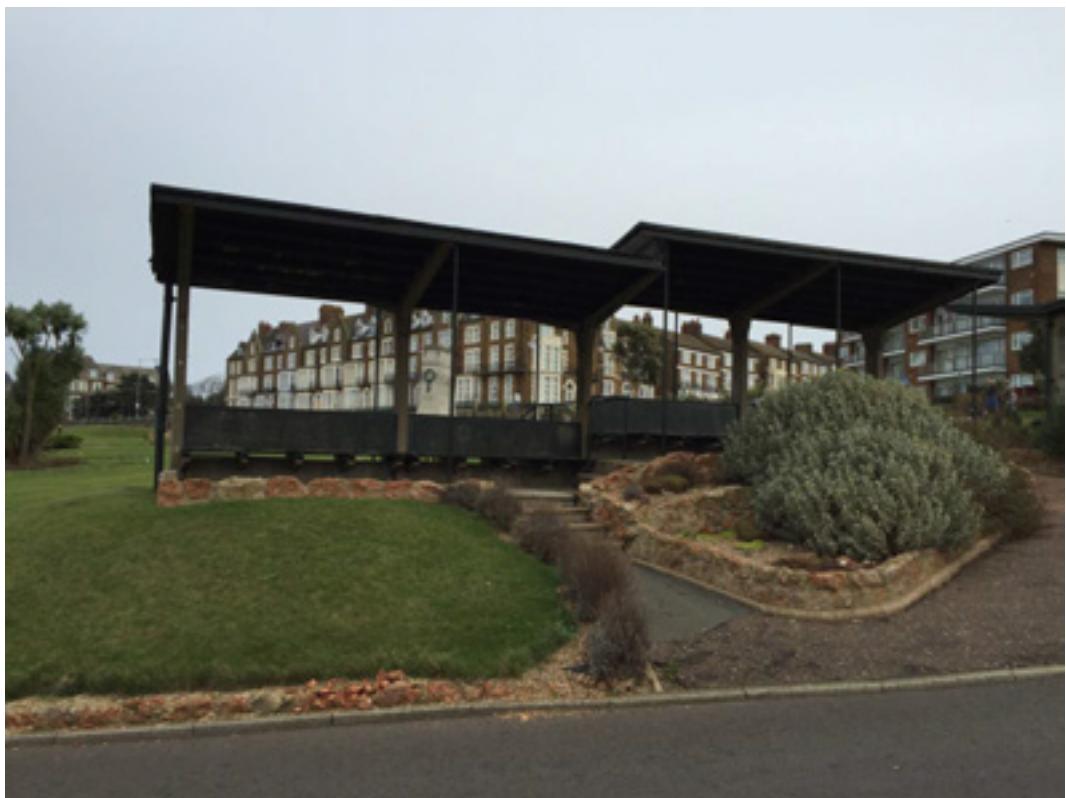
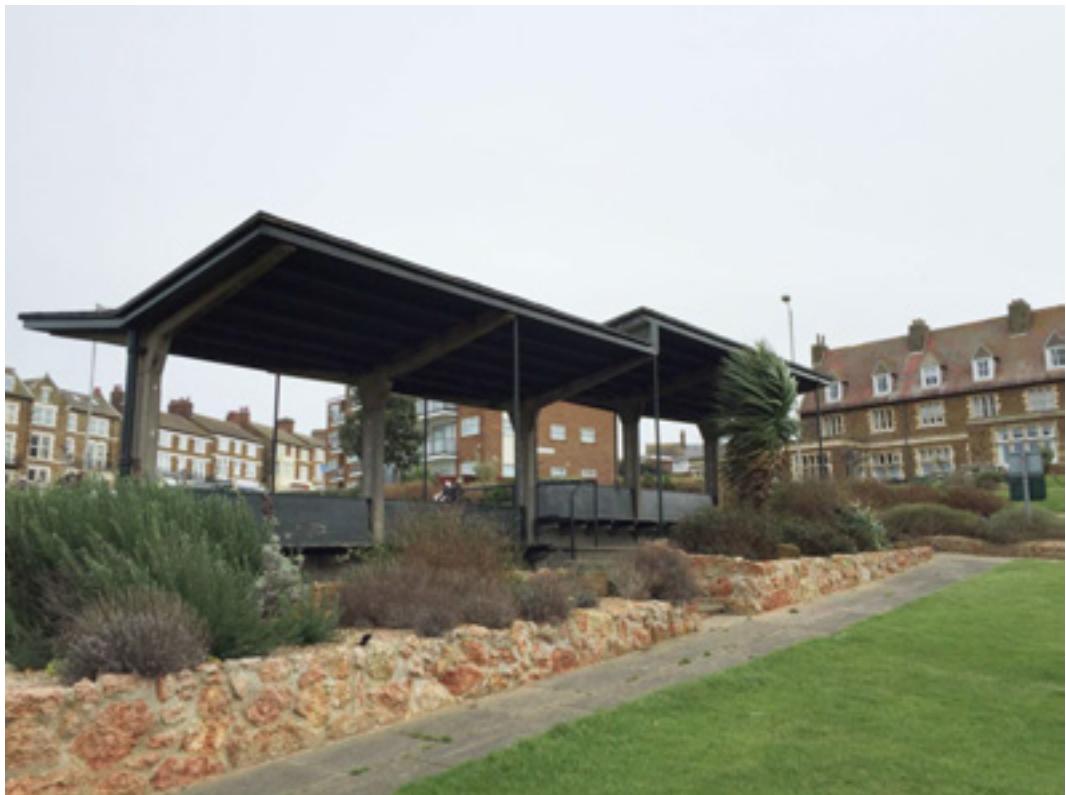
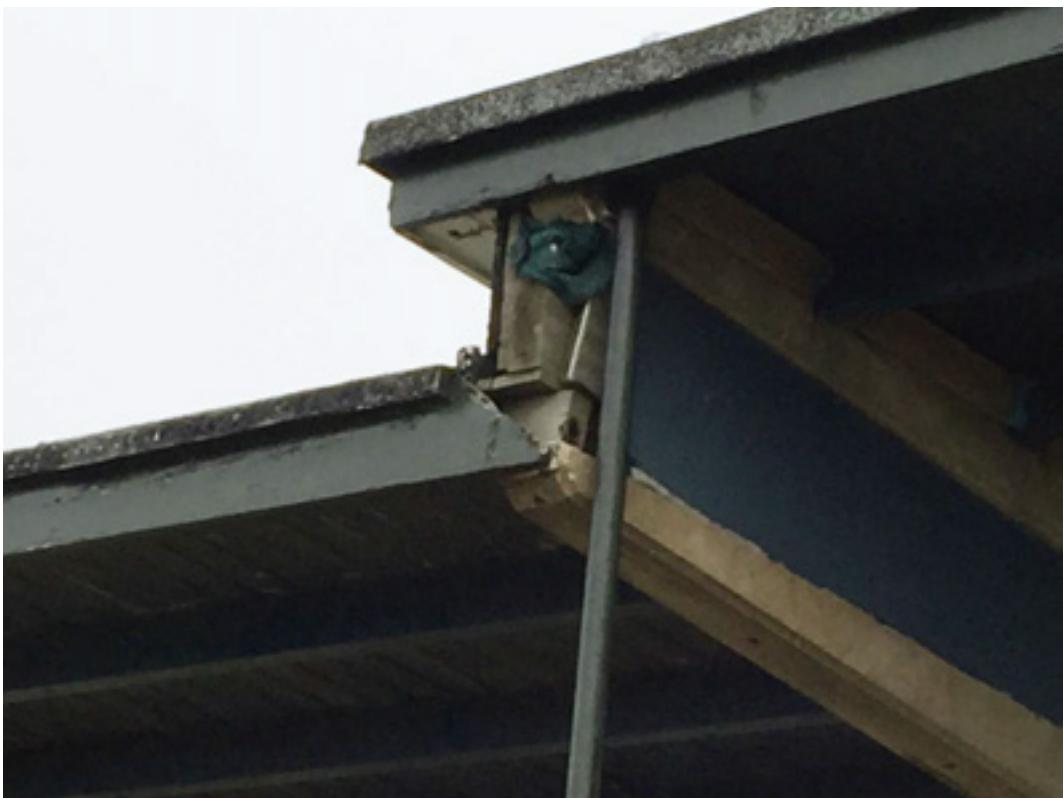
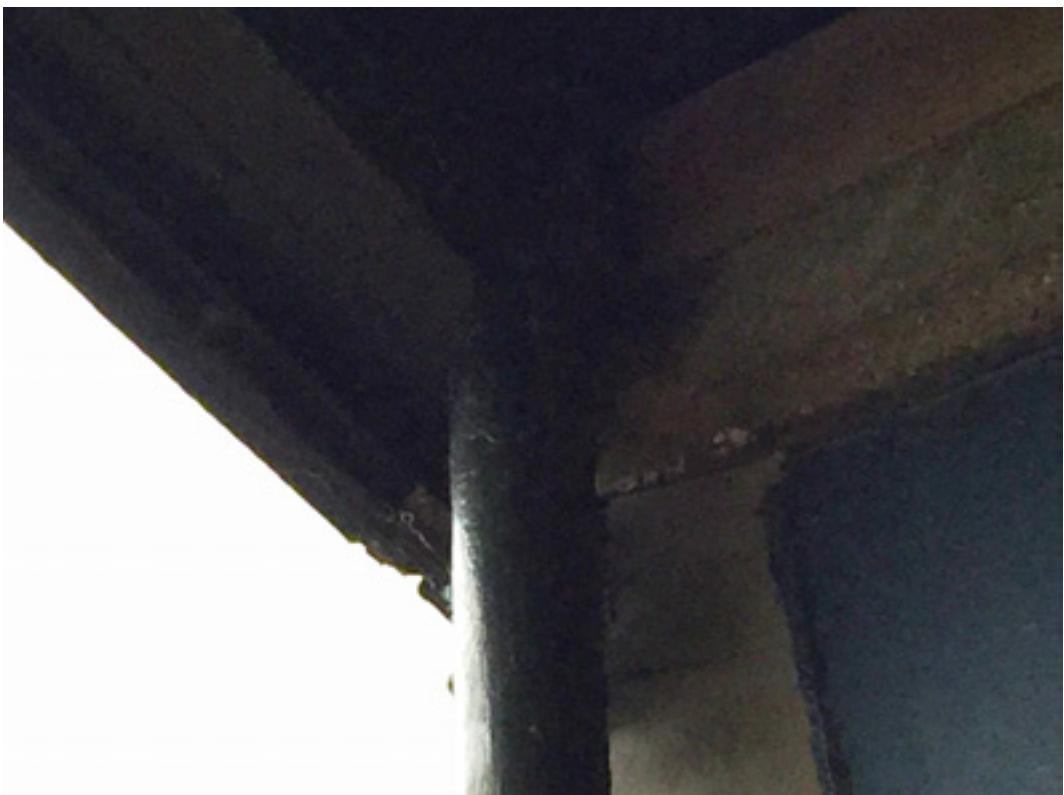
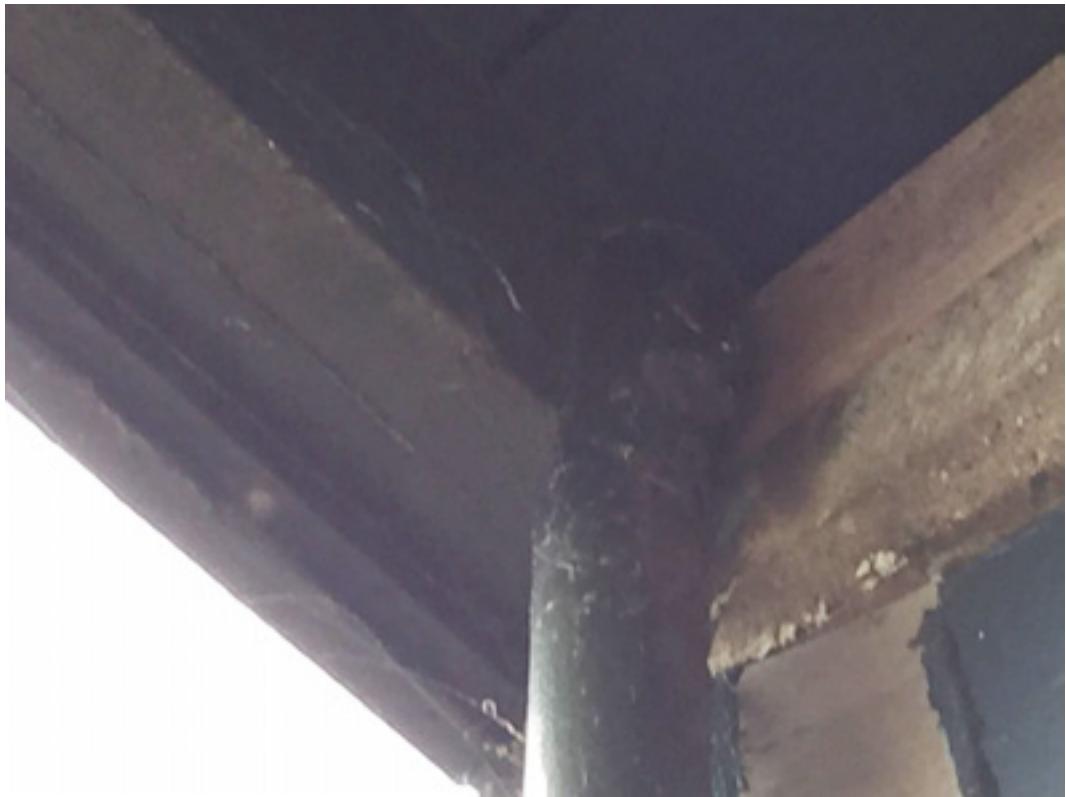
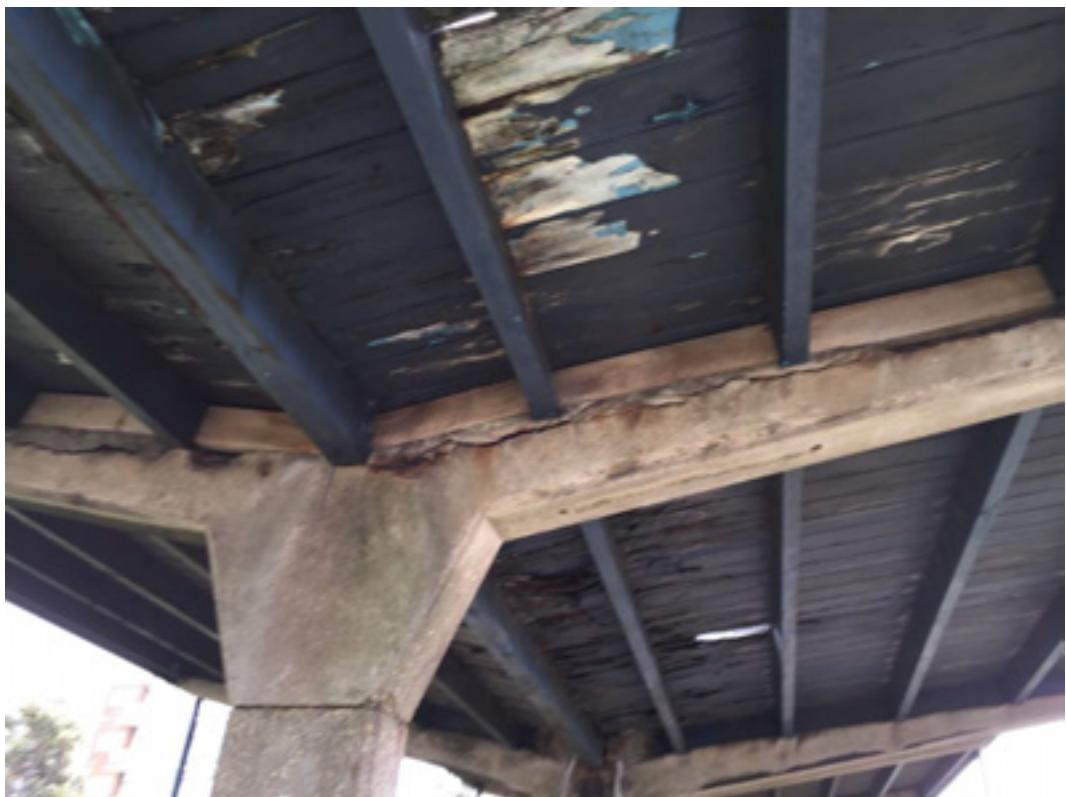
GULL WING STRUCTURE

- 5.05 The gull wing structures are in very poor condition. It would appear that concerns over their safety and condition have already been recognised and to some extent addressed by the insertion of additional tube supports. The deterioration observed in the concrete and the reinforcement is clearly a long standing issue and can only be expected to worsen considerably. Whilst it is possible to undertake concrete repairs to structures such as this the extent of these repairs cannot be determined until such time as the test results are available. However it is quite likely that the extent of repairs required will be so significant that they are neither practical or economic. This being the case it would be more economic to demolish the structures entirely and to replace them with some new form of structure. Clearly the location of the structures is very exposed and the gull wing form will be subjected to very significant wind forces in this location. It may be preferable therefore, if the structures are to be replaced, to consider an alternative form of structure and in any event to consider an alternative material for the construction. This could be either galvanised steel sections or possibly some form of timber construction. Clearly significant further consideration would be needed with regard to planning and structural design if this route were to be considered.

- 6.02 Similarly intrusive investigations will be required to establish the construction details of the stone retaining walls around the garden pathways.
- 6.03 The precast concrete gull wing structure is clearly in poor condition and it would appear that concerns have been to some extent addressed in the past by modifications to the structure. The structure is now in a very poor condition and detailed investigation of the concrete and reinforcement will be required before further recommendations can be made. It is likely that their complete replacement with a new form of structure, possibly using an alternative material may be the most economic way forward.
