Hunstanton Cliffs Preliminary Assessment

Hunstanton Coastal Management Plan

60552153

October 2017

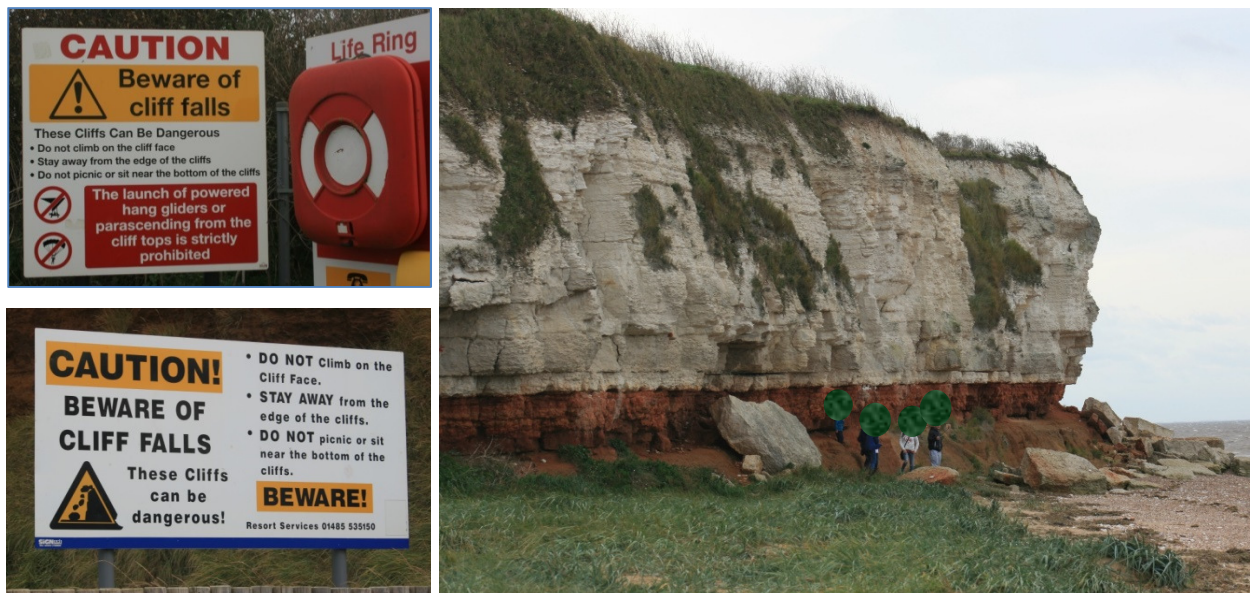
Ongoing erosion of recent years has claimed a significant amount of public space previously present adjacent to Cliff Parade, including a cliff top footpath and a significant area of land previously associated with the lighthouse, which previously included a larger plan area and further buildings on the seaward side of the existing building.

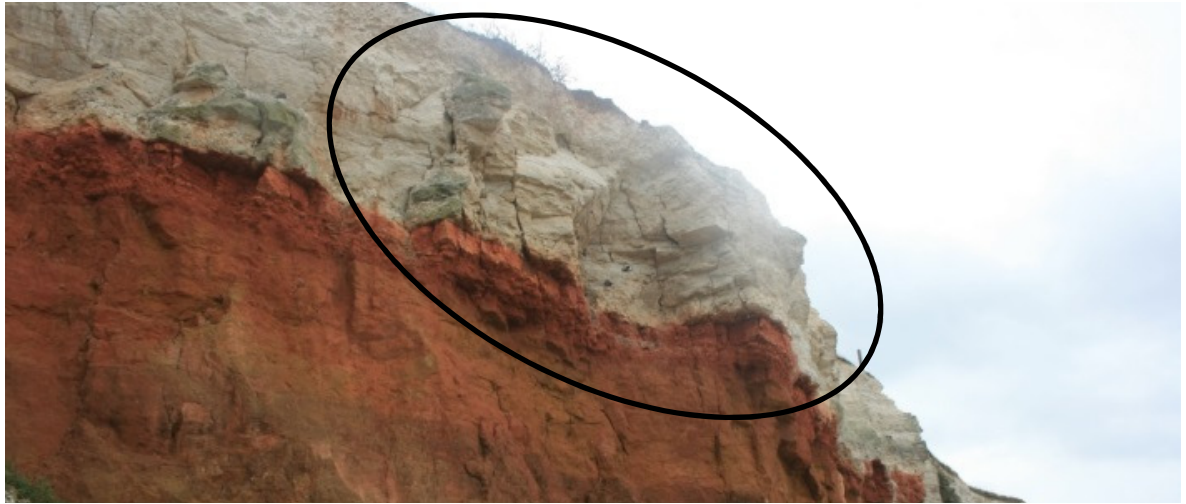
Erosion due to wave action along the base of the Carstone is evident along the base of the length of the cliff where it is not masked by debris from blockfalls. This erosion results in a smooth surface on the Carstone, as opposed to the broken appearance further up the cliff. Wave action also targets the joints, working away through scour, abrasion and hydraulic action to result in open joints, which are then prone to progressively worsening as the waves hit, resulting in significant loss of support to the material above.

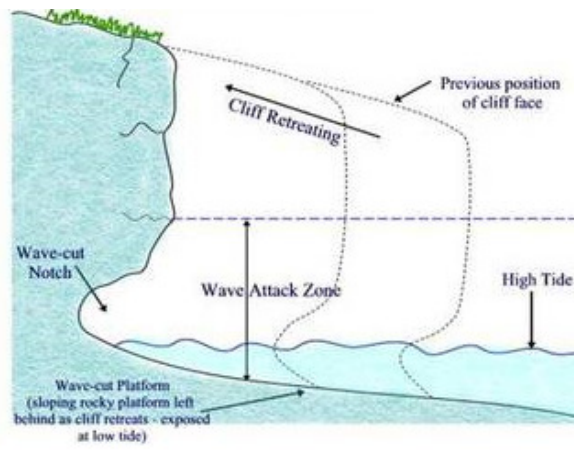
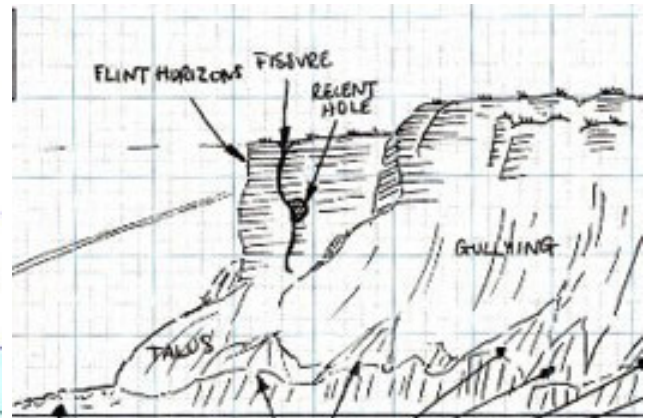
The images below depict the action of coastal erosion which results in retreating cliffs, as is present at Hunstanton, where there is a 'wave attack zone' extending well above the level of high tide, a 'wave-cut notch' undercut into the base of the cliff as the wave action erodes the Carstone, 'fissures' in both the chalk and the Carstone, which start to open up as the support below reduces, and 'gullying' as a result of the various actions of water running down the cliff face. Talus is a term given to failed material which gathers at the base of a cliff or face as a result of failure.
