Hunstanton Sea Cliff – Ground Engineering feedback following site visit on 11th October 2017

Prepared : David Townend 17/10/17

An AECOM team visited the area on 11th October 2017 to assess the current condition of Hunstanton Cliff from a Geotechnical and Coastal Engineering perspective, walking south to north along the beach and north to south along the cliff top.

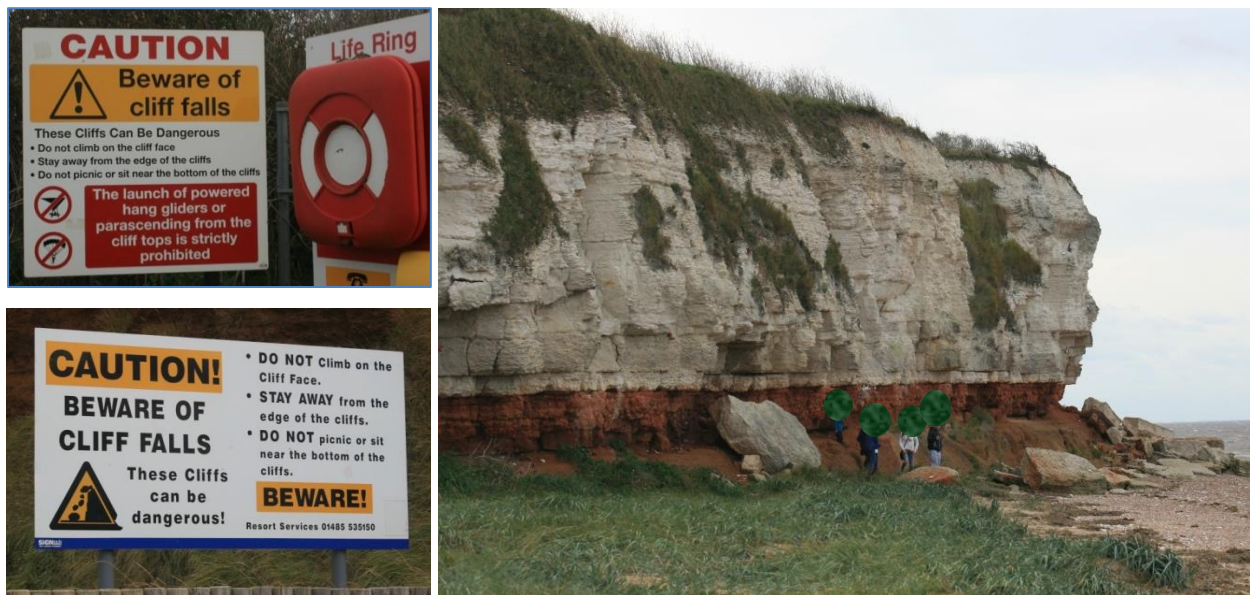
Although warning signs are displayed at beach access points at each end of the cliff, the public still encroach right up to the base of the cliff, oblivious of the risk.

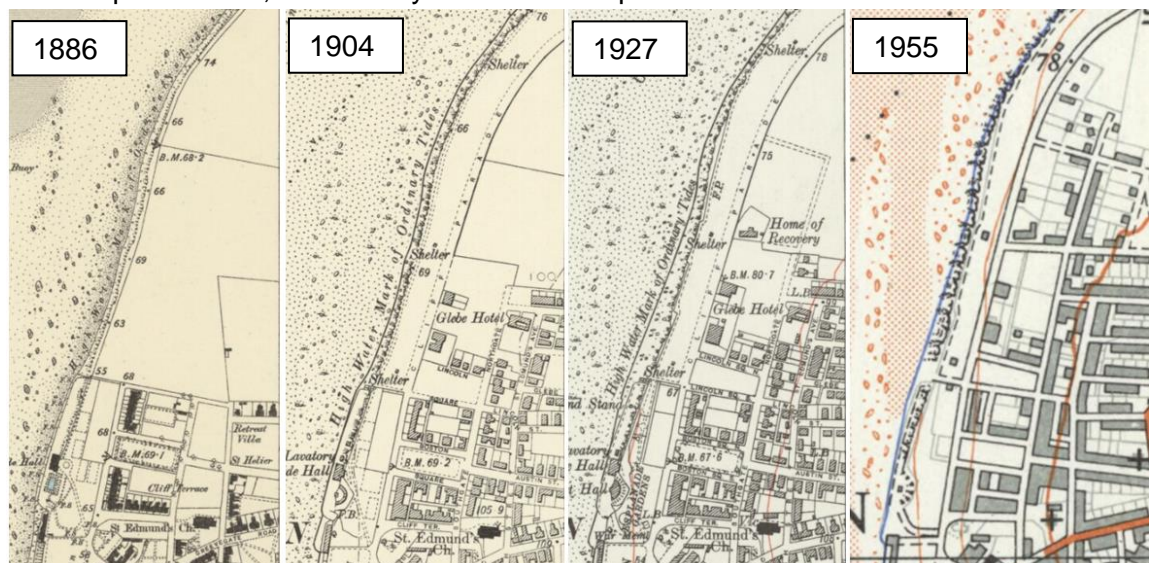
- Historic maps viewed on the National Library of Scotland website, dated 1886, 1904, 1927 and 1955, appear to show the progression of the cliff top to the east, with deviation of the top of the cliff, a boundary line and a footpath.

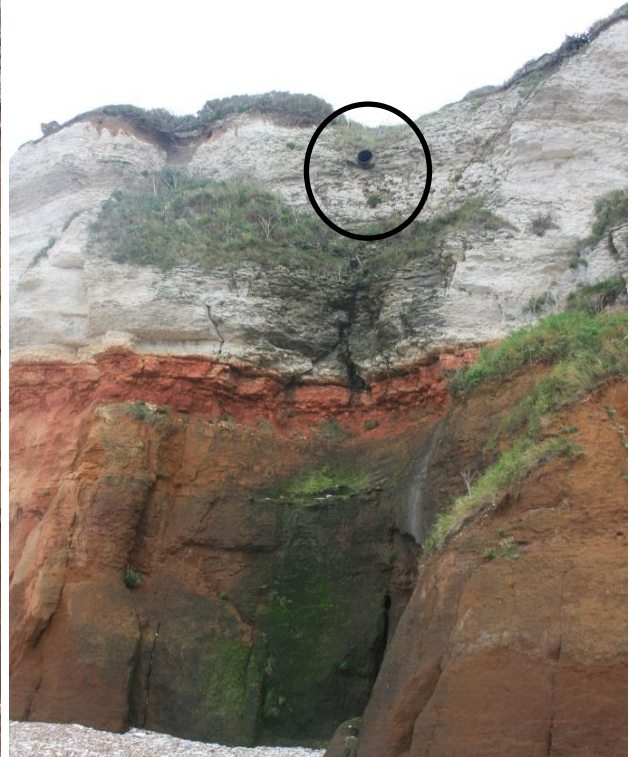
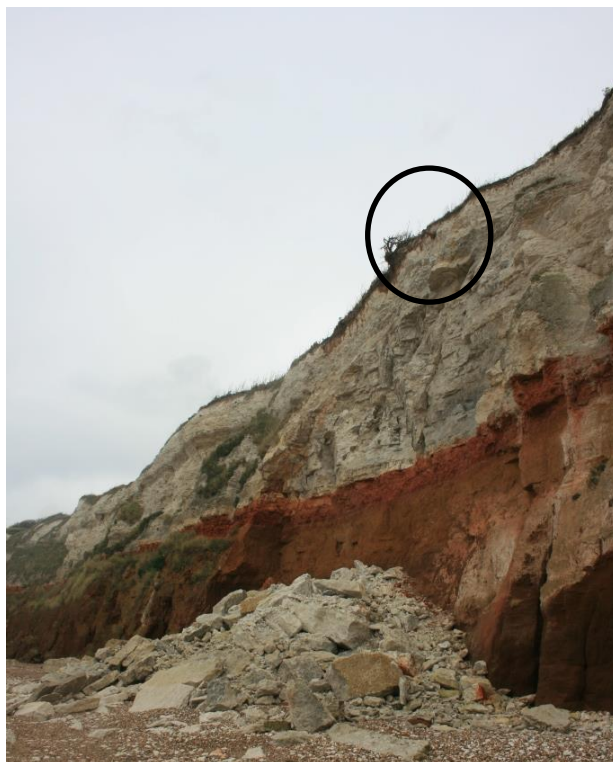
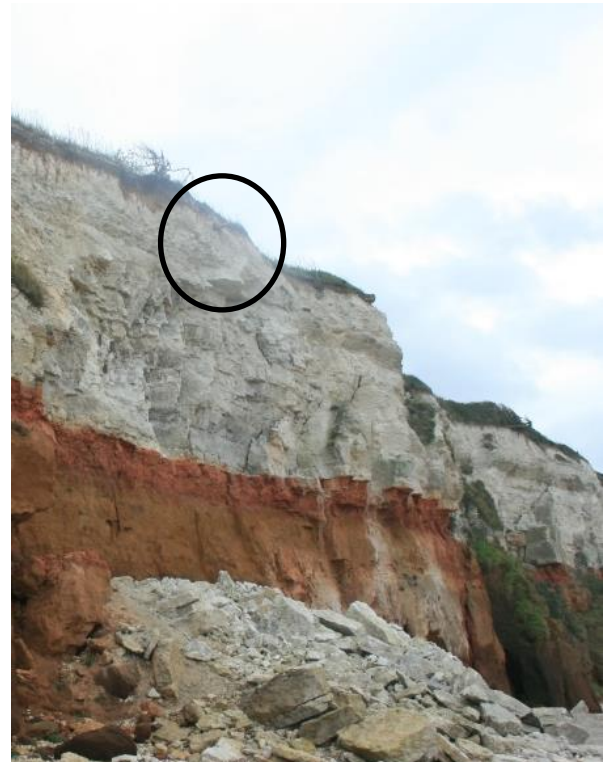
Surface staining is present along several sections of the face of the Carstone, which suggests that water does percolate out of the rock face, although being dry at the time, it is not known if this water originates as surface water flowing directly across the ground surface above and down the face, through joints in the chalk or along the interface between the chalk and the Carstone.
