# **Hunstanton Groyne Fields: appraisal of groyne effectiveness**

**Appraisal report**

**December 2021**

**Environment Agency**

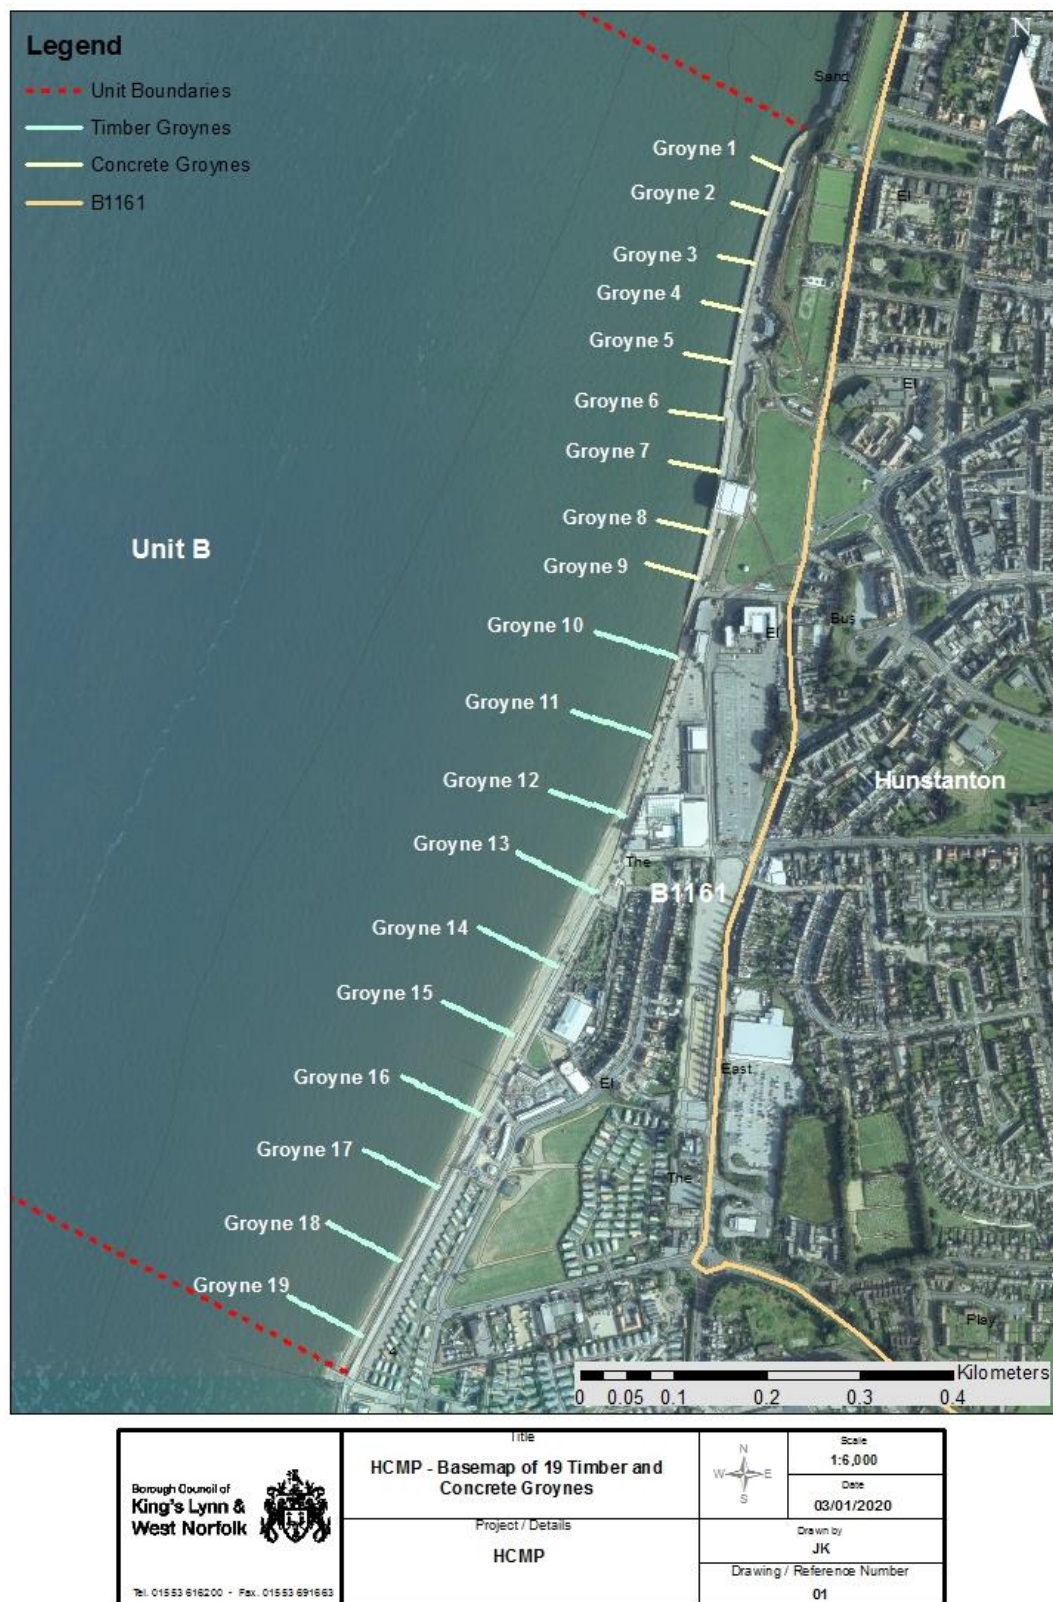
Figure 3-3 BCKLWN drawing showing the location of the concrete groynes (Groynes 1 to 9) and timber groynes (Groynes 10 to 19) along their frontage.

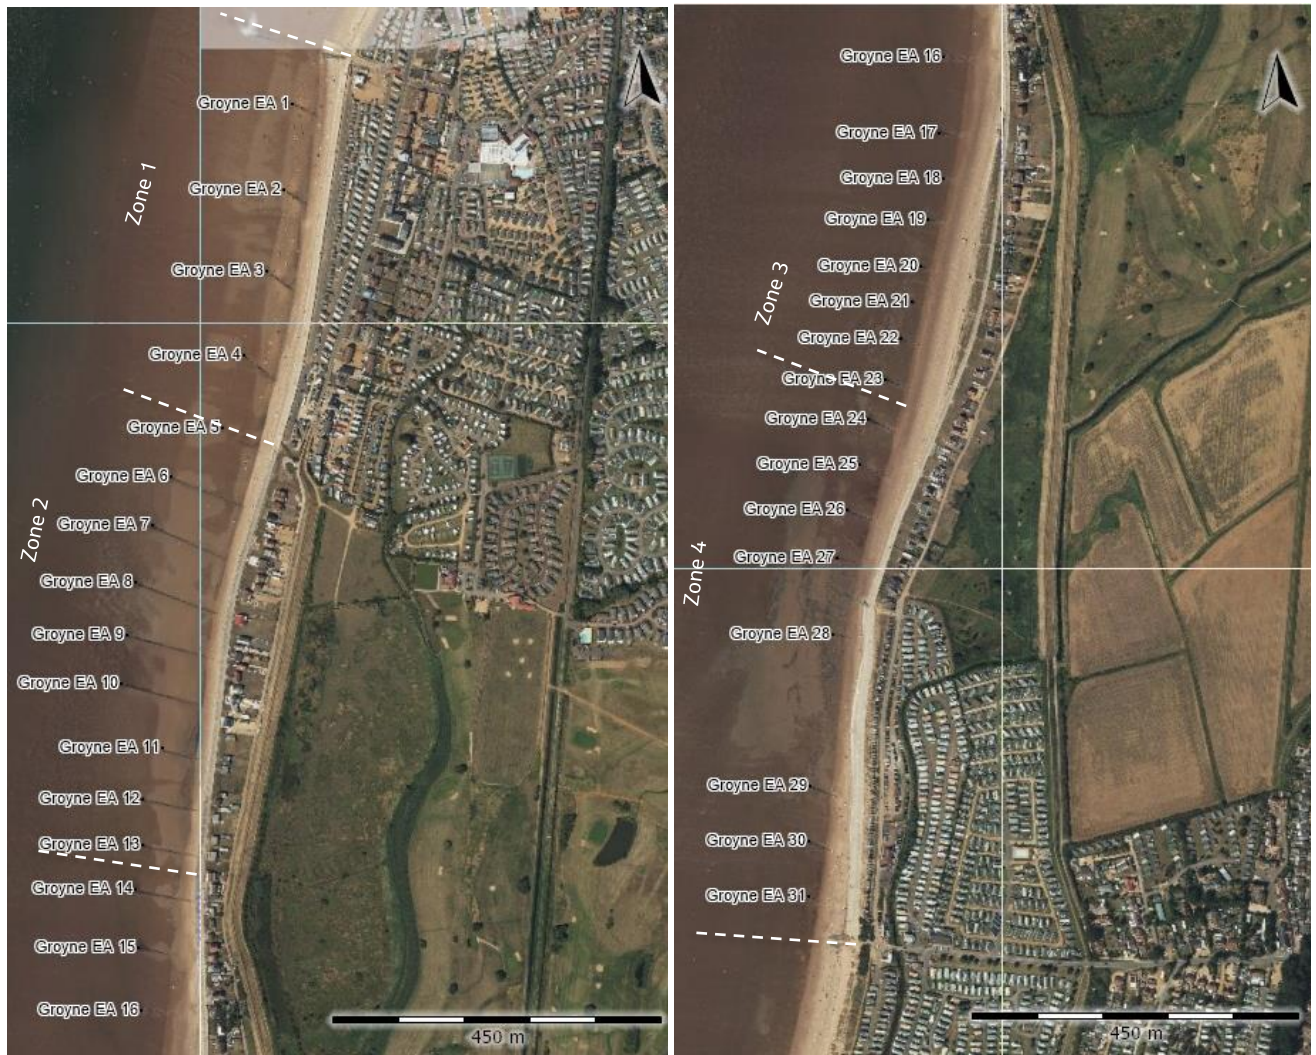
For the purpose of distinction and clarity in this study, the timber groynes along the Environment Agency frontage between the Power Boat Ramp and Jubilee Road, Heacham have been labelled EA1 to EA31 (Figure 3-4 and Figure 3-5). These are also permeable timber zig-zag groynes consisting of timber piles and walings with intermediate posts (stakes), which is unusual. There are no past details available on the Environment Agency timber groynes. However, from inspection they look identical in form to those along the BCKLWN frontage directly to the north, other than varying in length. As for the BCKLWN frontage, the basis of their design is therefore not known, but the same possible reasons exist as discussed above. The timing of their construction is also uncertain: anecdotal information suggests that they were also constructed around 1982, but photographs of the Heacham frontage in 1978 indicates that some zig-zag groynes were already present at this time. The only previous study containing any information on the structures along this frontage is WECMS (Royal HaskoningDHV, 2015); although this did not include any condition assessment of the timber groynes it refers to NFCDD (the National Flood and Coastal Defence Dataset) which recorded the overall condition (2006 to 2011) as 'Good' or 'Fair'.

Figure 3-5 EA timber groynes: Groynes EA1 to EA31. Also shown are Zone 1 to Zone 4, as defined in the Beach Survey Annual Reports (e.g. Jacobs, 2020).

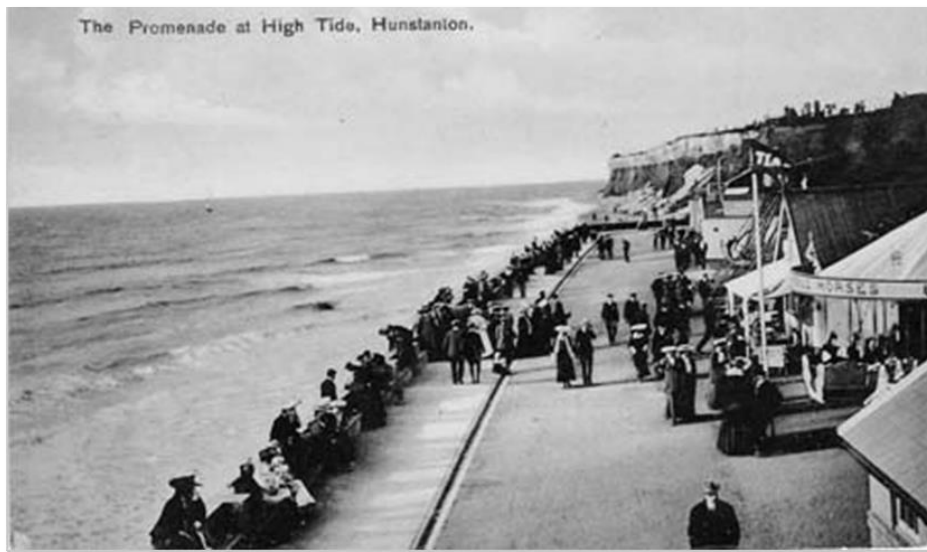
Figure 4-2) illustrates that at this time there was no beach exposed at high tide along the promenade frontage, whilst a photograph from 1893 at low tide (<https://www.francisfrith.com>) illustrates widespread exposure of Carstone in front of the North Promenade.

Figure 4-2 Hunstanton at high tide: date of photograph not known but assumed to be early twentieth century.  
Source: <http://www.hunstantoncivicsociety.org.uk>.

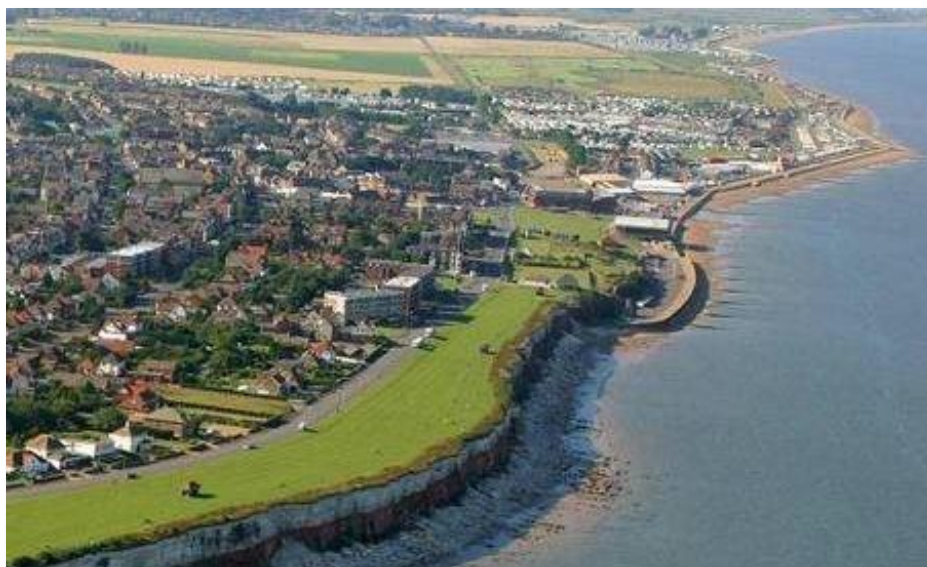
It is understood that concrete groynes were constructed in 1943, when six groynes were present between the start of the promenade of the pier. Subsequent replacement of the groynes is believed to have been undertaken in the early 1980s. Notably, construction of the promenade and defences has created a distinct promontory along this stretch of shoreline (as illustrated in Figure 4-3).

Figure 4-3 Aerial image of the coast. Taken from: <https://environmentagency.blog.gov.uk>

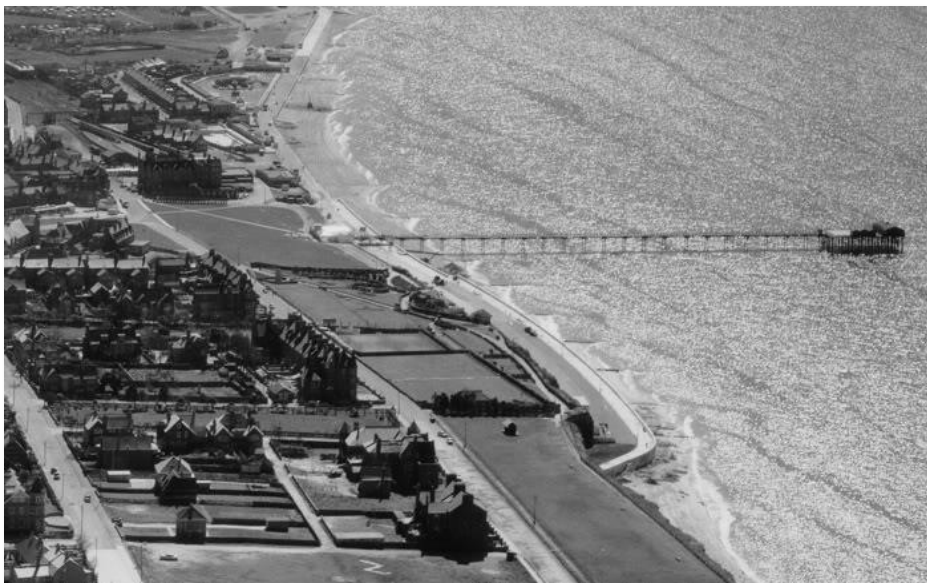
In terms of their influence when they were in better condition, no beach data for this period have been found and there is only limited information available from historical photographs (e.g. Figure 4-4), which shows the original six concrete groynes (before their replacement/ refurbishment in the 1980s). This photograph also shows exposure of Carstone at the northern end of the promenade and narrower upper beaches.

Figure 4-4 Hunstanton in the 1950s. Exact date of photograph is unknown. Source: <https://www.kingslynn-forums.co.uk>

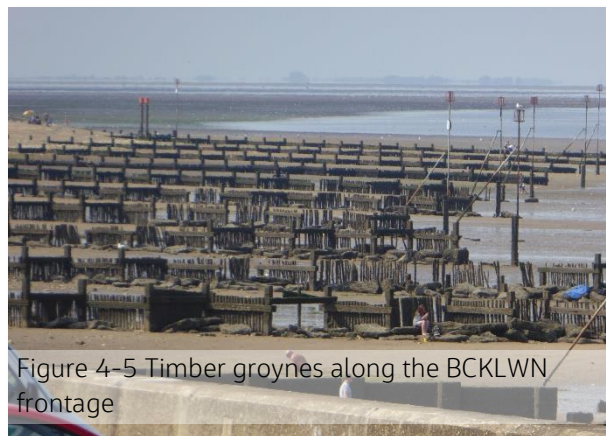
Moving southwards from the concrete groyne frontage the morphology of the beach changes south of Groyne 12, characterised by a much wider upper gravelly sand beach ('upper beach') and lower sand beach ('lower beach'), which transitions to a sandflat beyond the end of the groynes ('sandflat'). Beach volumes (across the whole profile) are much greater along this stretch than along the beaches further north.

The beach profile data and LiDAR indicate differing patterns of change along the frontage, as illustrated in Figure 4-6. Along the northern half of this frontage, there has been a trend of beach lowering and therefore beach sediment loss over the past 10 years. In contrast, the southern half has generally seen net gain across the upper beach.

Figure 4-5 Timber groynes along the BCKLWN frontage

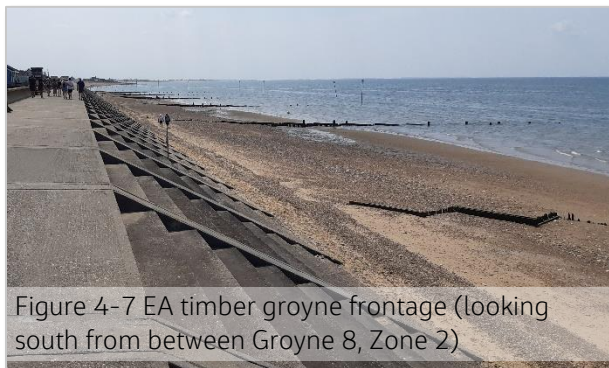
Figure 4-7 EA timber groyne frontage (looking south from between Groyne 8, Zone 2)

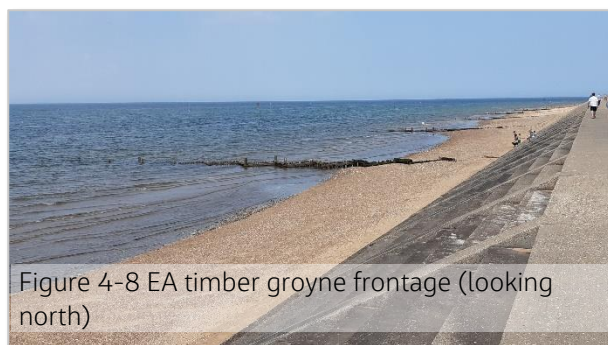
Figure 4-8 EA timber groyne frontage (looking north)
