# Jacobs Groyne Effectiveness Report

Kevin Burgess - Jacobs

Borough Council of  
King's Lynn &  
West Norfolk

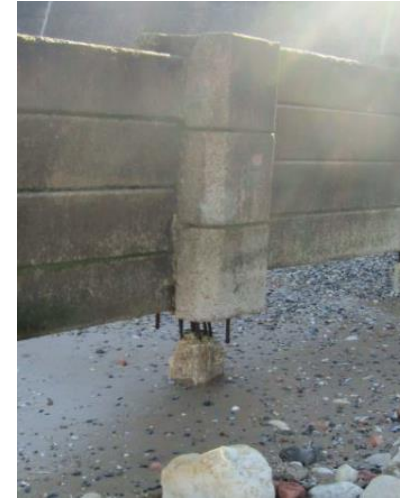
Groyne 4

- Concrete – unusual material choice
- Condition 'Poor' to 'Very Poor' throughout
- Missing planks etc but main structural issue is due to beach lowering below design levels, and abrasion

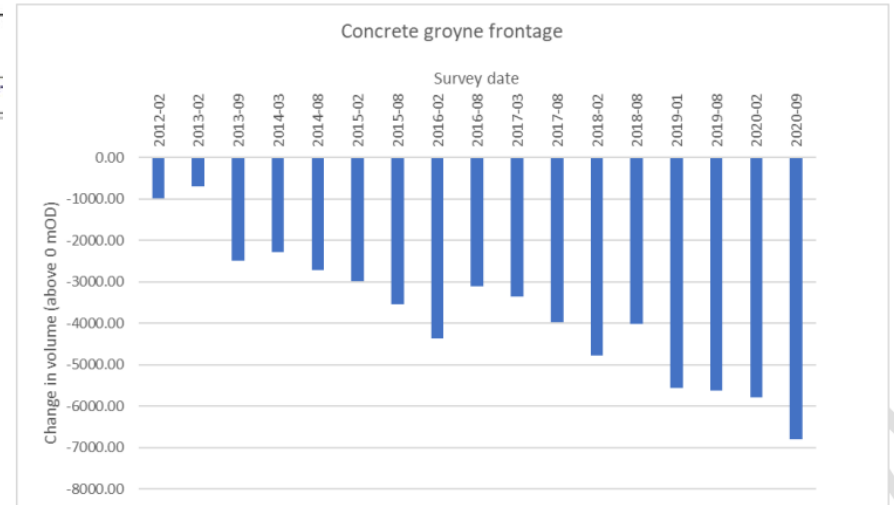
Change in beach volume above level 0mOD – relative to Sept 2011

## Typical changes in beach profile

- Sand is almost non-existent – little evidence that substantial volumes of sediment have ever regularly moved onto this shoreline
- Promontory & high exposure to waves – unlikely for sediment to be retained for very long, even if a reasonable input of sediment
- Little differential in level of any beach material across the groynes
- Elevation of the groynes is too low to be effective in front of a reflective seawall

- Even if the groynes were made higher and longer it is still unlikely that these would have much effect
- At the very least need a different form of groyne design and recharging, but effectiveness would still be questionable

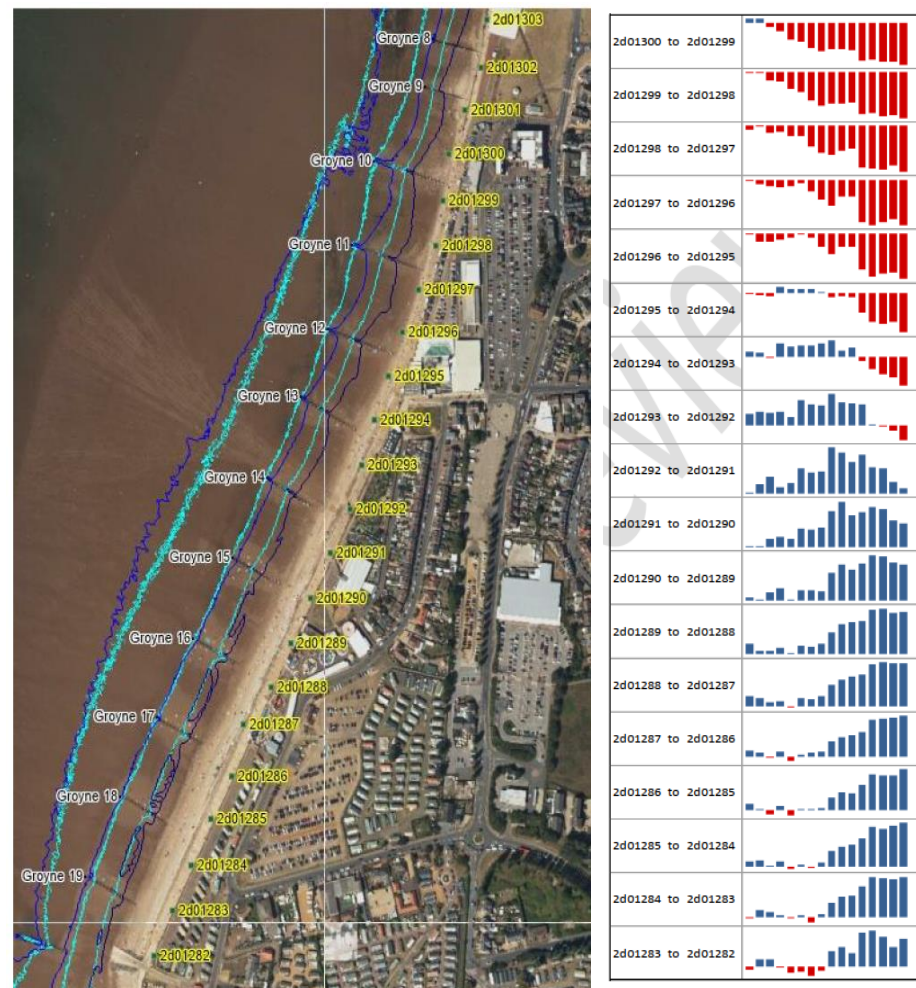
Position of -1mOD, 0mOD and +1mOD contours in 2012 (light blue) and 2020 (dark blue)

## Contrast in beach response

Sparklines show changes over time north to south for upper beach (above MSL)

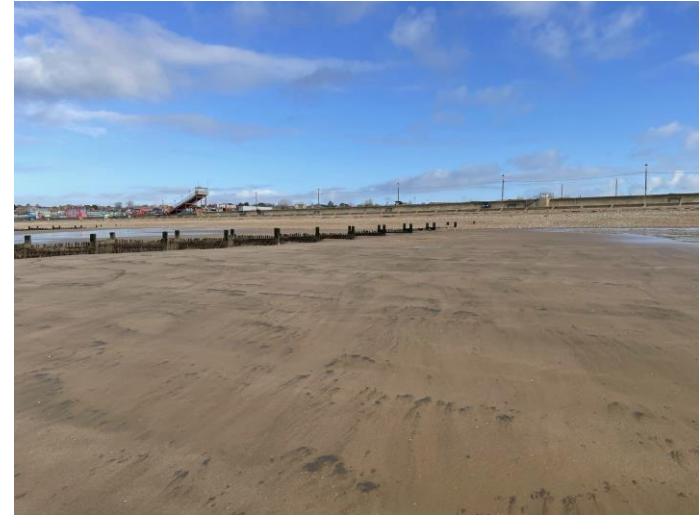
- By design, these groynes will not prevent wave-driven transport of sands
- But they may influence current flows across the lower beach, enabling deposition and retention of some finer sediment there
- Some possible evidence of this in the vicinity of the Power Boat Ramp
- But no evidence of any influence on the alongshore movement of the upper beach

- With exception of southern end, reinstatement of these is unlikely to have significant effect – but they are not doing any harm either.
- Permeable groynes would still have the issue of insufficient sediment supply

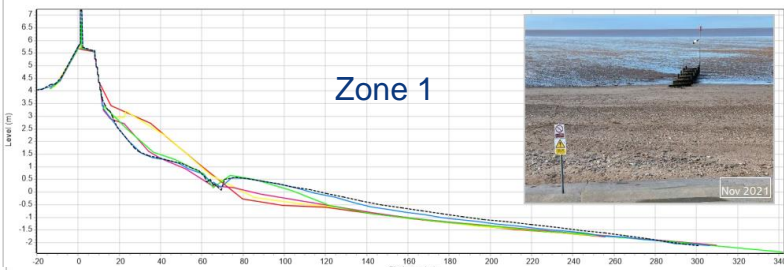
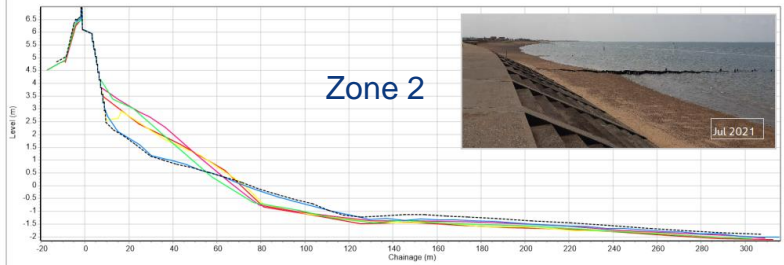
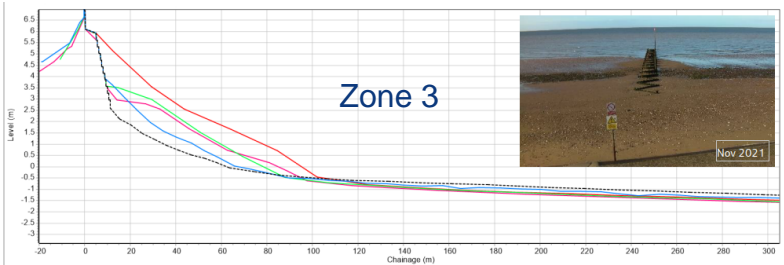
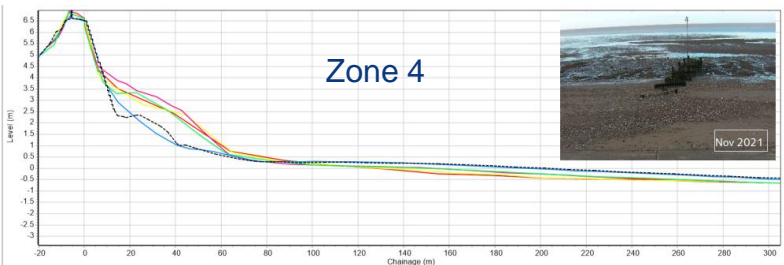
## Typical changes in beach profile

- No differential in levels – groynes seem to be largely ineffective in respect of alongshore movement
- But again may be influencing current flows on lower beach, in particular in Zone 1.
- Zone 2 – promontory, toe of wall exposed and it clear that elevation of groynes is too low (if effective)
- Zone 3 – better beach – but groynes appear to have no discernible influence – due to alignment of seawall creating embayment
- Zone 4 – groynes clearly redundant

- With exception of Zone 1, reinstatement of these is unlikely to have significant effect – but they are not doing any harm either.
- Sand recycling provides sediment supply to upper beach – retention against seawall might be improved if the landward sections were replaced with higher impermeable structures
