Hunstanton Capital Sea Defence Works Briefing

Thursday 7th August 2025 Dave Robson & Jade Kite

Outcomes of Geotechnical Investigations

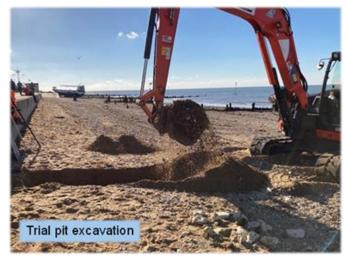
Geotechnical Investigation

- Excavation of 25 trial pits along the base of the seawall to expose the conditions seawall foundations which are normally buried beneath beach material.
- A ground penetrating radar survey to assess the internal condition of the promenade deck
- A falling weight deflectometer to test the material strength of the concrete promenade deck
- On site investigations were completed in Autumn 2024, and a final report of outcomes received in July 2025
