# VERIFICATION REQUIREMENTS FOR GAS PROTECTION SYSTEMS

Technical Guidance for  
Developers,  
Landowners and  
Consultants

Yorkshire and Lincolnshire  
Pollution Advisory Group

Version 1.1 – December 2016

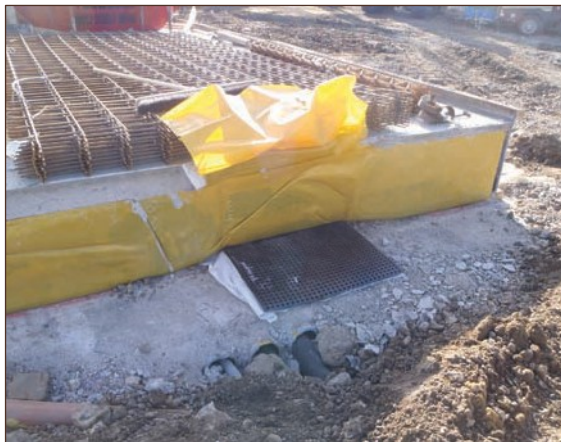
**Figure A4.7** Geovent protruding out of the frontage of the unit. Gas membrane along the sides of the slab preventing lateral gas ingress (courtesy Alderburgh Group)

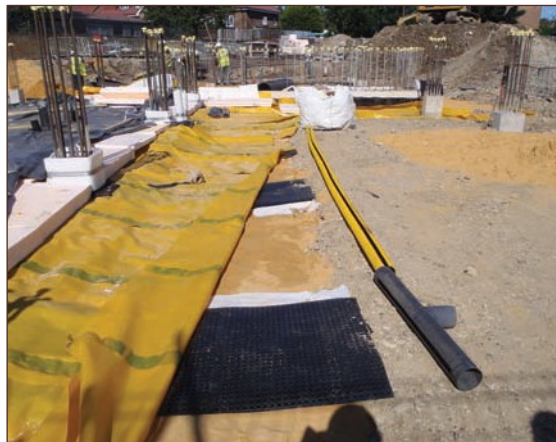
**Figure A4.8** Geovent beneath the 2000g taped gas membrane lined up with collector pipes (courtesy Alderburgh Group)

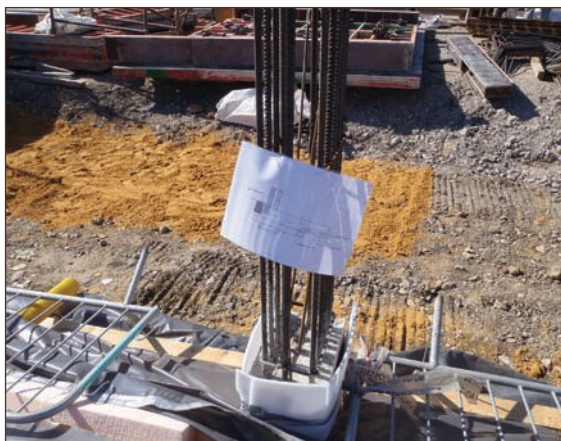
**Figure A4.9** On site schematics to aid construction workers build the gas protection system (courtesy Alderburgh Group)

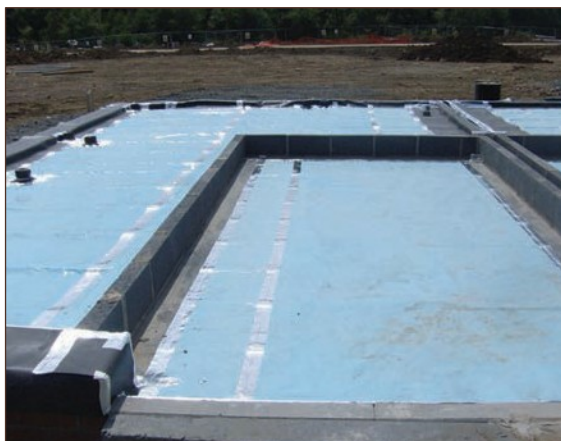
**Figure A4.11** Gas membrane continued through cavity wall and above air bricks (courtesy Hydrock)

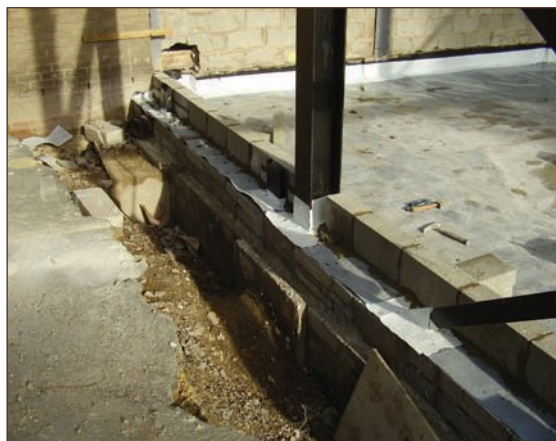
**Figure A4.12** Good edge detail across cavity (courtesy PAGeotechnical Ltd)

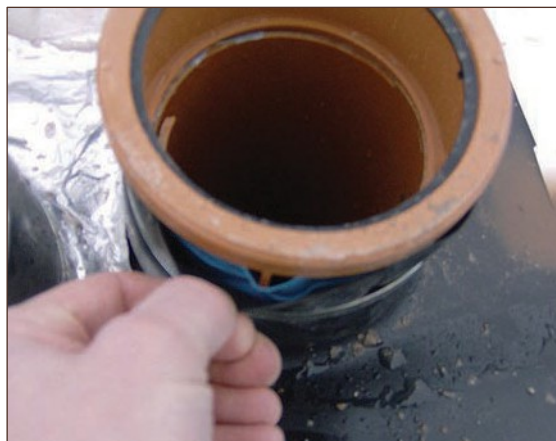
**Figure A4.28** Bead of double sided butyl tape provided between interfaces of ID top hat and OD service pipe. When compressed with jubilee clip, forms an effective seal (courtesy Smith Grant)

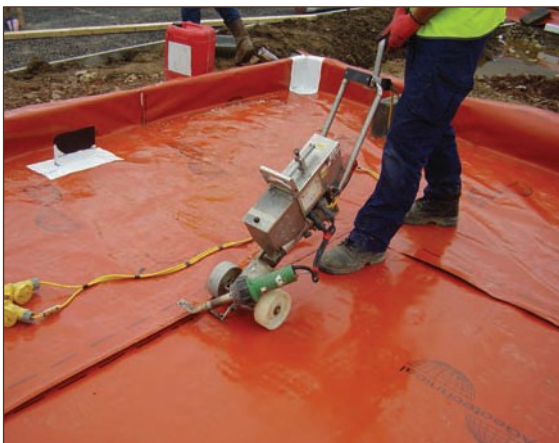
**Figure A4.31** Extrusion welding (courtesy PAGeotechnical Ltd)

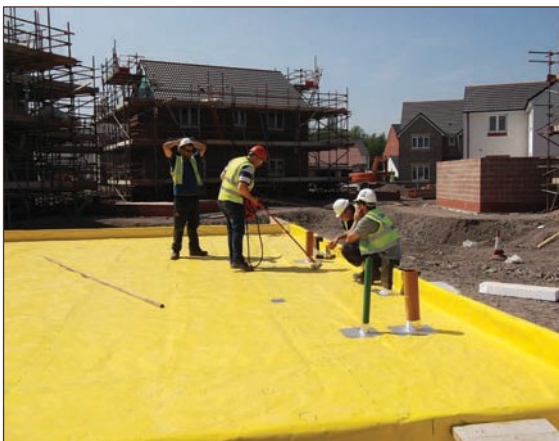
**Figure A4.43** Dielectric porosity testing for housing scheme (courtesy NHBC)

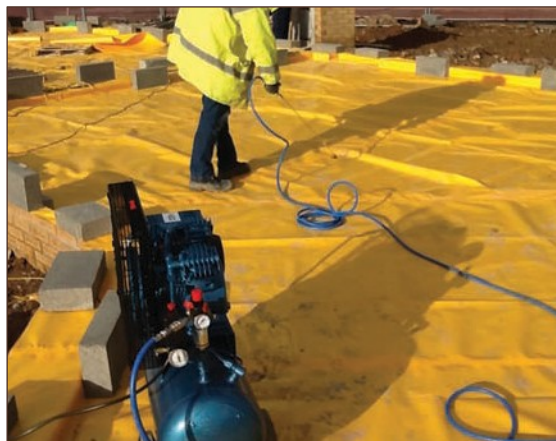
**Figure A4.44** Air lance test, used to test the quality of welded seams along gas membrane joints (courtesy MEC Environmental Ltd)

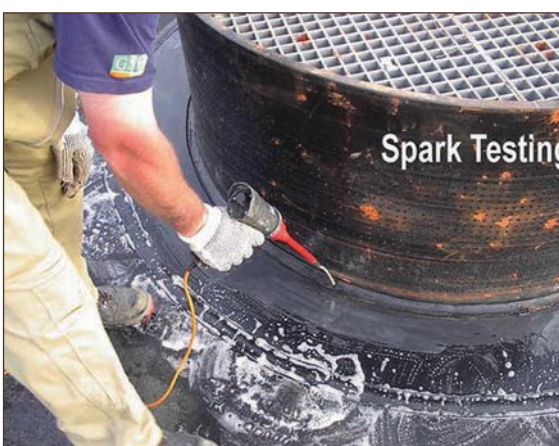
**Figure A4.45** Spark testing (courtesy GSE Environmental)

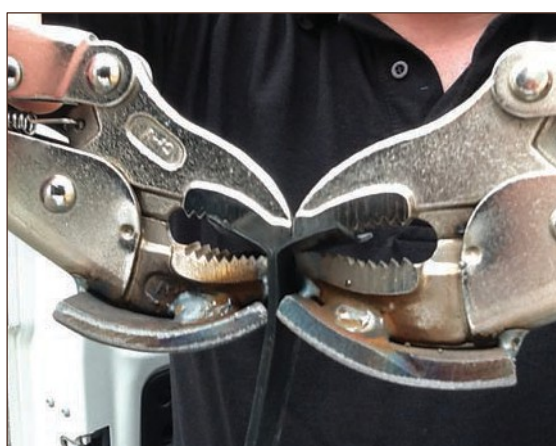
**Figure A4.46** Testing a weld with 'dog bone' grips (courtesy MEC Environmental Ltd)

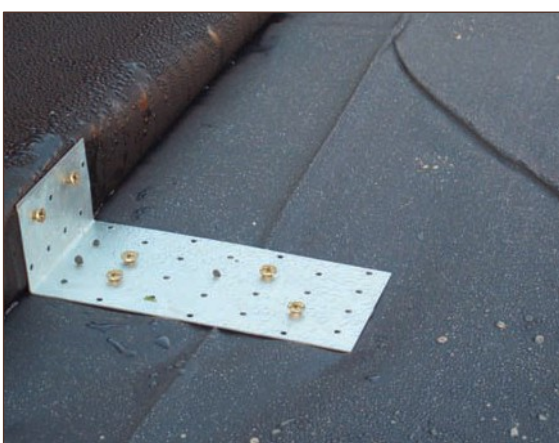
**Figure A4.47** Follow-on works purposefully penetrating gas membrane (courtesy Card Geotechnics Limited)

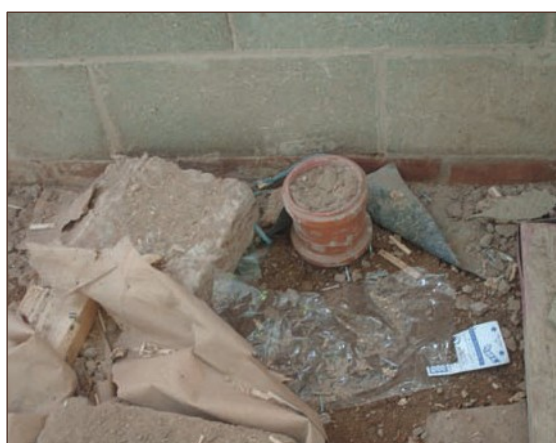
**Figure A4.48** Loose nails and over construction debris likely to be left in place beneath gas membrane – poor preparation of gas membrane prior to sealing service penetration (courtesy Card Geotechnics Limited)

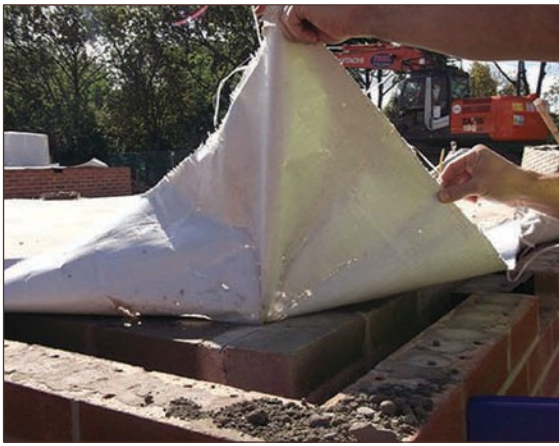
**Figure A4.49** *Lifted gas membrane at corner position. Light penetrating through confirms damage to aluminium internal core layer (courtesy NHBC)*

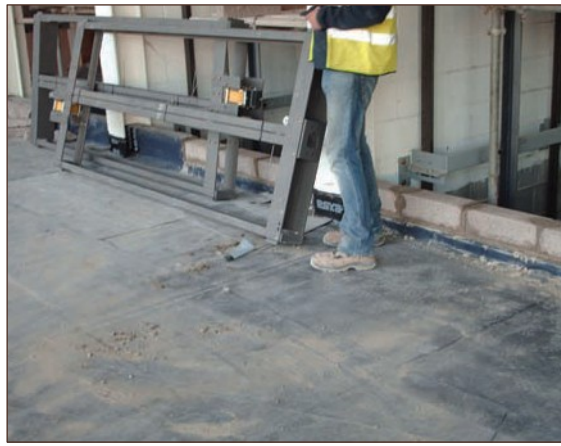
**Figure A4.50** *Large/heavy/sharp objects being moved over unprotected gas membrane (courtesy Card Geotechnics Limited)*

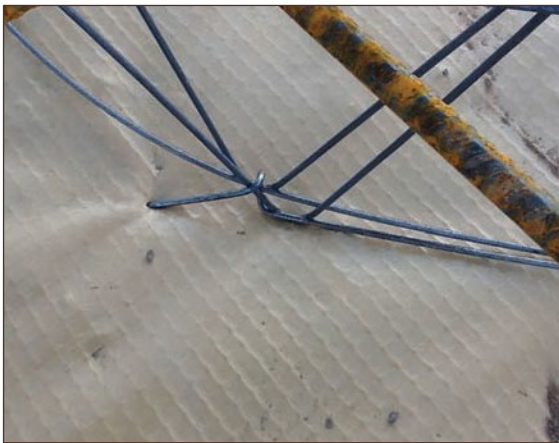
**Figure A4.51** *Gas membrane torn by reinforcement (courtesy MEC Environmental Ltd)*

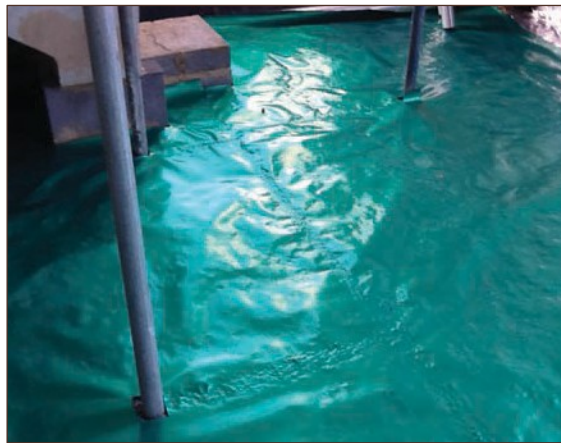
**Figure A4.52** *Gas membrane cut by scaffolders and bricklayers after installation (courtesy MEC Environmental Ltd)*

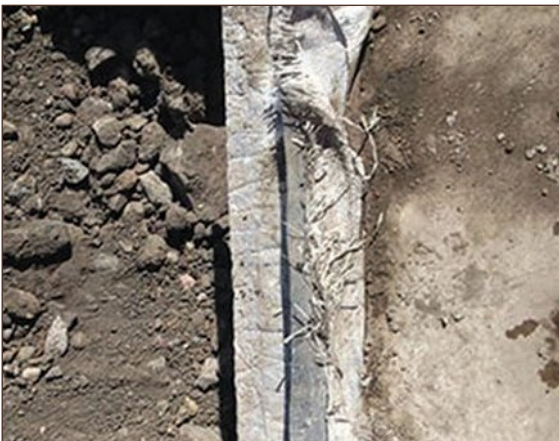
**Figure A4.53** *Gas membrane left exposed for long period of time, shows significant fraying at cavity edge (courtesy NHBC)*

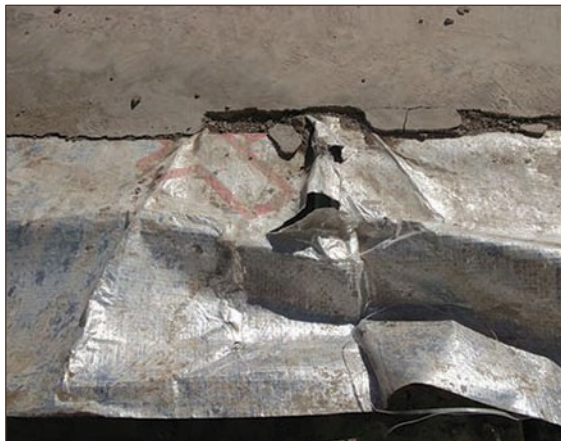
**Figure A4.54** *Gas membrane damage/tearing at edge of ground floor slab screed layer where it was left exposed to elements for period of time (courtesy NHBC)*

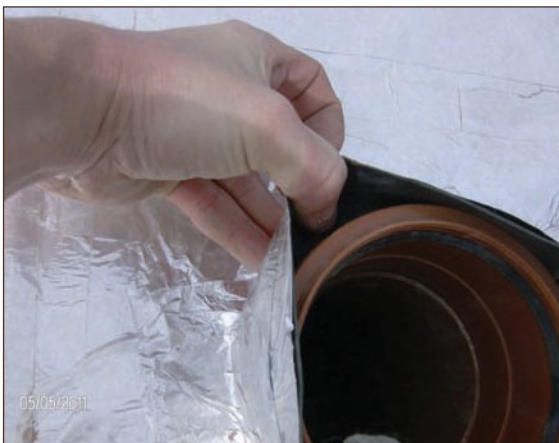
**Figure A4.73** No bead of double sided butyl tape provided between interfaces of ID top hat and OD service pipe: cannot be compressed enough to form seal (courtesy Smith Grant)

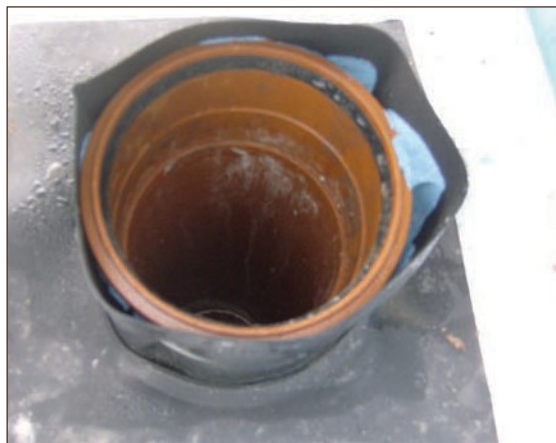
**Figure A4.74** Gap between OD of service pipe and ID of top hat too large: cannot be compressed enough to form seal, even with the application of additional tape (courtesy Smith Grant)

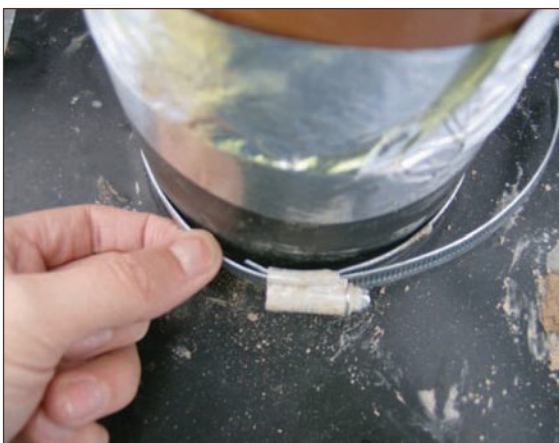
**Figure A4.75** Jubilee clip on service entry insufficiently tightened so joint is uncompressed (courtesy Smith Grant)

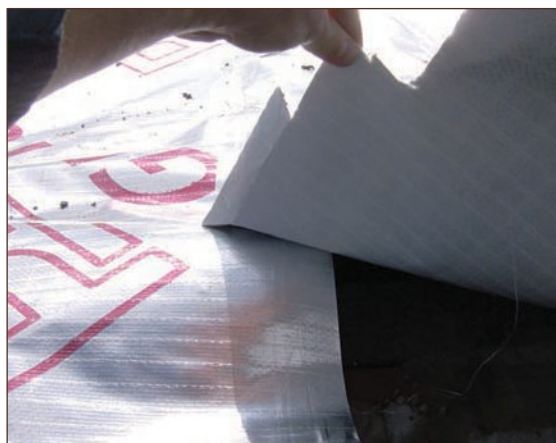
**Figure A4.76** No double sided tape used in joints (courtesy Smith Grant)

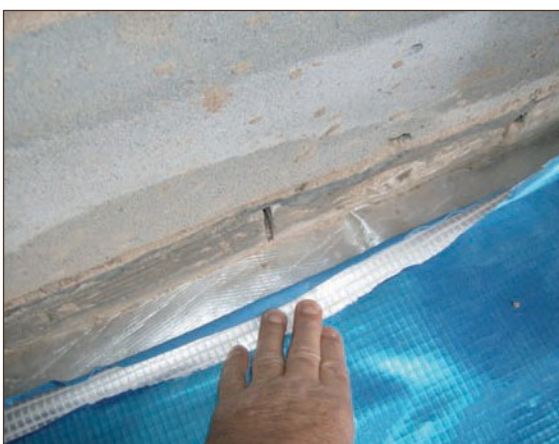
**Figure A4.77** Small lap and no single sided tape used to achieve secondary seal (courtesy Smith Grant)

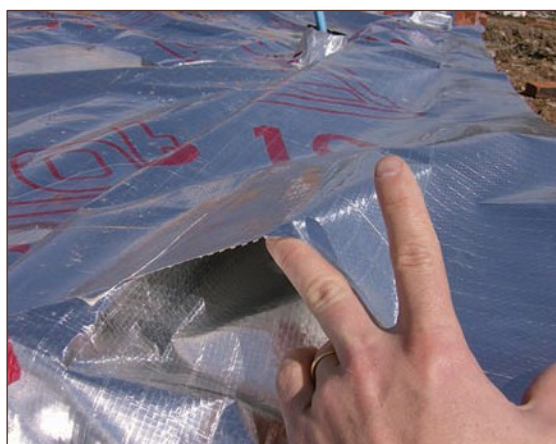
**Figure A4.78** Gap in jointing over wall cavity big enough to insert fist (courtesy Smith Grant)
