Borough Council of Kings Lynn and West Norfolk

Hunstanton Wave Wall Options

September 2014

Hunstanton Promenade Wave Wall Options

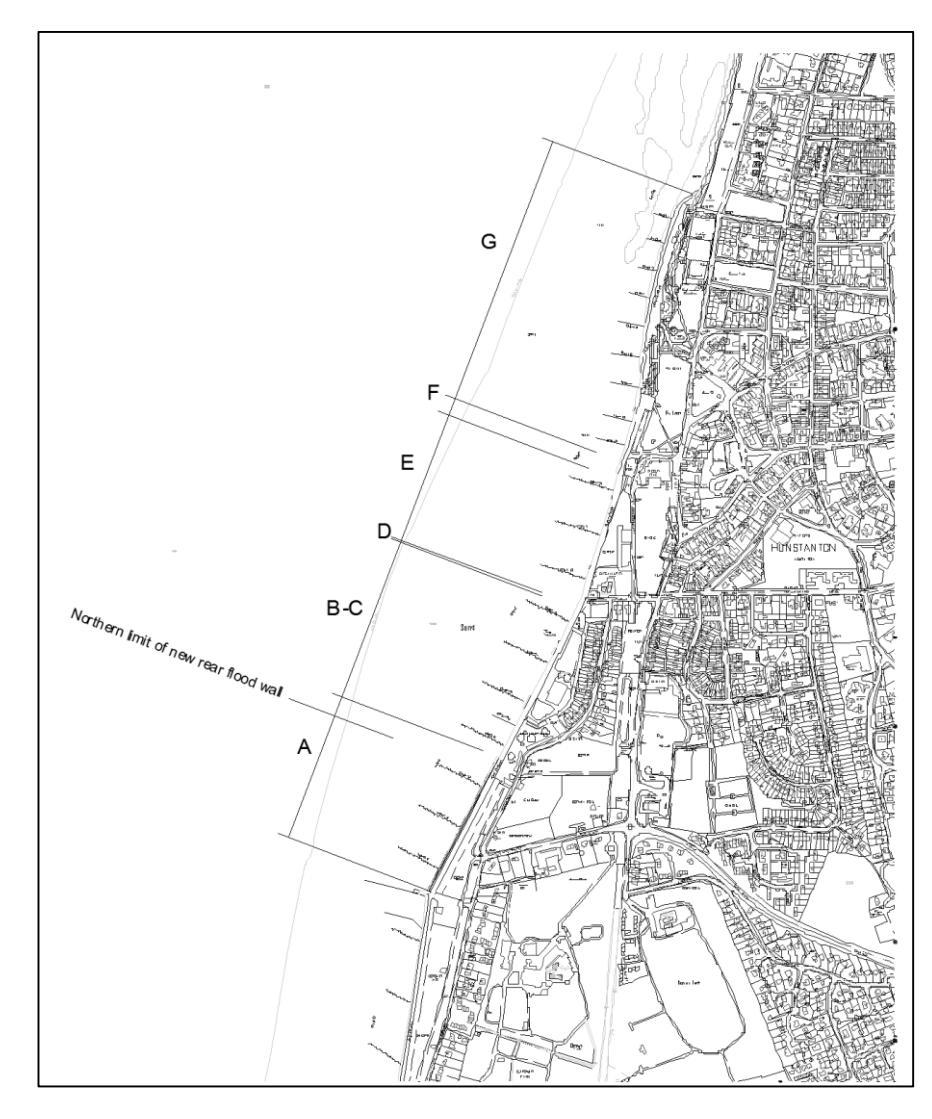
Figure 1 Hunstanton Frontage Defence Lengths

- 2.3. The main defences consist of a sea wall of varying ages and profiles and a promenade with a low wave return wall at its rear. The frontage is shown in Figure 1. Section A is owned and managed by the Environment Agency (EA). Sections B to G are managed by the Borough Council of Kings Lynn and West Norfolk (BCKLWN).

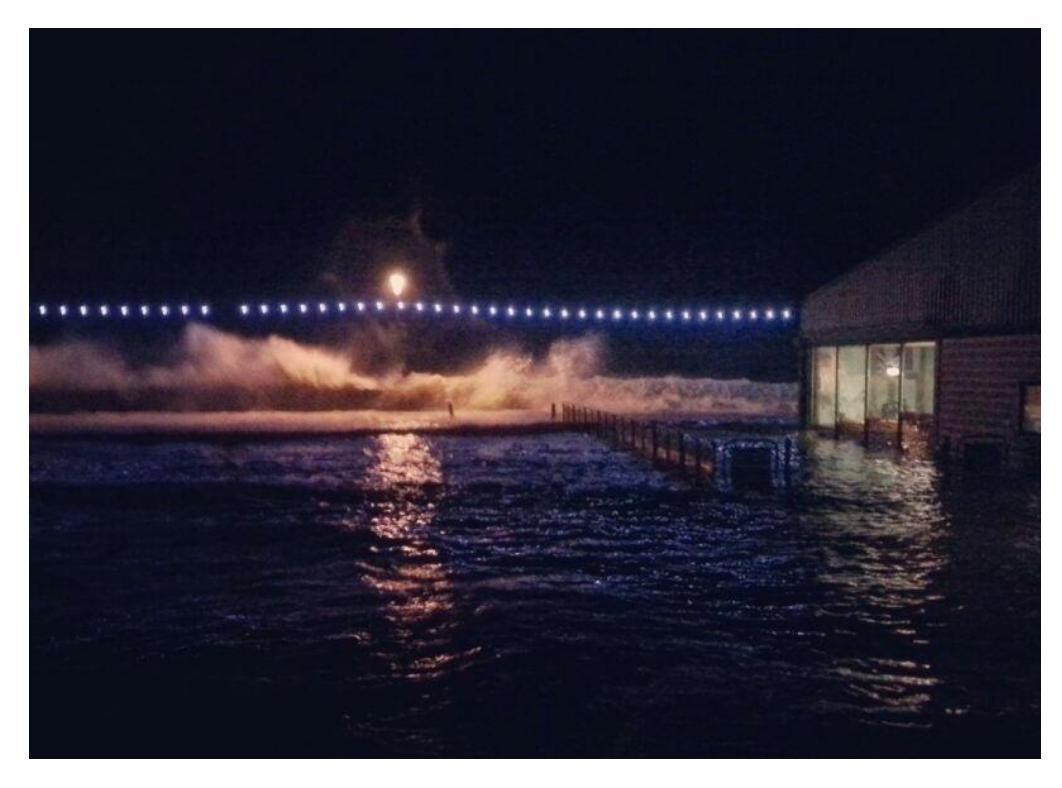
Figure 2: Overtopping and flooding at the Sea Life Sanctuary

- 2.6. The storm surge of 05 December 2013 caused considerable damage along much of the east coast of Britain. Within The Wash, the Hunstanton frontage was no exception. The very high water levels, coupled with moderate wave conditions led to considerable wave overtopping of the defences and consequent damage. In particular the Sea Life Sanctuary suffered extensive damage and is not expected to re-open until October 2014, some 10 months after the event. Other property, not immediately behind the sea wall suffered flood damage; e.g. Searles Leisure Resort (Figures 2 4).

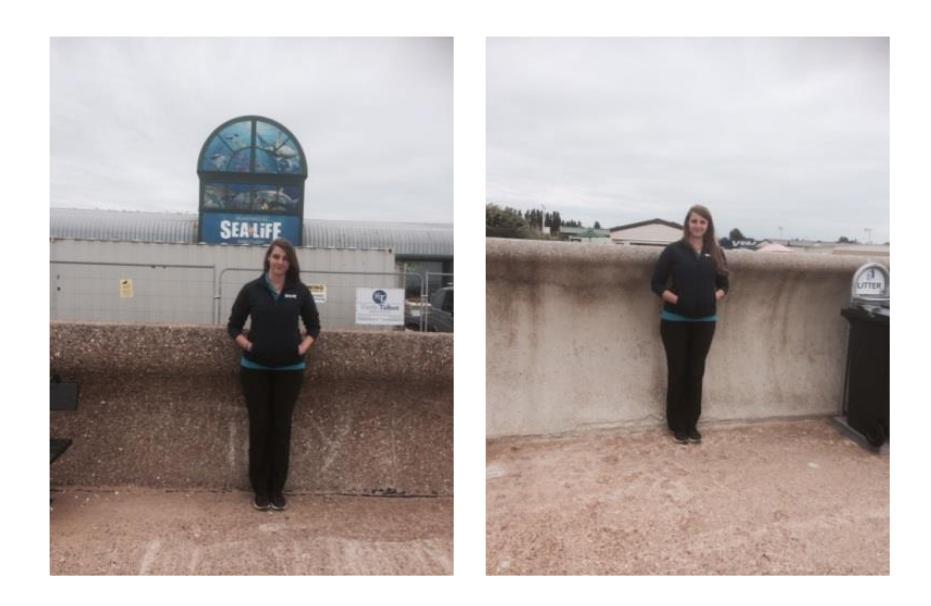
Figure 5: Comparison of existing (Left) with EA (Right)

- 6.1. Permanent solutions
 - 6.1.1. Enlarged Wave Wall
 - 6.1.1.1. For uniformity of appearance and performance, to replicate the EA wall to the south must be the favoured solution. Visually, it does not overly intrude and the comparison photographs below show that attractions and amenities would remain visible to adults from the promenade. It should, perhaps be noted that such a wall would be above the eye level of most children. However, it is not particularly effective as it only reduces theoretical overtopping rates by around 25 to 30%.

- 6.1.1.2. The new profile has been constructed around the existing wall which remains as a core. While it has the advantage of low maintenance cost, it has a high capital cost. It is estimated that the cost of such a wall is £1,550 per metre run. This would include the necessary re-positioning of the amenity lighting columns and other furniture. The benefit : cost ratio at 0.08:1 is very low (See section 9) making this option of little economic value.

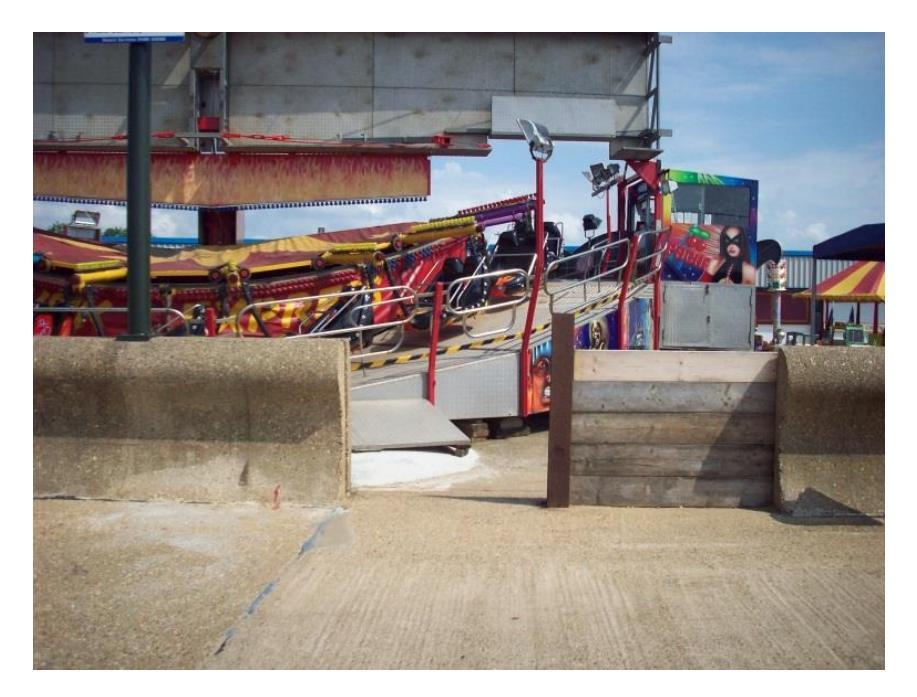
Figure 6: Fairground with wave wall and flood boards

- 6.2.2.1. The defences already include simple flood boards that are used to infill the gaps in the wave wall (Figure 6). Outside the winter season they are removed to permit free pedestrian passage through the wall. The gaps are only completely sealed when a storm event is forecast. The principle can be extended to an extension of the wave wall, though the boards and their supports should be installed at the start of the winter season as a precautionary measure and left in place throughout the winter simply because of the risk that the work necessary to install them could not be undertaken in the time available in advance of a storm.

- 7.1. Section B Fairground
 - 7.1.1. Section B is 117 metres long and is the most southerly section of wall owned by BCKLWN. The primary defence is a concrete sea wall of the top of the beach. Beach level varies. The wall profile consists of an upper vertical section atop a stepped revetment. The promenade is over 10 metres wide. To the rear of the promenade is a 1.15 metre high wave return wall. This wall is breached in a number of places to permit movement between the promenade and the fairground (Golden Sands Amusements) that is immediately behind these defences. Provision has been made to insert flood boards, located within steel channel or 'H' sections and held in place with timber wedges. (Figure 6)

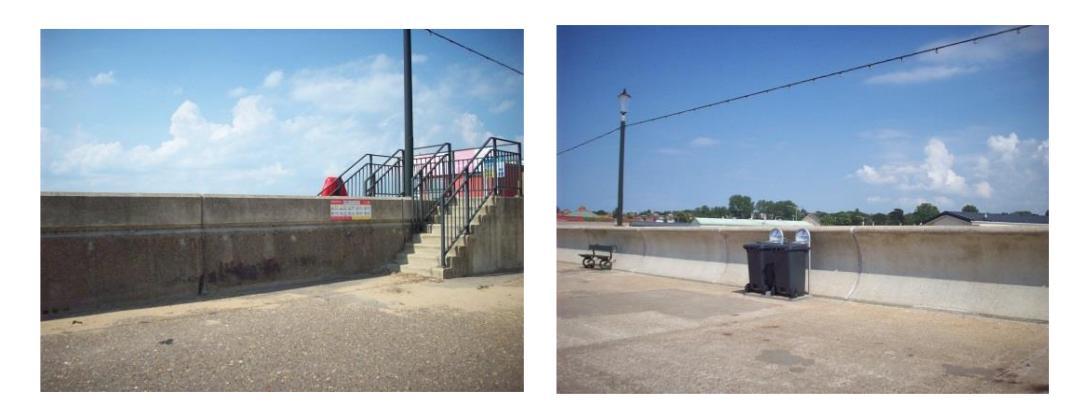
Figure 8: EA Section A defences with raised wave wall (front and rear views)

- 7.1.5. To the south (Section A) the wall is owned by the EA. This wall has been raised by 430mm by enlarging the pre-existing wave return wall. Clearly one obvious option is to continue the EA profile northwards. Such a wall would reduce overtopping by approximately 25% in storm conditions. However, it is estimated the cost would be around £181,350 at today's prices. This is likely to be considerably in excess of any direct benefit that can be derived, though it should be considered in conjunction with any major refurbishment of the defences.

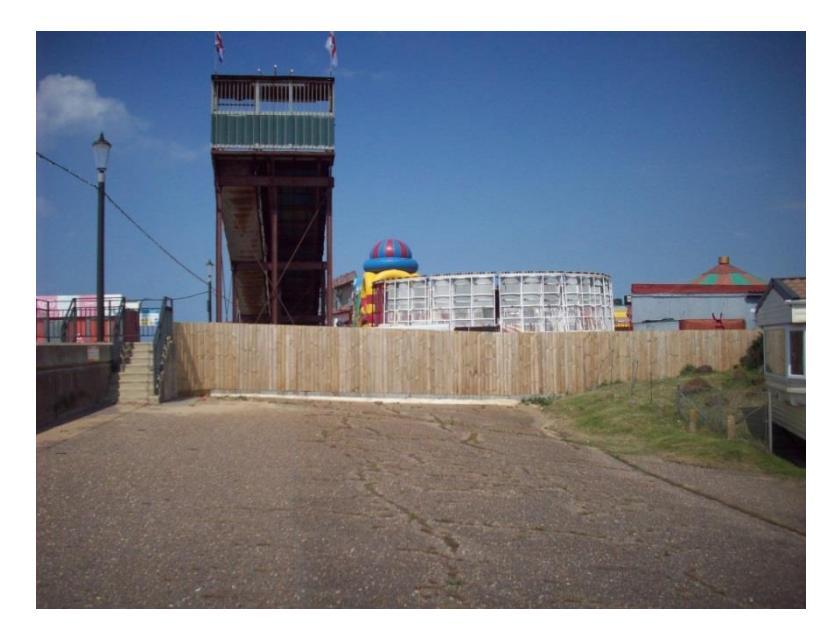
Figure 9: Existing fence between Fairground and Caravan Park

- 7.1.8. It is however recommended that the present bank between the fairground and caravan park is extended west to join with the wave wall and so provide a better impediment to shore parallel flows. For security, if desired, the close boarded fence can be repositioned on the top of the bank. (Figure 9)

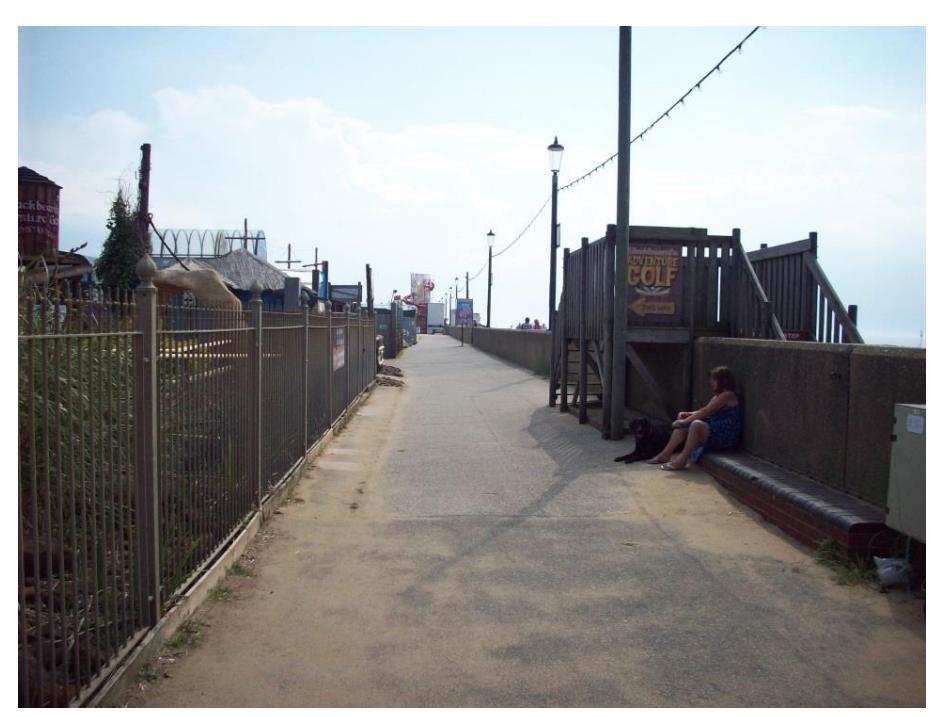
Figure 11: Walkway between wave wall (R) and attractions (L) showing timber steps over wave wall

- 7.2.4. The main means of accessing the attractions within Section C is from the Promenade, although there is a walk way immediately behind the wave wall. Hence visibility is an essential factor. This tends to direct away from options that raise the height of the wave wall permanently. An exception to this would take the form of a glass extension to the wall. It is, however, relatively expensive. The estimated cost for the whole of Section C is £326,000.

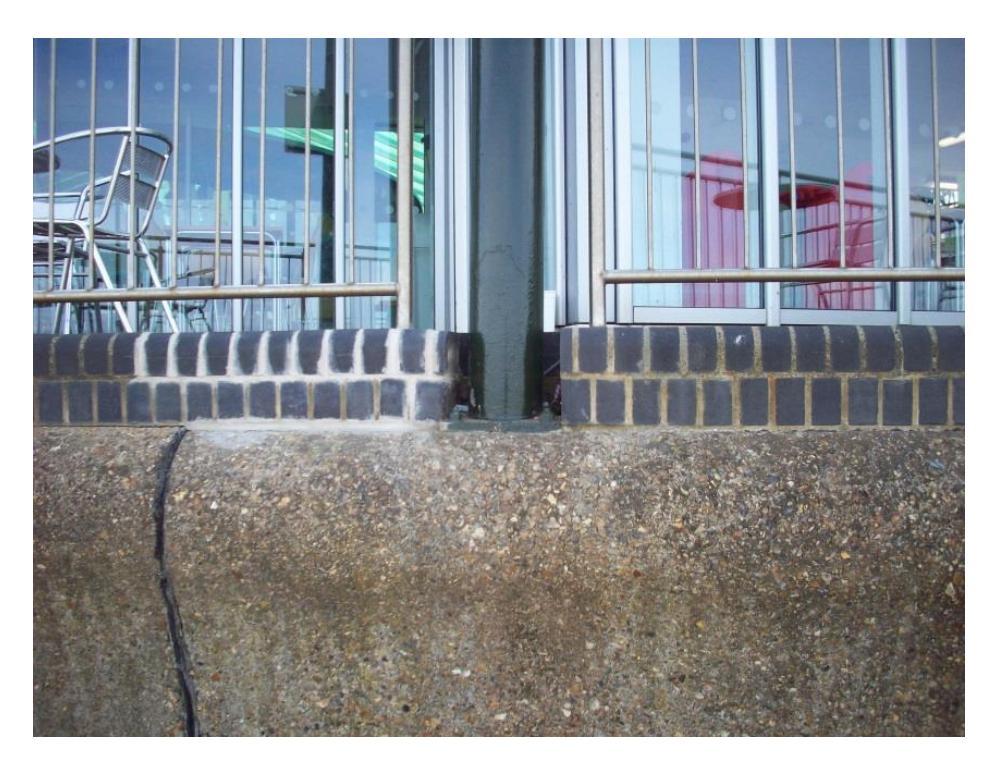
Figure 13: Oasis leisure Centre - detail of railings, lamp column and brickwork

- 7.3.3. Except for the Oasis Centre there is little or no economic benefit to be gained from preventing overtopping of this section, other than to prevent water flowing to adjoining sections, with consequent damage to properties in these sections. Therefore it is recommended that solutions in this section focus on preventing movement of water, particularly to the south towards the Sea Life Sanctuary. They should also seek to ensure that there are clear pathways for water to return to the sea as waves and tides permit.
- 7.3.4. The Oasis Leisure Centre within this section can be treated separately. The basic form of the defence structure is as the remainder of the section, but since the floor level of the Centre is approximately 225mm above the top of the wave wall, two courses of brickwork have been added to the wall raising it by 225mm (Figure 13).

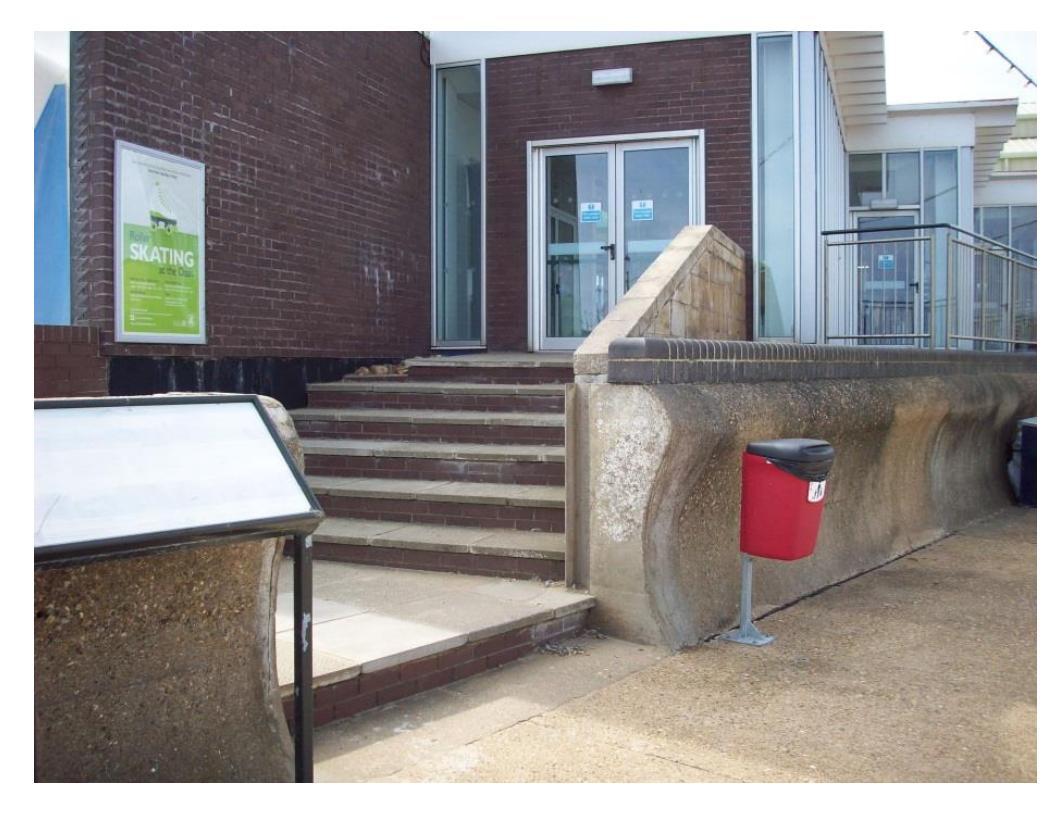
Figure 14: Oasis Leisure Centre - NW steps and access

- 7.3.5. In the 2013 event, the building's North-west corner suffered some damage to doors with some resulting damage to carpets in the immediate area.
- 7.3.6. It is recommended that the configuration of the flood boards in this area (Figure 14) is altered to reduce the vulnerability of the building, while at the same time permitting drainage through the wave wall.

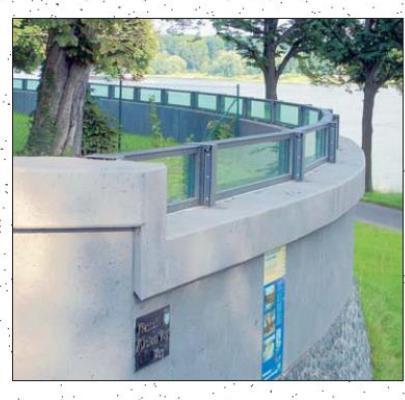
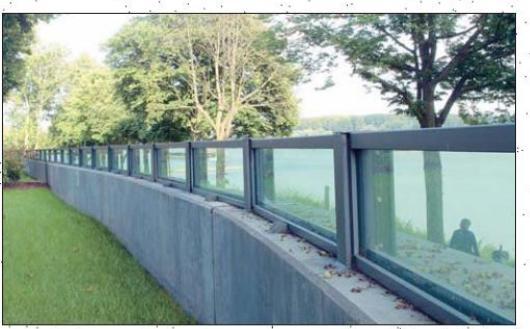
In order to surmount this problem a permanent glass wall of 400 mm height was constructed on the top of the reinforced concrete wall. This solution ensured that the required protection height was achieved, whilst at the same time taking into account all the design criteria, the adherence to this ensured the stability of the individual property values.

It was crucial for the glass wall sections to be as long as possible to reduce the number of support posts so as not to obstruct the views, but at the same time the sections had to be robust enough to withstand the heavy loads. With this in mind high performance laminated safety glass was used combined with slim yet exceptionally strong frames, this allowed spans of 2 m in length.

The laminated safety glass element was made up from a single pane of safety glass with two external sacrificial panes plus two internal support panes. All glass elements were heat soak tested in order to meet the high safety require-

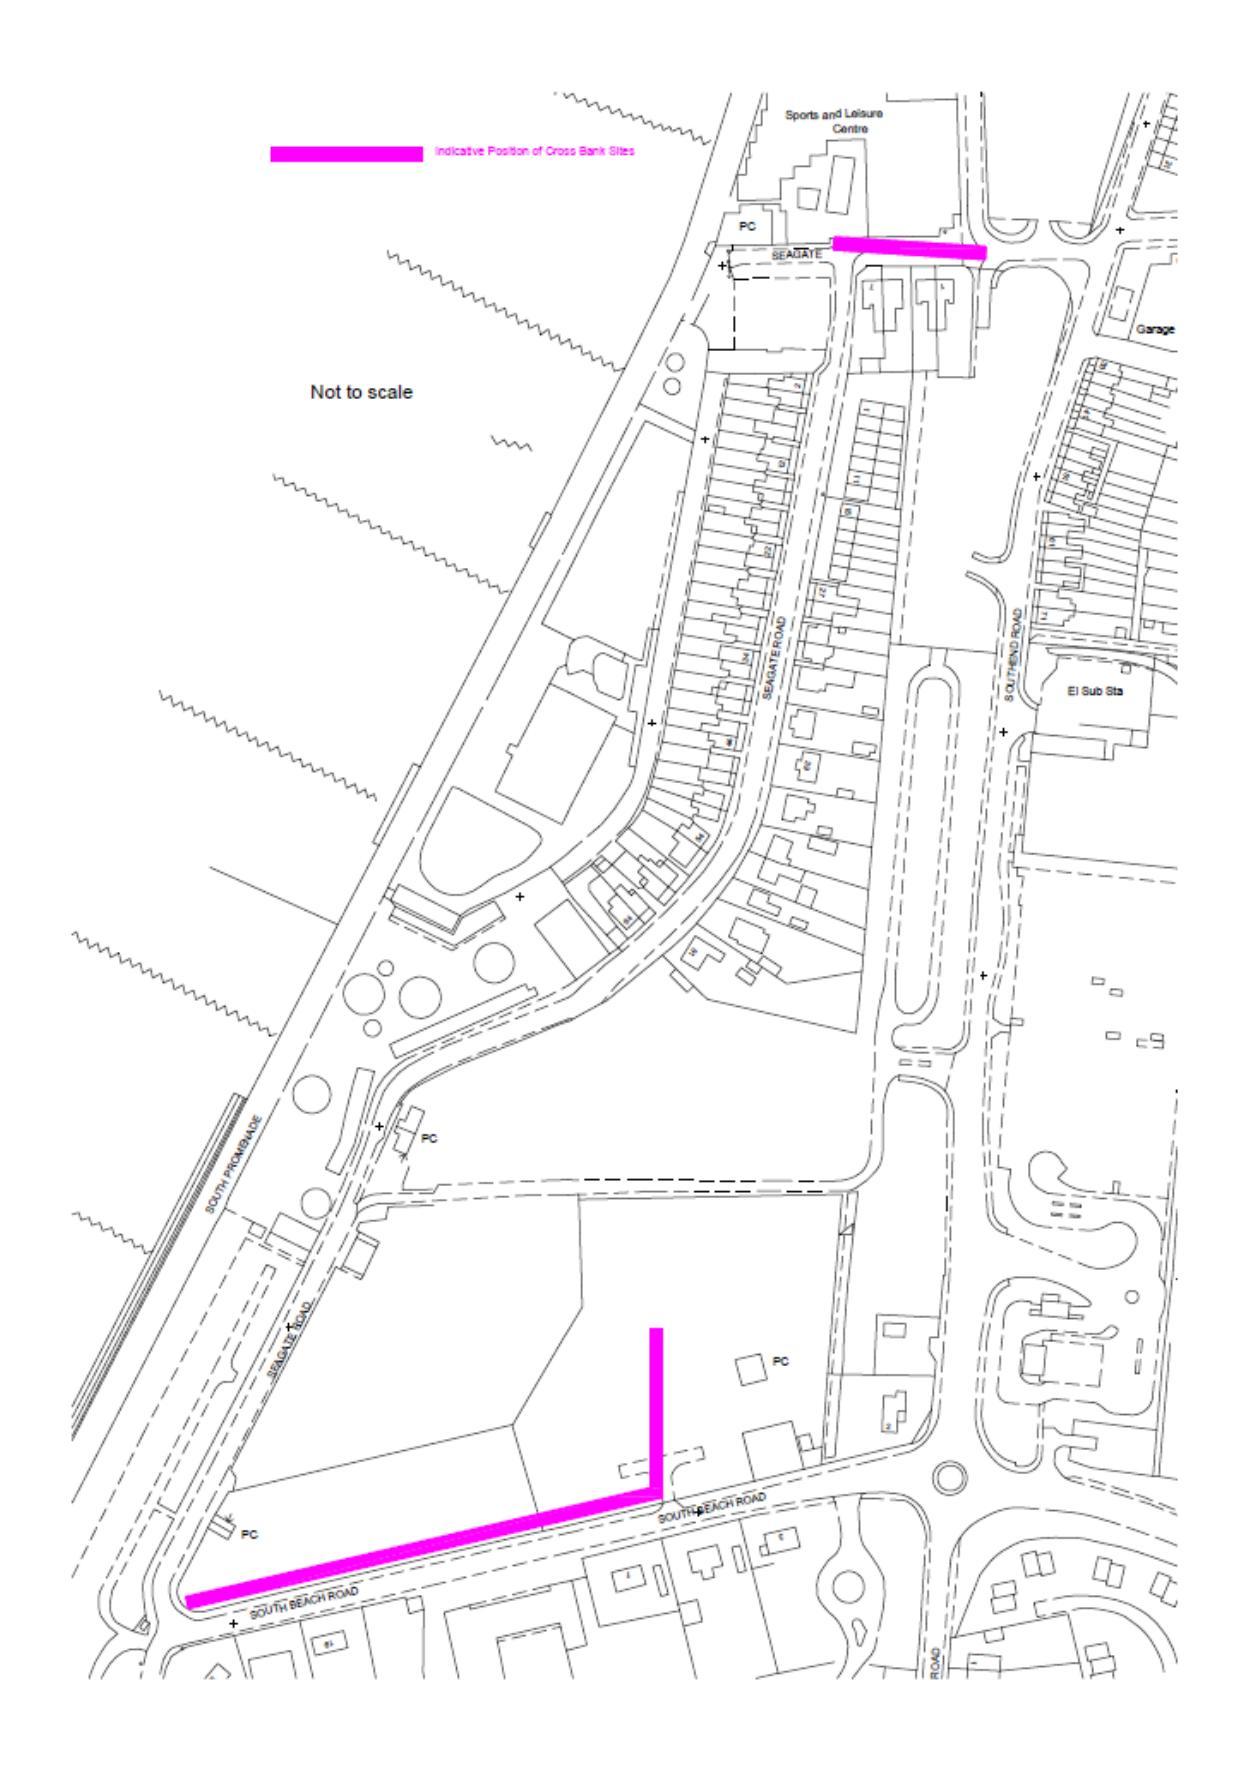
Appendix 3 Drawing showing locations for flood cross banks

- 6.3.4. It is recommended that reducing water dispersal such as occurred in December 2013 could significantly reduce consequent damage. This may be effected by some simple cross banks. Although they may not entirely impede flows they may reduce them sufficiently for other measures such as temporary bunds to be put in place. A budget price of £30,000 is suggested.
- 6.3.5. The suggest locations are shown on the Drawing at Appendix 3. The bank at the north end of Seagate Road would have the additional advantage that surface water would be diverted away from low areas and discharge to the sea.
