Contaminated Land Inspection Report

Dobby Drive & St Nicholas Retail Park King's Lynn

December 2017

Reference no. S145100001250

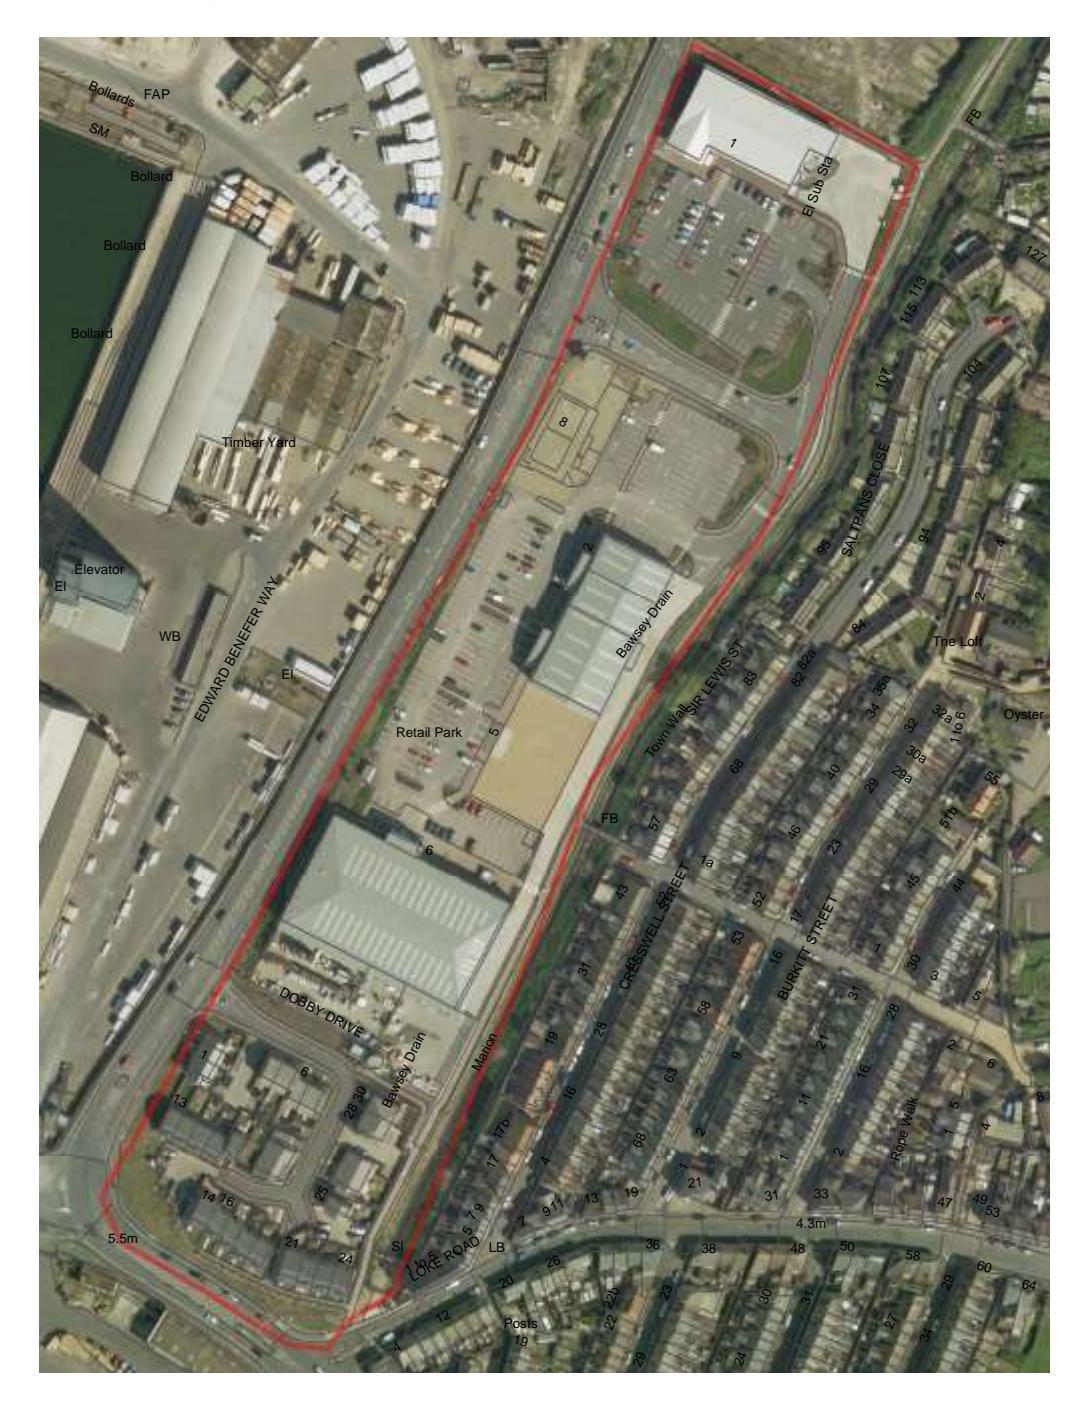
Figure 1: Site layout and surroundings

The site's present use is predominantly retail with a small number of residential units in the south. Figure 1 below shows the site layout on 2006-09 aerial photography. Photographs of the site are in appendix A.

2006-2009 – Figure 1 (on page 3) shows the site laid out as it is currently. The residential development is shown in the south of the site with small areas of garden and soft-landscaping. The north of the site is occupied by retail units and car-parking and some pads where retail units will be situated.

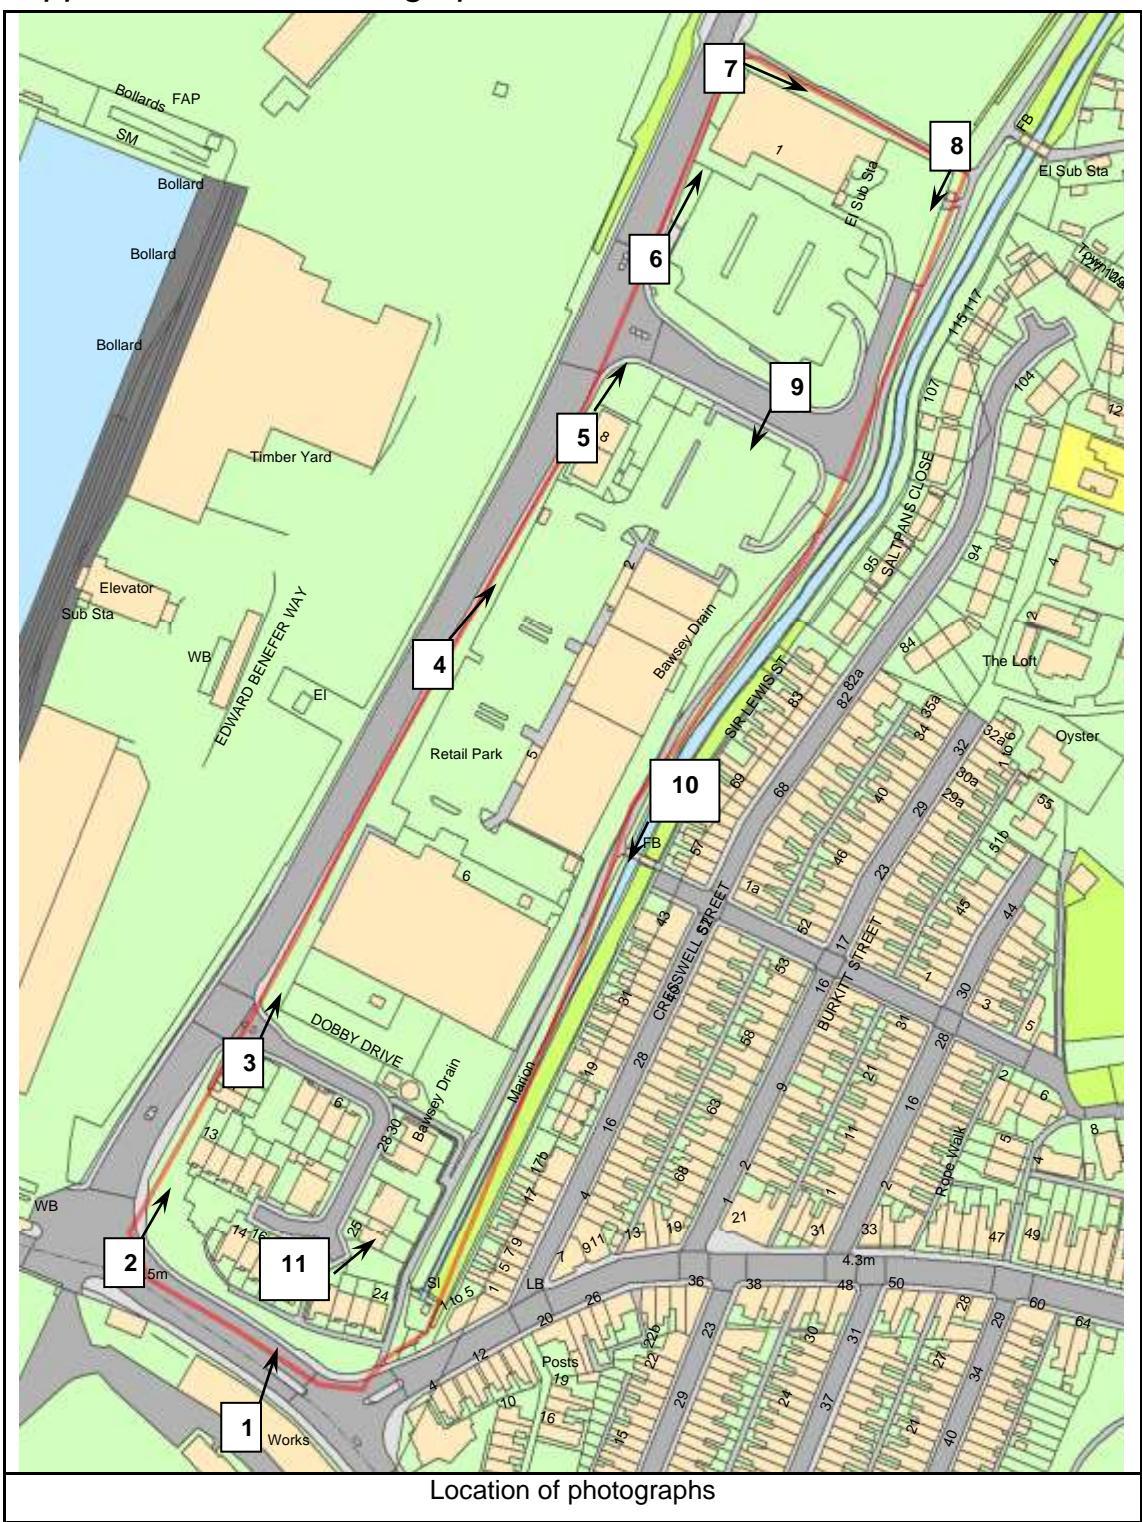
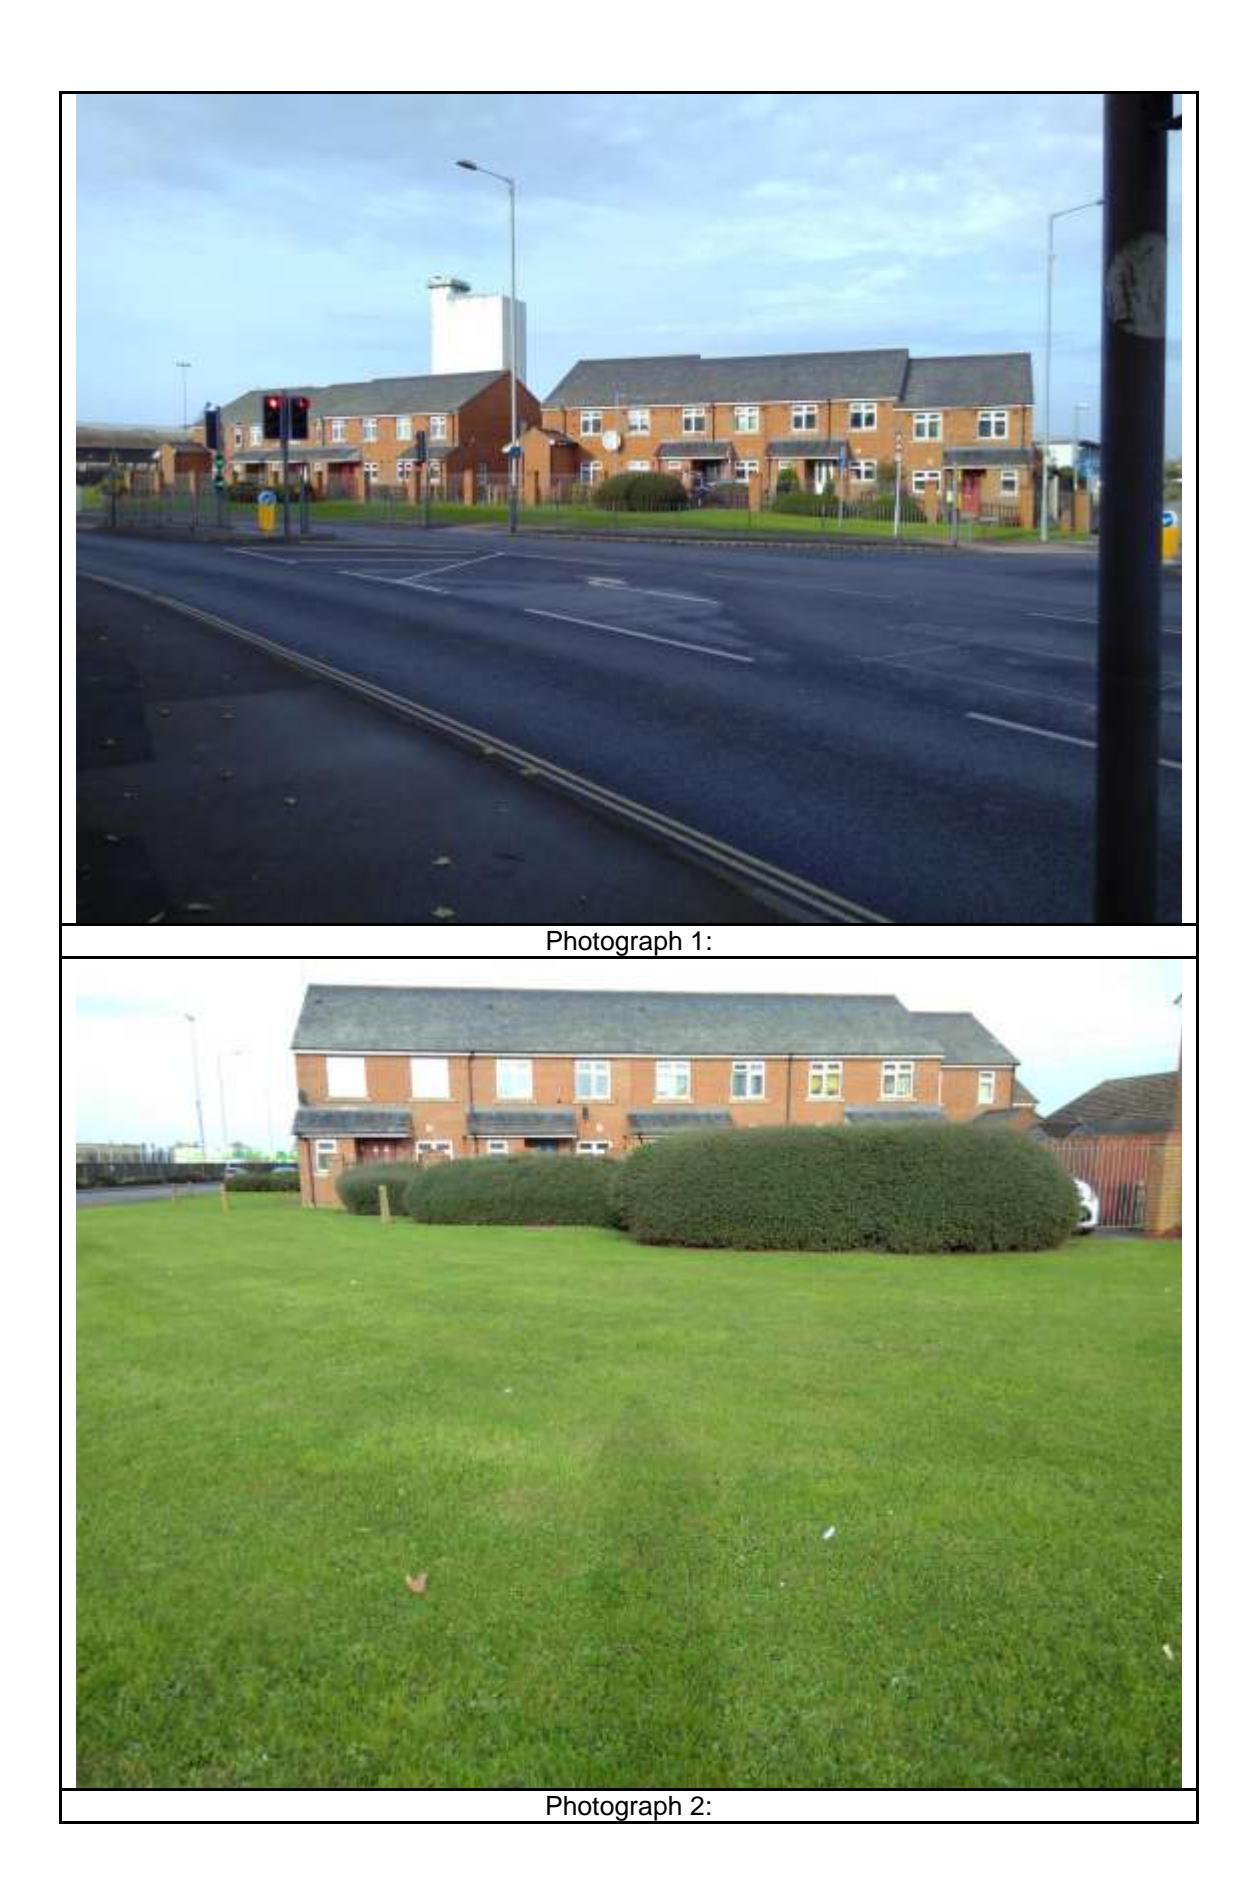
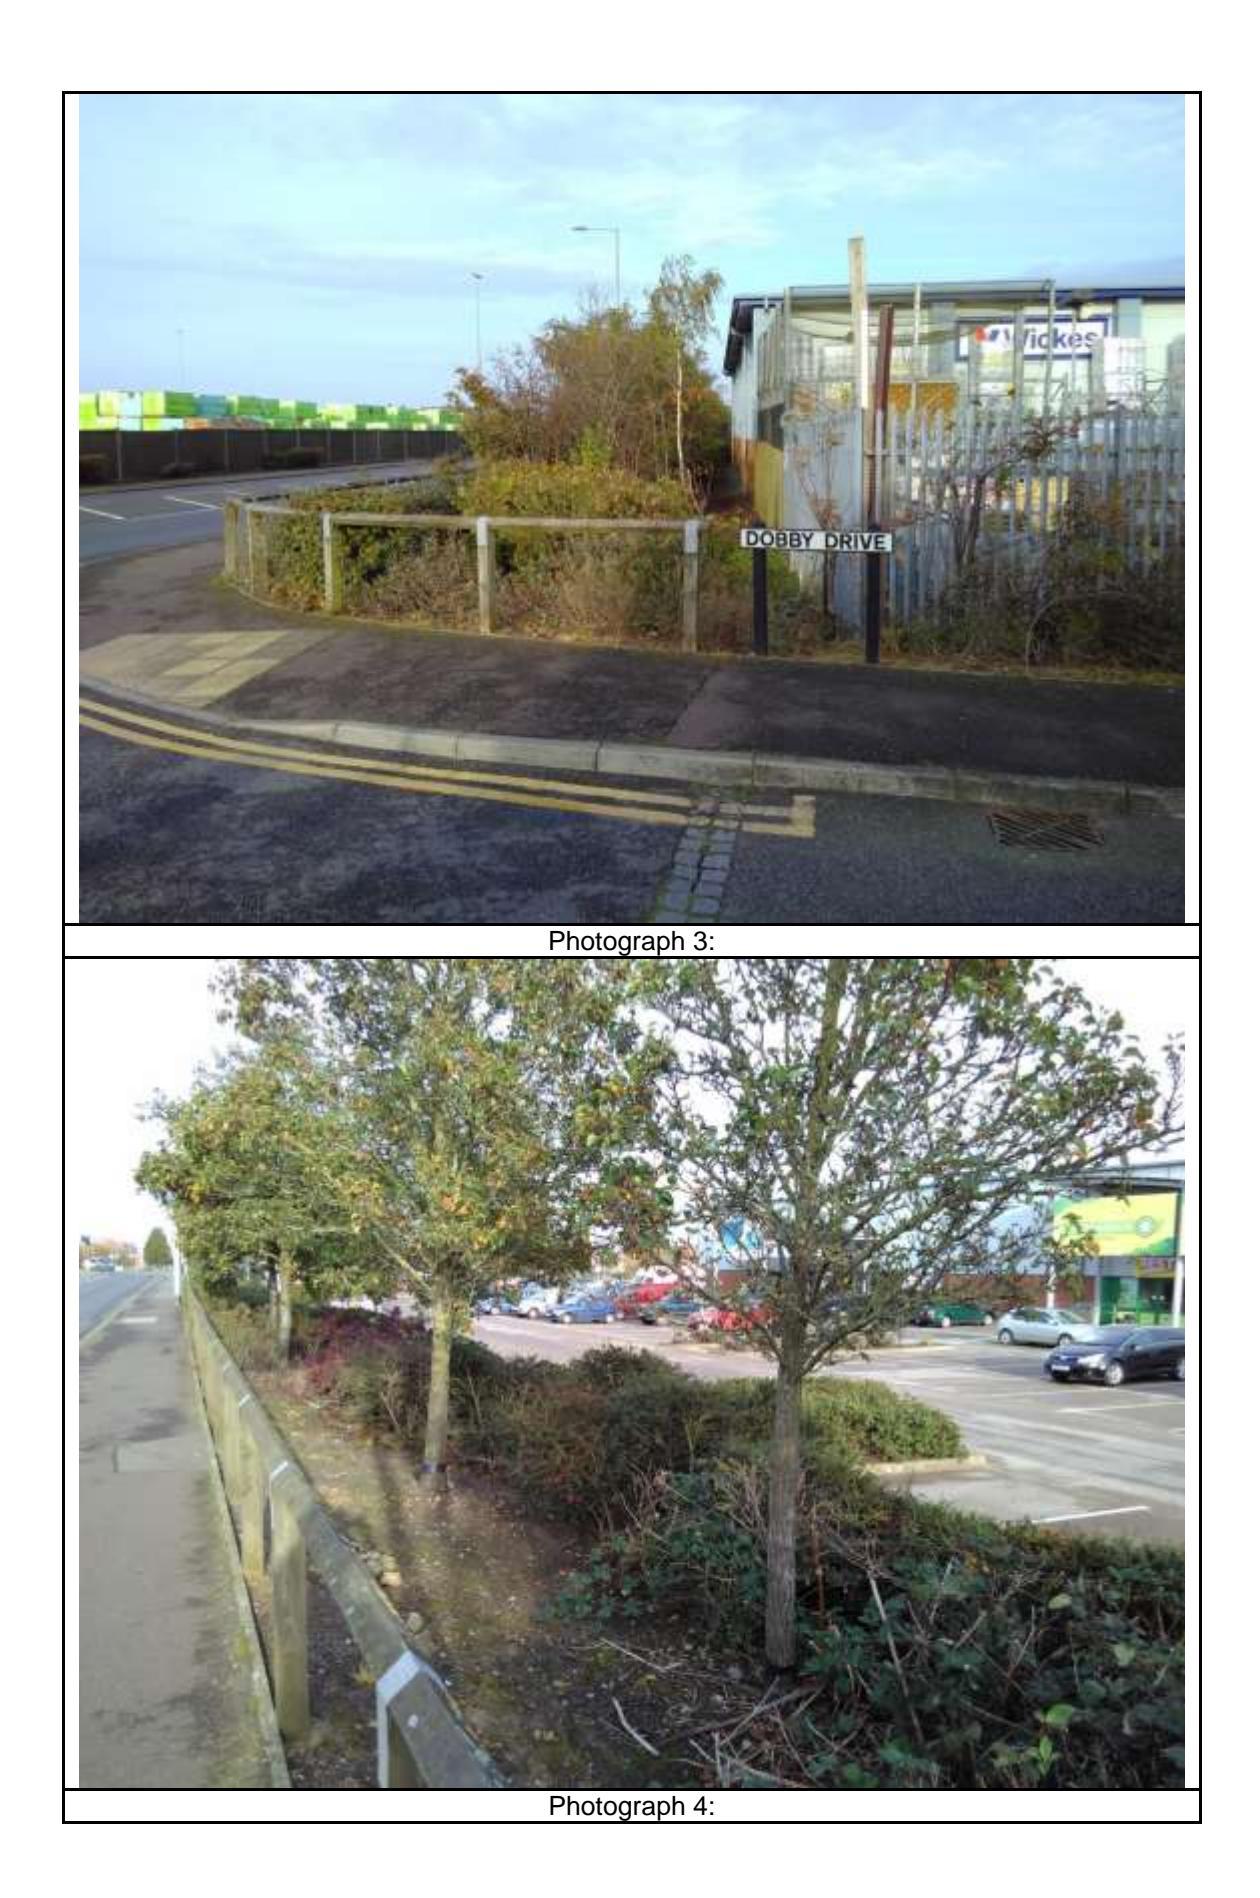
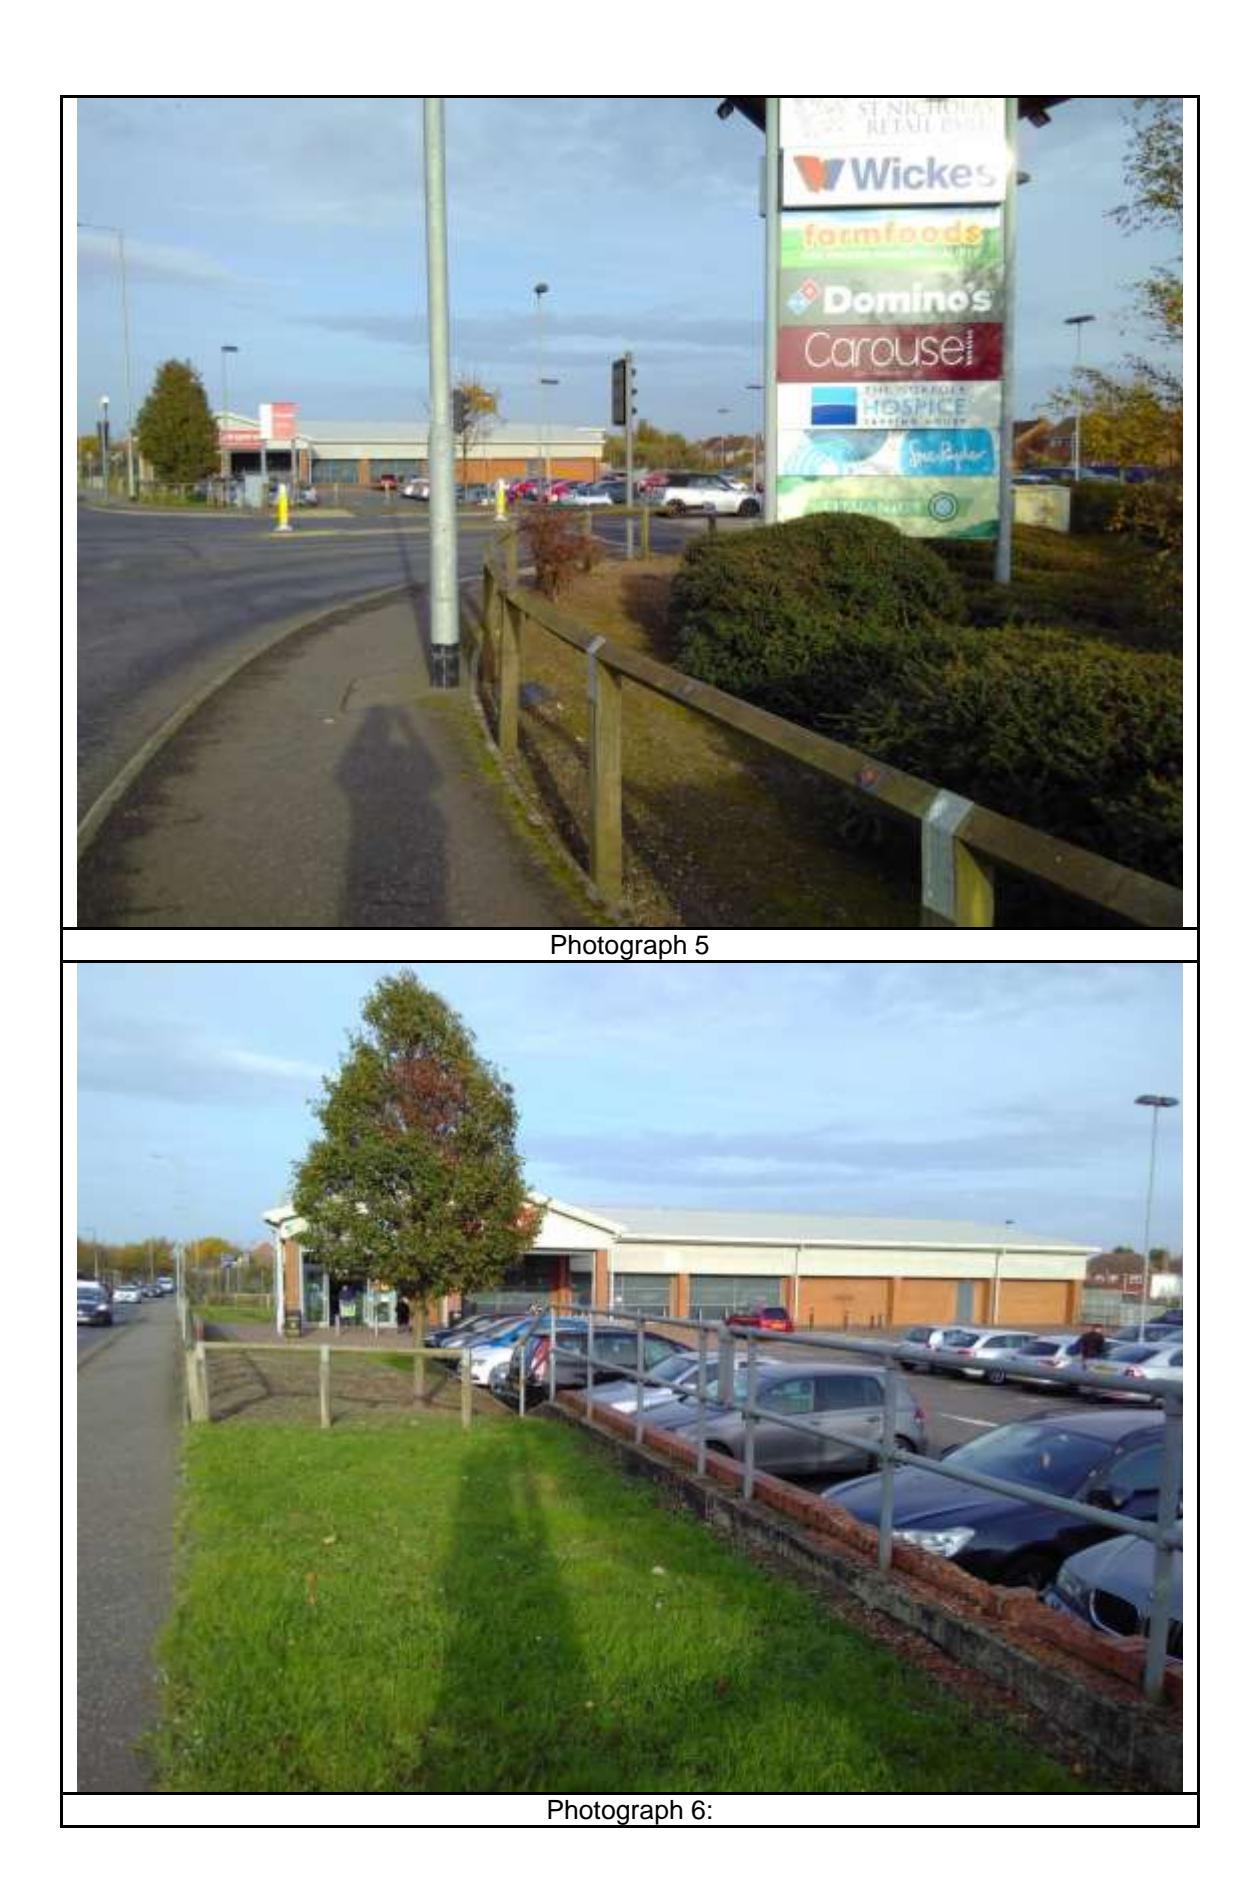
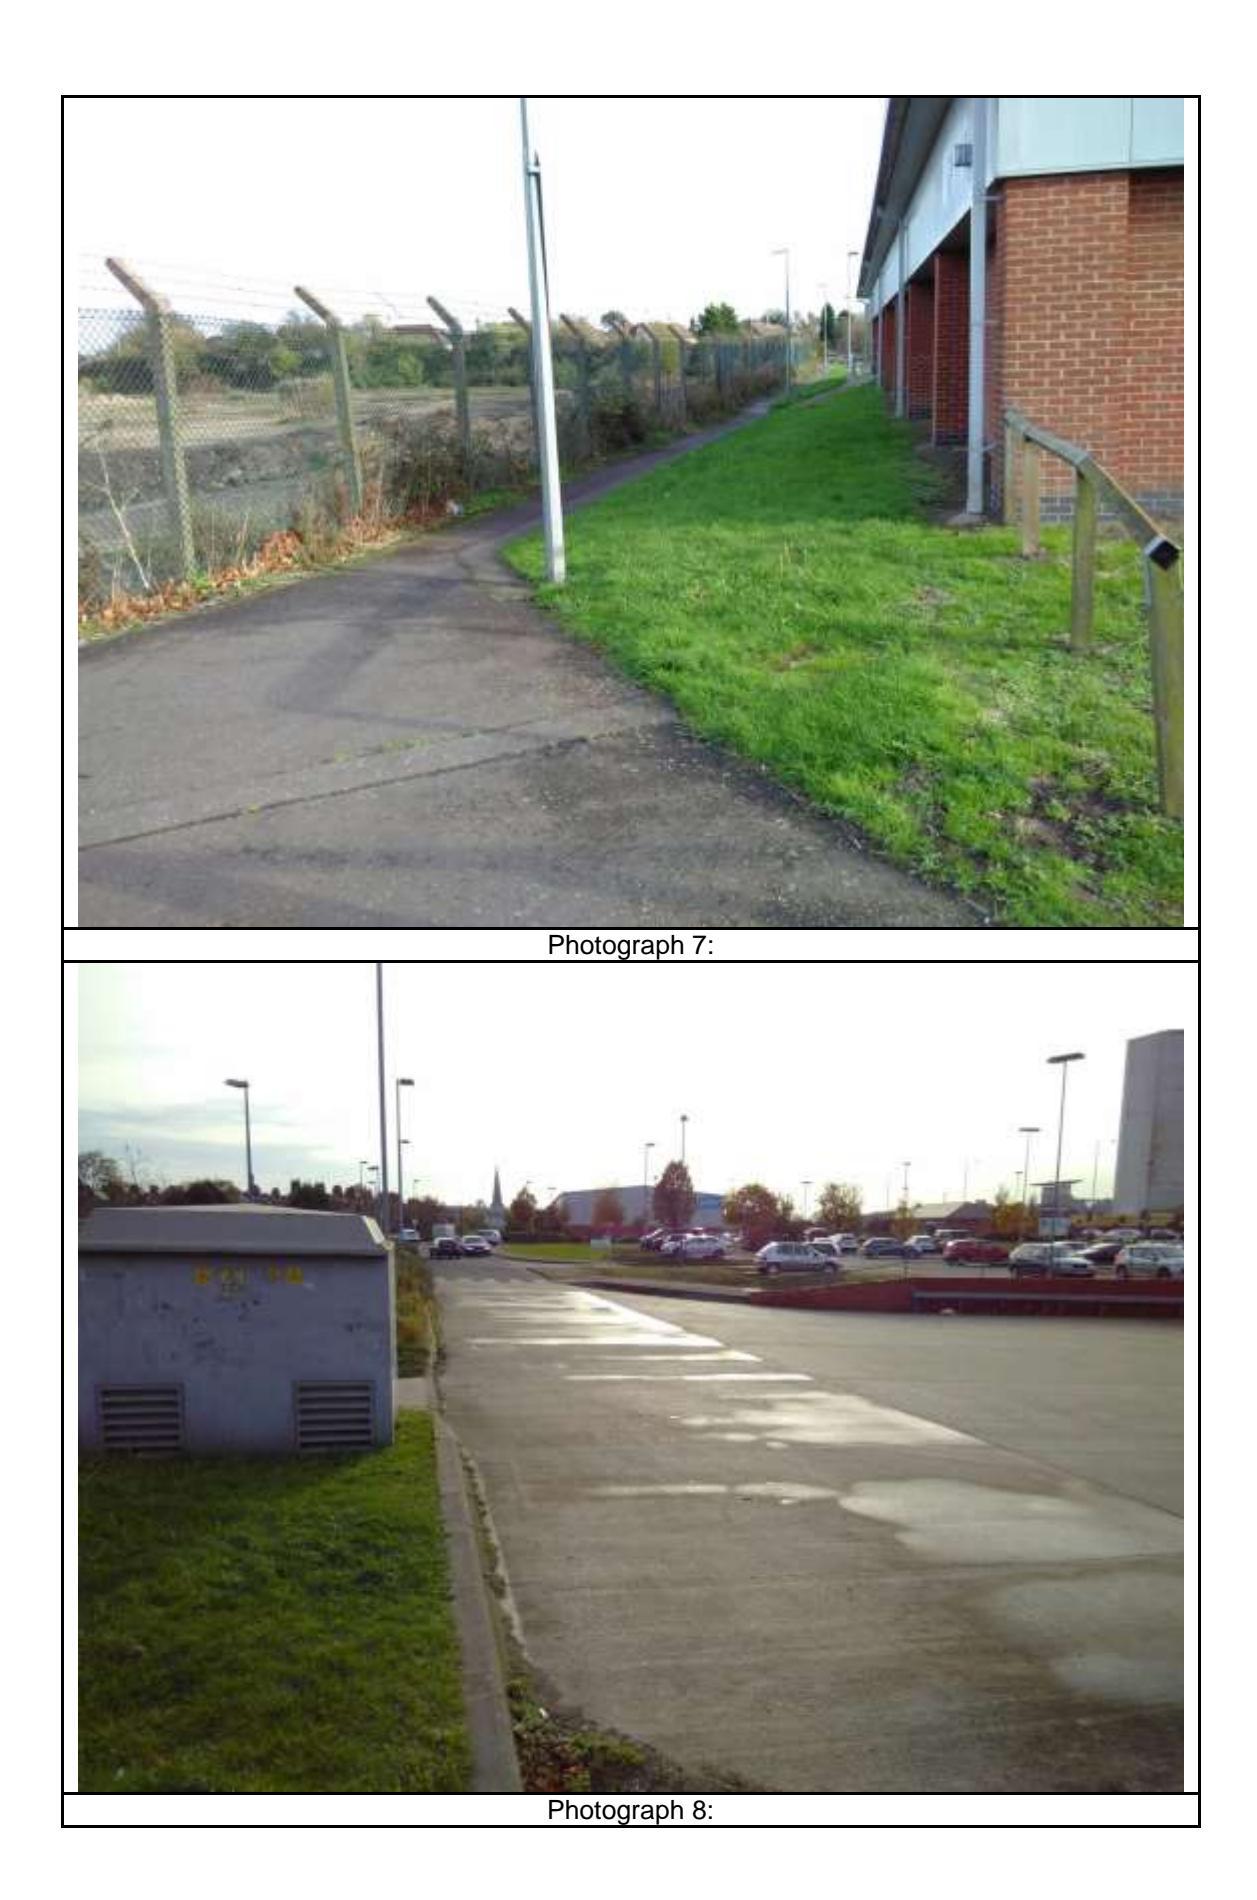
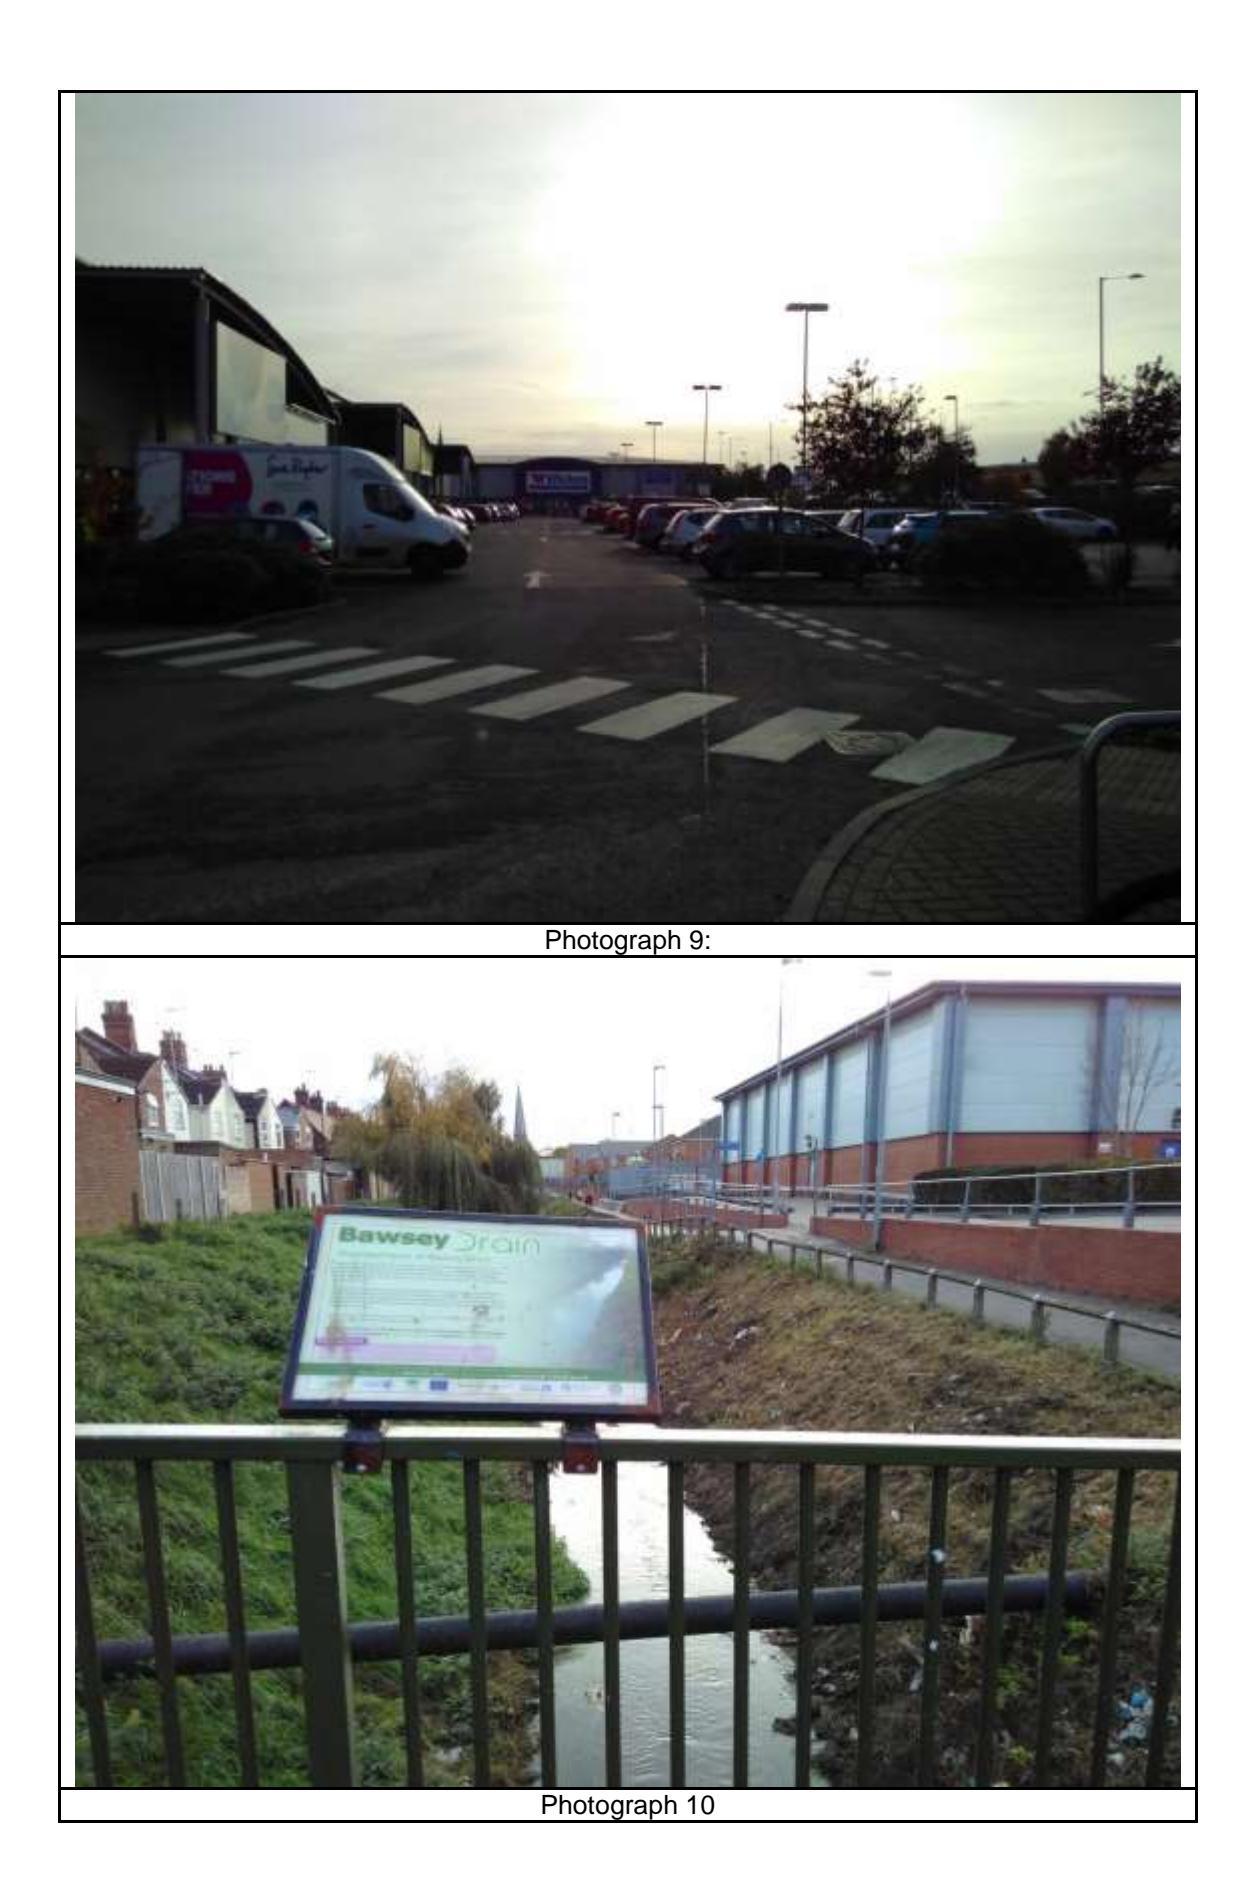
The site is fully developed. Photographs 1, 2 and 11 show the houses on Dobby Drive. Photographs 3 to 9 show the retail park. The site is predominantly hard surfaced with small residential gardens and limited areas of soft landscaping. Vegetation on site appears healthy and with no visible signs of damage or distress. There were no visible indicators of contamination within exposed soil.

The Bawsey Drain (photograph 10) at the east of the site has well vegetated banks and clear-looking water. However, the Bawsey Drain is subject to flytipping in this area and items of household and other general waste (paper, card, plastic, garden waste and shopping trolleys) were observed on the banks and in the water. However, there were no visible signs of contamination from the site affecting the water quality. Part of the retaining wall in the eastern part of the site contains drainage holes at the base. There was no evidence of staining which could suggest that contaminated water is draining from here towards the Bawsey Drain.

Regularly spaced gas vents were observed in the houses on Dobby Drive (photograph 11). The Dobby Drive site is elevated above the Bawsey drain and surrounding land with retaining walls on the eastern side. This suggests that the land was raised as recommended in the remediation plan.

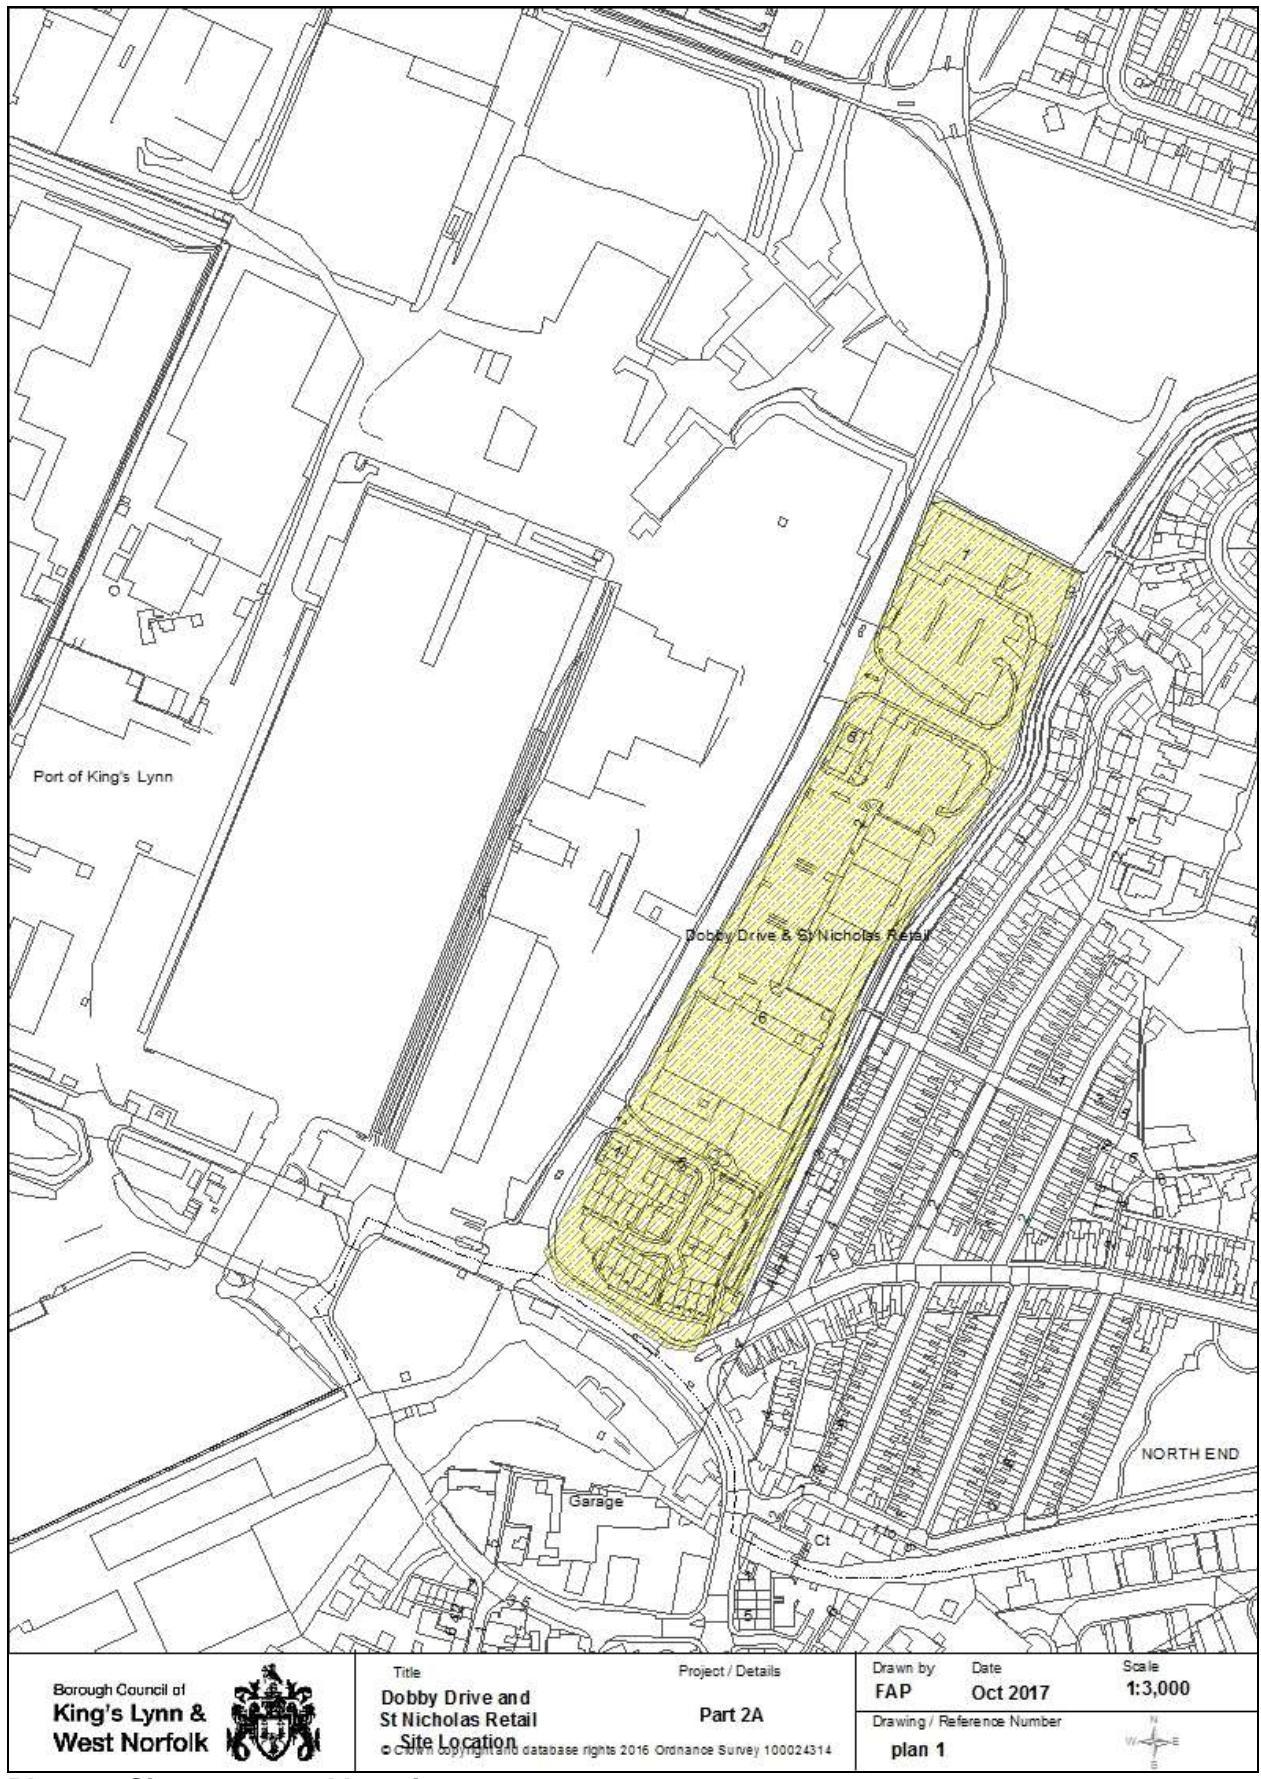
Plan 1 – Site extent and location

The site is situated on Edward Benefer Way in King's Lynn, postcode PE30 2HW. The location is shown in Appendix B. The grid reference for the centre of the site is 562013 320900.

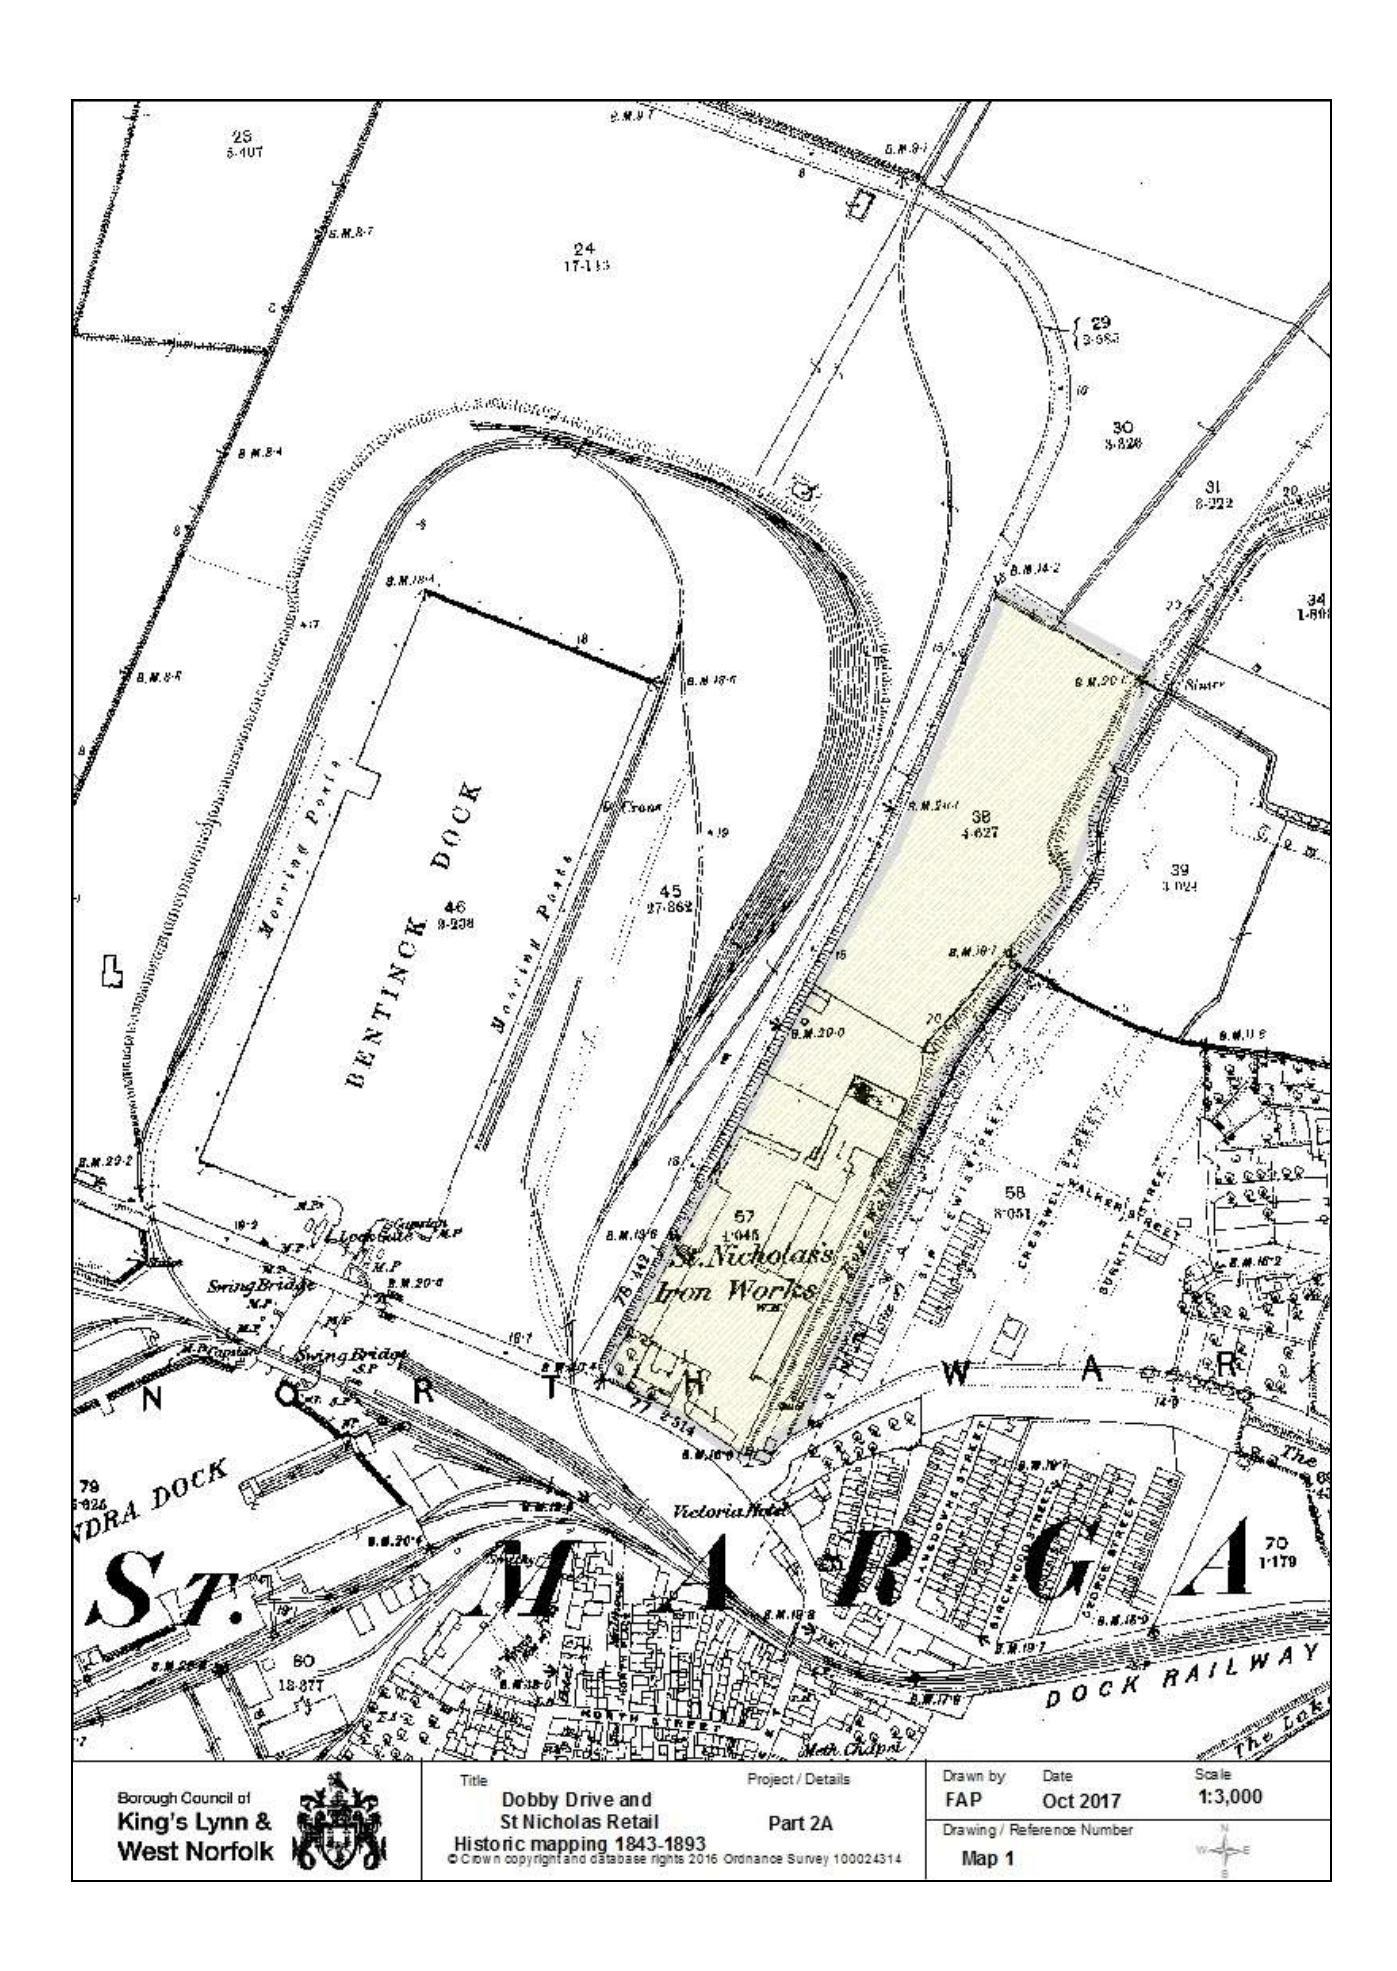
1843 – 1893: Map 1 shows the site to be labelled as St Nicholas Iron Works. There are large buildings indicated in the southern half of the site. The northern part of the site appears vacant. A Rope Walk, embankments and ditches are indicated on the eastern boundary with housing beyond that. Kings Lynn Docks are situated to the west and south and further houses are also indicated. Land to the north is open fields.
