Contaminated Land Inspection Report

Dobby Drive & St Nicholas Retail Park King's Lynn

December 2017

Reference no. S145100001250

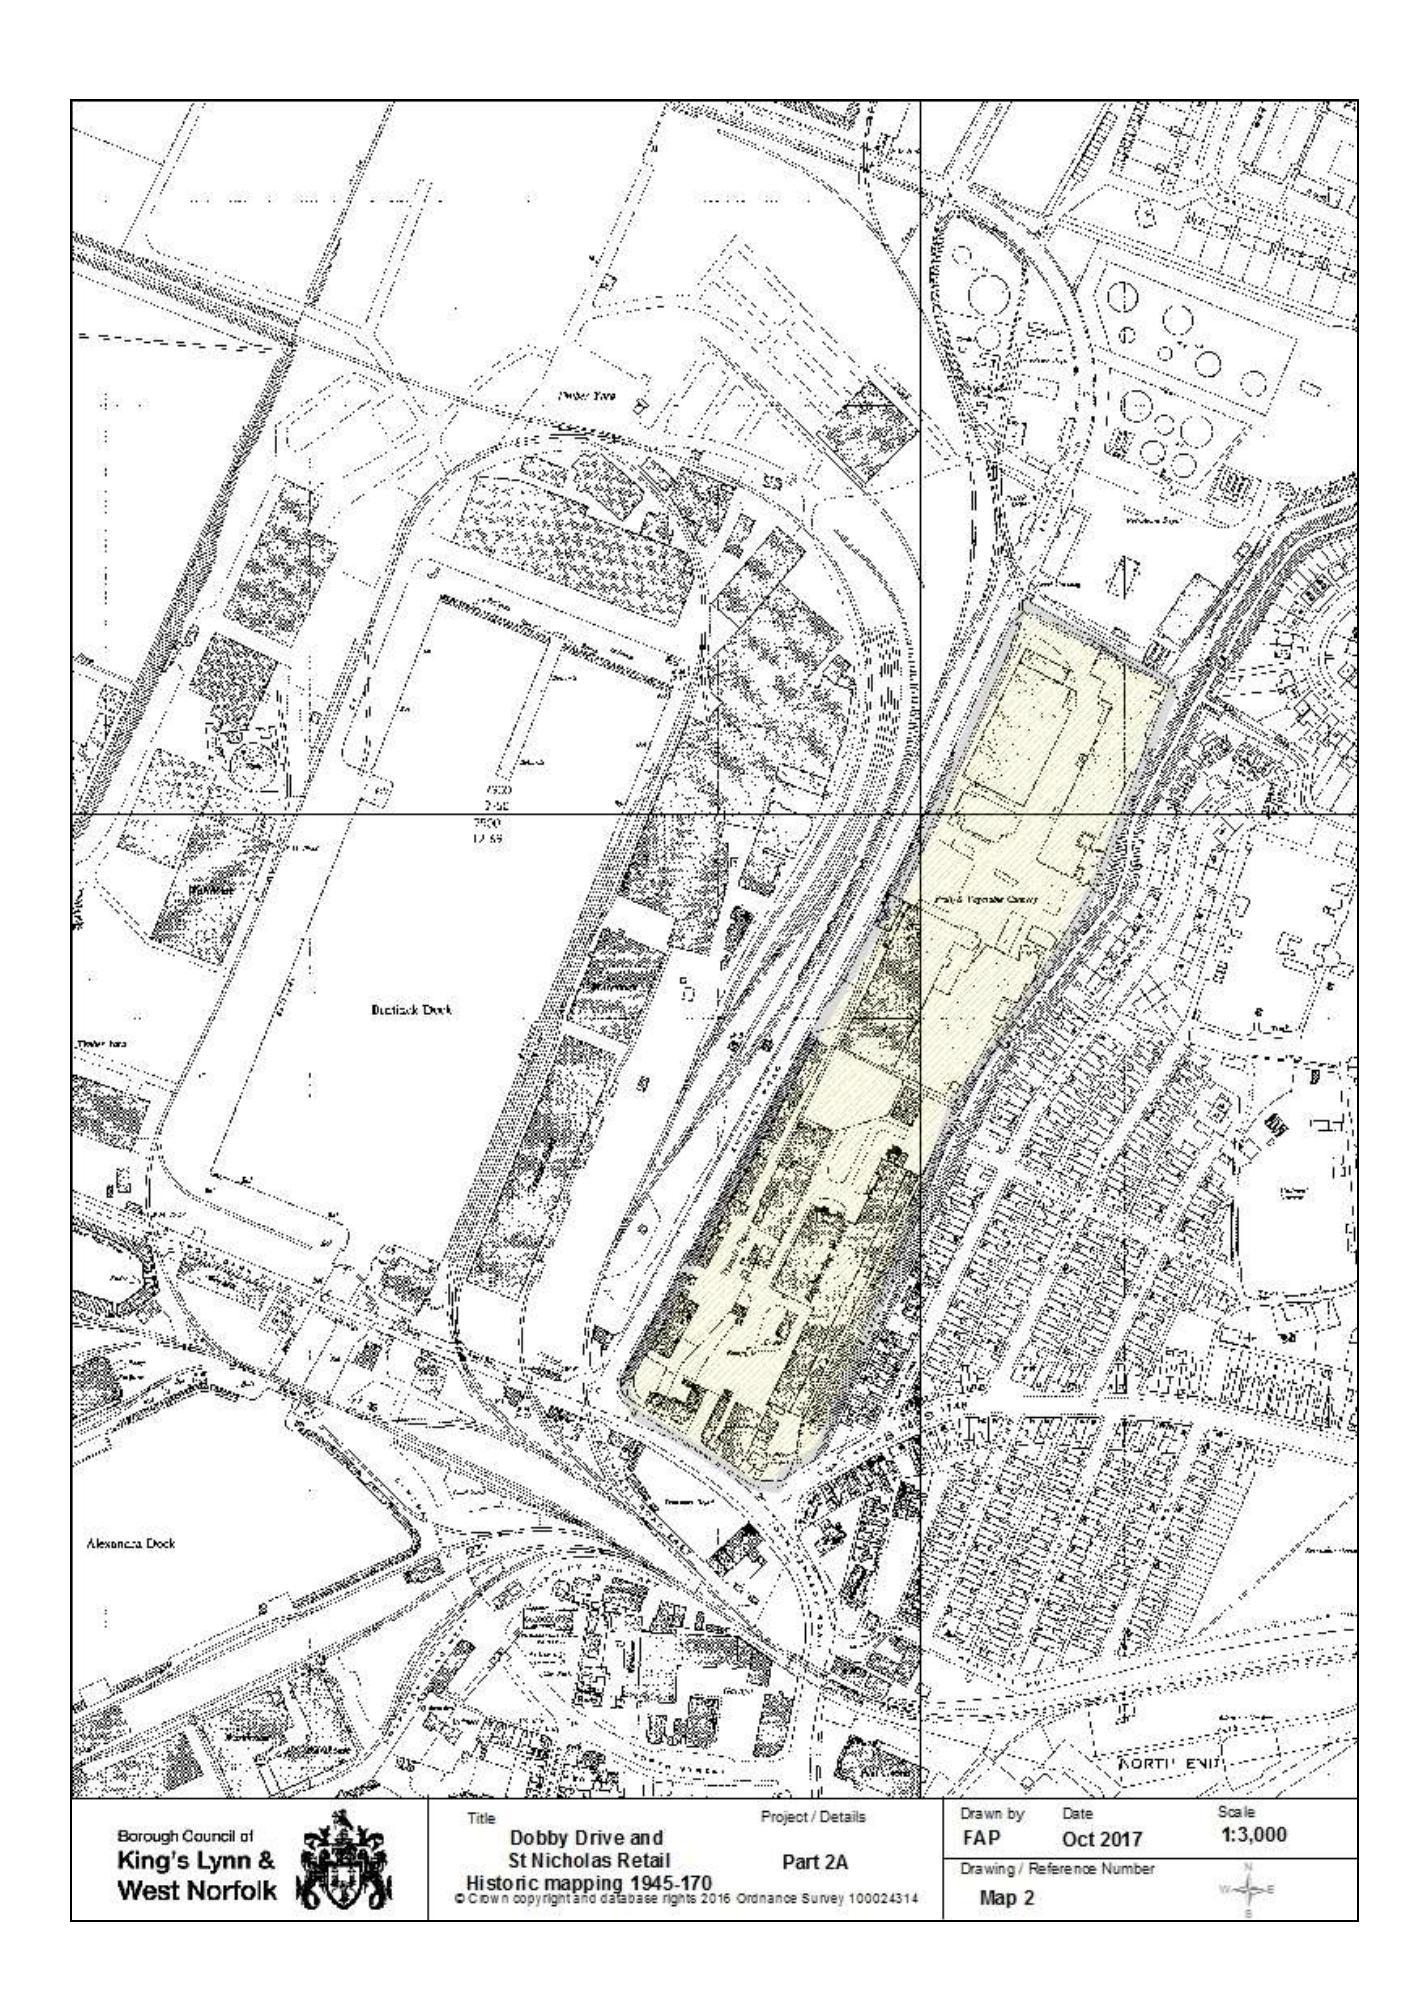
1945 – 1970: Map 2 shows the site labelled as Engineering Works and Transit Depot in the southern half and Fruit and Vegetable Cannery in the northern half. A building on the southern boundary is labelled Estuary House. This is likely to be the house originally built for the Ironworks' owner. The drain to the east is labelled Bawsey Drain. Land to the north of the site is labelled as a Petroleum Depot and contains a large number of tanks.

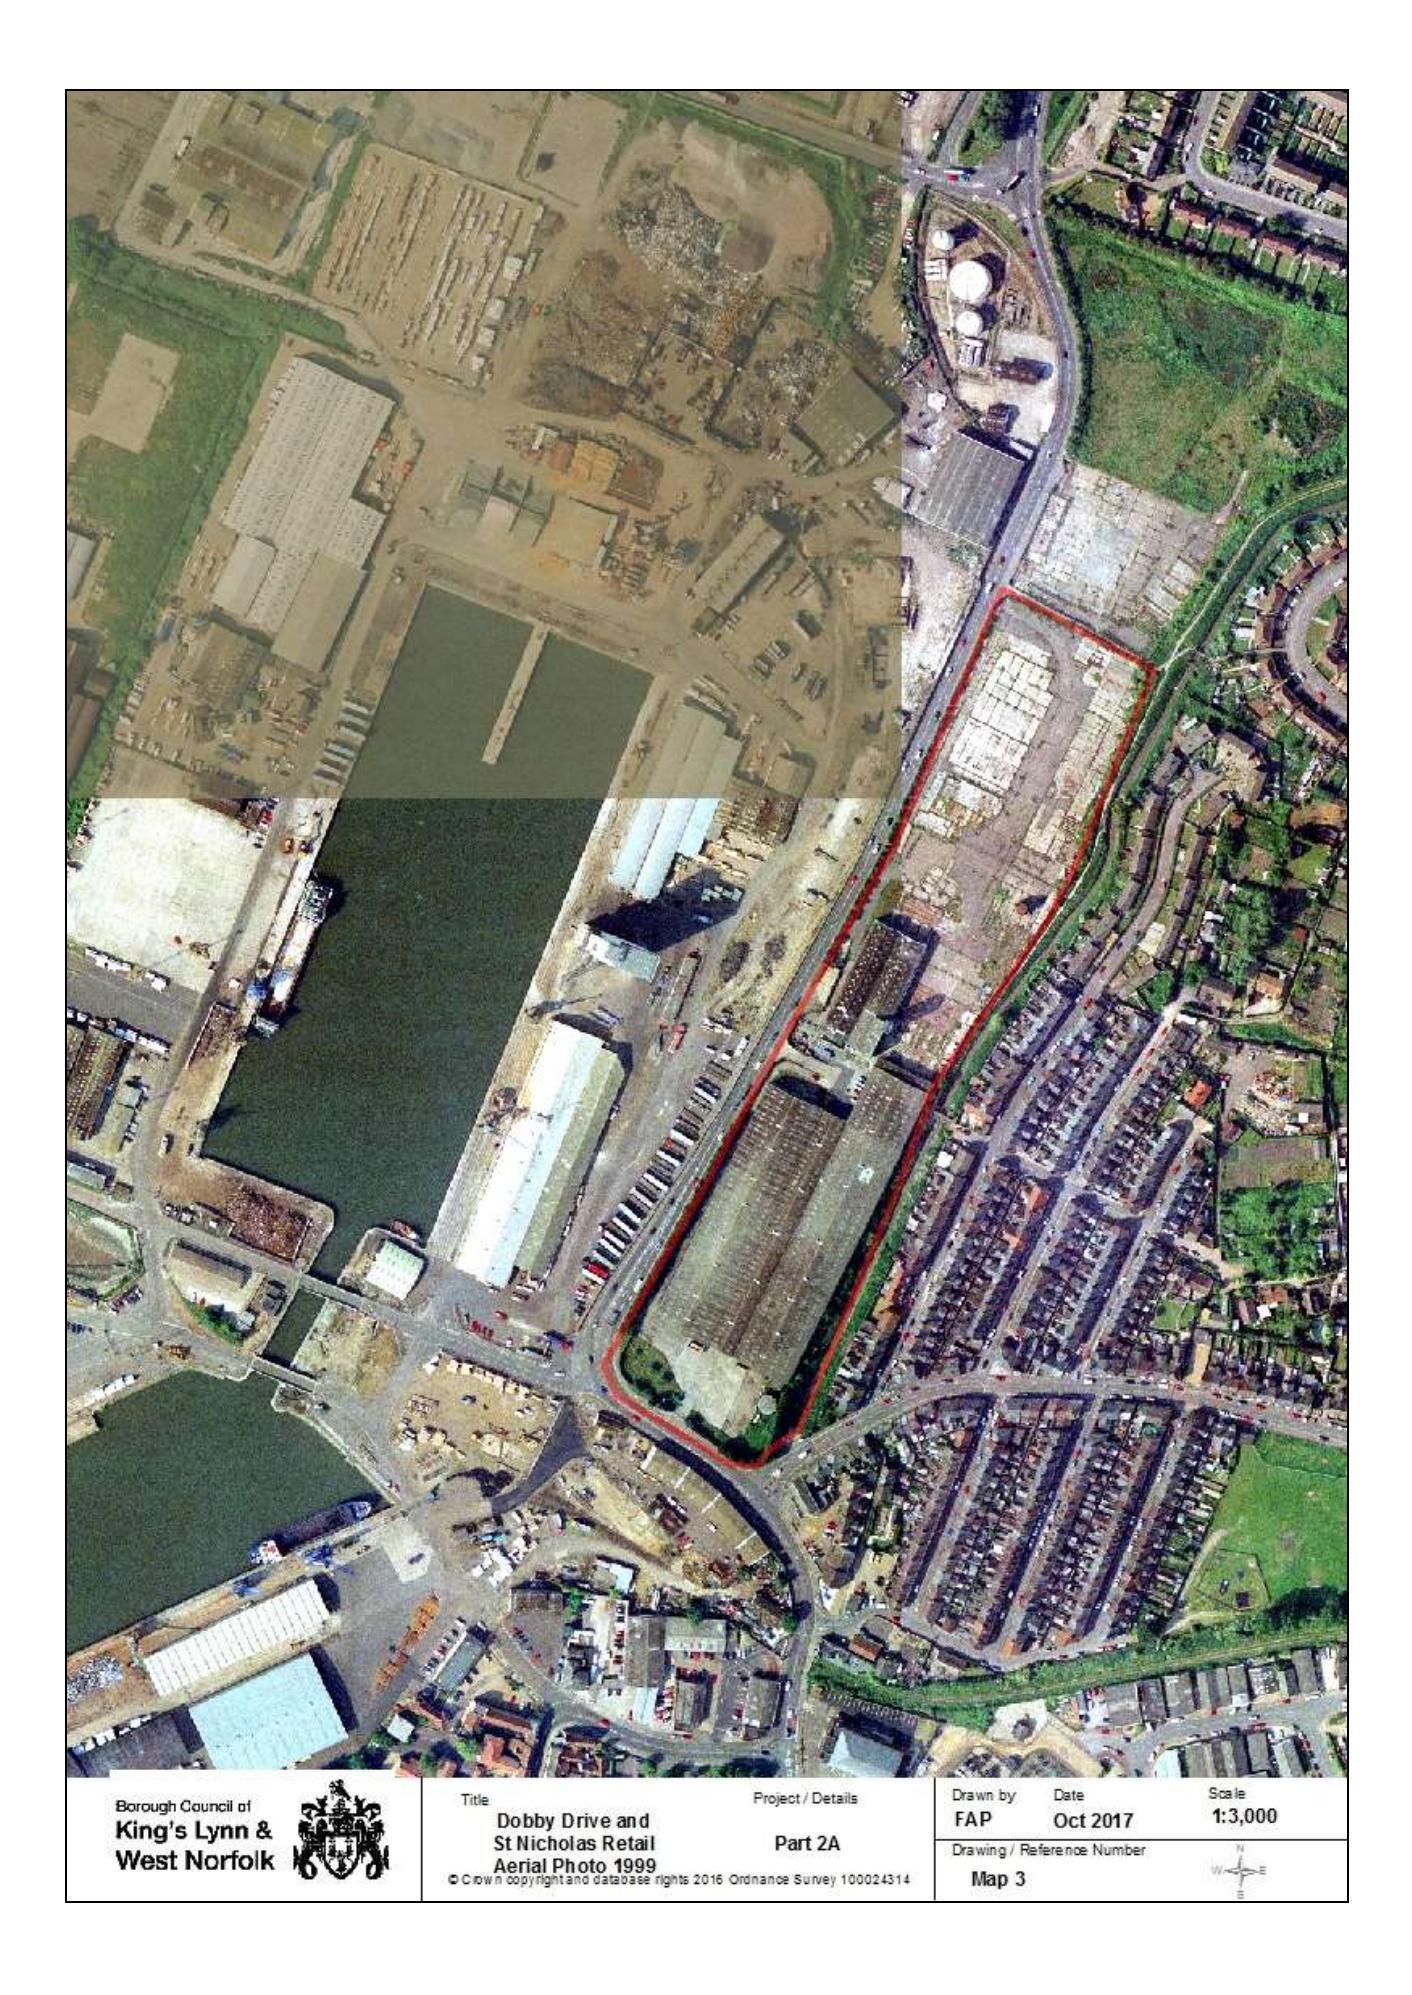
1999 – Map 3 - The site has an open, predominantly hard-surfaced frontage in the south (approximately 40m deep) with a tank structure in the south eastern corner and a small area of soft landscaping in the south-western corner. The remainder of the southern half of the site is covered with three large shed type buildings. The northern half of the site appears to have been cleared of buildings and is covered with the remaining concrete pads and one remaining tank structure. The former allotments to the north appear to have been concreted and the former tank farm further to the north has been removed and appears to be rough grassland.
