Contaminated Land Inspection Report

Former Brickyard and Landfill, Broadend Road, Walsoken, King's Lynn

April 2018

Reference no. S560100055153

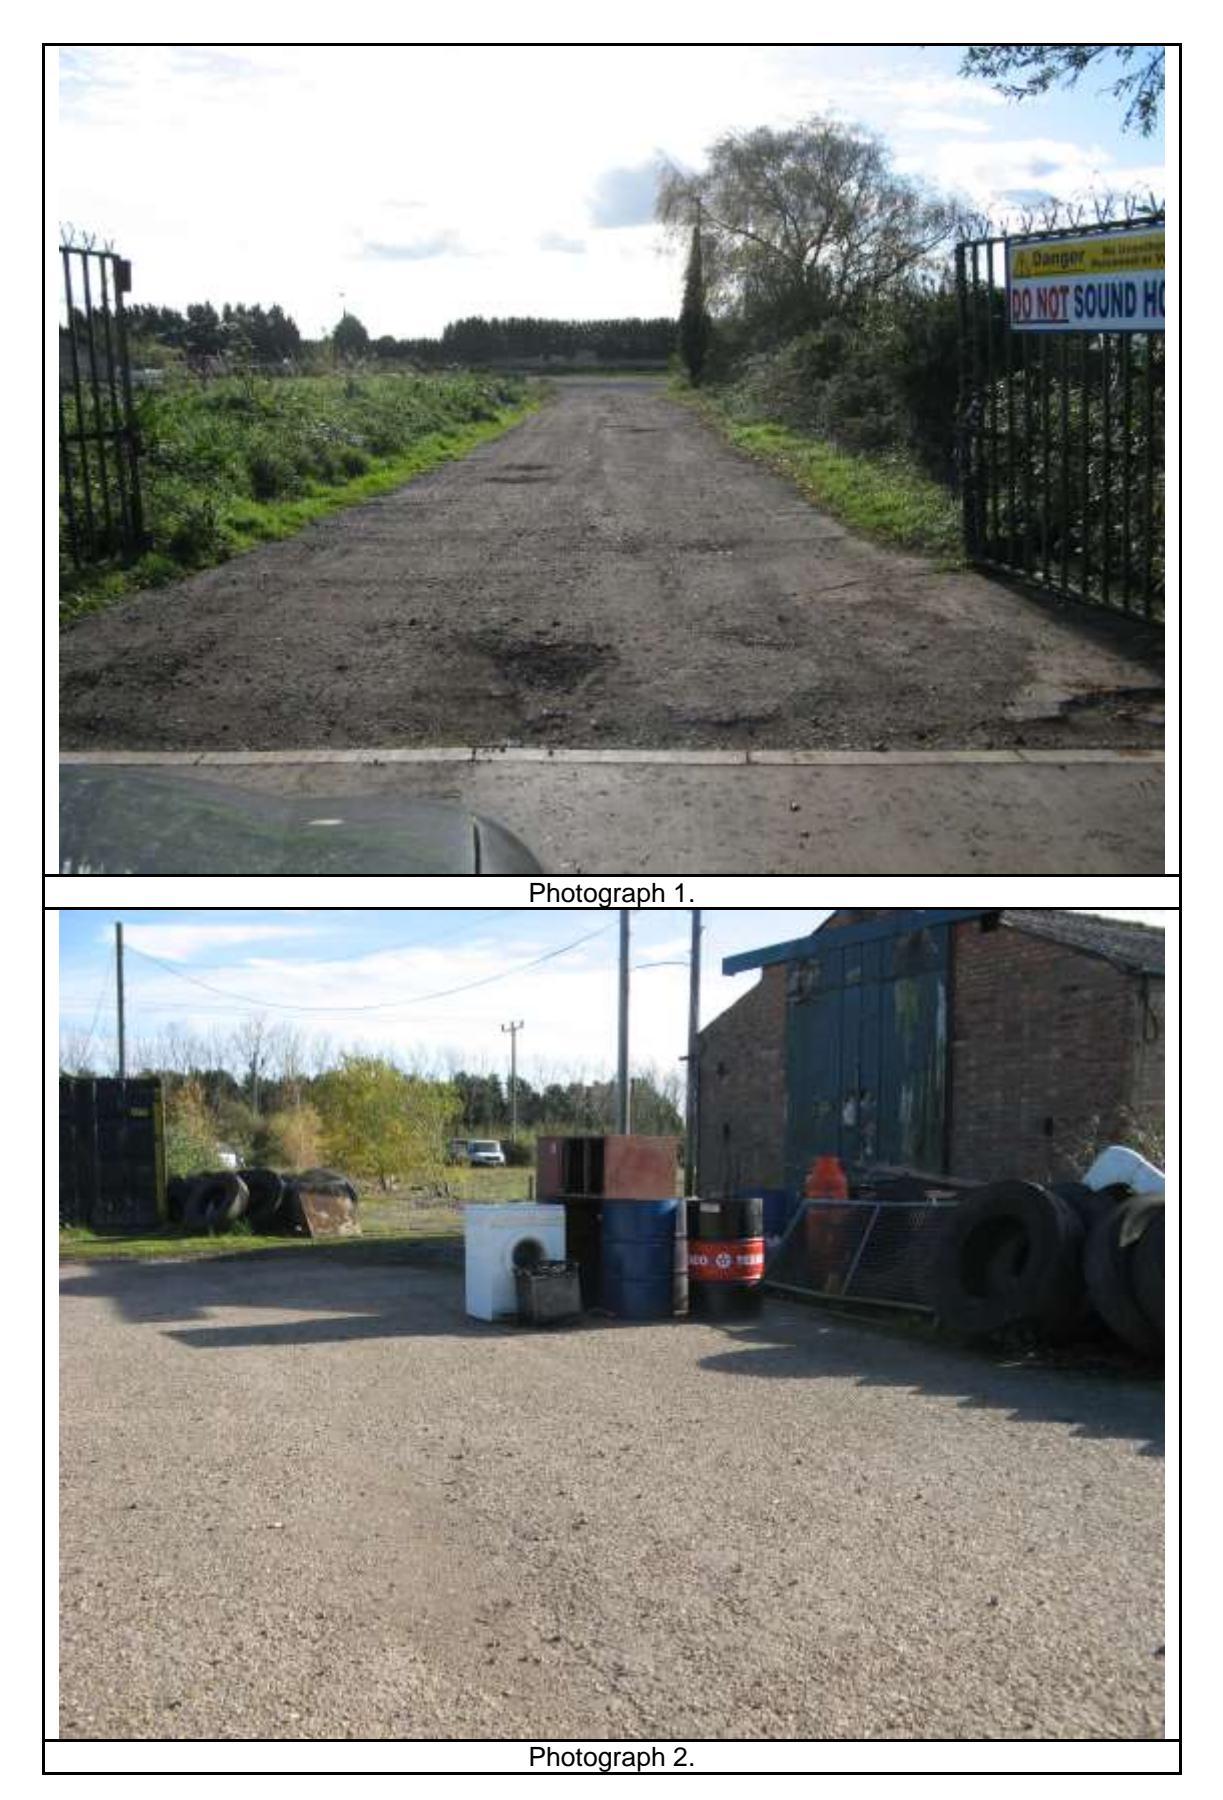
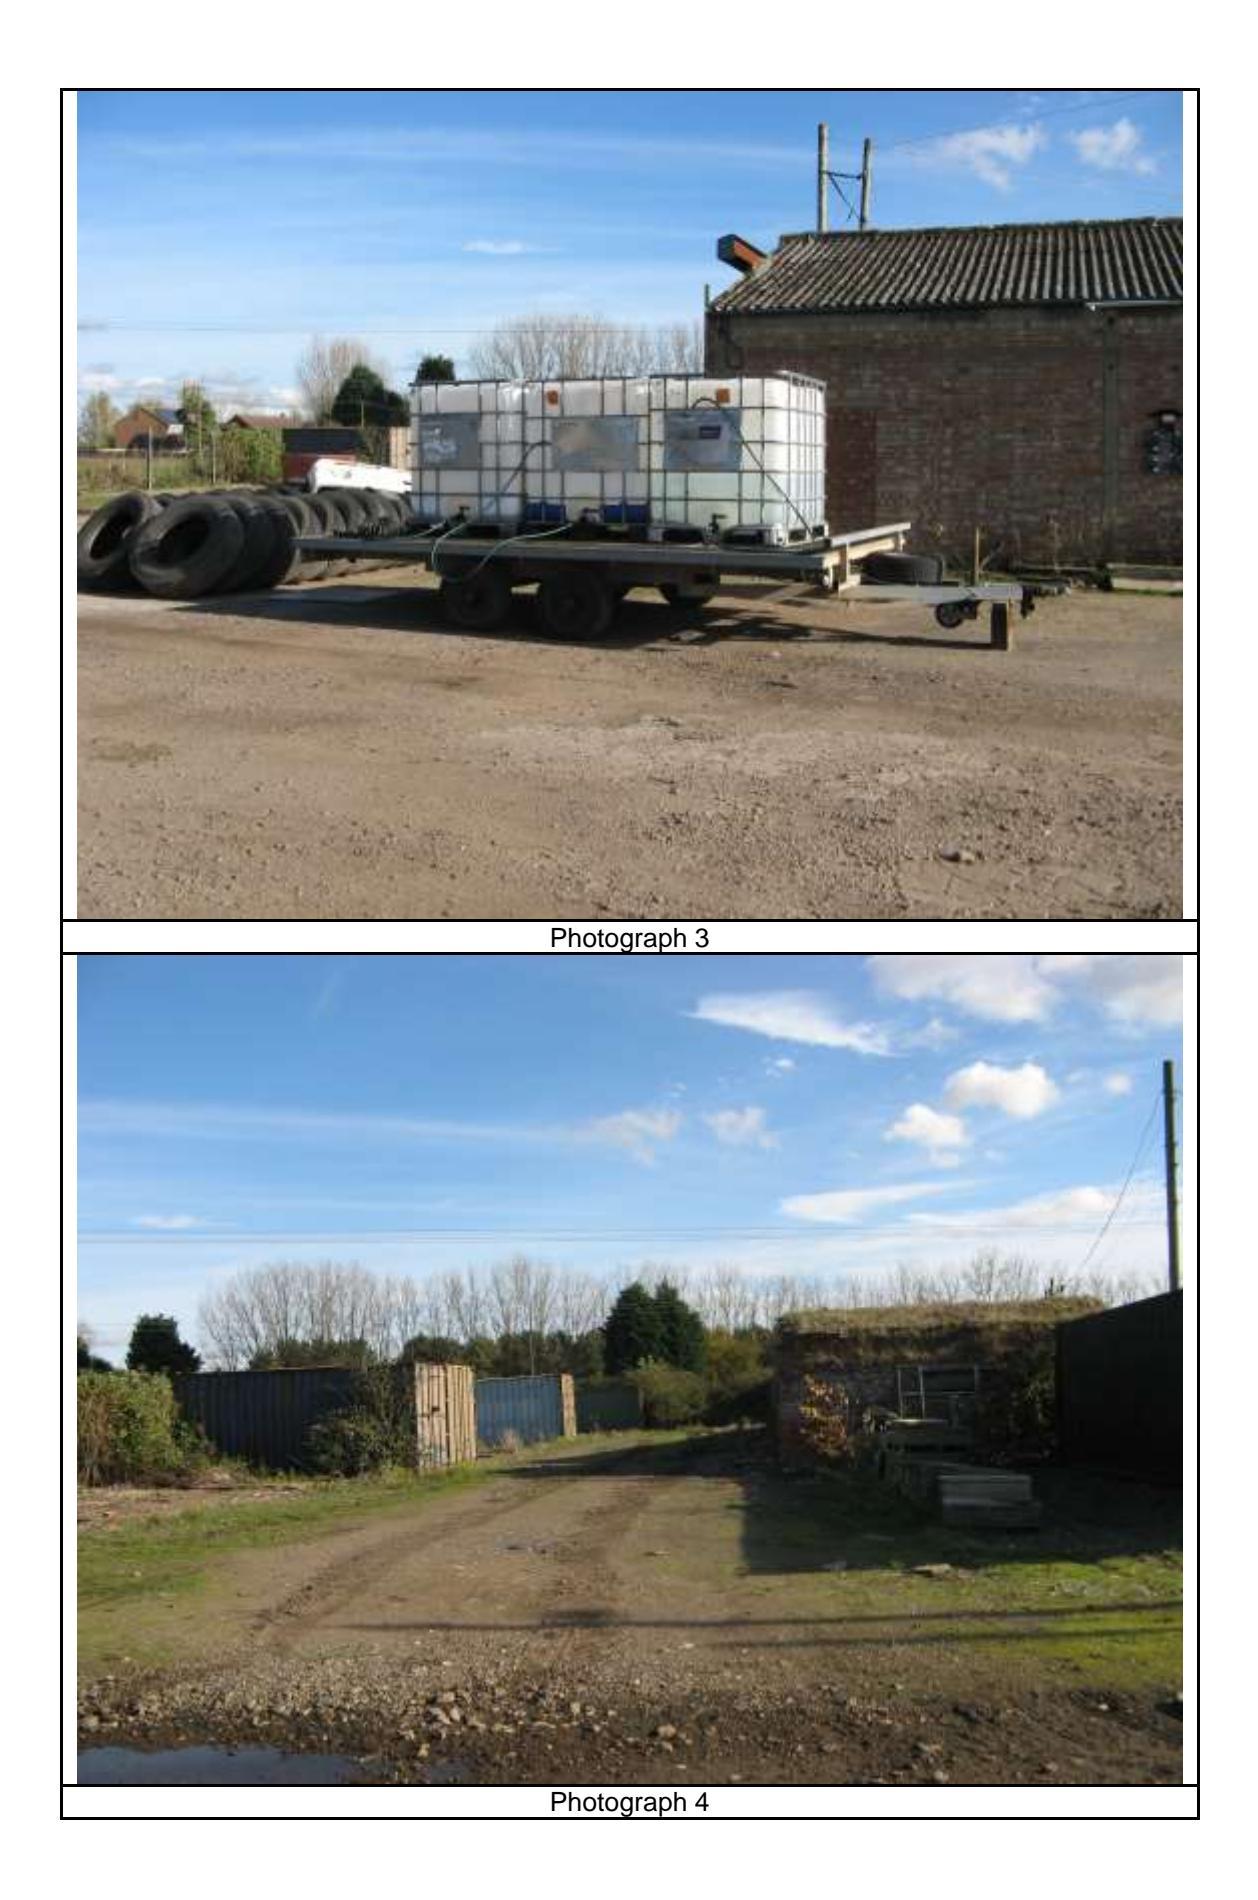
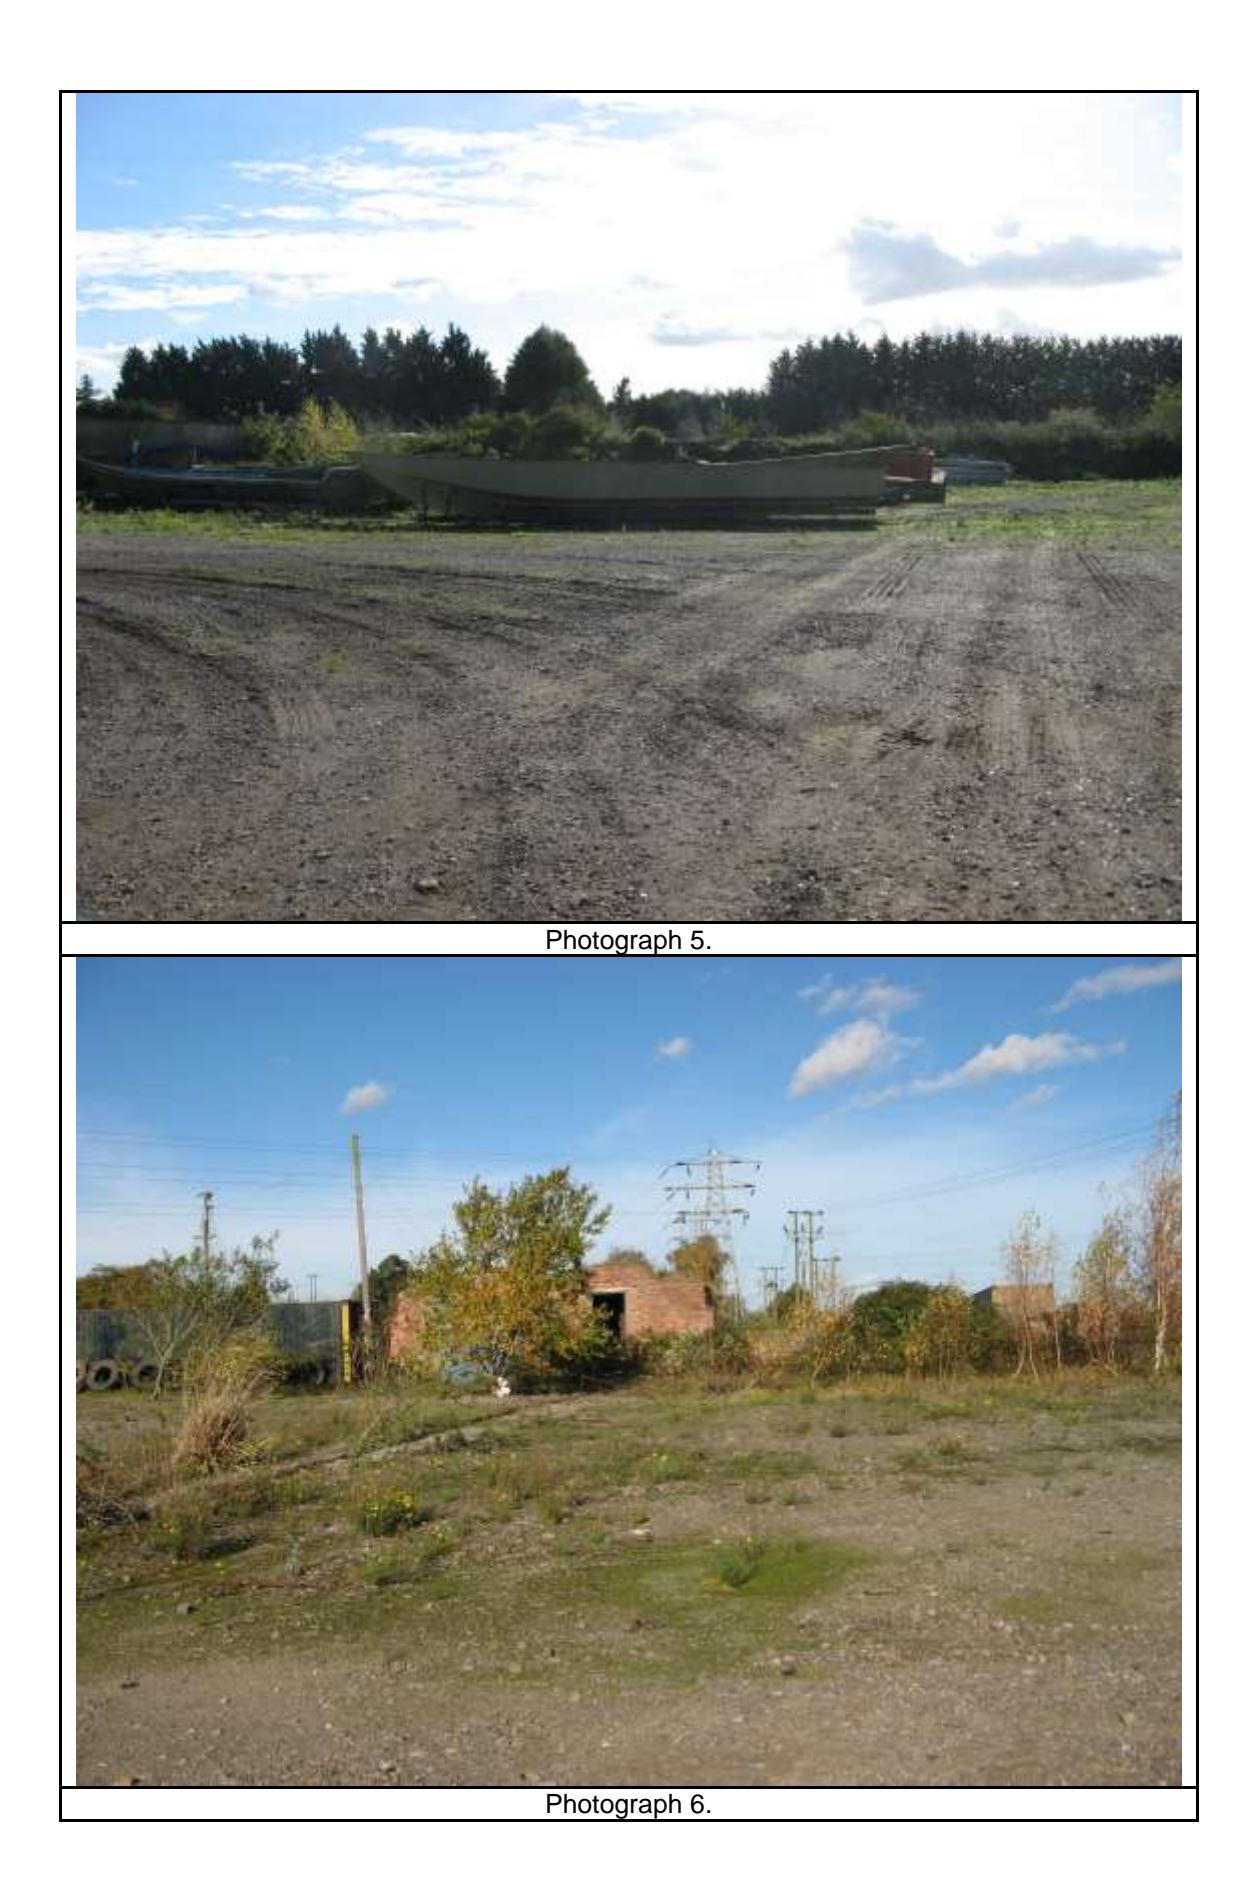
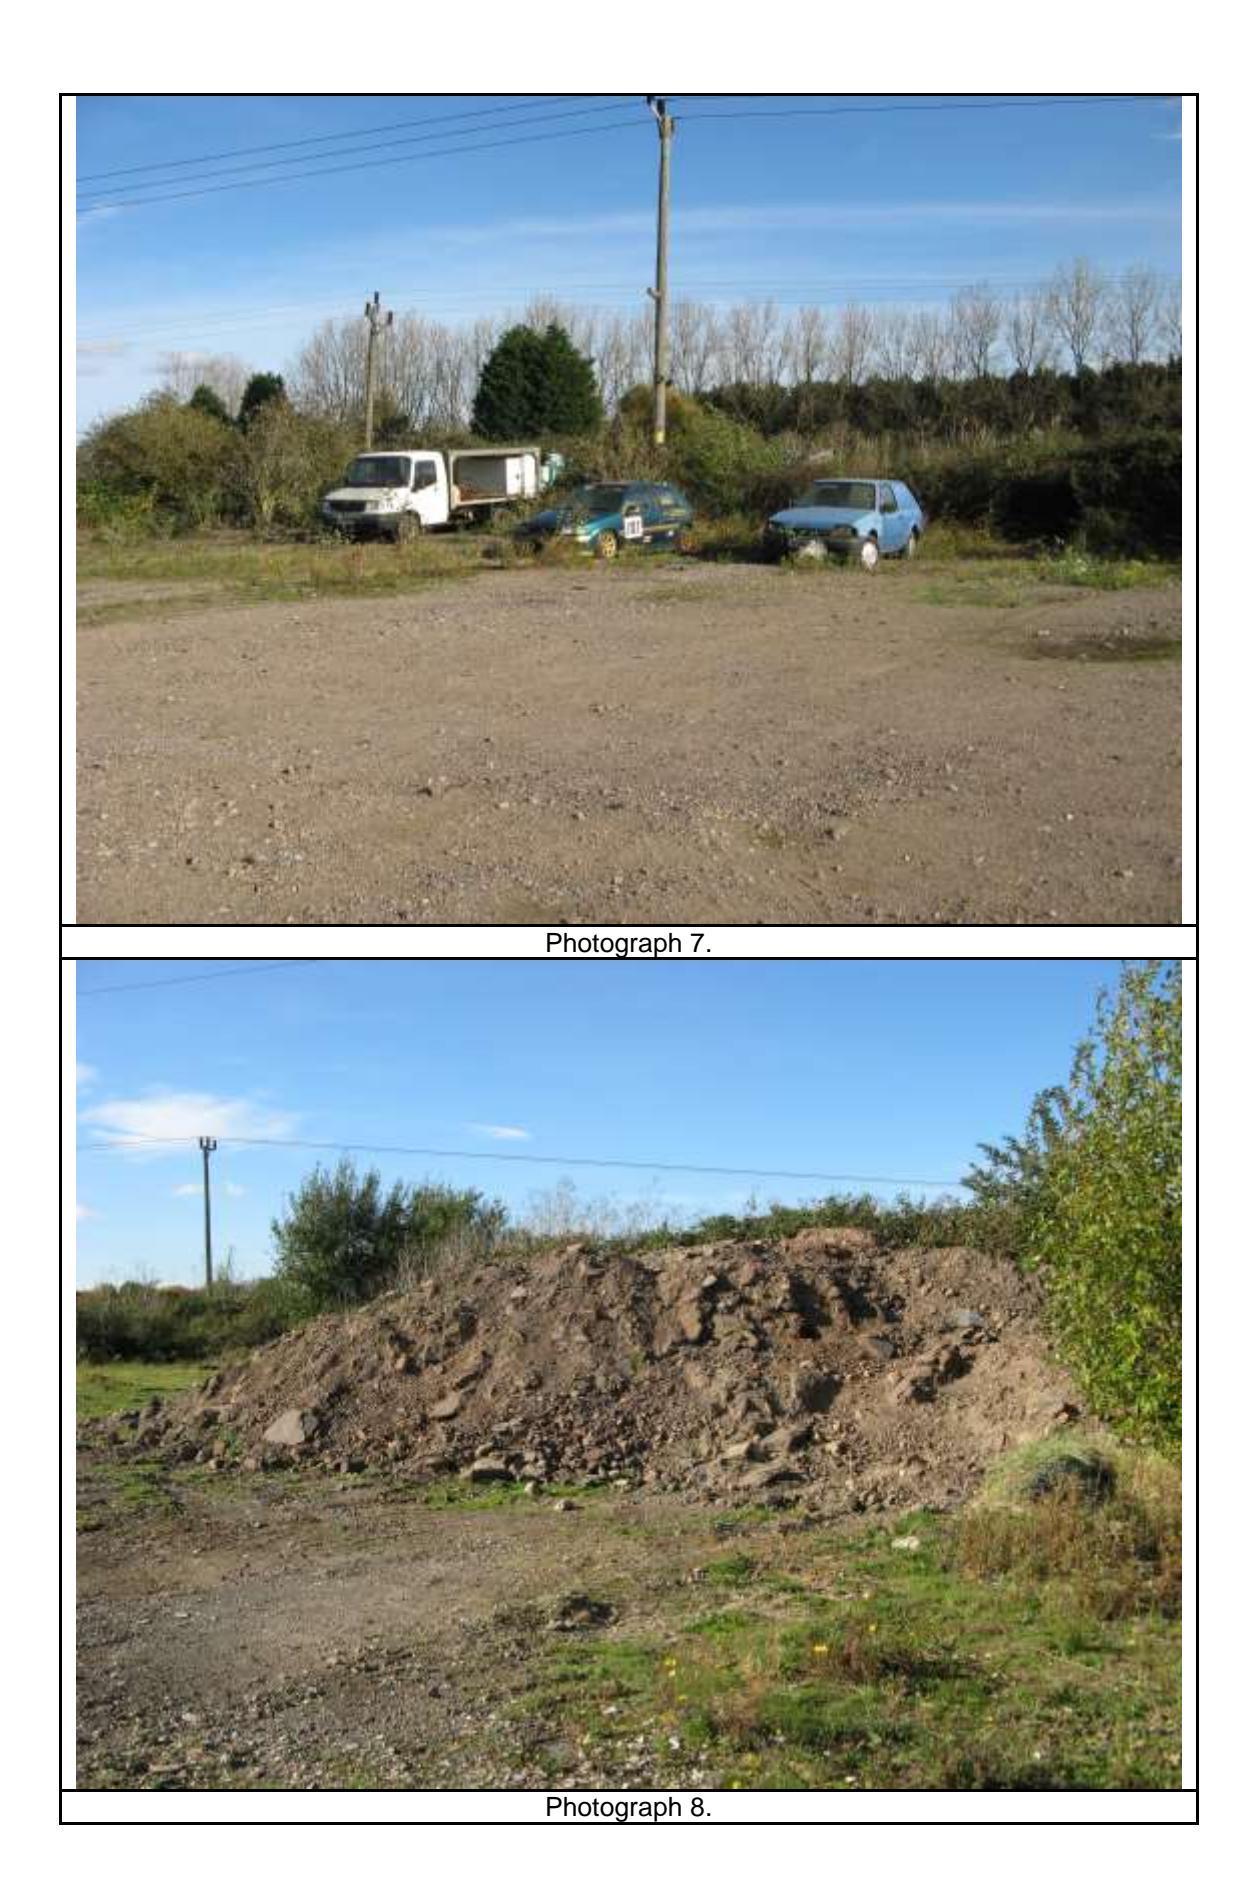
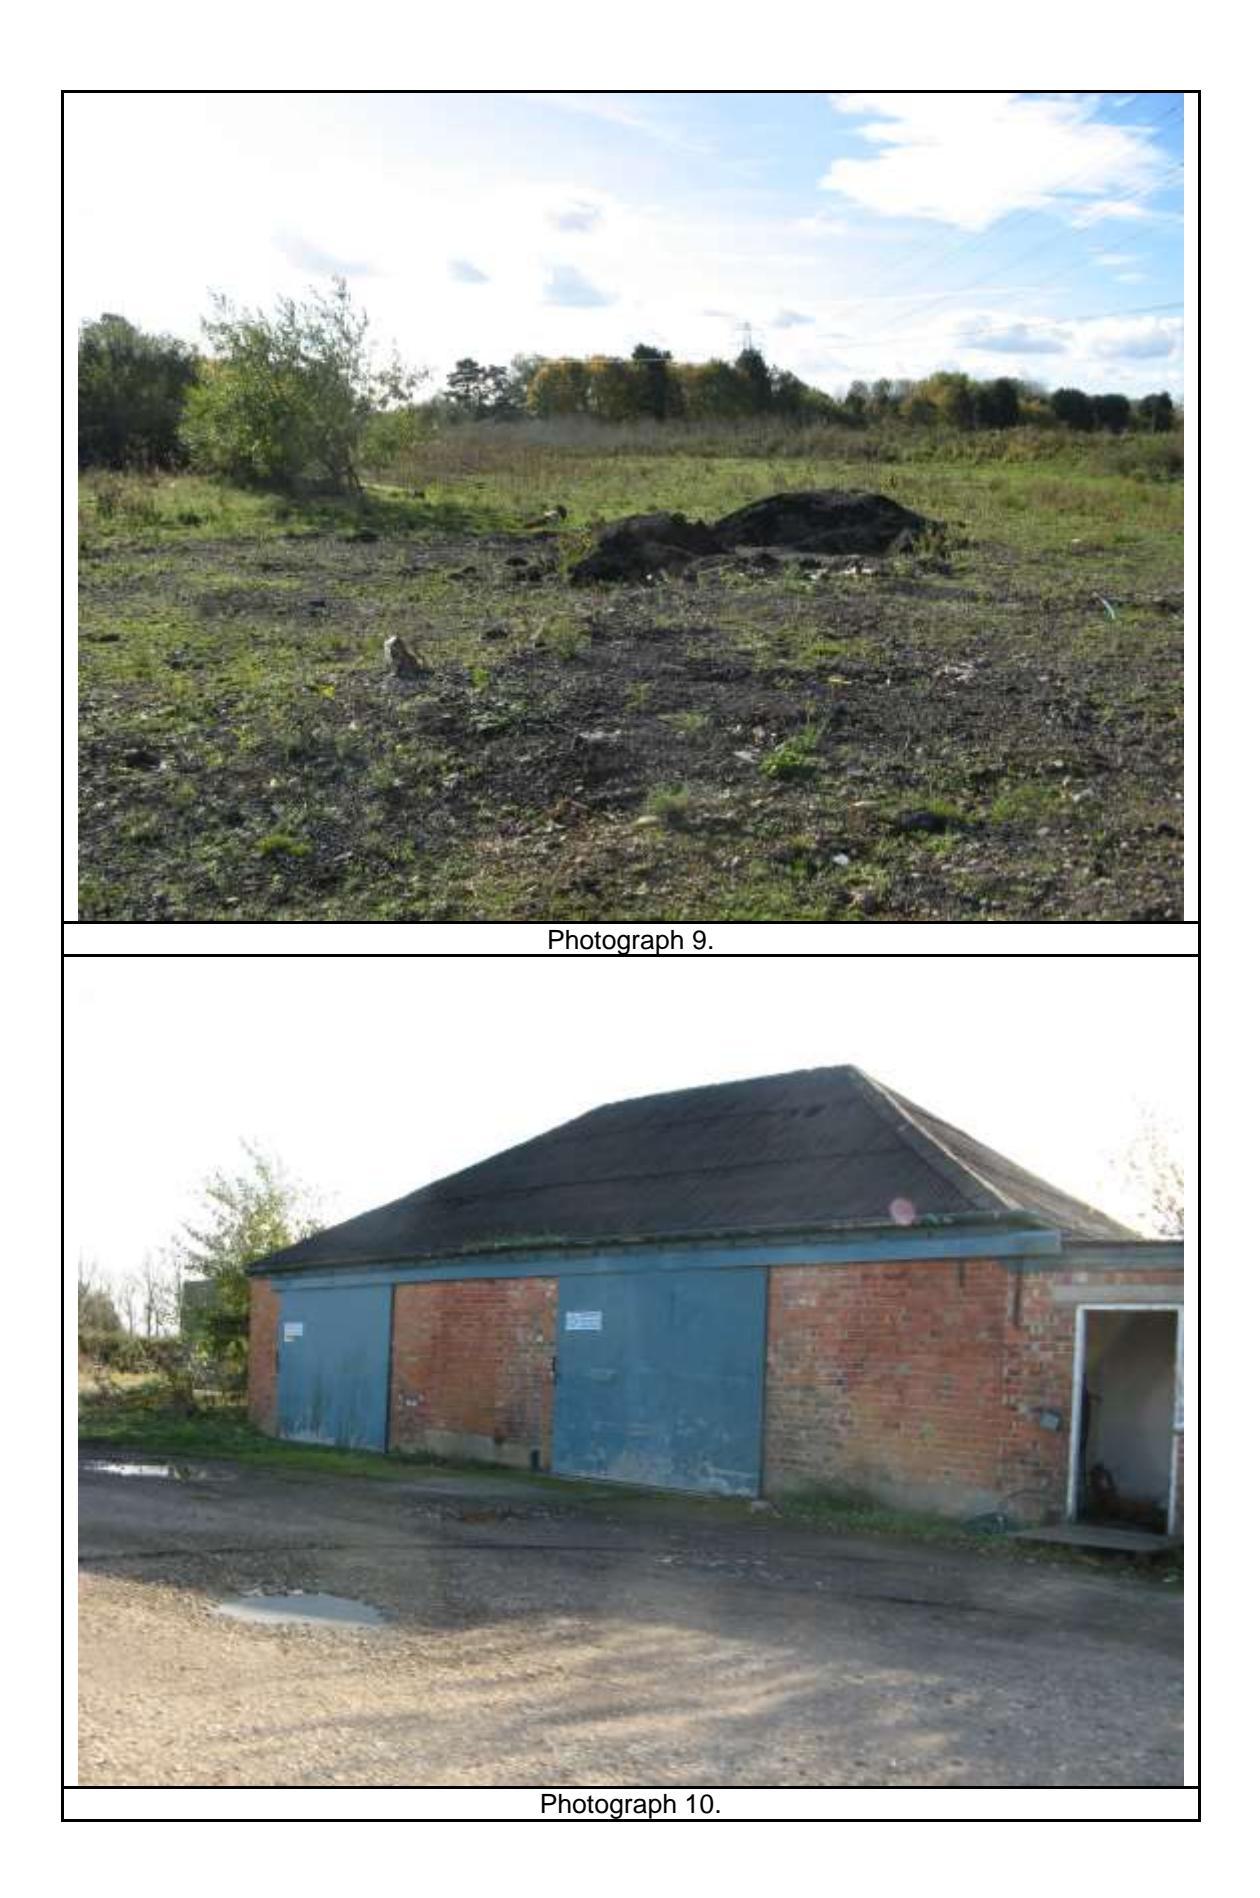
Appendix A Site Photographs

The site is located to the south of Broadend Road via a temporary road. The site was generally flat; the central part had been laid to a temporary surface with gravel, and hardcore. The area surrounding the centre of the site was generally covered with scrub vegetation.

The central portion of the site contained several brick and wooden buildings including what appeared to have been former brick kilns. These appeared to have either been used as offices, storage buildings and a mechanical workshop which contained an inspection pit. On the southern boundary several fiberglass boat hulls were noted. Multiple shipping containers were noted on site but were not accessed at this time. Sixteen derelict cars and trucks were noted on the eastern part of the site.

The area where the refuse tip was denoted was generally flat and was surfaced with made ground comprising brick, concrete, gravel and glass in a clay matrix. No hazardous material was noted on the surface of the landfill. A mound of soil intermixed with brick and concrete was noted to the north of the tip, but this appears to have been deposited recently.

A number of empty Intermediate Bulk Containers, labelled as being used to store Adblue, and oil drums were noted adjacent to the mechanical workshop. Adjacent to the drums were other items of scrap metal including a washing machine.

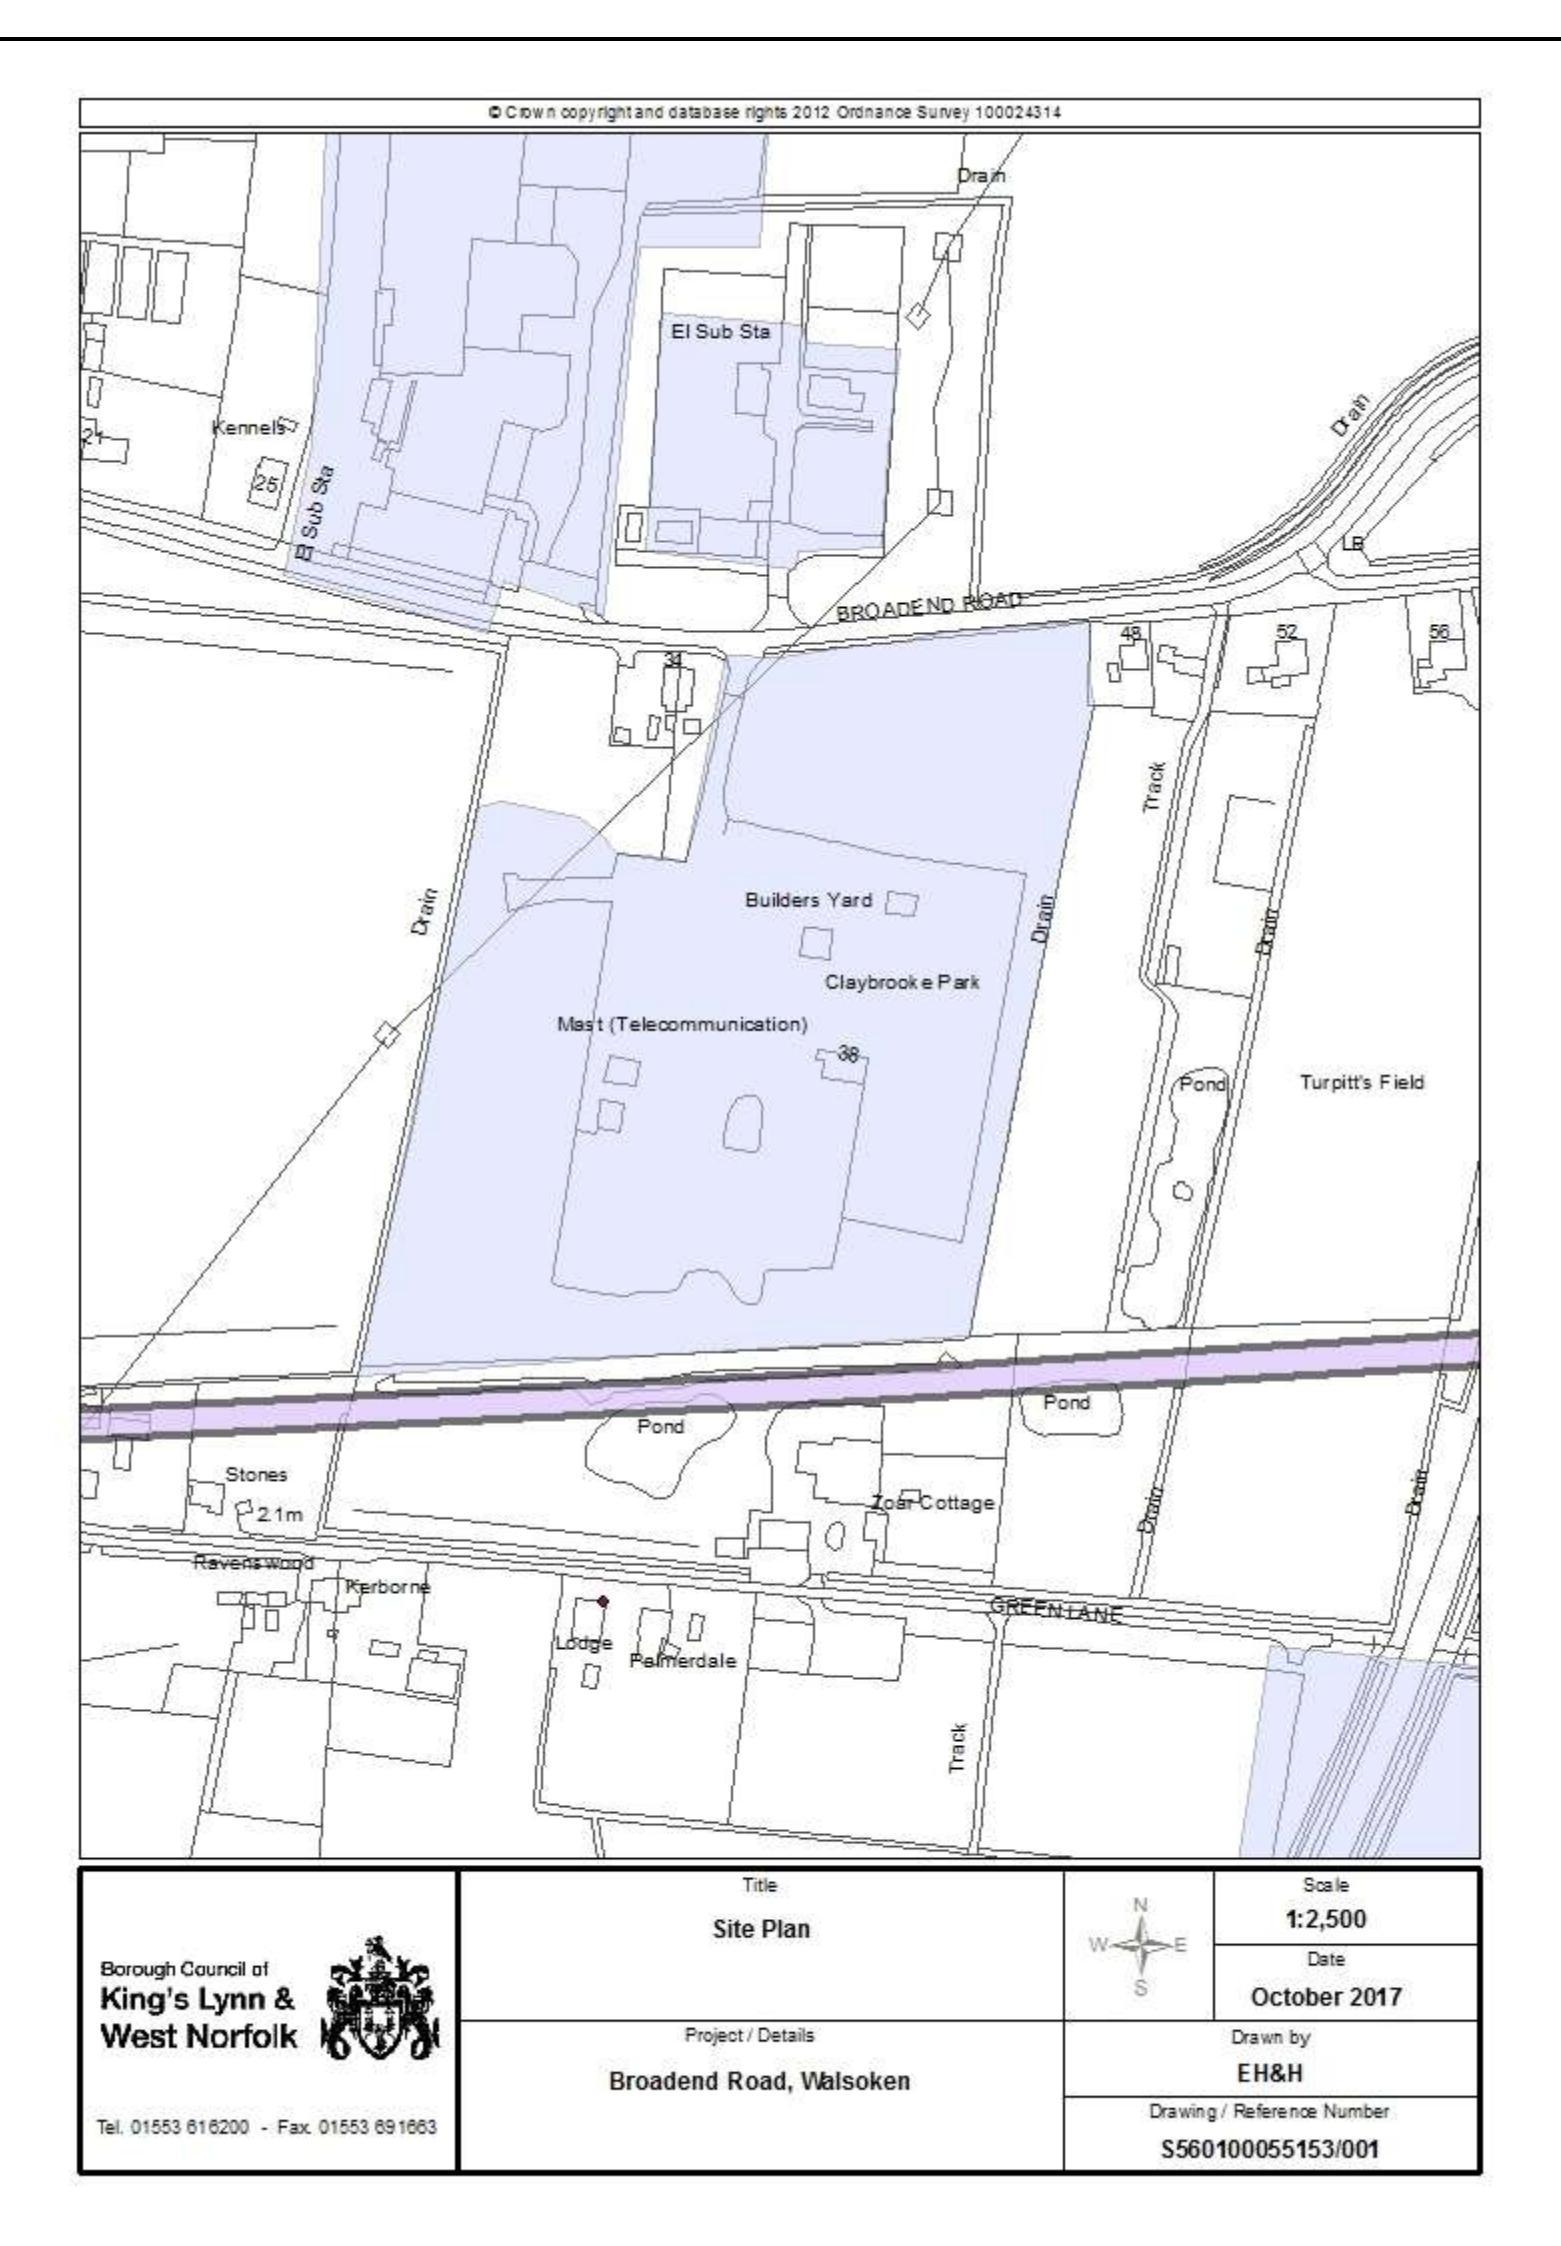
The site (drawing CL17/101) was a Brickyard and Tile Works, part of which was denoted as a refuse tip on historic maps.
