# Contaminated Land Inspection Report

# Former Brickworks, Lamsey Lane Heacham, Norfolk

April 2018

Reference no. s560100033315

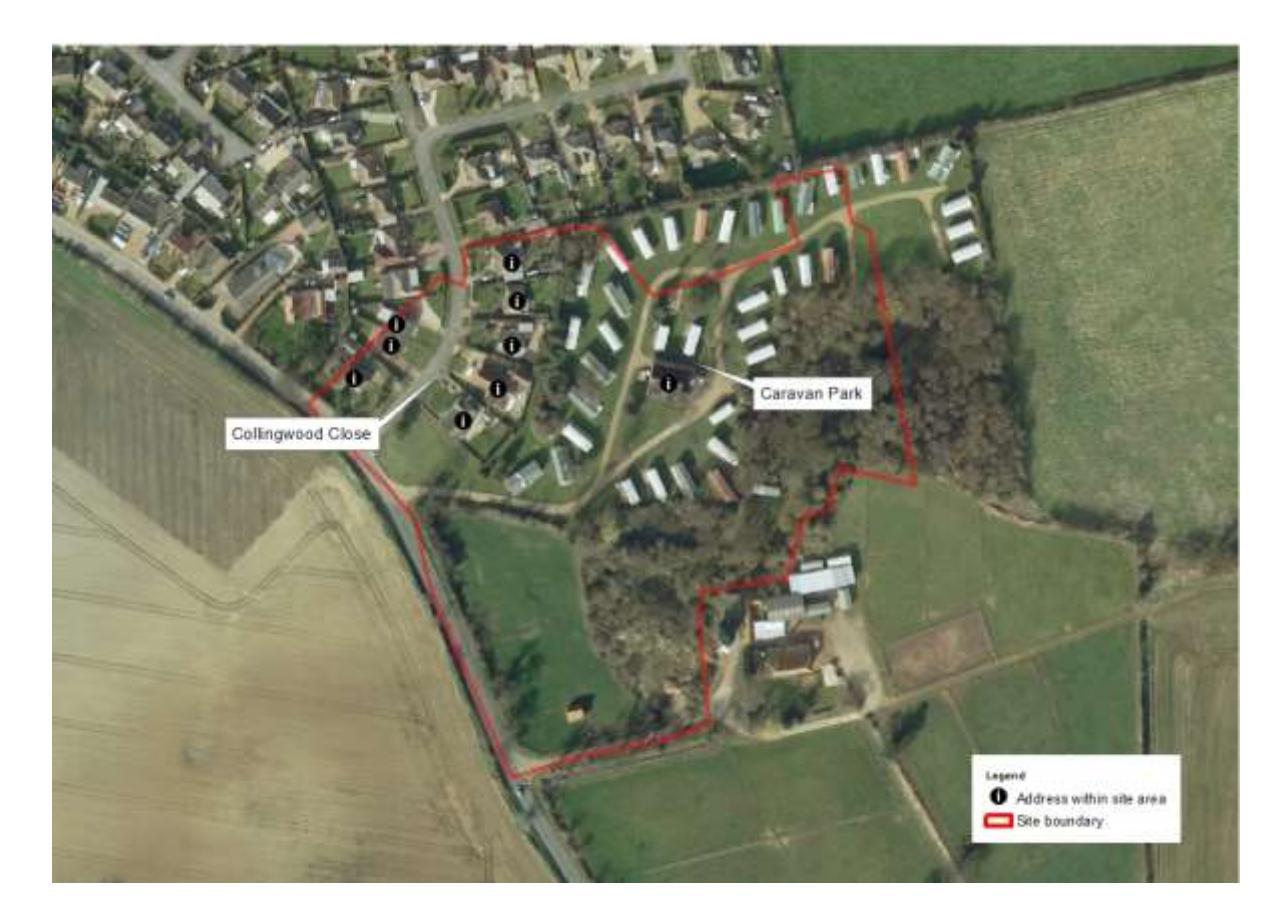
Figure 1: Site layout plan

The site's present use is as a holiday caravan park (Meadows Caravan park), eight houses on Collingwood Close and a paddock associated with Mount Pleasant equestrian centre. Meadows Caravan Park is licensed for holiday use from mid-February to mid-January each year. The site layout plan below (figure 1) below shows these areas. Photographs of the site are in appendix A.

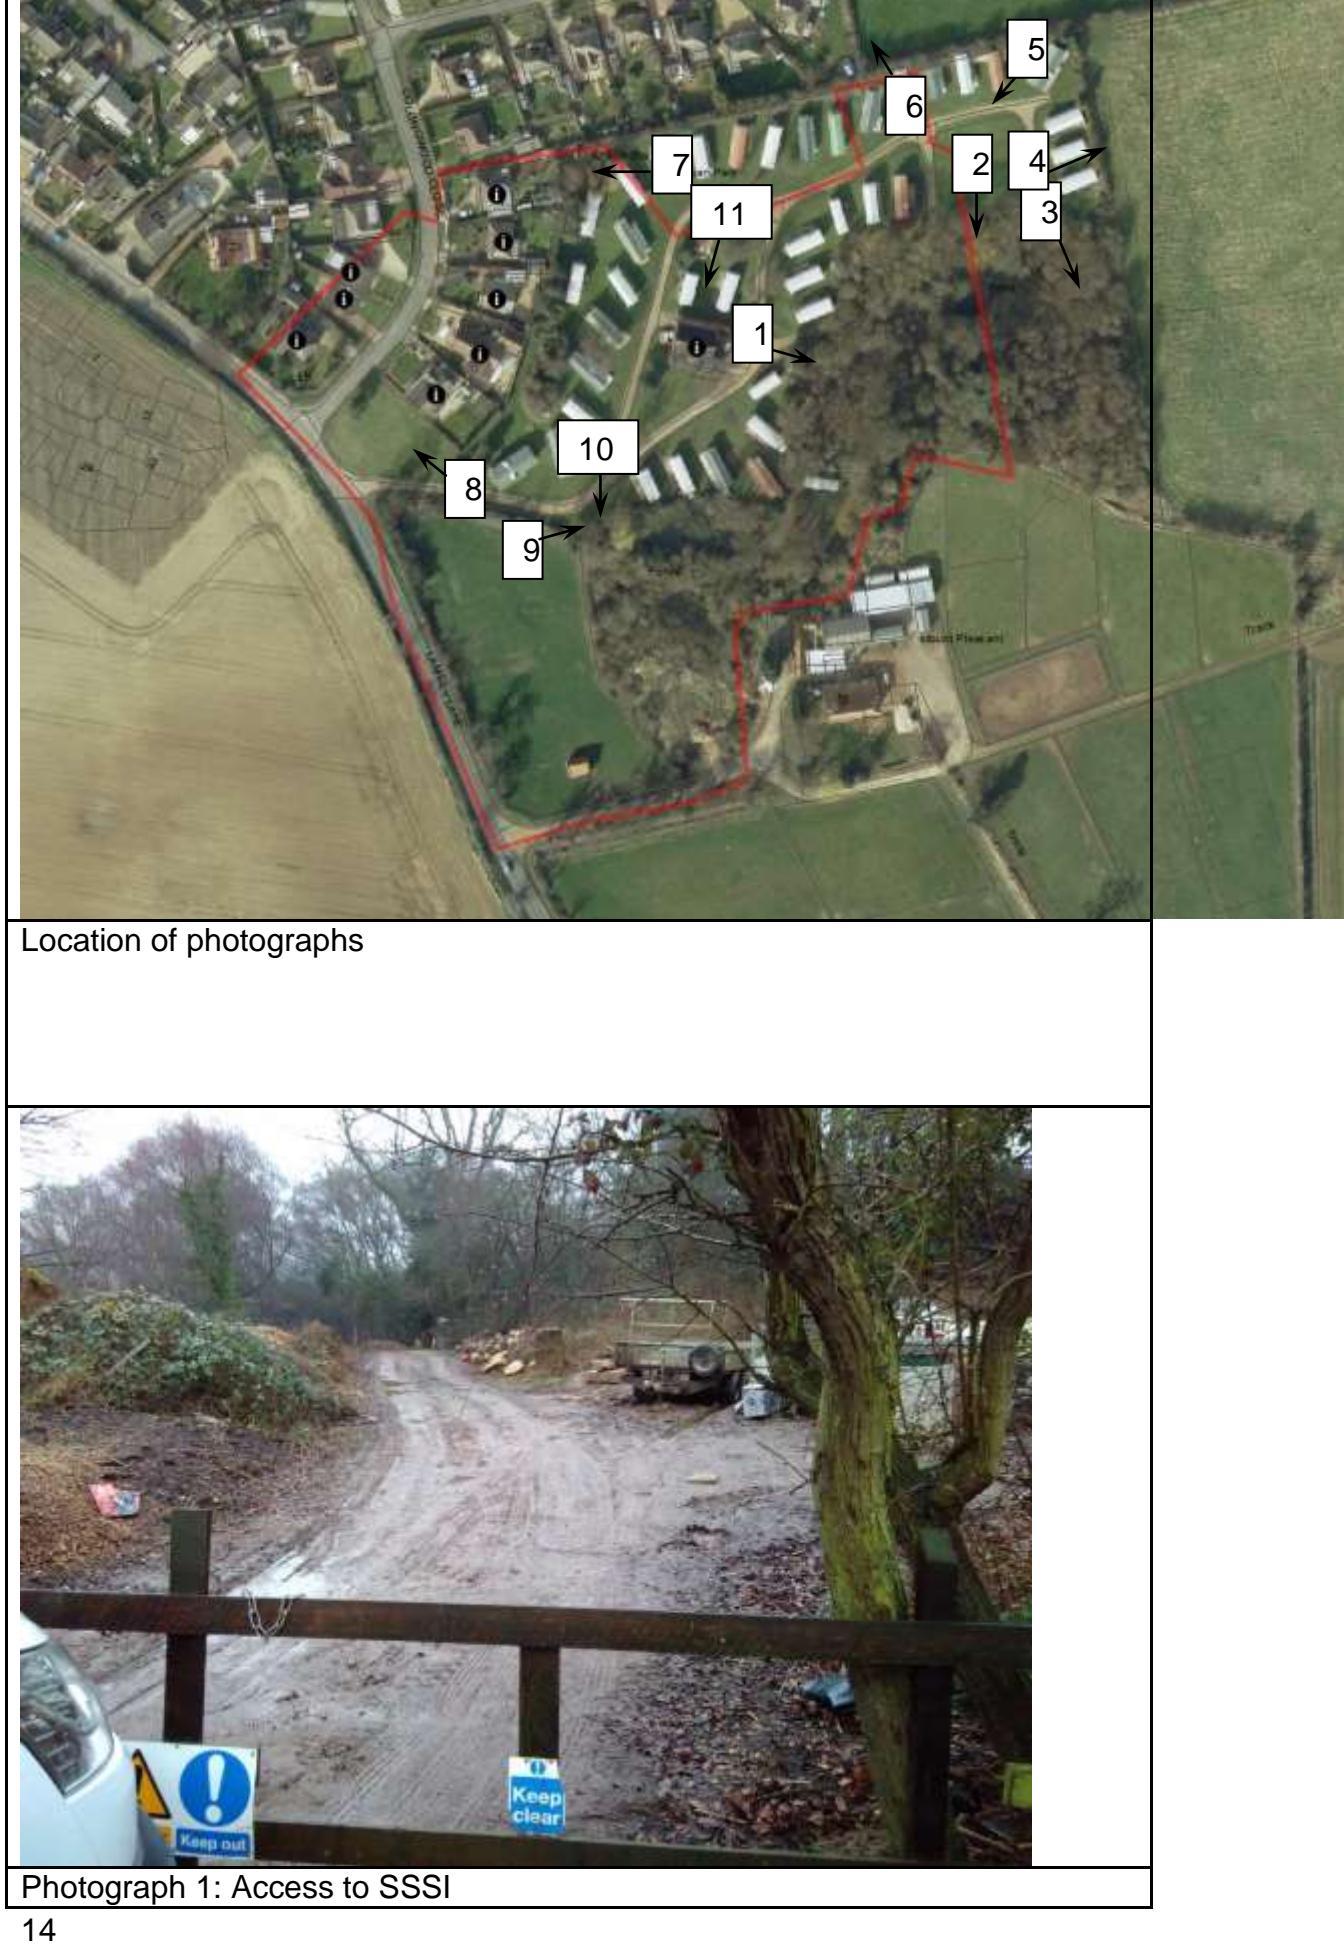
The SSSI in the north east of the site is a low-lying wooded area (photographs 1, 2 and 3). The trees were being maintained at the time of the site walkover. Staff were noted to be wearing appropriate personal protective equipment including work gloves. The higher ground in this area, on the eastern side of the site is used for general and scrap storage. The south-eastern boundary slopes upwards to the adjacent land. This slope is very steep in places (a change of 2-5m elevation) indicating the extent of former excavations (photograph 2). Parts of the north-eastern boundary also slope steeply upwards to adjacent land (photograph 4).

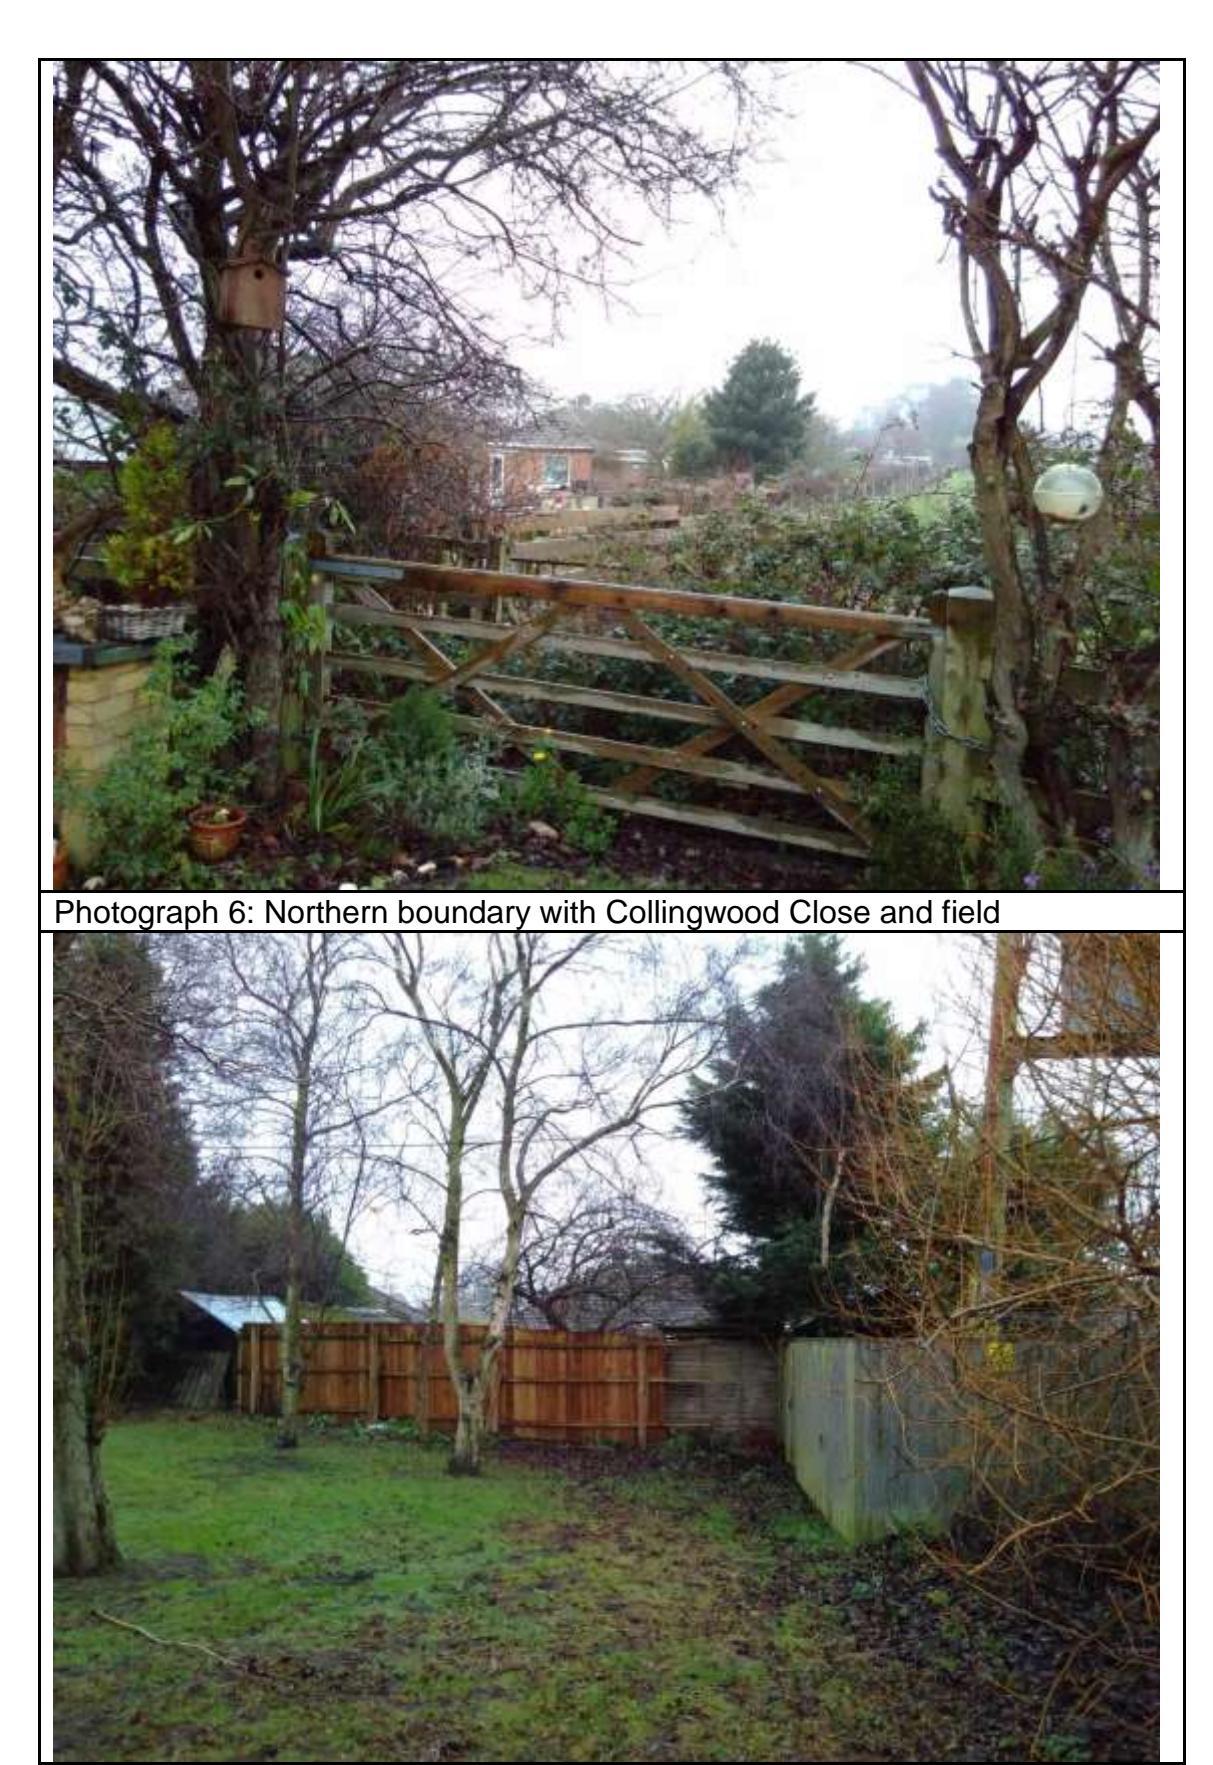
Photograph 7: Northern boundary with Collingwood Close

Site boundaries consist of hedges and fences as shown on photographs 6, 7 and 8. There was no perceptible change in topography between the Caravan Park and Collingwood Close. A number of ponds are present in the south and the east of the caravan site, the pond (photograph 9 and 10) contained water and was well vegetated with healthy vegetation and there was evidence of wildfowl inhabiting this area. The Carstone geology was visible in the presumed cut face at the south of the pond.

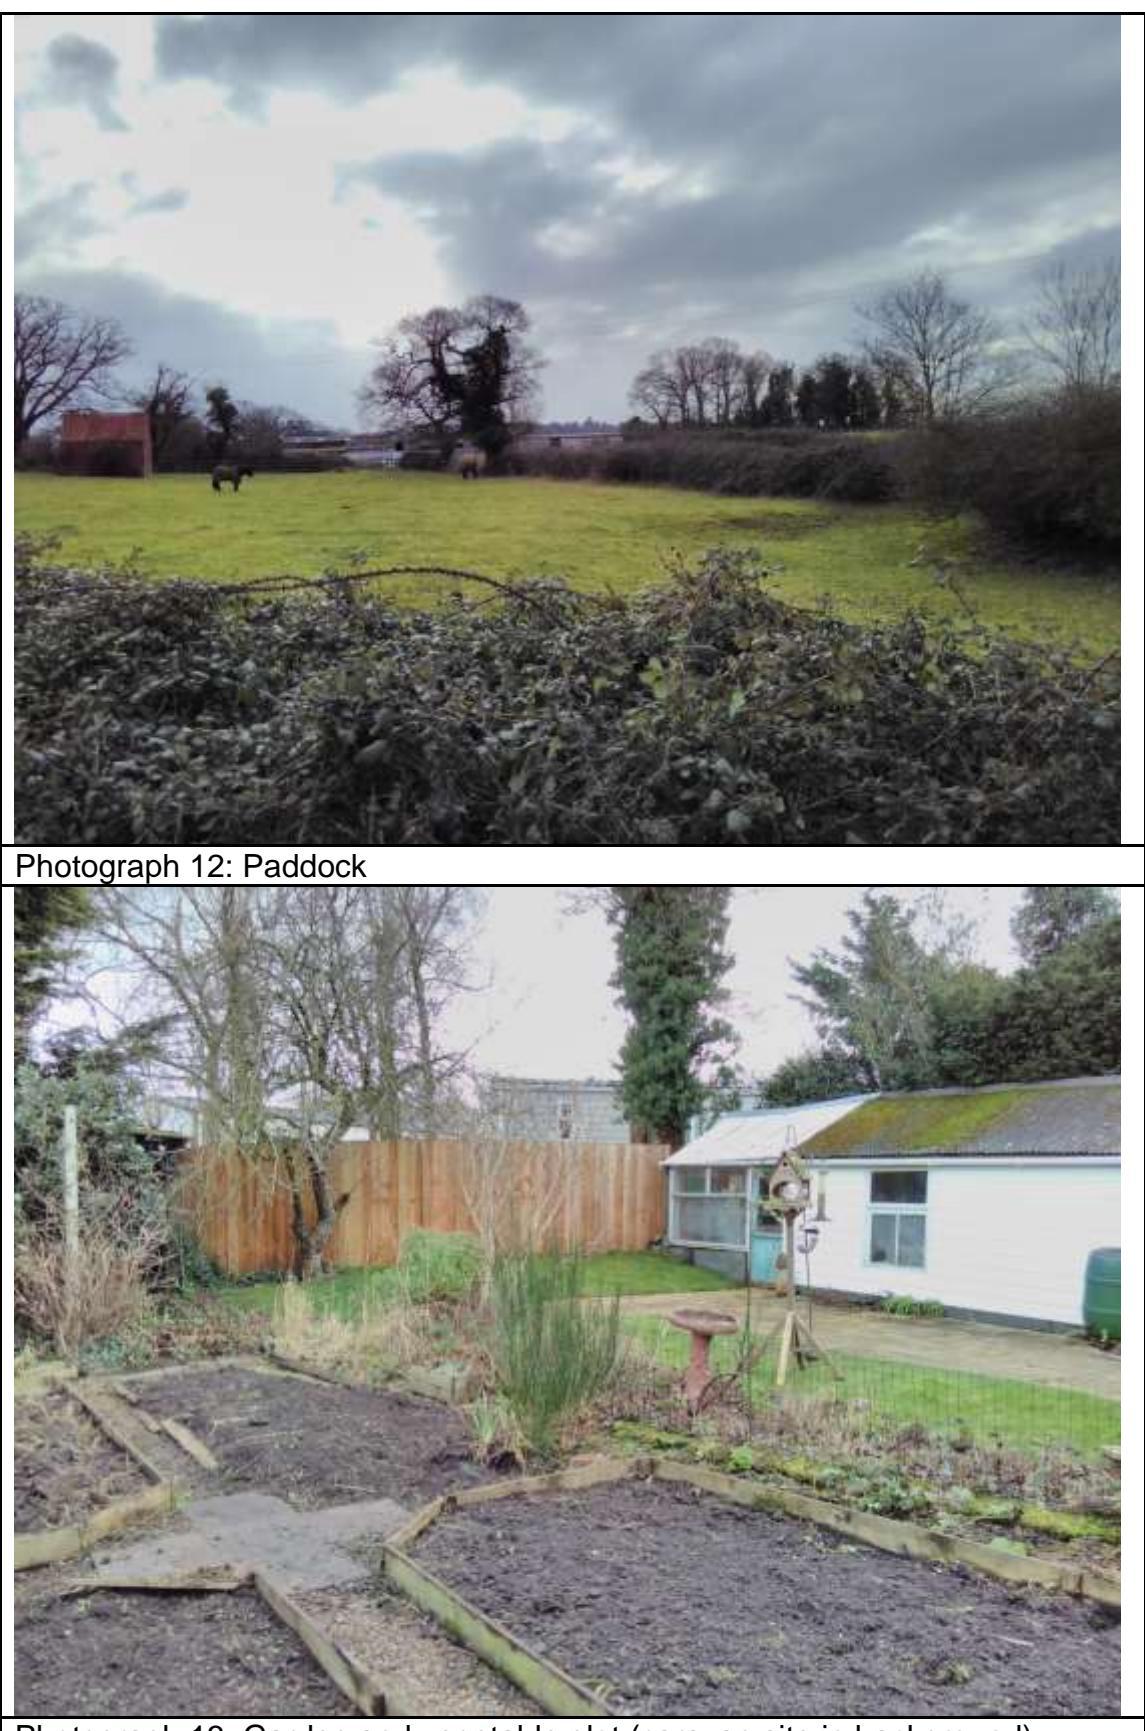
Photograph 13: Garden and vegetable plot (caravan site in background)

Part of the site is occupied by 8 residential dwellings with domestic gardens, predominantly laid to lawn with borders or hard surfaced. Part of one garden contains a vegetable plot which could provide the possibility for prolonged contact with soils and home-grown produce. Some residents reported the presence of brick rubble in gardens. This is considered to be from demolition of brickworks buildings. No visible evidence was noted of brickworks process wastes or fuel ash in garden soils. There is a potential pollution linkage and circumstances are possible under which an event could occur.

Consideration was given to taking soil samples from within the vegetable plot for chemical analysis. However as an examination of historic maps indicates that the brickworks main process areas were not located in the area that is now the garden with a vegetable plot, it is by no means certain that even over a longer period such an event would take place and it is less likely in the short term. The probability of a contamination event occurring on the residential part of the site is considered to be LOW.

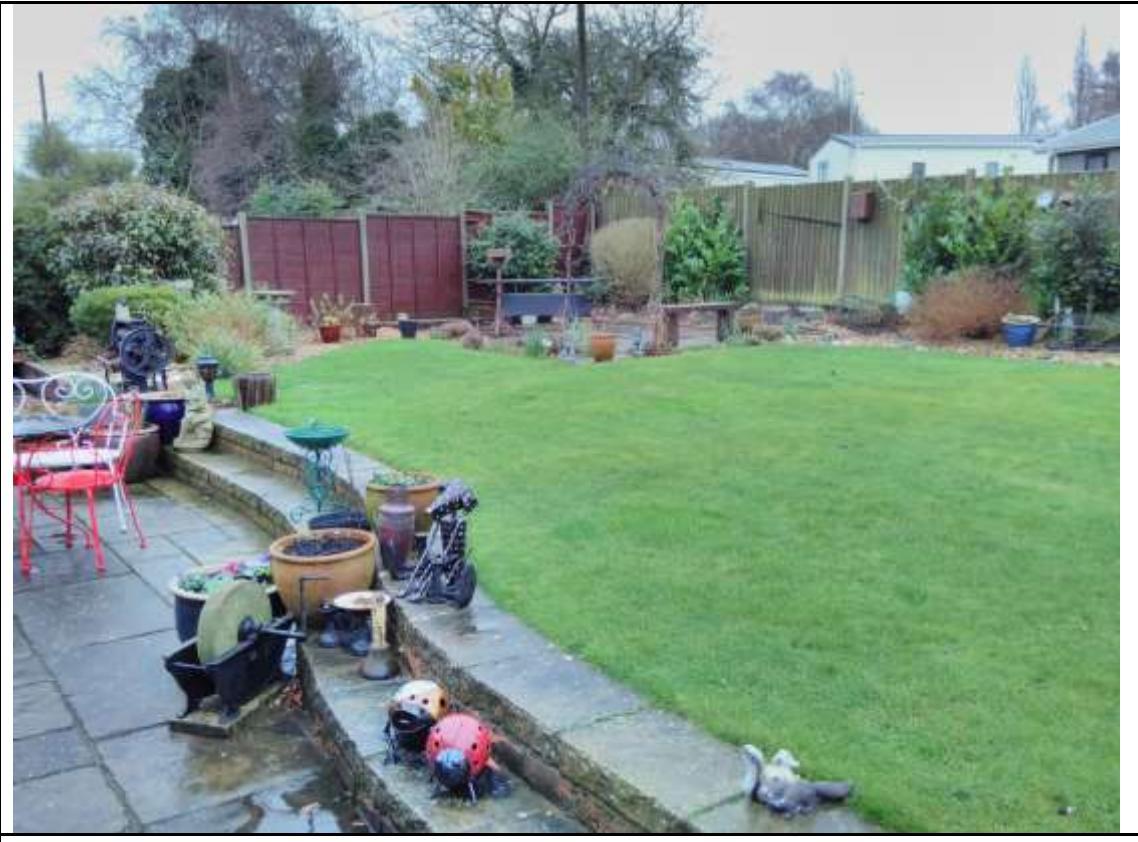
Photograph 14: Garden, hard surface, laid to lawn with borders & shingle (caravan site in background)

Visits were made to the houses and gardens within the site on Collingwood Close. Gardens to the east of Collingwood Drive generally slope upwards towards the caravan site. Gardens to the west are fairly level. All the gardens were noted to have thriving lawns and plants. Garden sizes range from 75–200m<sup>2</sup>. One garden was observed to contain a vegetable plot (photograph 13). The majority of garden space is soft landscaped with lawns, borders and shingled areas as shown in photograph 14. Residents to the east of Collingwood Drive, adjacent to the caravan park, reported finding brick fragments in garden soils. A number of gardens had Heacham bricks as garden ornaments (as shown on the cover photograph). However these were reported to have been obtained from a source within the village. The residents of two properties on the east of Collingwood Drive reported that a 'mound' of rubble, including bricks and soil had to be removed from the fence line adjoining the caravan site when they first moved in.
