Borough Council of King's Lynn & West Norfolk

Contaminated Land Inspection Report

Stow Road, Wiggenhall St Mary Magdalen

Reference no. CL 022155.2

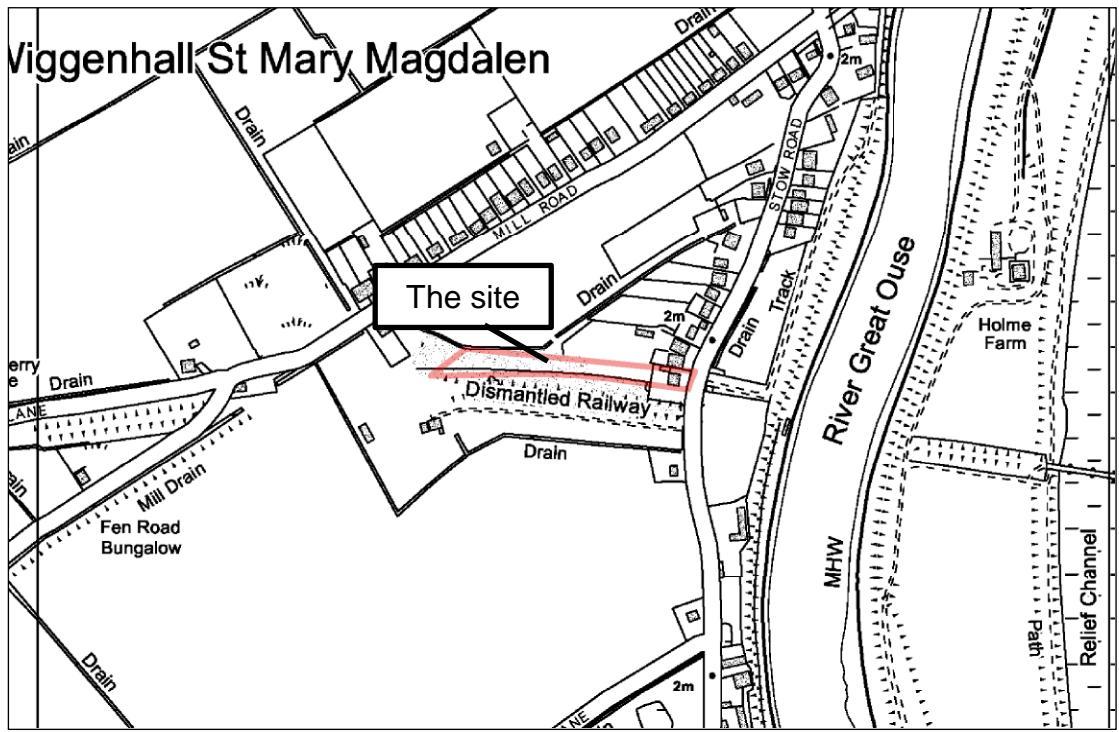
Map 1: Site location

The site is now occupied by a residential property with a domestic garden, and part of a paddock. The location plan below (map 1) shows the site and the surrounding semi-rural area. Photographs of the site are in appendix A.

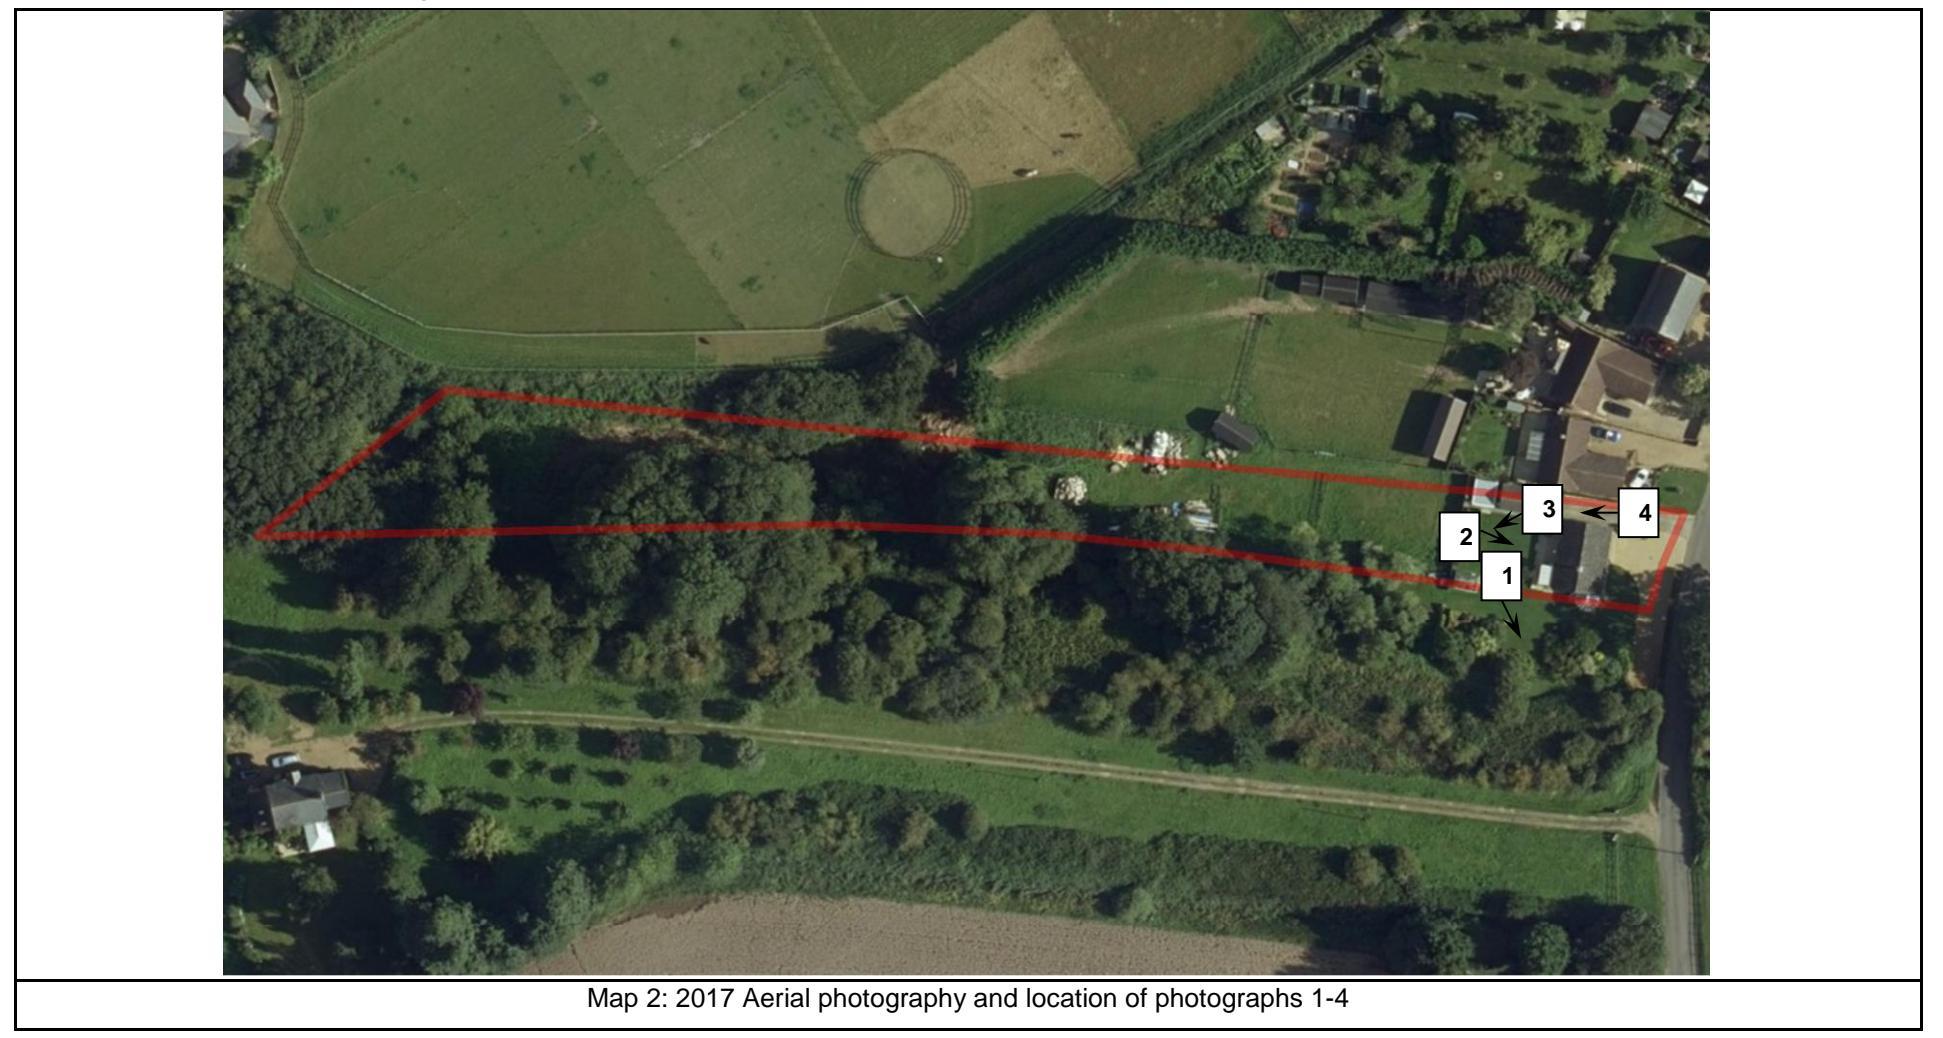
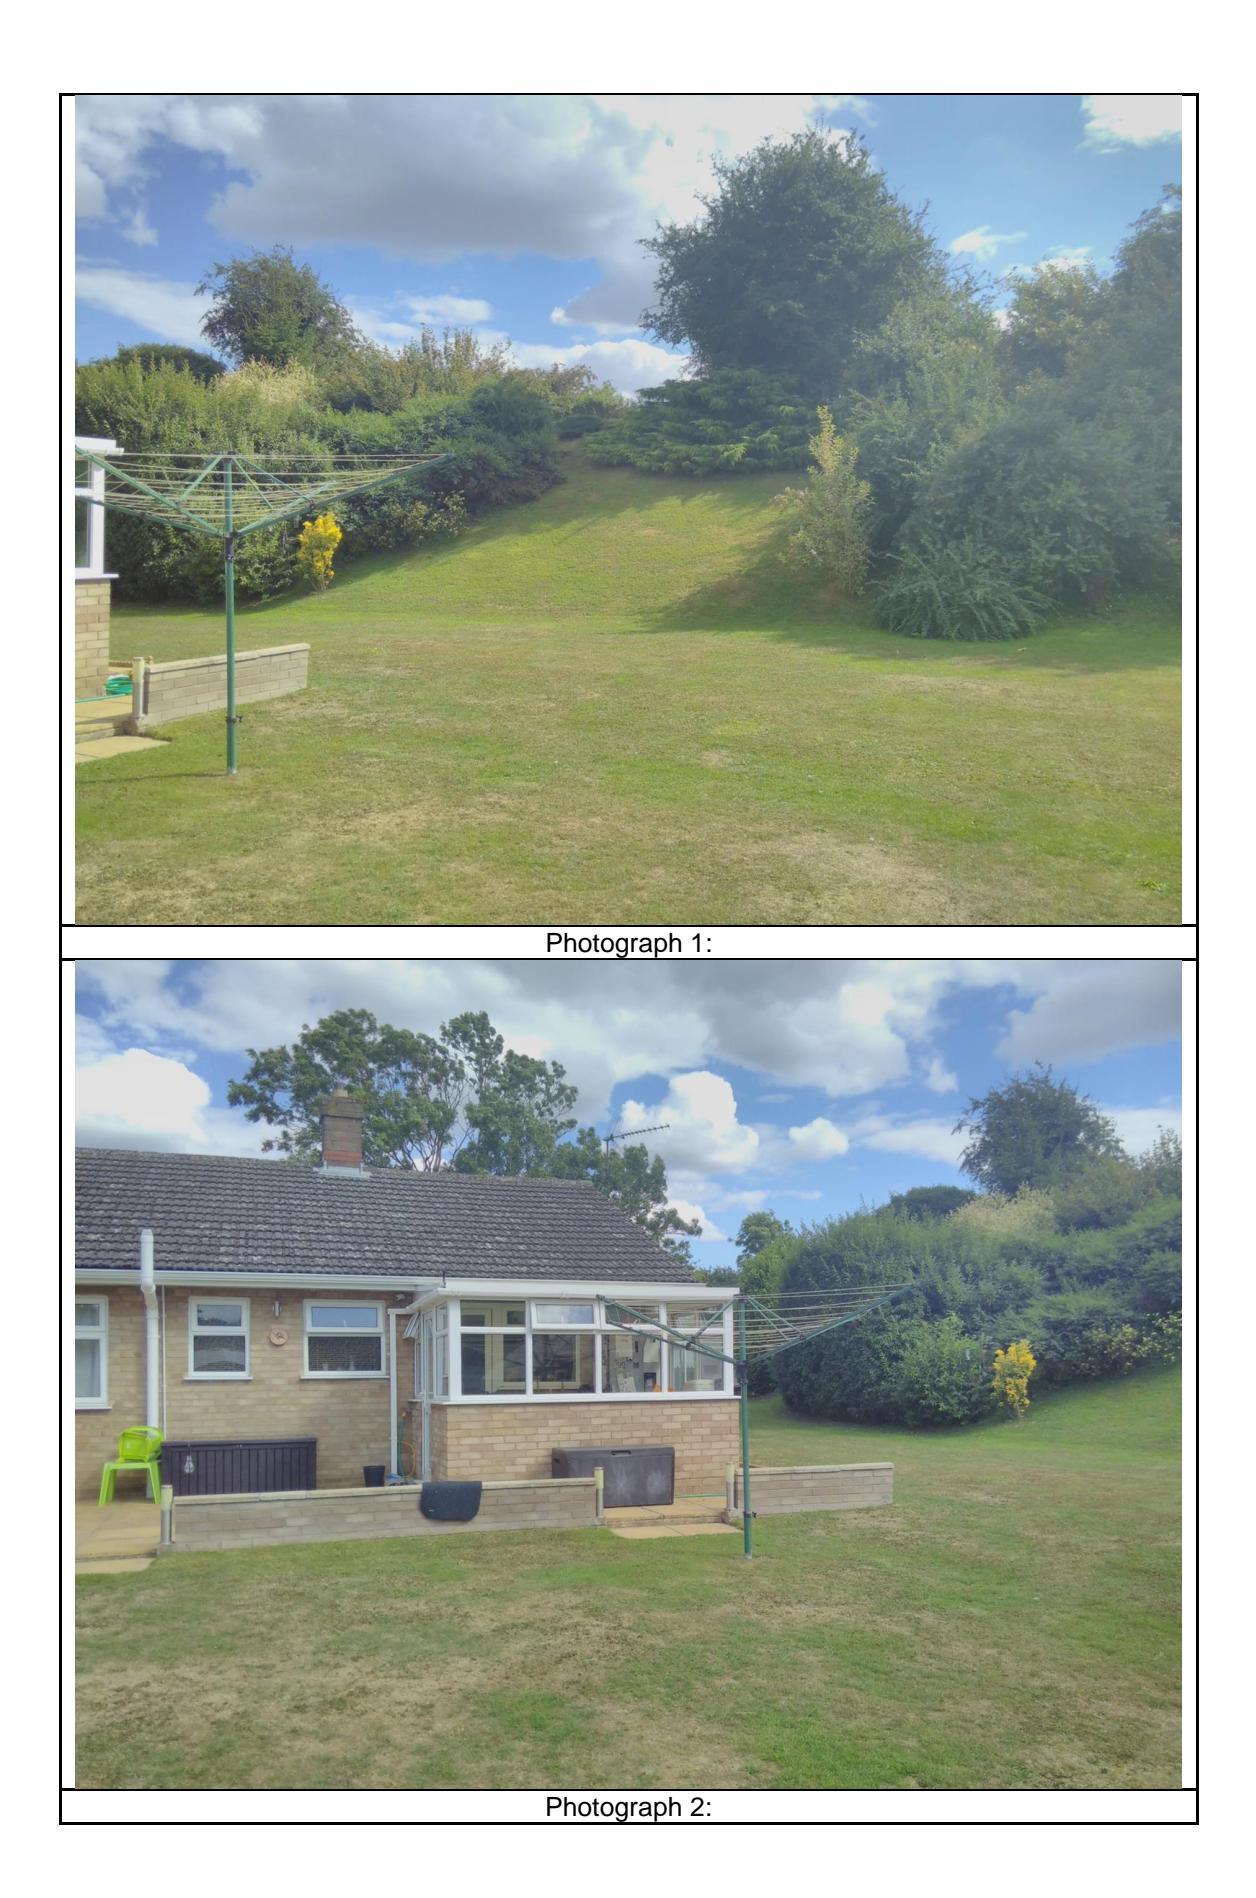
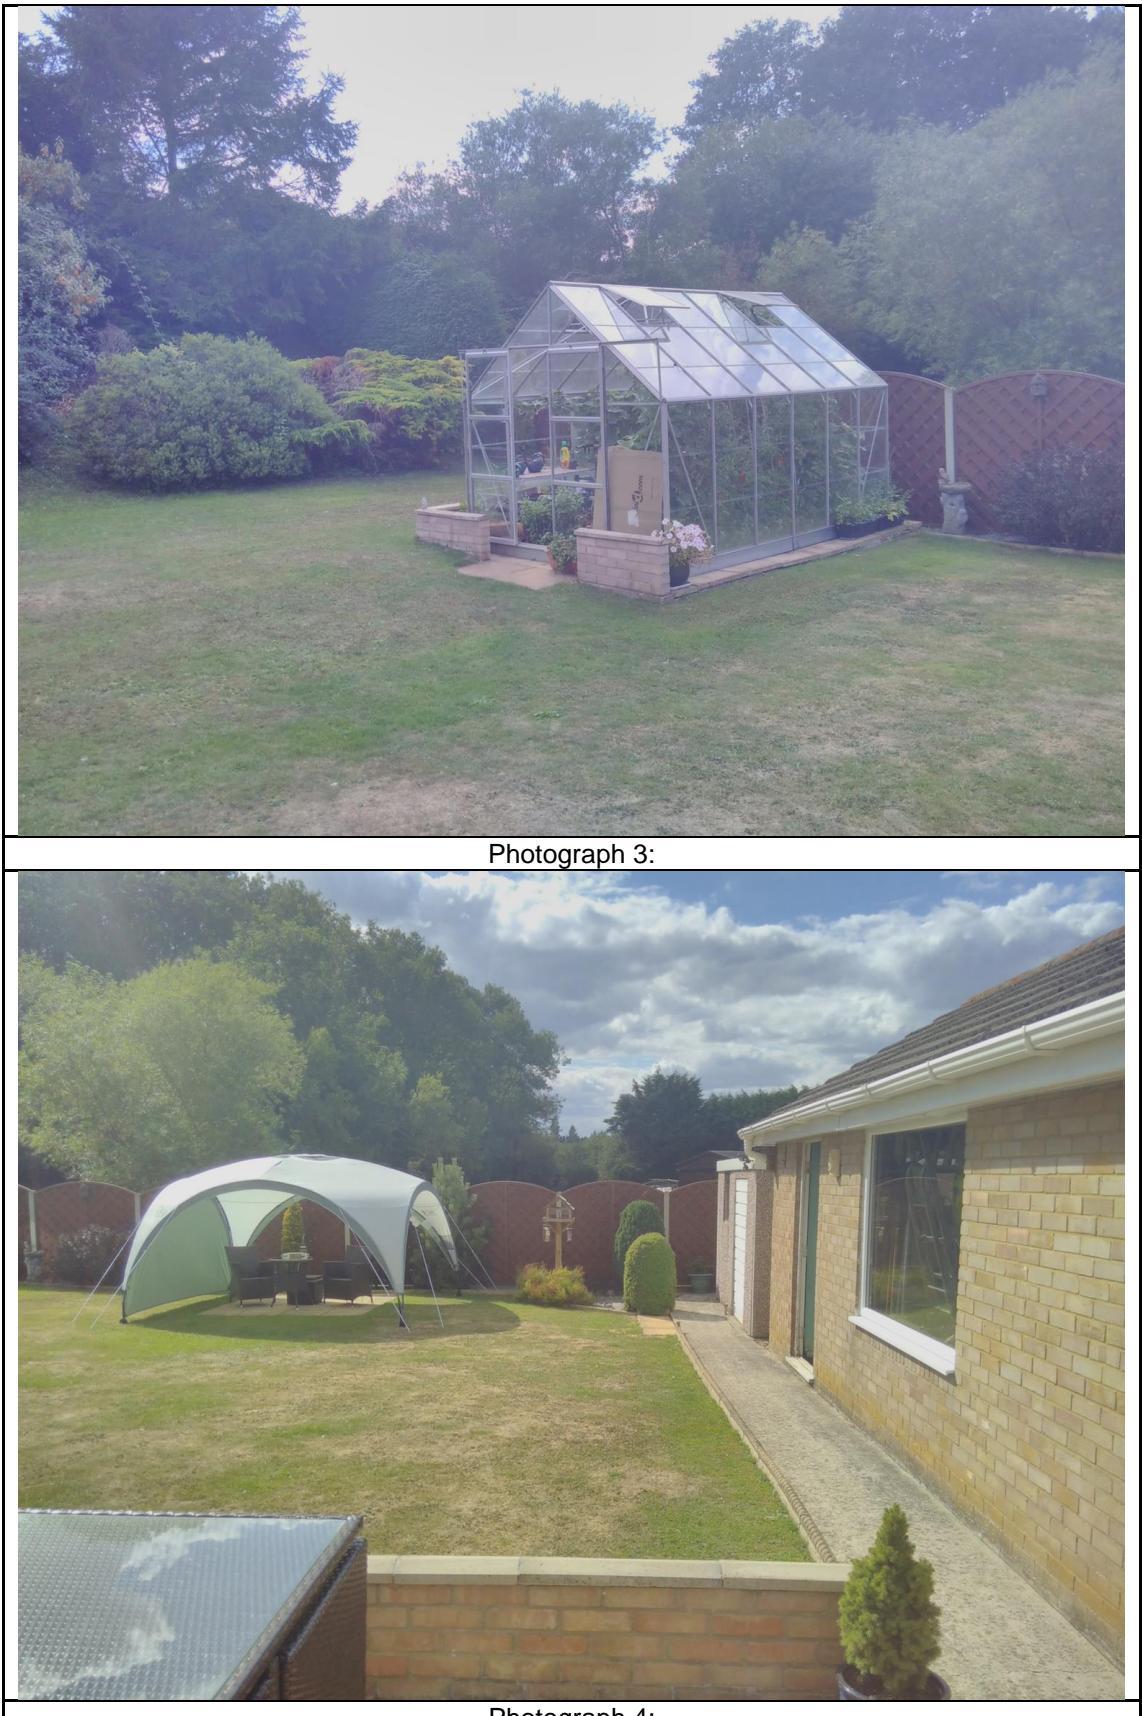
Appendix A: Site Photographs

The garden of number 92 Stow Road was accessed with the owners who live in the house at this address. The property has a garden which extends to the rear and southern side of the house. The current residents bought the property in 1984 and later also acquired the railway embankment to the south which now forms part of the garden. The railway embankment slopes downwards into the garden and is grassed and planted with shrubs (photographs 1 & 2). The residents of 92 say that they have re-laid the lawns and had to clear and level out the ground on the embankment which was overgrown. The residents report that when excavations were made in the garden, the subsurface appeared to be made up with soils, old road surfacing material, hoggin and carrstone.

The garden of number 92 is predominantly lawned. There is a small greenhouse for growing vegetables in which the ground level is raised to

provide a suitable growing medium. All the vegetation appeared healthy and the ground appeared generally level (Photographs 3 & 4). The site walkover took place following a significant period of hot dry weather and grass dieback was common across the region. No evidence of waste material was noted at the surface and no signs of subsurface movement were observed.

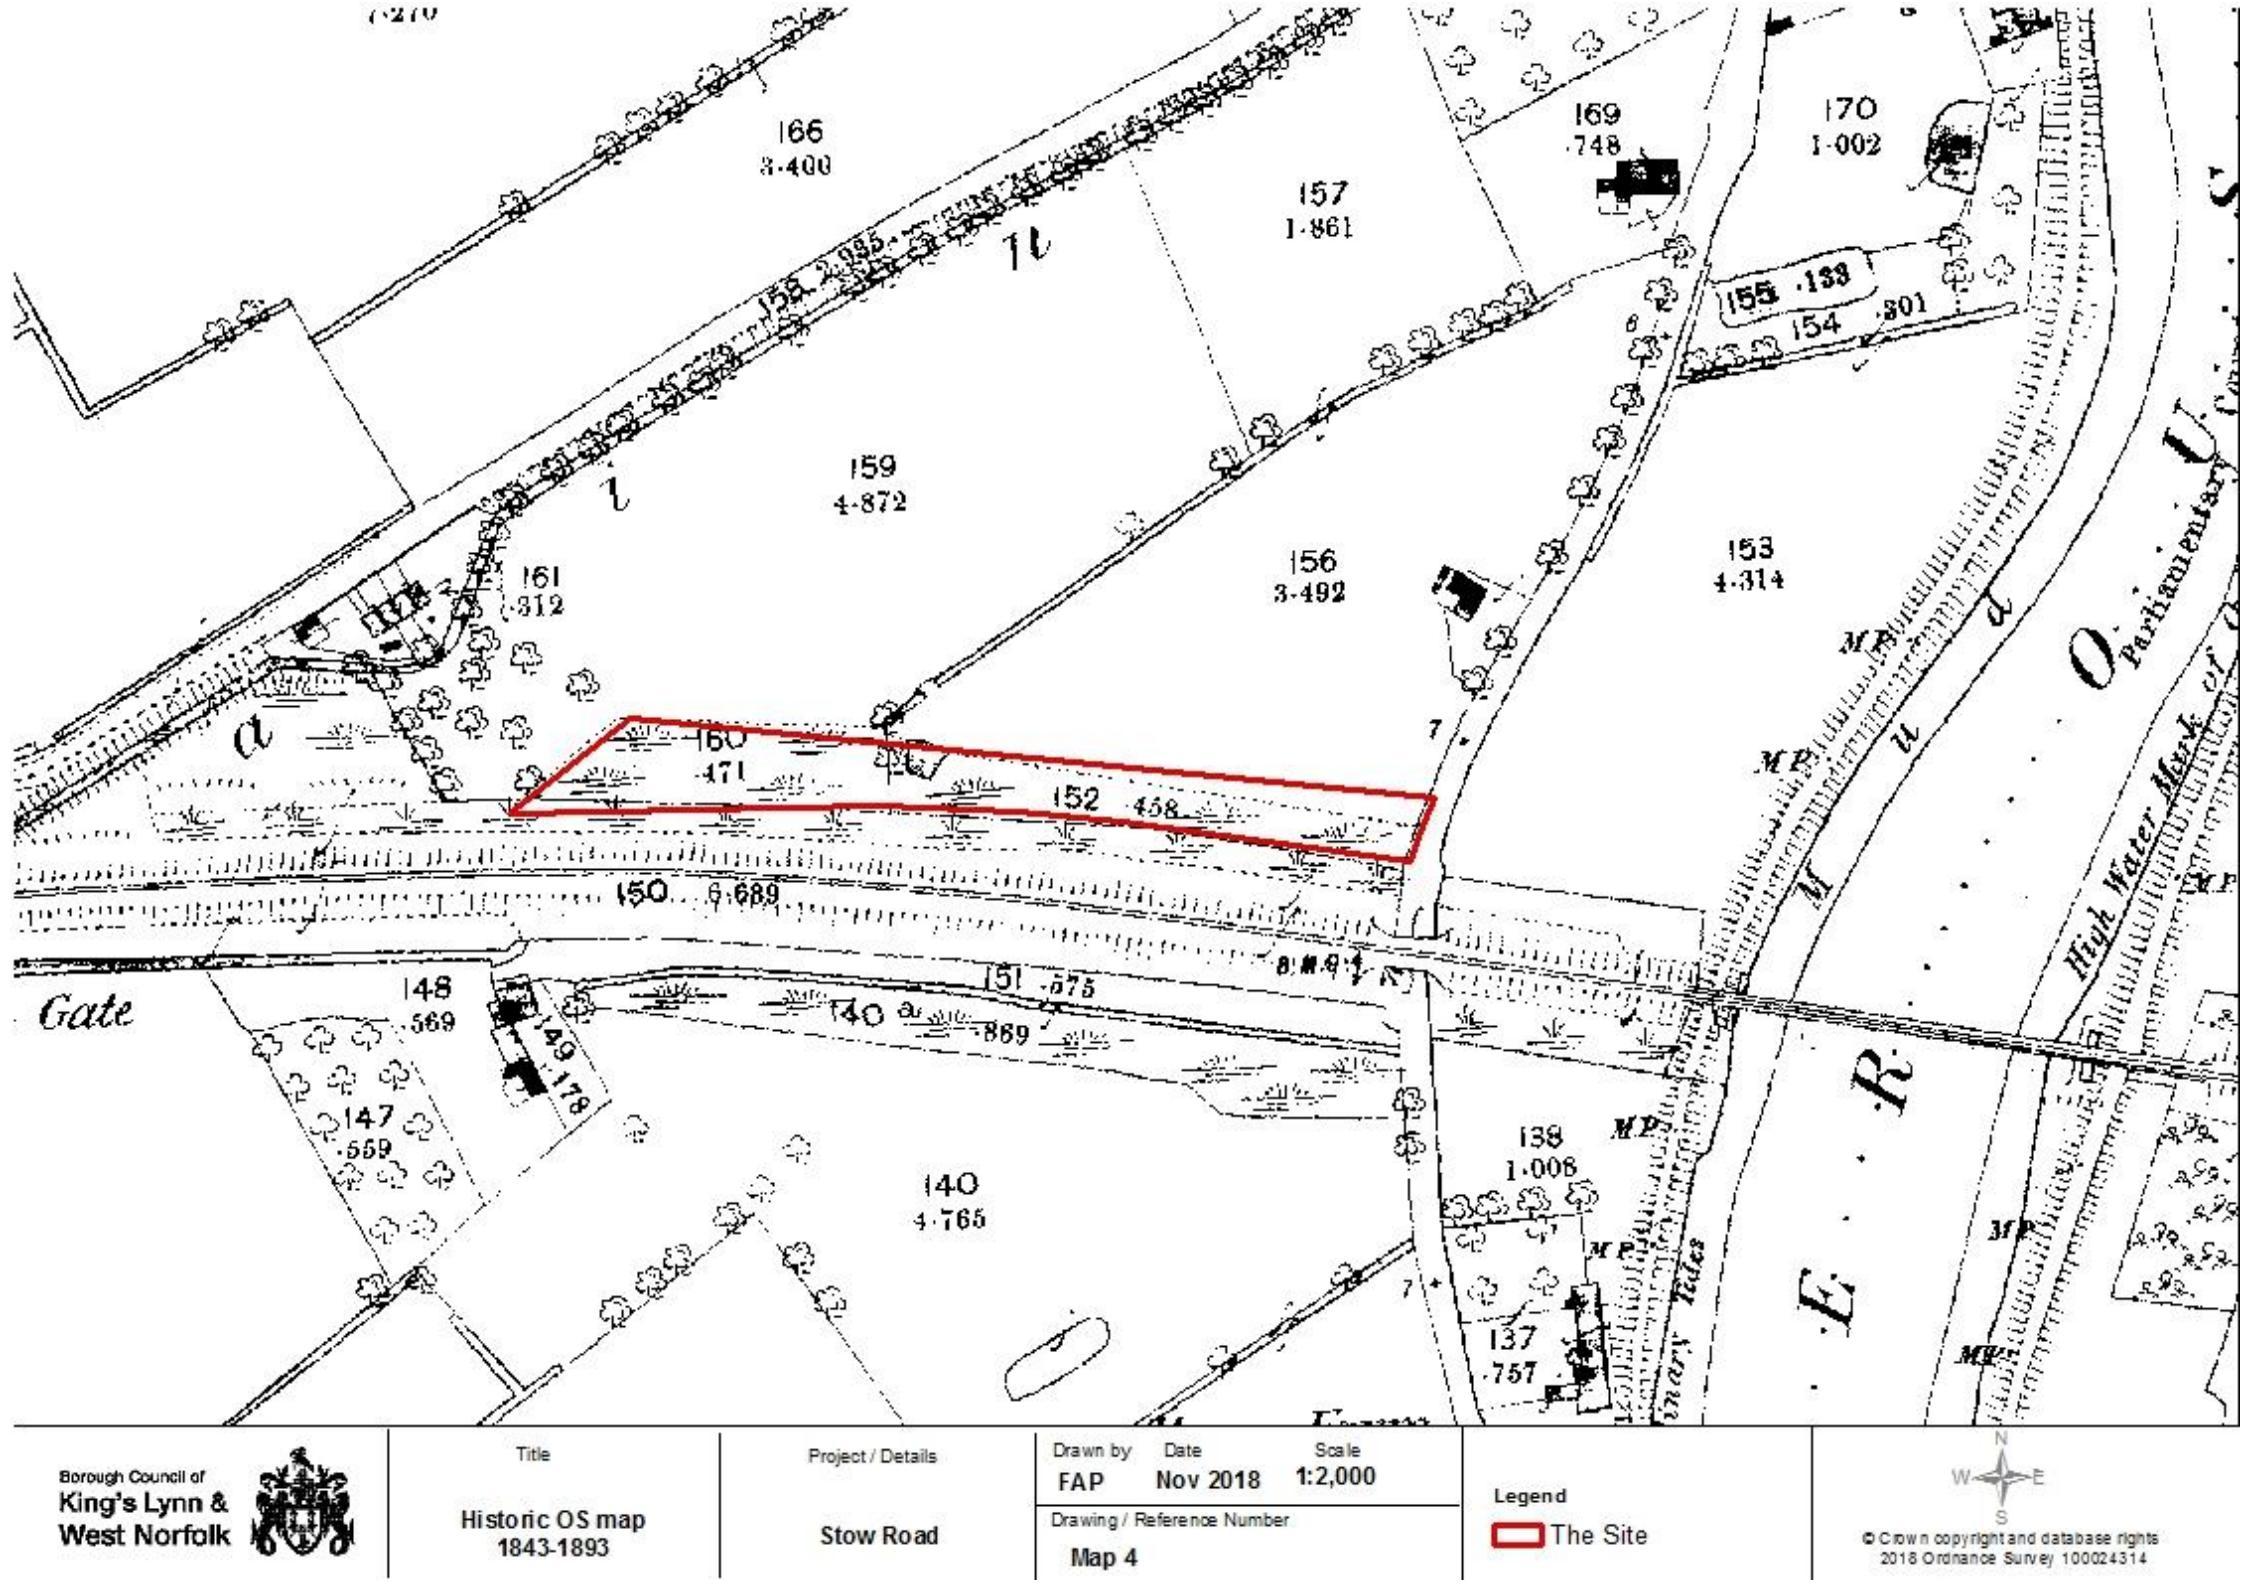
1843 – 1893: (Map 4) The site is indicated as being a marsh with a field to the north, Stow Road to the east, a railway line, on an embankment, to the south and additional marsh to the west. A residential dwelling is depicted in the field to the north.
