PLAN G: Improvements to Accessibility

PLAN H1:Appraisal - Footpaths, Steps, Ramps and Walls

PLAN H2:Appraisal - Footpaths, Steps, Ramps and Walls

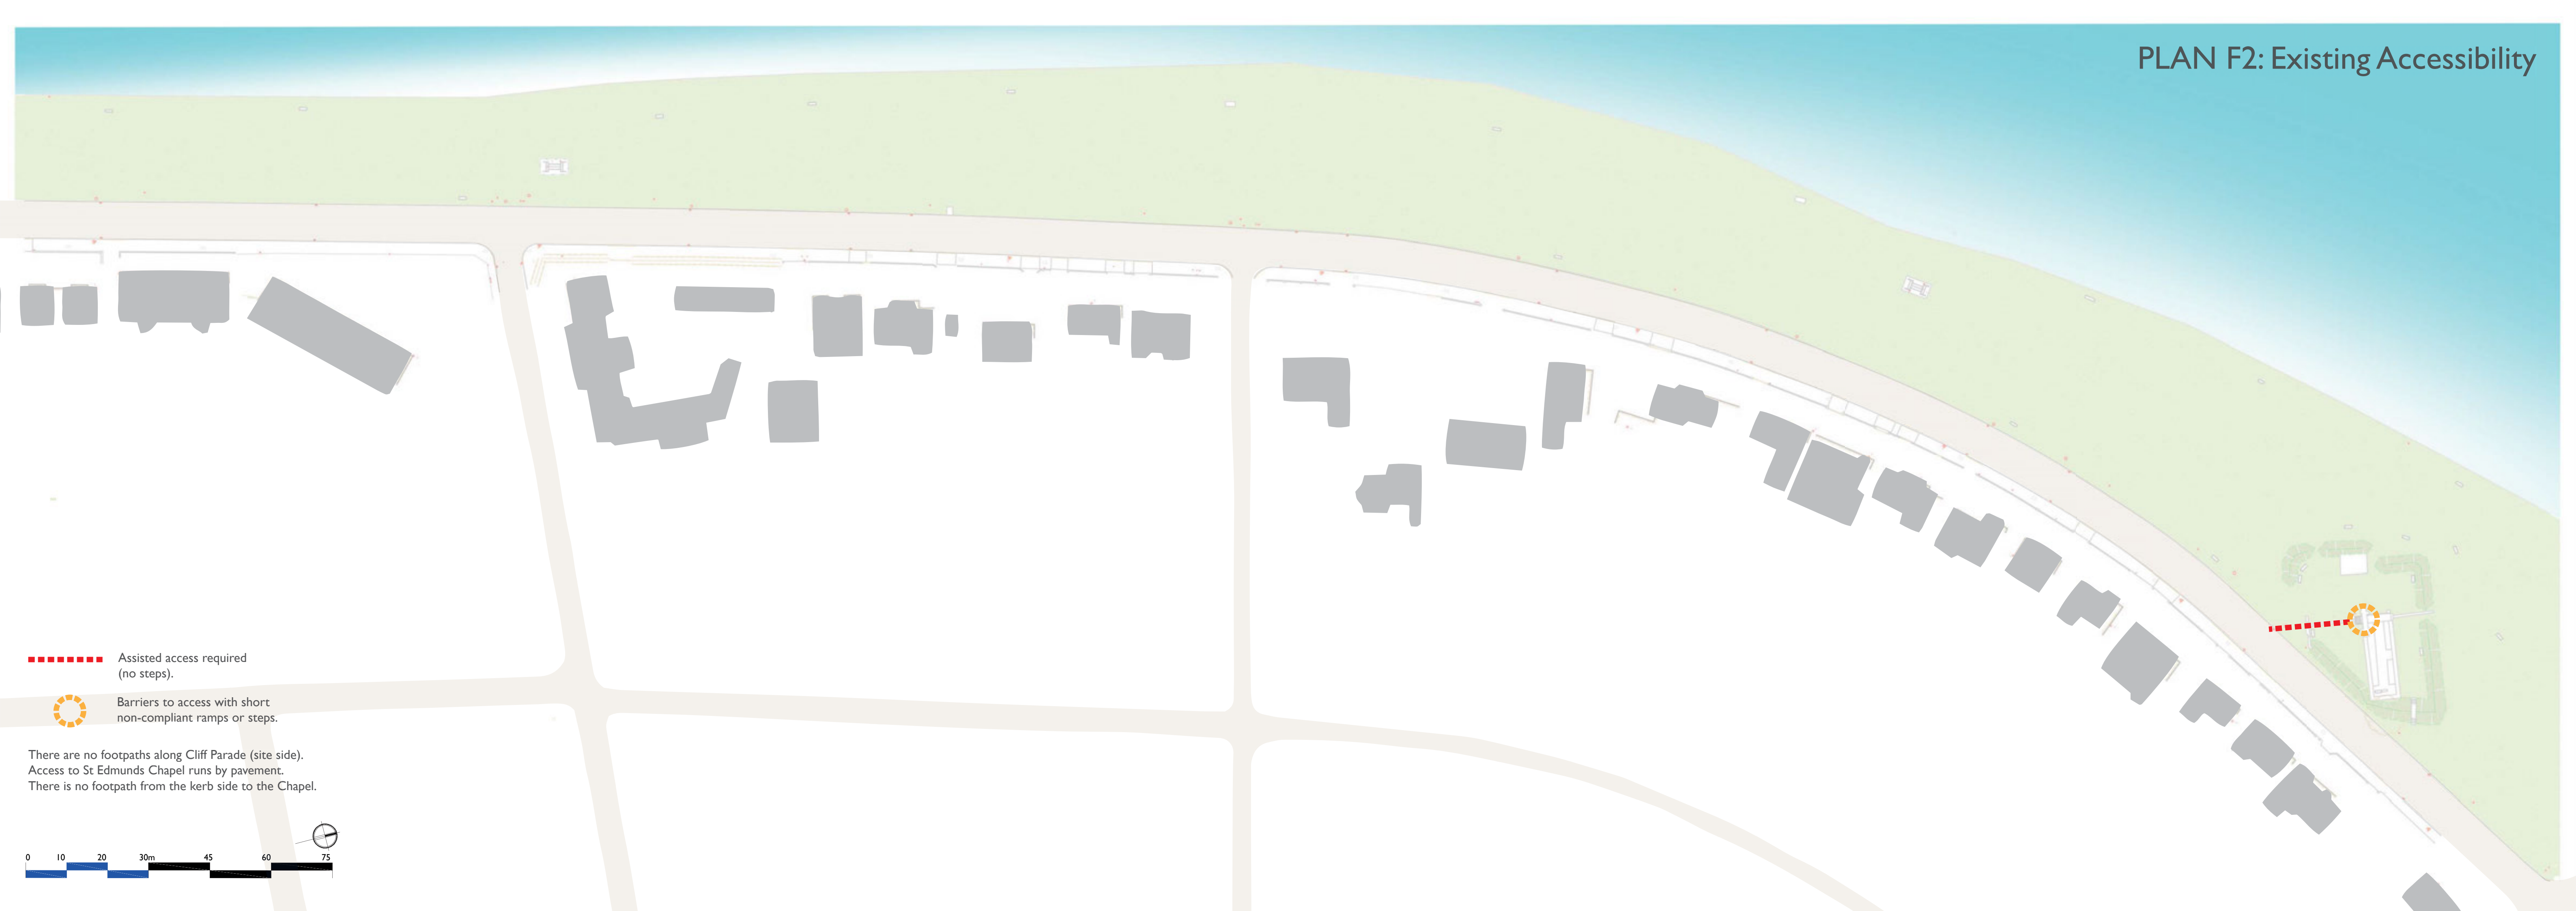
Assisted access required (no steps).
-

Barriers to access with short non-compliant ramps or steps.

There are no footpaths along Cliff Parade (site side).  
Access to St Edmunds Chapel runs by pavement.  
There is no footpath from the kerb side to the Chapel.

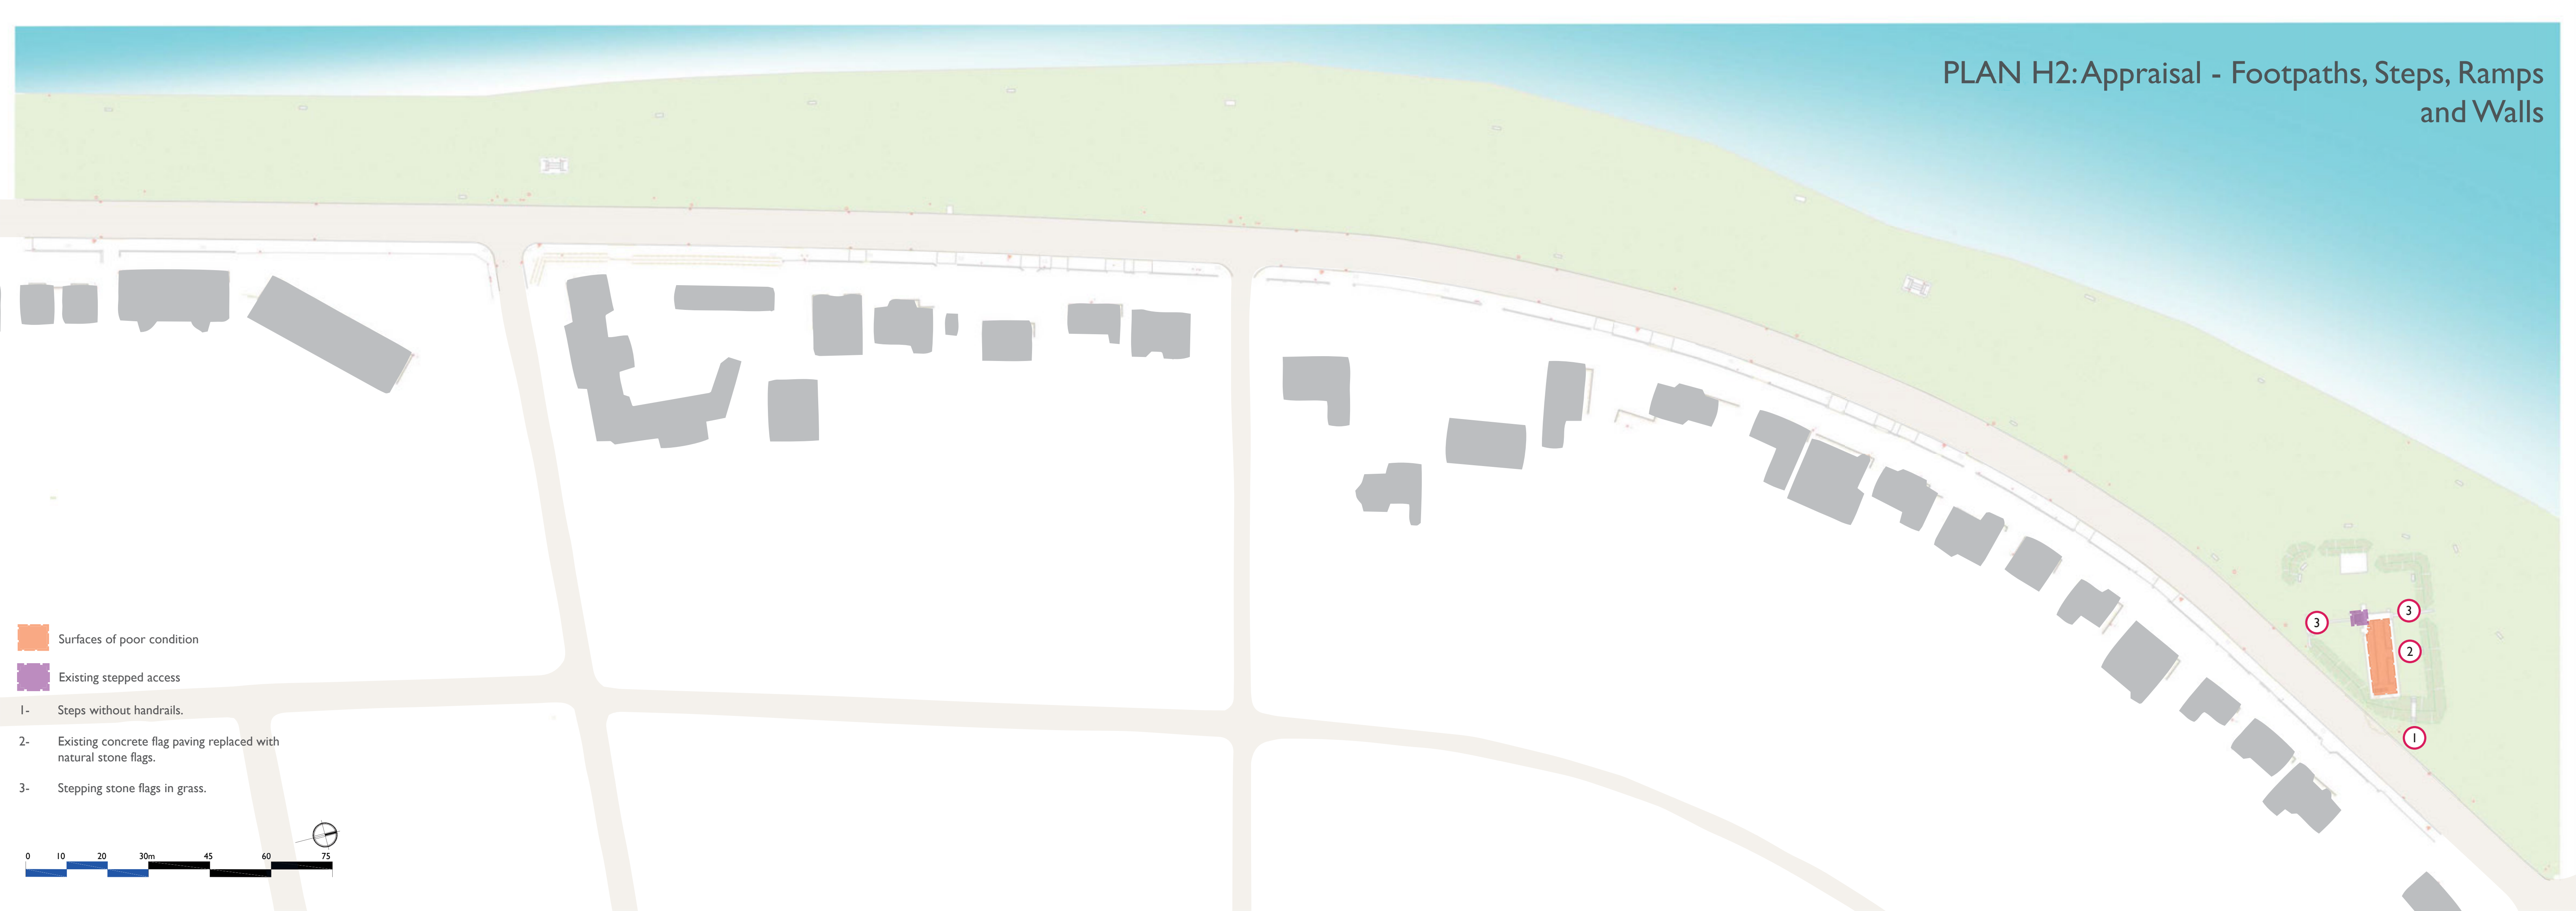
- Surfaces of poor condition
- Existing stepped access
- 1- Steps without handrails.
- 2- Existing concrete flag paving replaced with natural stone flags.
- 3- Stepping stone flags in grass.
