VERIFICATION REQUIREMENTS FOR COVER SYSTEMS

Technical Guidance for
Developers,
Landowners and
Consultants

**Yorkshire and Lincolnshire
Pollution Advisory Group**

Version 4.1 – June 2021

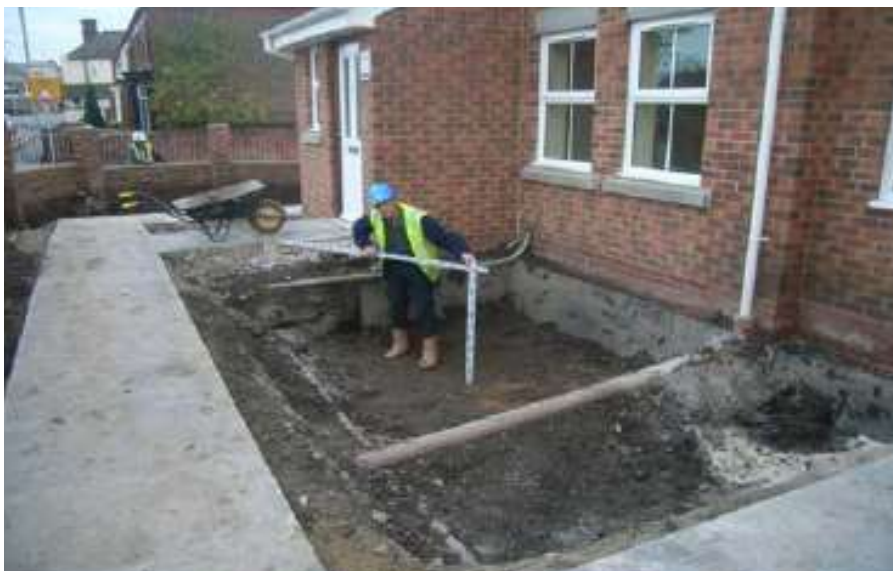
Photograph 4:
Depth check of inert cover within areas of front gardens.

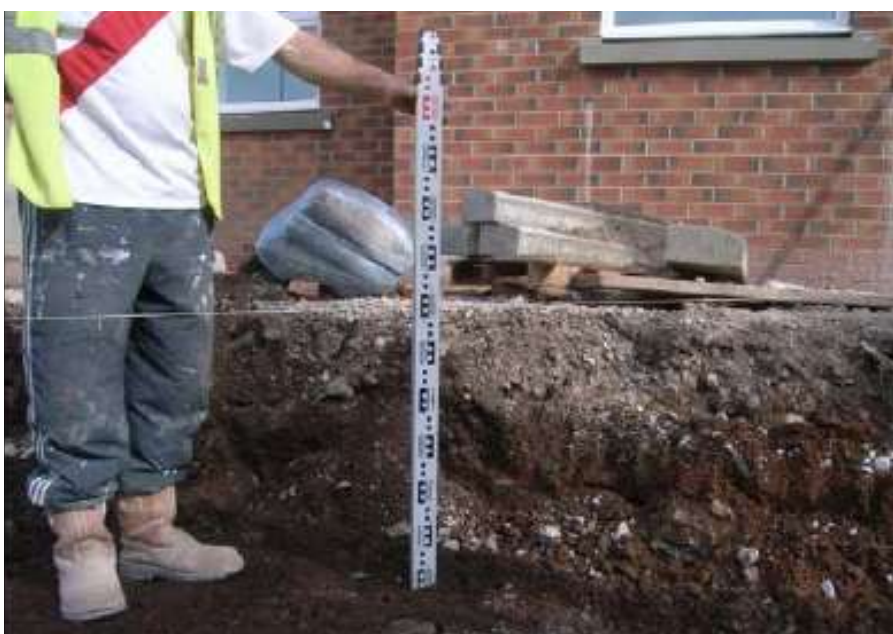
Photograph 5:
Depth check of inert cover within rear gardens. Taut string line spans across excavation.

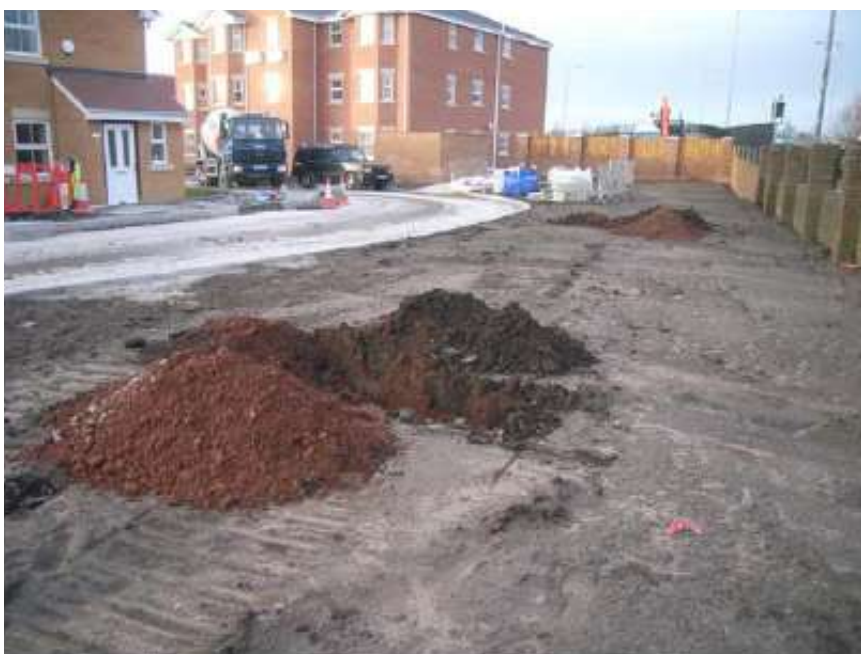
Photograph 7:
Shows the spatial
location of the
verification pit.
