## Hunstanton Coastal Defence Emergency Works FAQs

A series of frequently asked questions (FAQs) have been produced by the Borough Council of King's Lynn and West Norfolk following a large void developing beneath the Hunstanton Coastal Defences resulting in a subsequent collapse of part of the asphalt surfaced promenade.

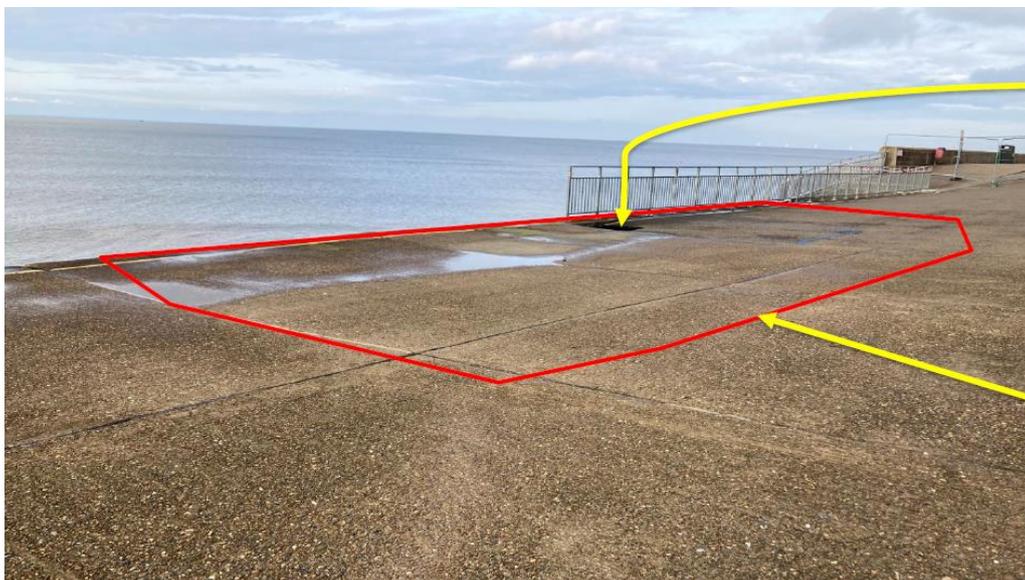
Between the evening of Wednesday 4<sup>th</sup> and morning of Thursday 5<sup>th</sup> February 2026, high tides and strong winds caused around 20cm to 30cm of beach material to be eroded. This resulted in tidal action forming a void under the promenade deck and resulted in partial collapse of an asphalt area of promenade.

Hole in asphalt

Approx  
dimensions of  
void  
underneath

Firstly, gaps in the blockwork and concrete pad edges will be sealed to prevent any concrete mix from seeping out from behind the fill area and on to the beach. A section of trench sheet pile will then be installed at the base of the seawall directly in front of the void area.

Additional access holes will be cored into the top of the concrete promenade pad to allow concrete to be poured in. The concrete will be poured in 0.5m to 1m depth layers to allow it to settle and cure between pours. The access holes will then be sealed once the fill has been completed.

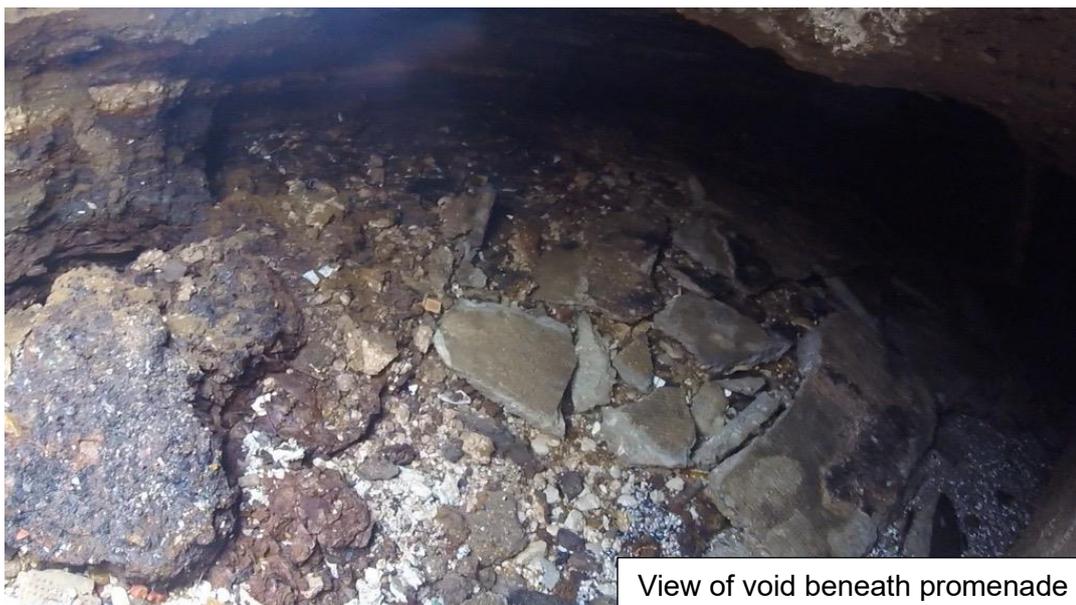
View of void beneath promenade

Further investigations identified that a large void had developed beneath the promenade.

Current estimates of its size are 4m wide, 3.5m deep and 15m long.

High tides combined with strong winds resulted in further erosion of beach material at the base of the Hunstanton Coastal Defences. This resulted in a further 20-30cm of beach material erosion leading to the base of the seawall becoming exposed.

This meant waves were able to travel beneath the base of the seawall and washout internal fill material leading to a void developing. This void resulted in a lack of structural support to the promenade deck above, leading to its collapse and a hole at the surface forming.

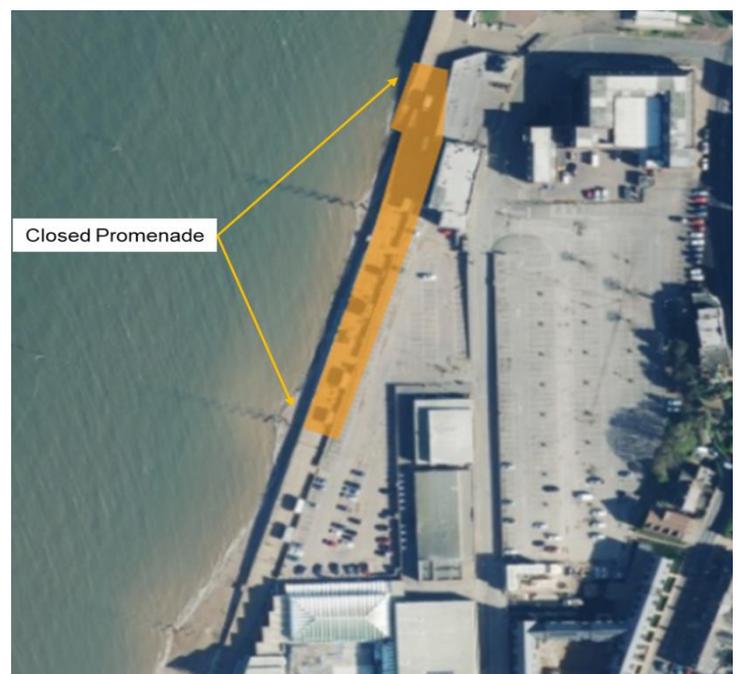
Yes – the current 140m cordon for both pedestrian and vehicles around the void will remain in place while these works are undertaken. Please do not enter the area of promenade which is closed and use alternative routes to access the remainder of the promenade and beach.

This cordon will remain in place until emergency works are completed.

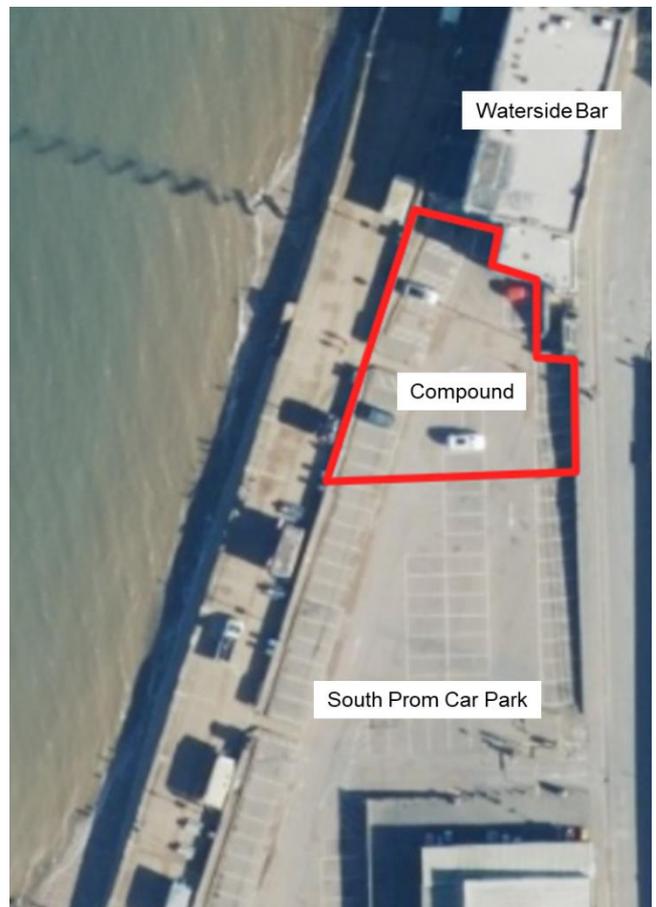
Yes – for the duration of these works, a fenced off compound, including welfare cabin, skip, concrete mixers, and a concrete pump will be set up at the northern end of the South Prom Car Park. Appropriate signage will be placed on the fencing around the compound to notify members of the public of the works taking place.

At times, plant will be required to push trench sheet piles into the beach material at the base of the seawall. In addition, a concrete truck and pump will be present on the South Prom Car Park to fill the void. When this is required, appropriate warning signage will be displayed around the working area, and works will take place for short durations to ensure the safety of both operatives and members of the public.
